# THE CLARK FORK RIVER REACH A REMEDIATION AND RESTORATION PROJECT

Bill Bucher, P.E.

May, 2017

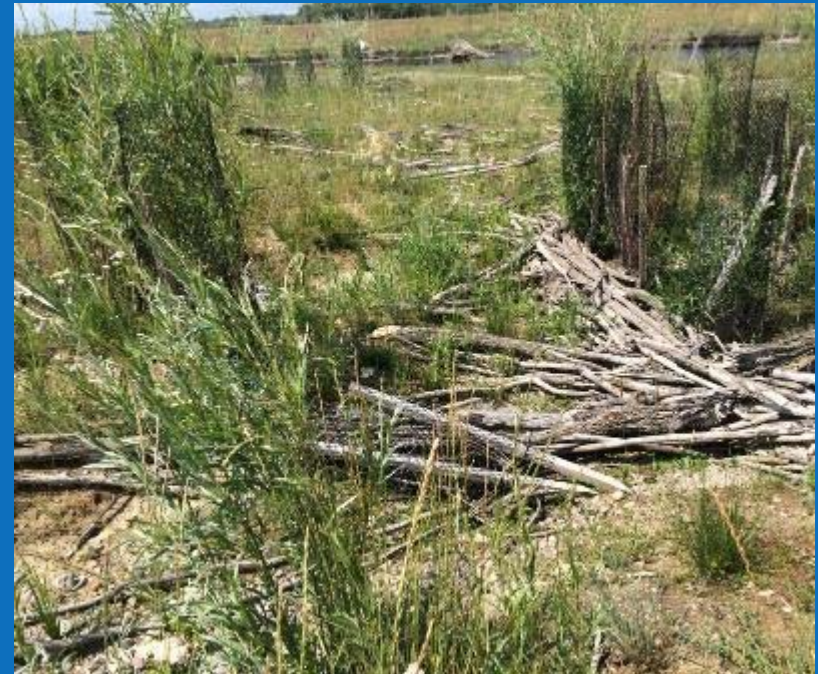
# Phase 1 Geomorphic Evaluation – 2015 & 2016 QRA

- Conducted by Applied Geomorphology and RESPEC
- Channel Stability – largely stable
- Floodplain stability – No designed floodplain channels creating elevated avulsion risk
- Floodplain Elevation – Clear evidence of floodplain inundation with wood mobilization and fine sediment deposition.

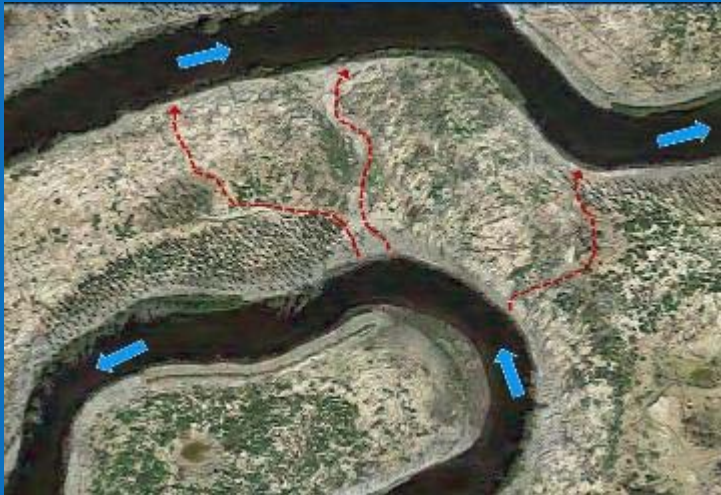
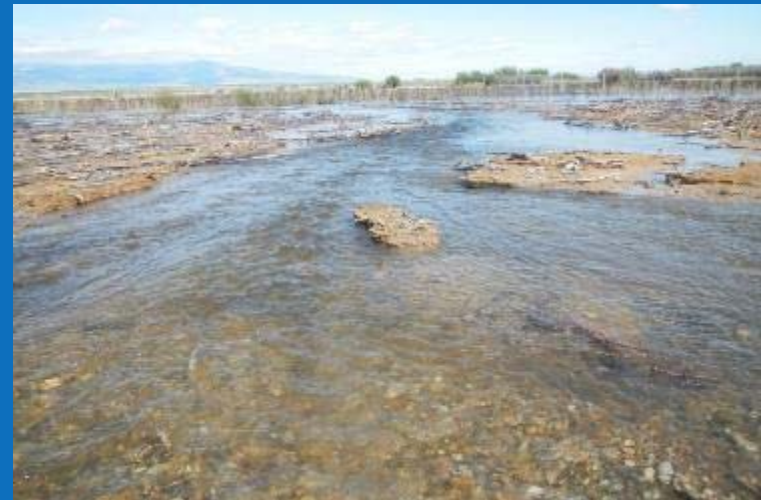
# Phase 1 Geomorphic Evaluation – 2015 & 2016 QRA

- Out-of-bank flow in 2014 caused small avulsion paths across one meander tab.
- Banks heights are design approximately to the height of the two year recurrence flood event.
- Flow in 2014 was about 40 cfs higher than 2-year recurrence event.

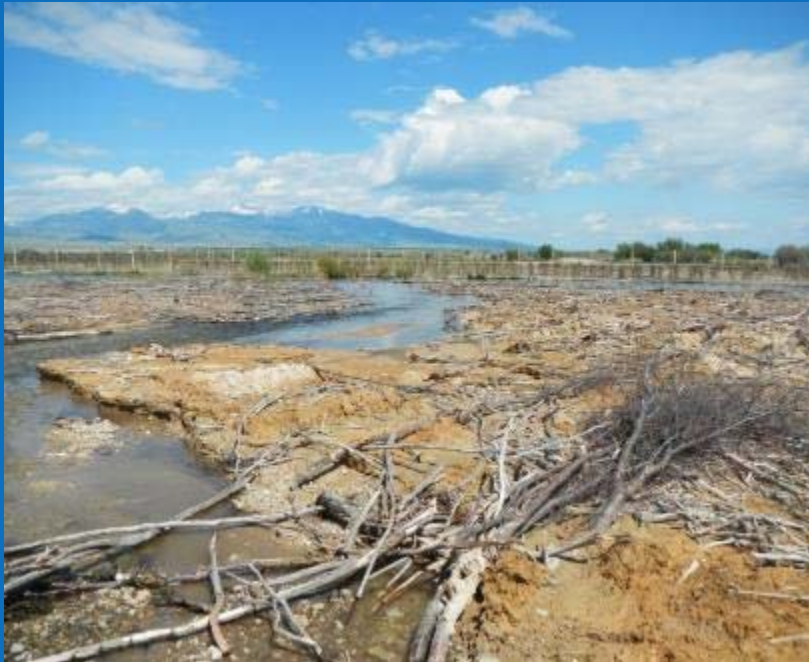
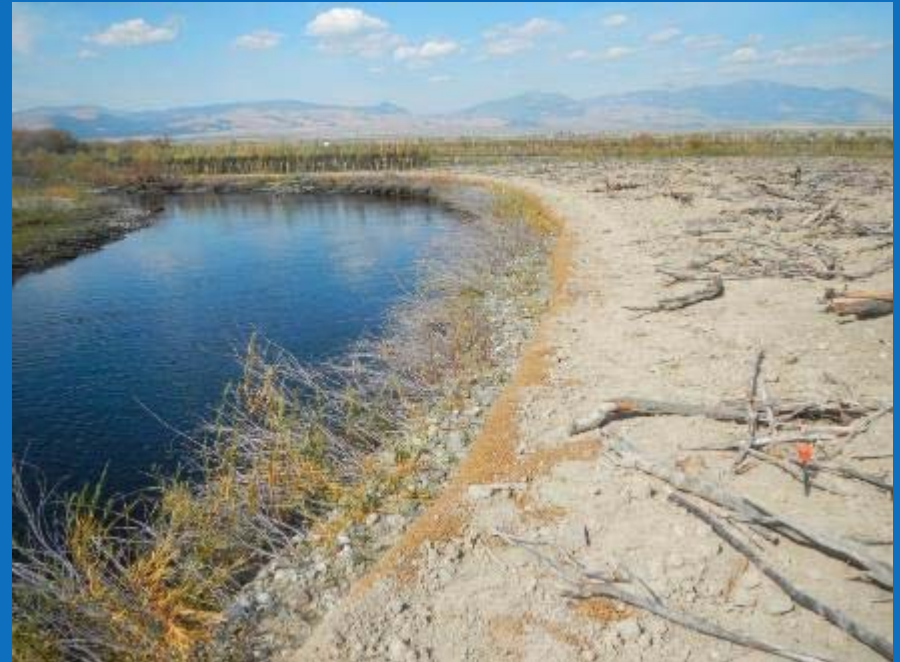
# Phase 1 Geomorphic Evaluation

- Erosion due in part due to design and construction variance.
- Avulsion paths were backfilled and planted, upstream bank was elevated.

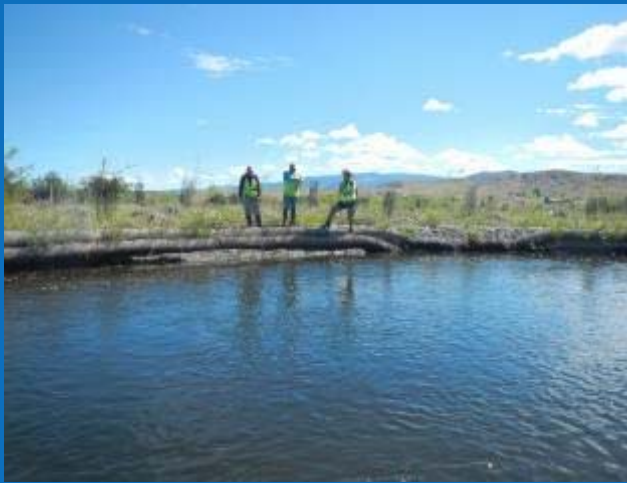
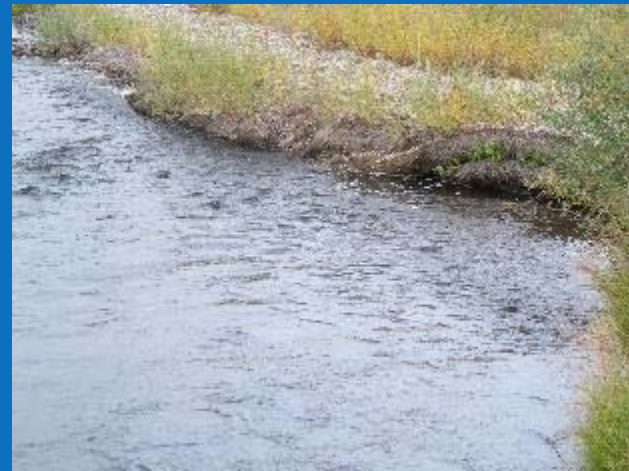
# Phase 1 Geomorphic Evaluation

- Some slumping of Double Vegetated Soil Lifts but none requiring maintenance
- Fabric used for Double Vegetated Soil Lifts (high strength woven coir) is disintegrating faster than expected but not a concern as long as willows are establishing.
- Willow growth is generally very robust in stream banks.

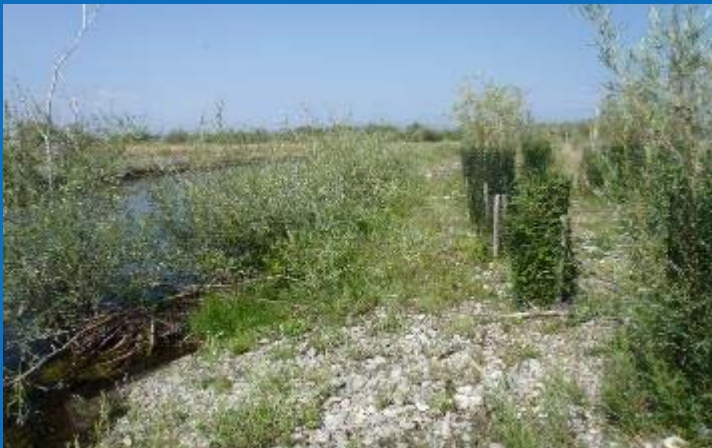
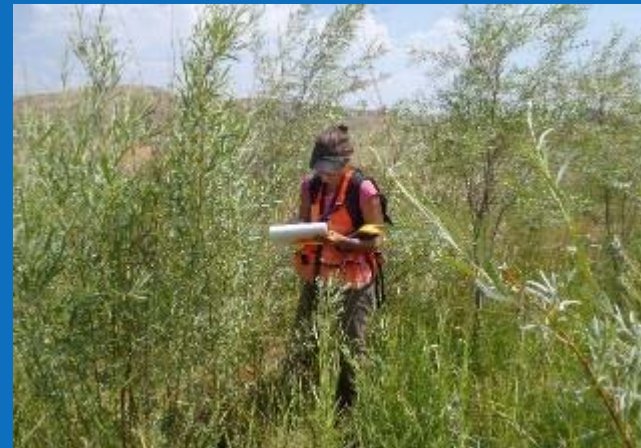
# Phase 1 Vegetation Evaluation 2015 & 2016

- Conducted by Geum and RESPEC
- Canopy Cover Woody Vegetation on Streambanks – trending towards 40% cover (5-year goal)
- Canopy Cover Woody Vegetation on Floodplain – Trending towards 30% cover (5-year goal)

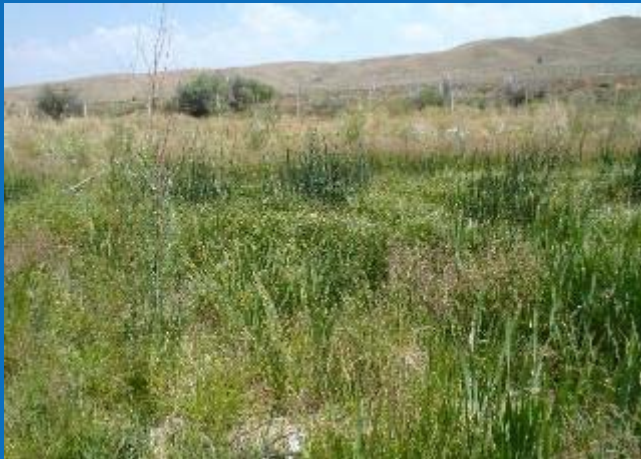
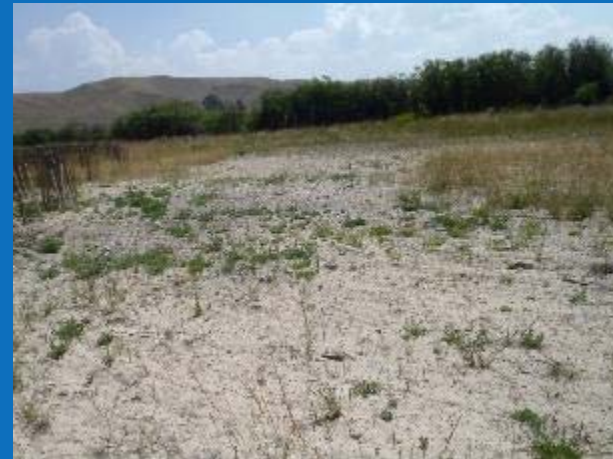
# Phase 1 Vegetation Evaluation 2015 & 2016

- Herbaceous Vegetation on Floodplain – Majority of plots meet 20% cover by year 1; trending towards 5-year performance goal of 80% cover.
- Planted Woody Vegetation Survival – Majority meet 80% survival in year 1 but fell below 80% in year 2; however, overall canopy cover is increasing.

- Herbaceous plantings are meeting goals.
- Browse protection is helping woody plant establishment but is not entirely effective
- Complete wildlife exclosures are most effective.
- Also recommend installation of browse protectors in outer bank planting units of Phase 1.
- Recommended repairing exclosures and browse protectors.

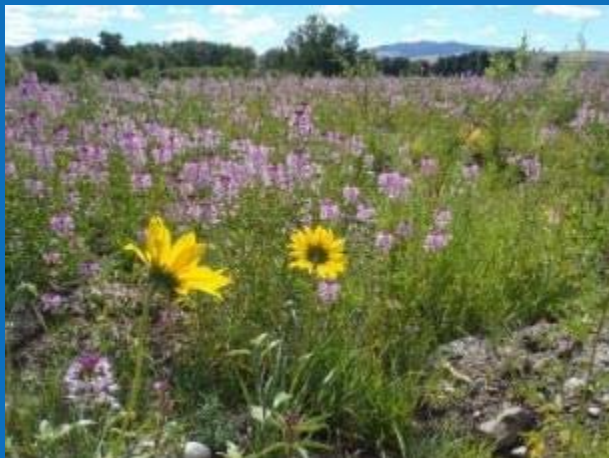
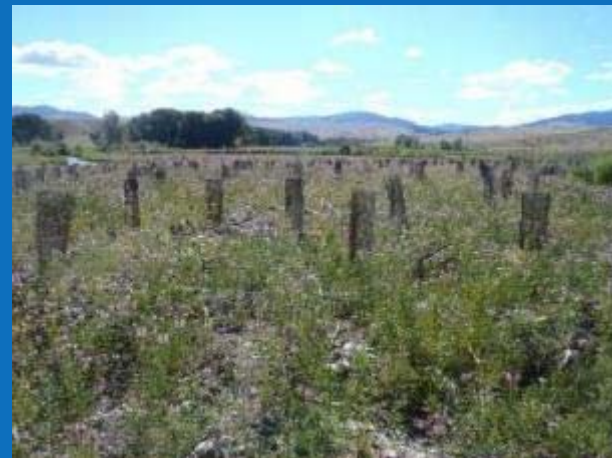
# Phase 5 Vegetation Evaluation 2016

- Canopy Cover of Woody Cover on Streambanks – 42% of plots are meeting 5-year goal of 40% cover.
- Woody Vegetation survival – 71% of plots meeting 80% cover (5-year goal).
- Incomplete evaluation of floodplain cover for woody vegetation and herbaceous plants.
