Emergency Response at the Ute Ulay Mine Tailings Site, Lake City Colorado

Michael J. Gobla, P.E.

U.S. Department of the Interior
Bureau of Reclamation

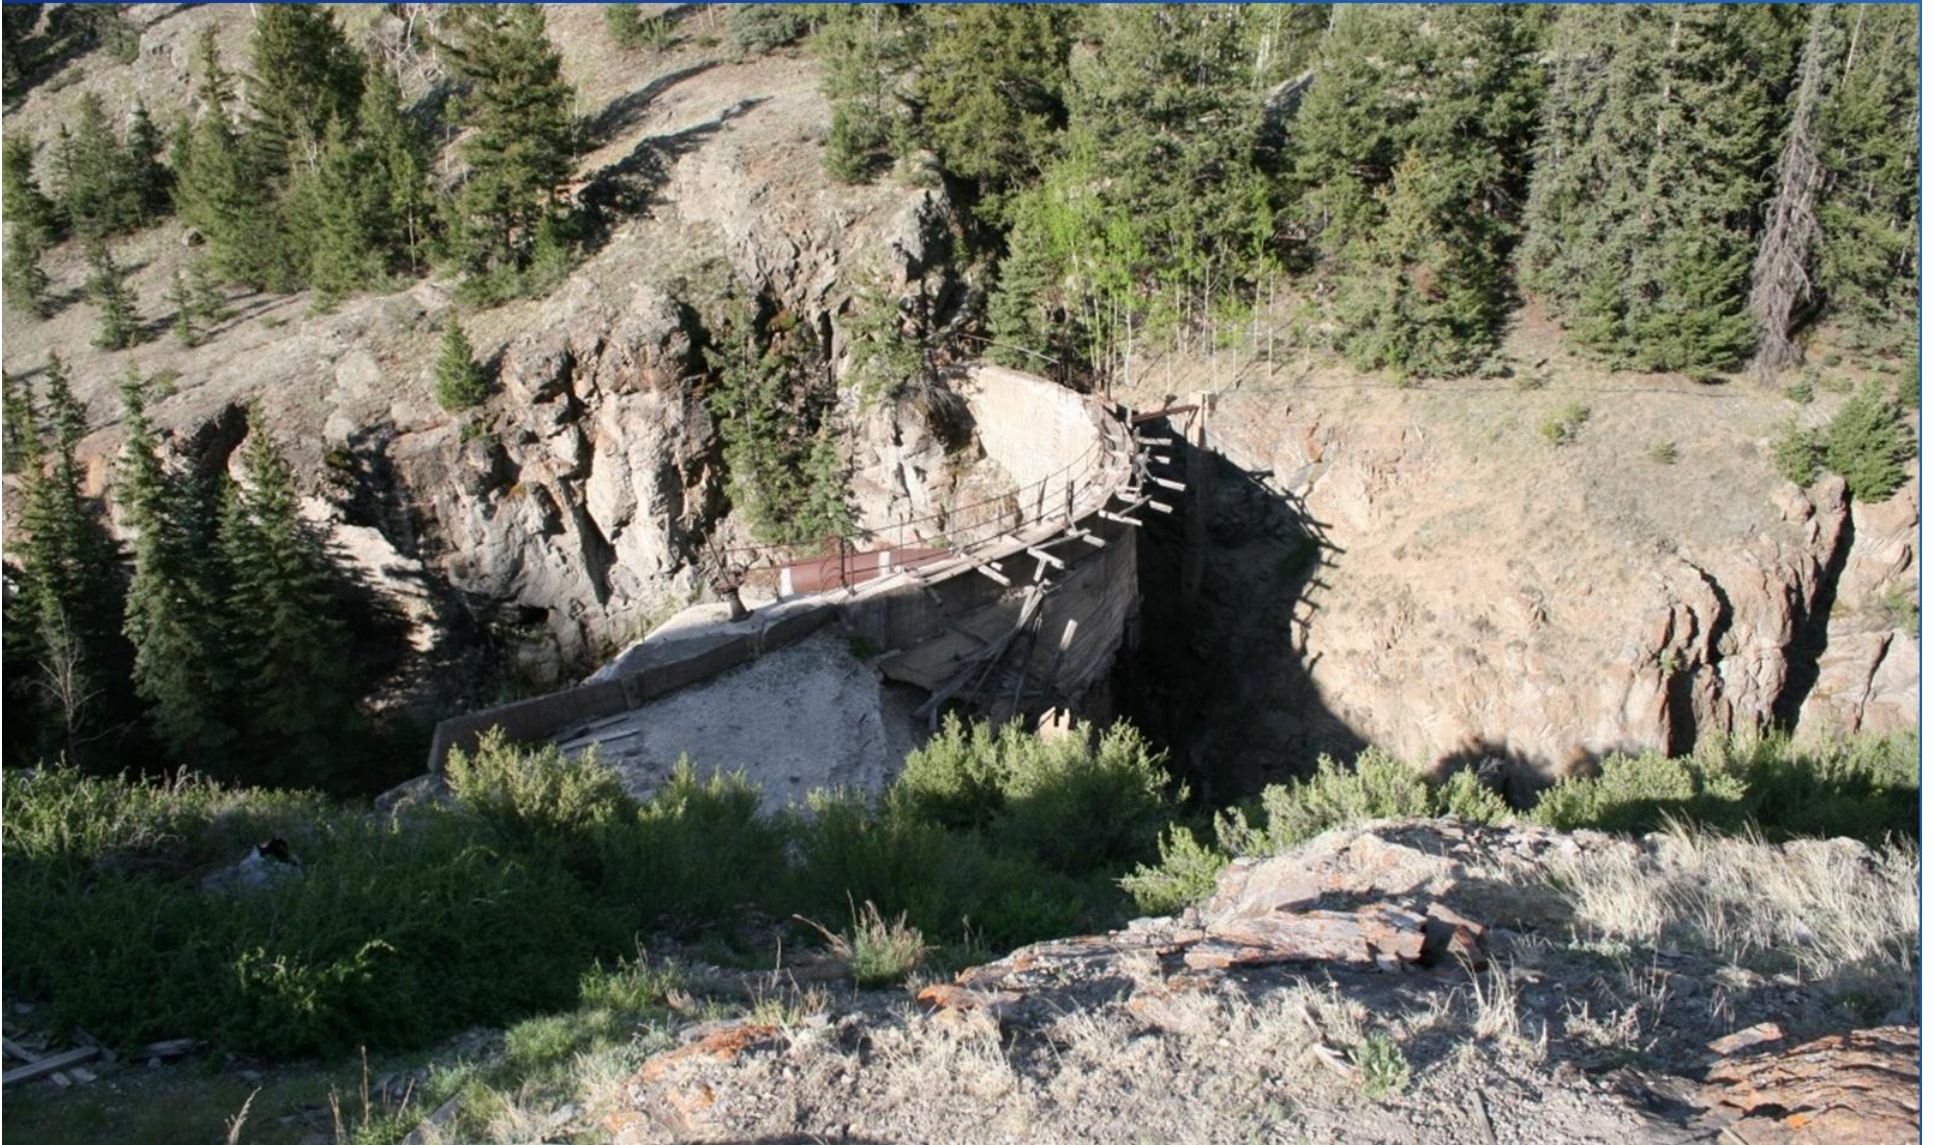
Historic Dam supplied water to hydroelectric plant that ran the mill

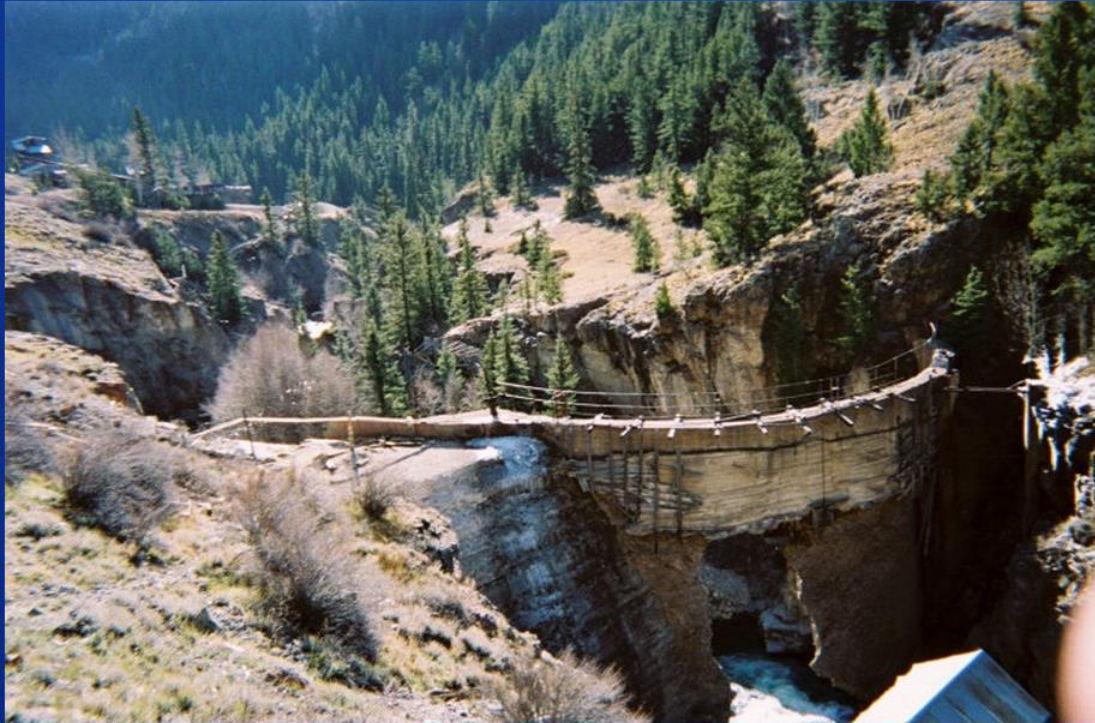
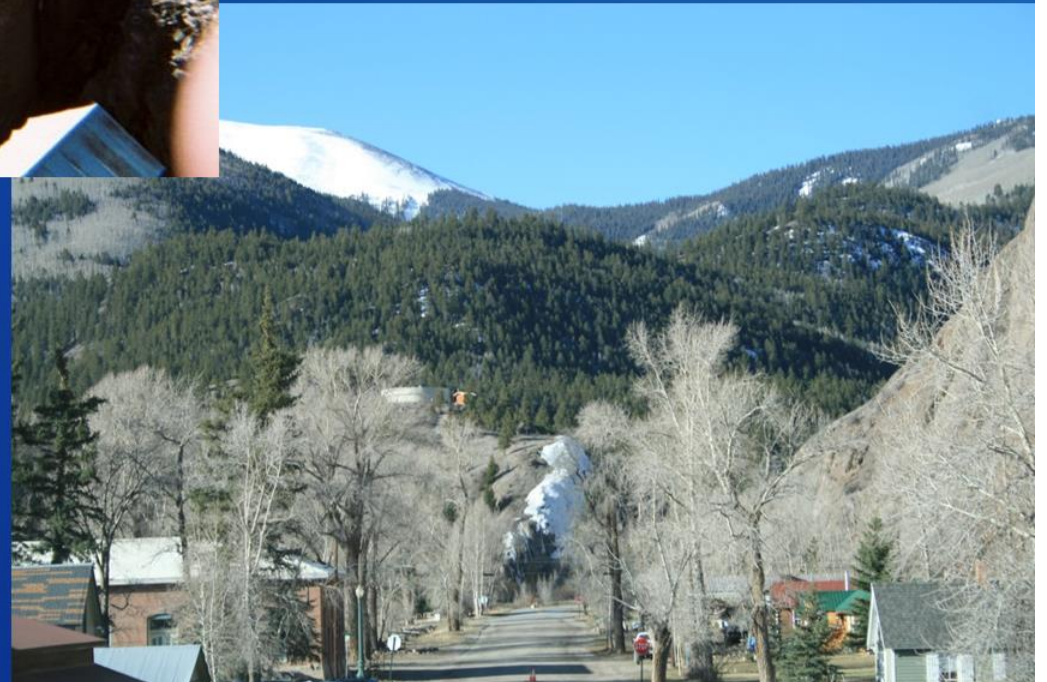
1973 Dam Break – 14 mile fish kill

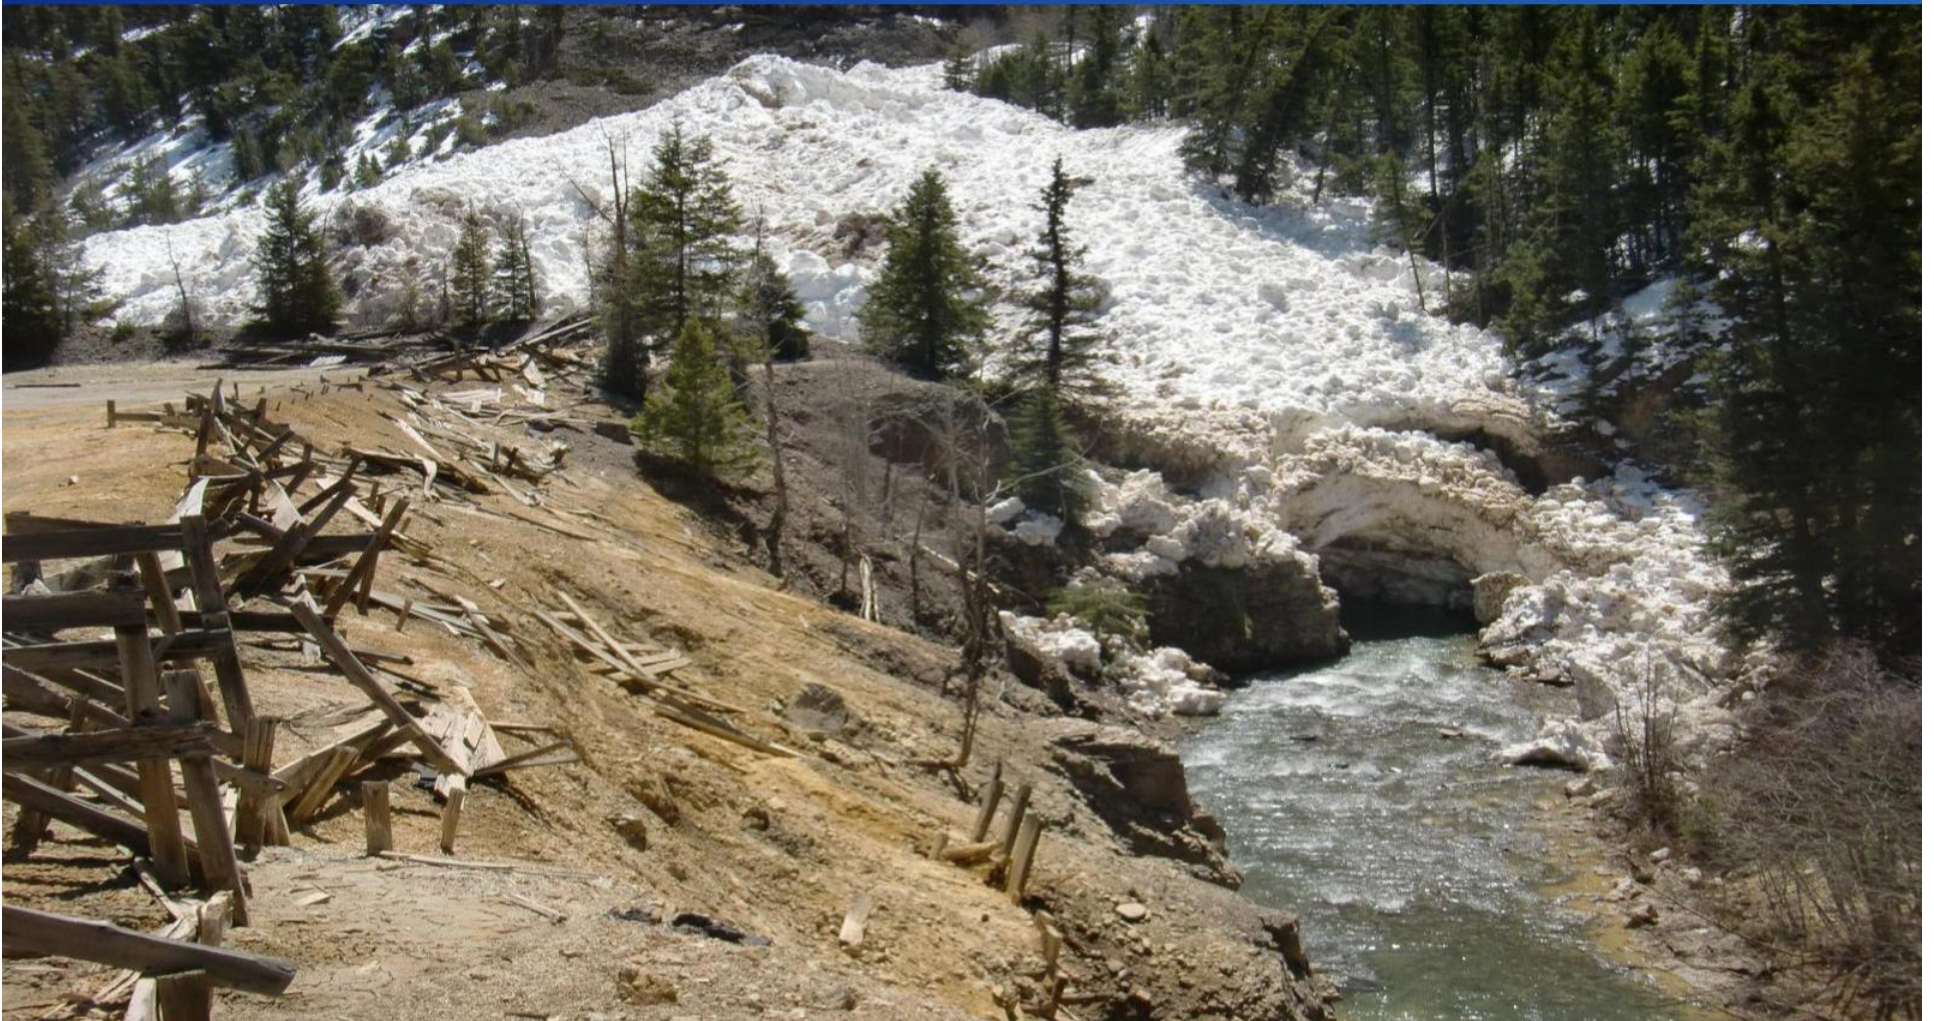
April 2011 - Avalanche blocks Henson Creek

A 30-ft deep pool formed against the tailings and waste rock. The snow dam failed 24 hours later.

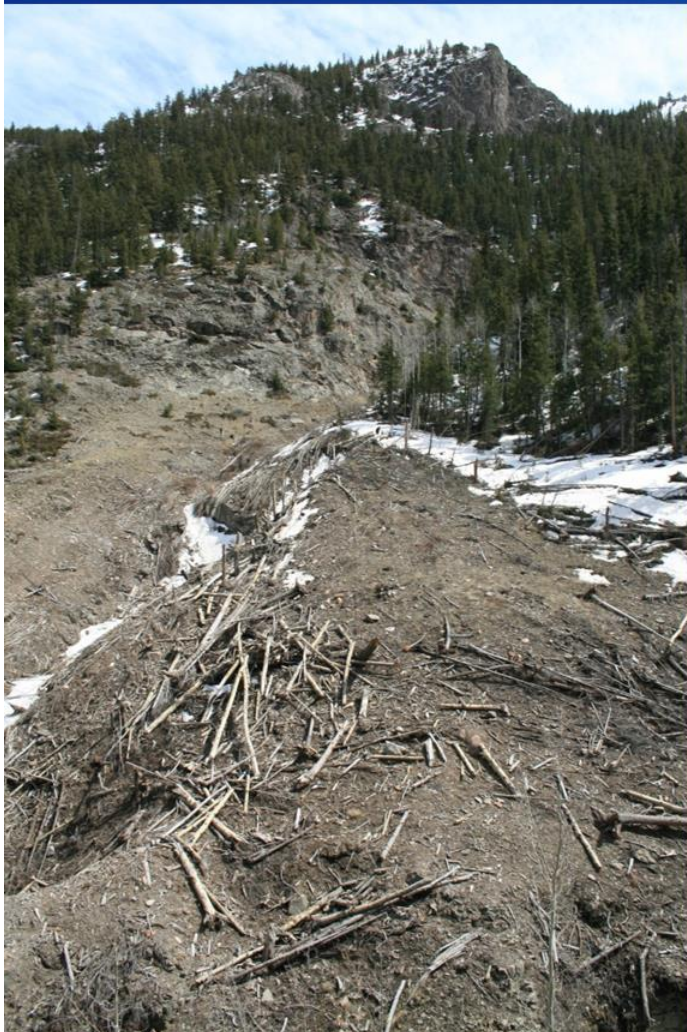
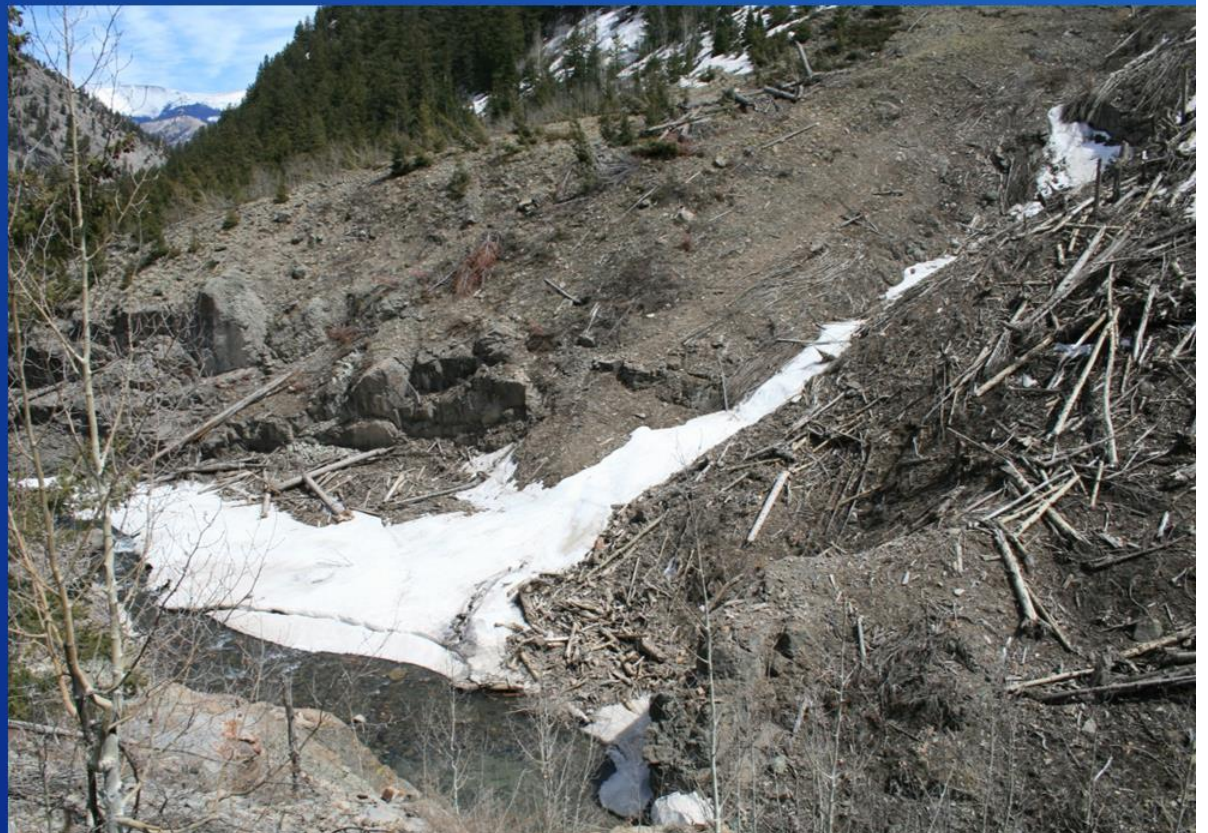
Avalanche path to Henson Creek

Avalanche pathway, likely to reactivate in the future.

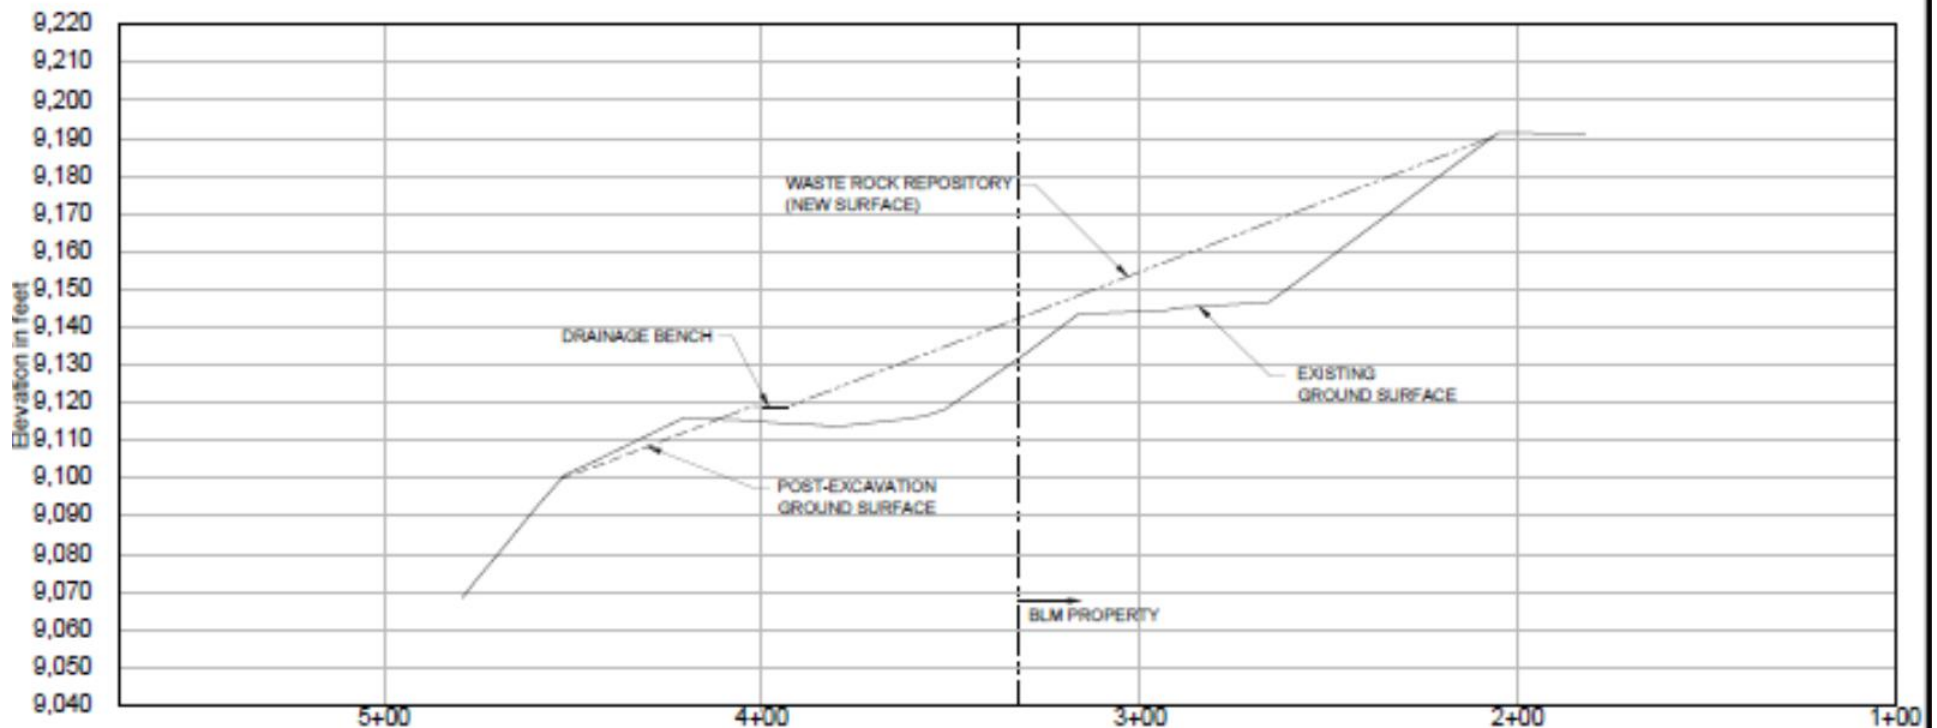
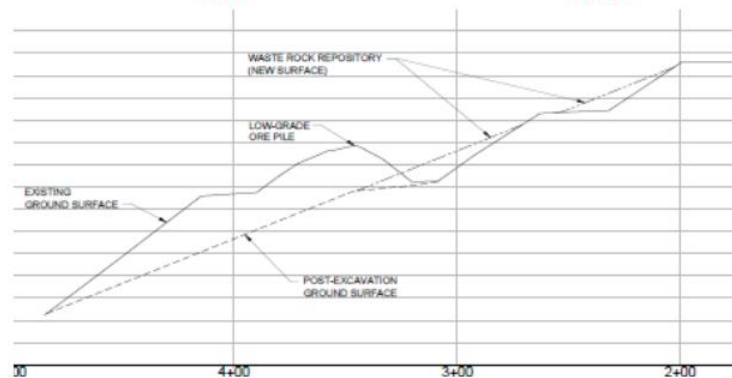
SECTION B - B' EXISTING AND RE-GRADED GROUND SURFACE PROFILES

Engineer noted the presence of soft materials

Subsurface investigations at the site have identified soft, saturated silt and clay tailings in the former settling basin area. Our design included two items to help mitigate the tailings in this area.

We did not formally estimate the magnitude of expected settlement associated with consolidation of the tailings, and we did not estimate the duration over which such consolidation might be expected to occur. Large settlements in this area could have an adverse effect on the performance of the drainage bench near the toe of the repository.

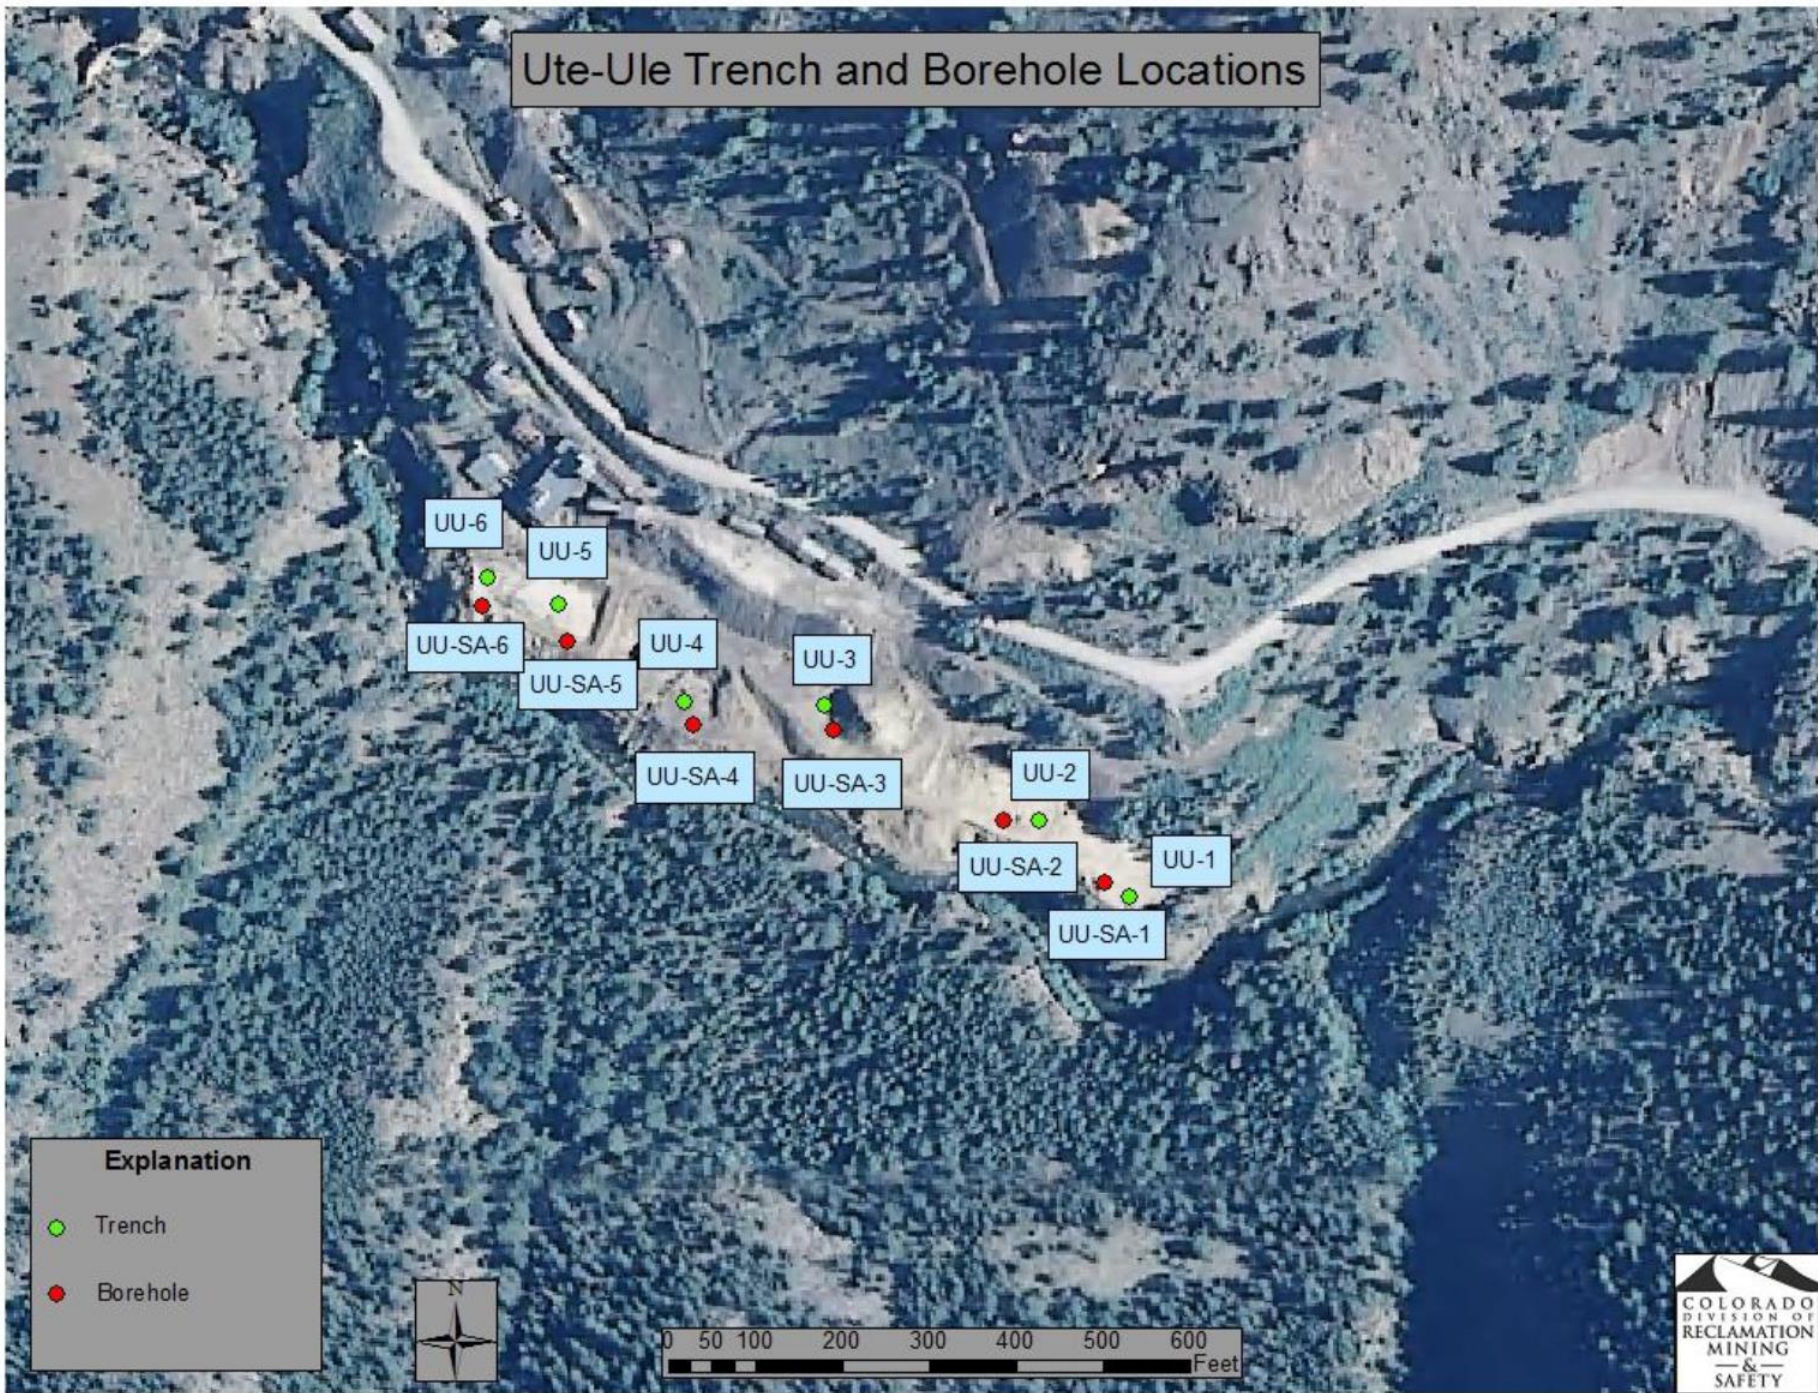
Ute-Ule Trench and Borehole Locations

Tailings are 1 to 3 SPT blowcount material, 10 to 20 feet deep!

This would not support a high fill

The engineering firm should have realized the stability analysis was deeply flawed!

Suggestion to amend the upper 1 ft. of soft tailing with cement to improve support for the fill made EPA question the design

There also was a suggestion to install wick drains to reduce moisture content

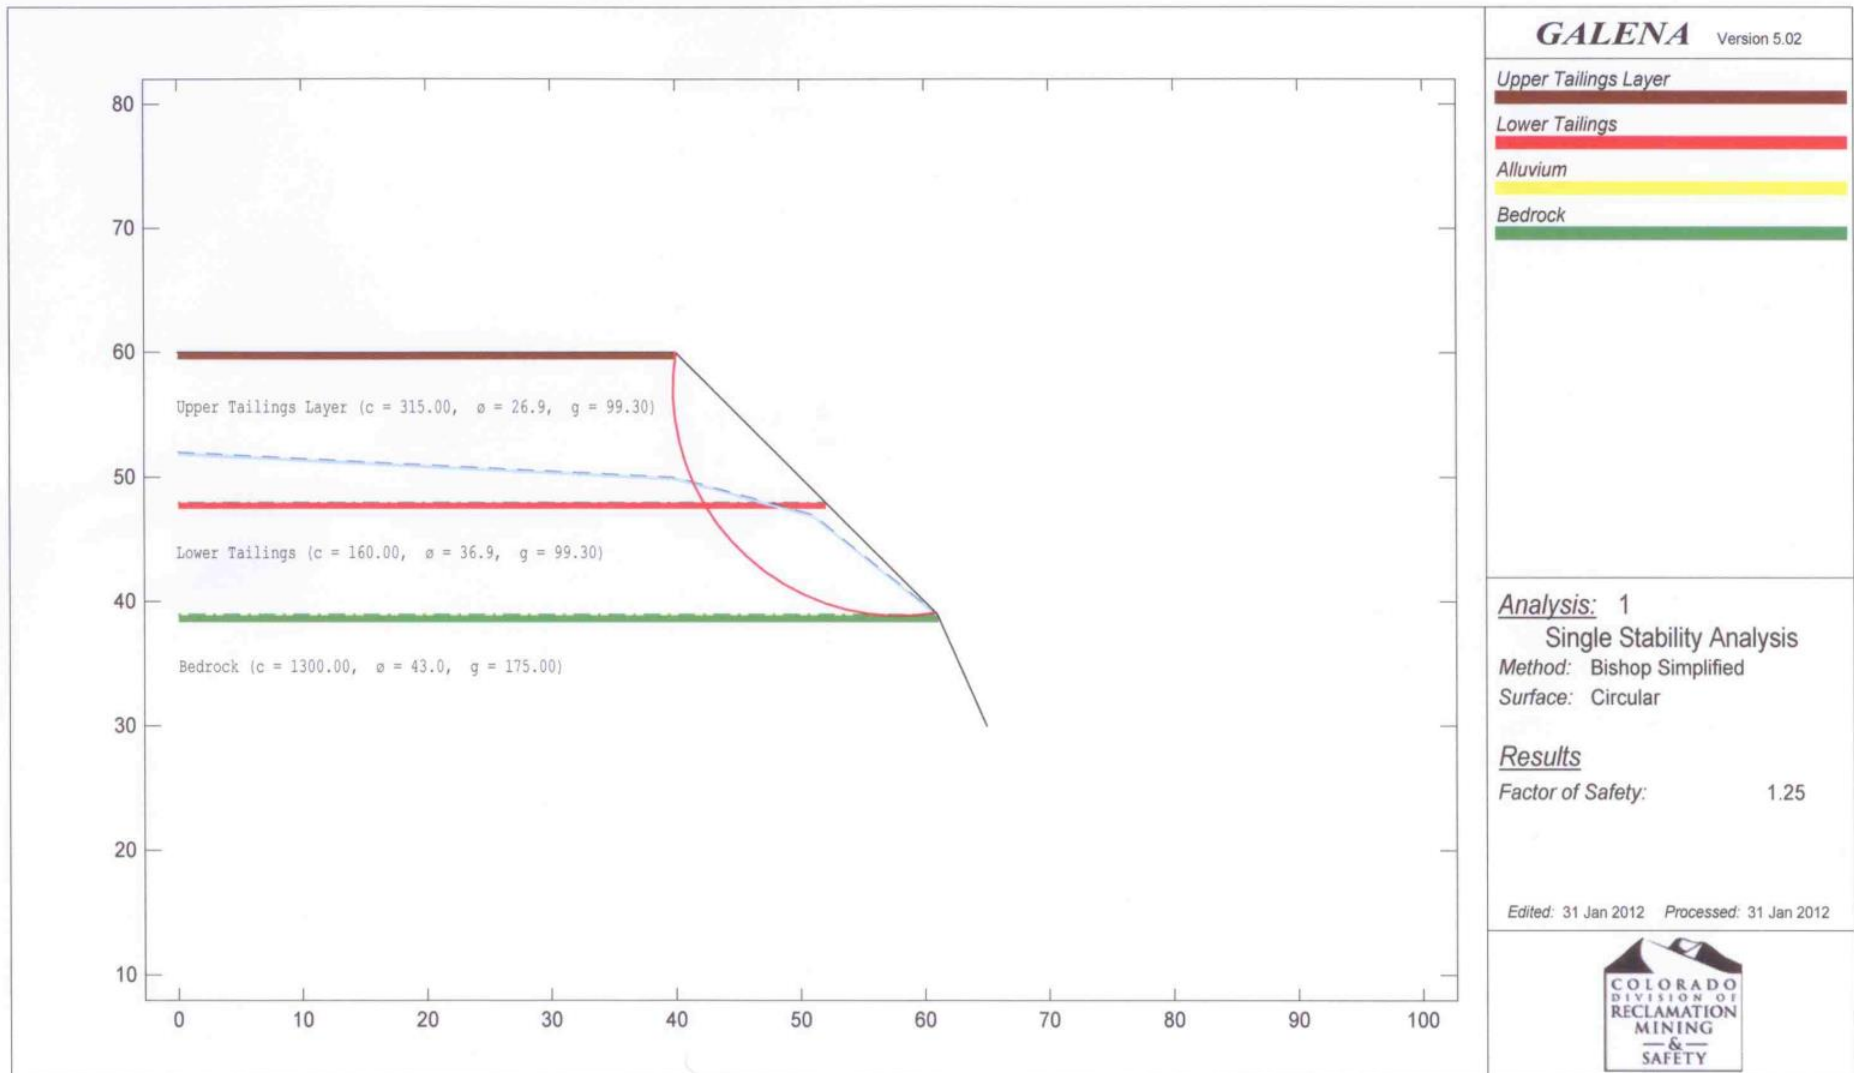
Project: Ute Ulay Stability Analysis
 Cross Section UU-SA-2. 1:1 slope, adjusted for apparent cohesion.

Original design would have led to a massive slope failure

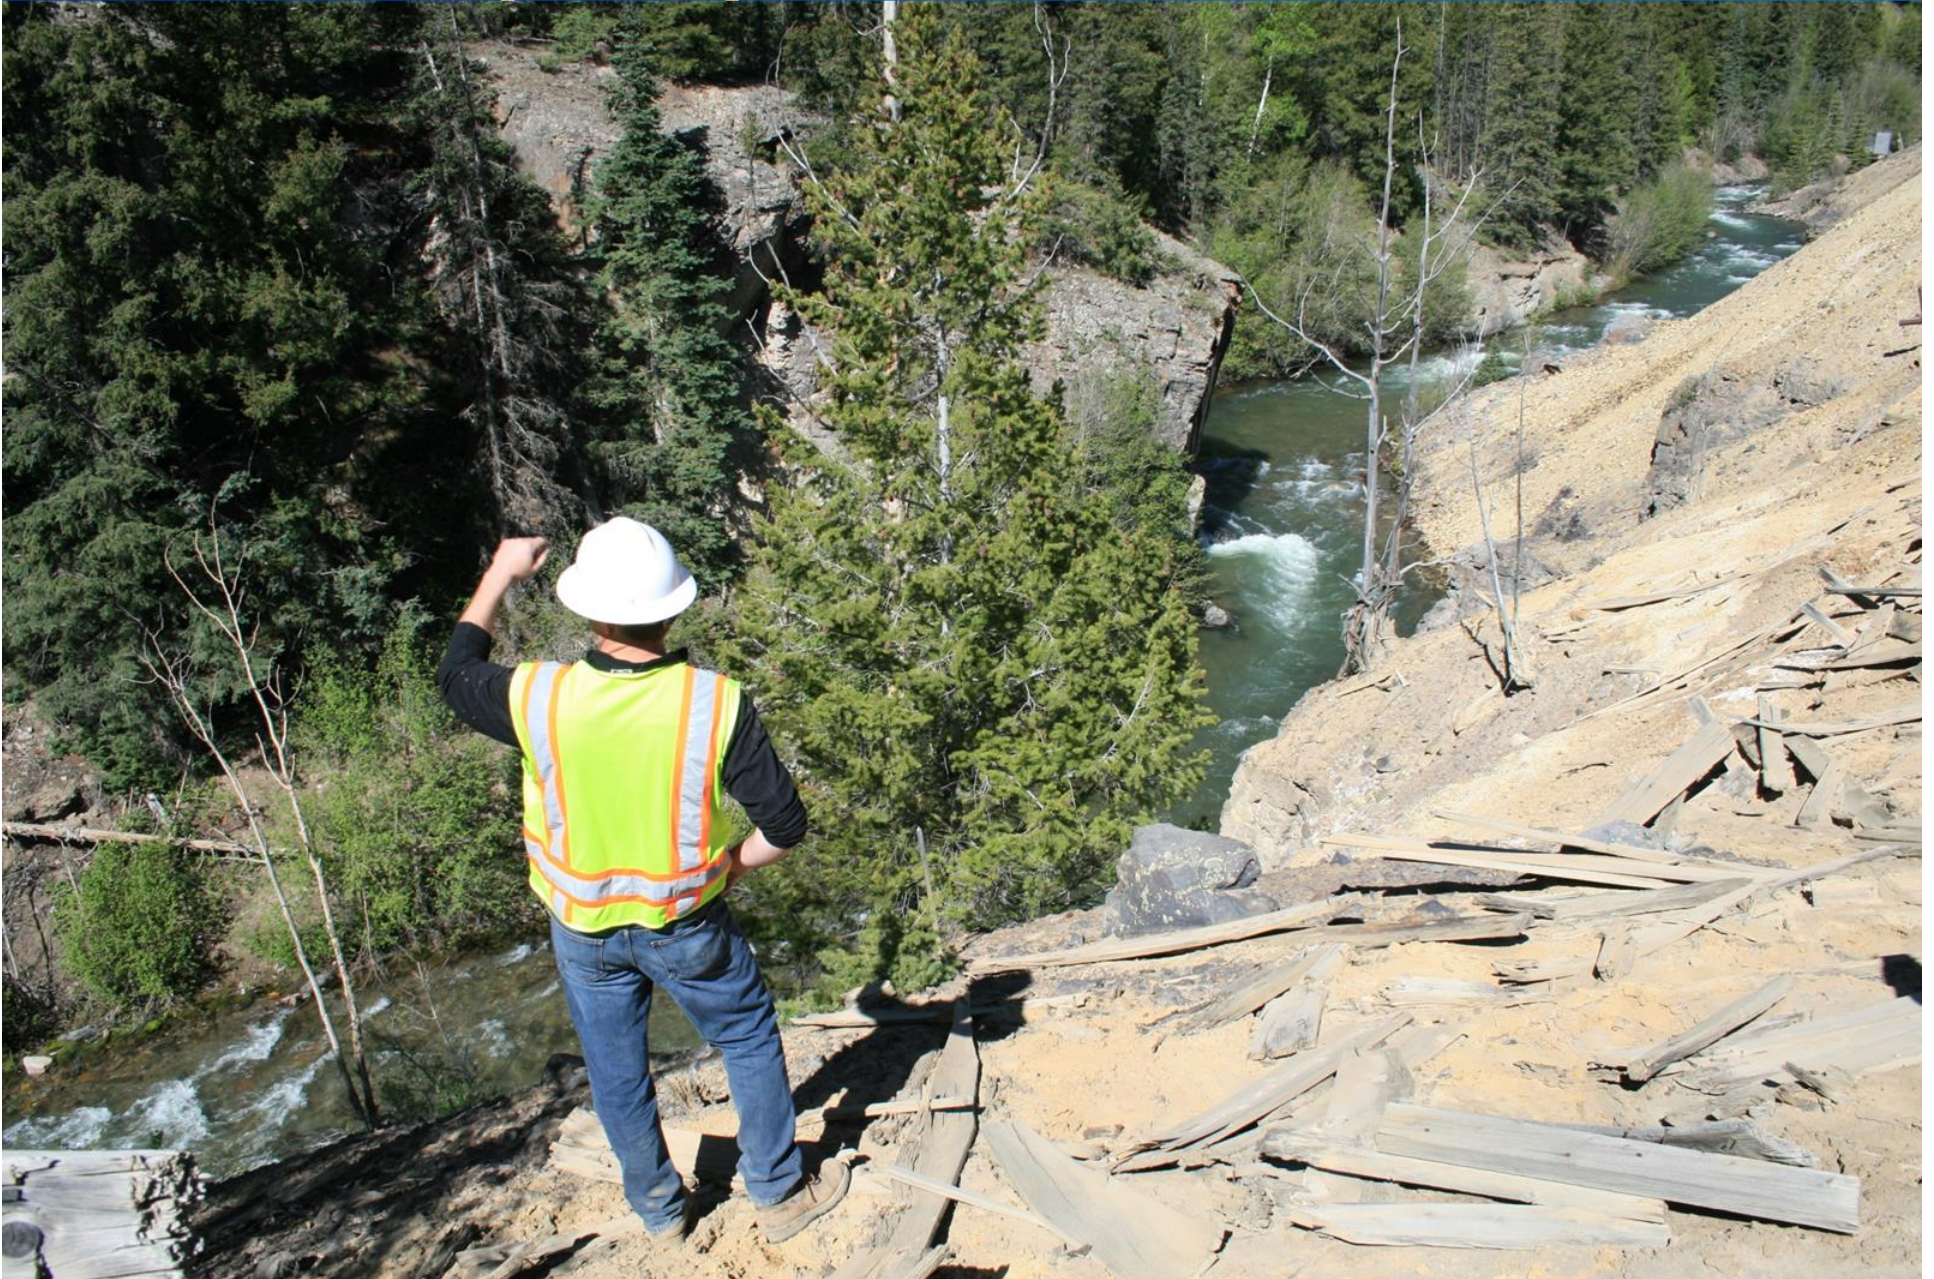
Steep slopes above swift water

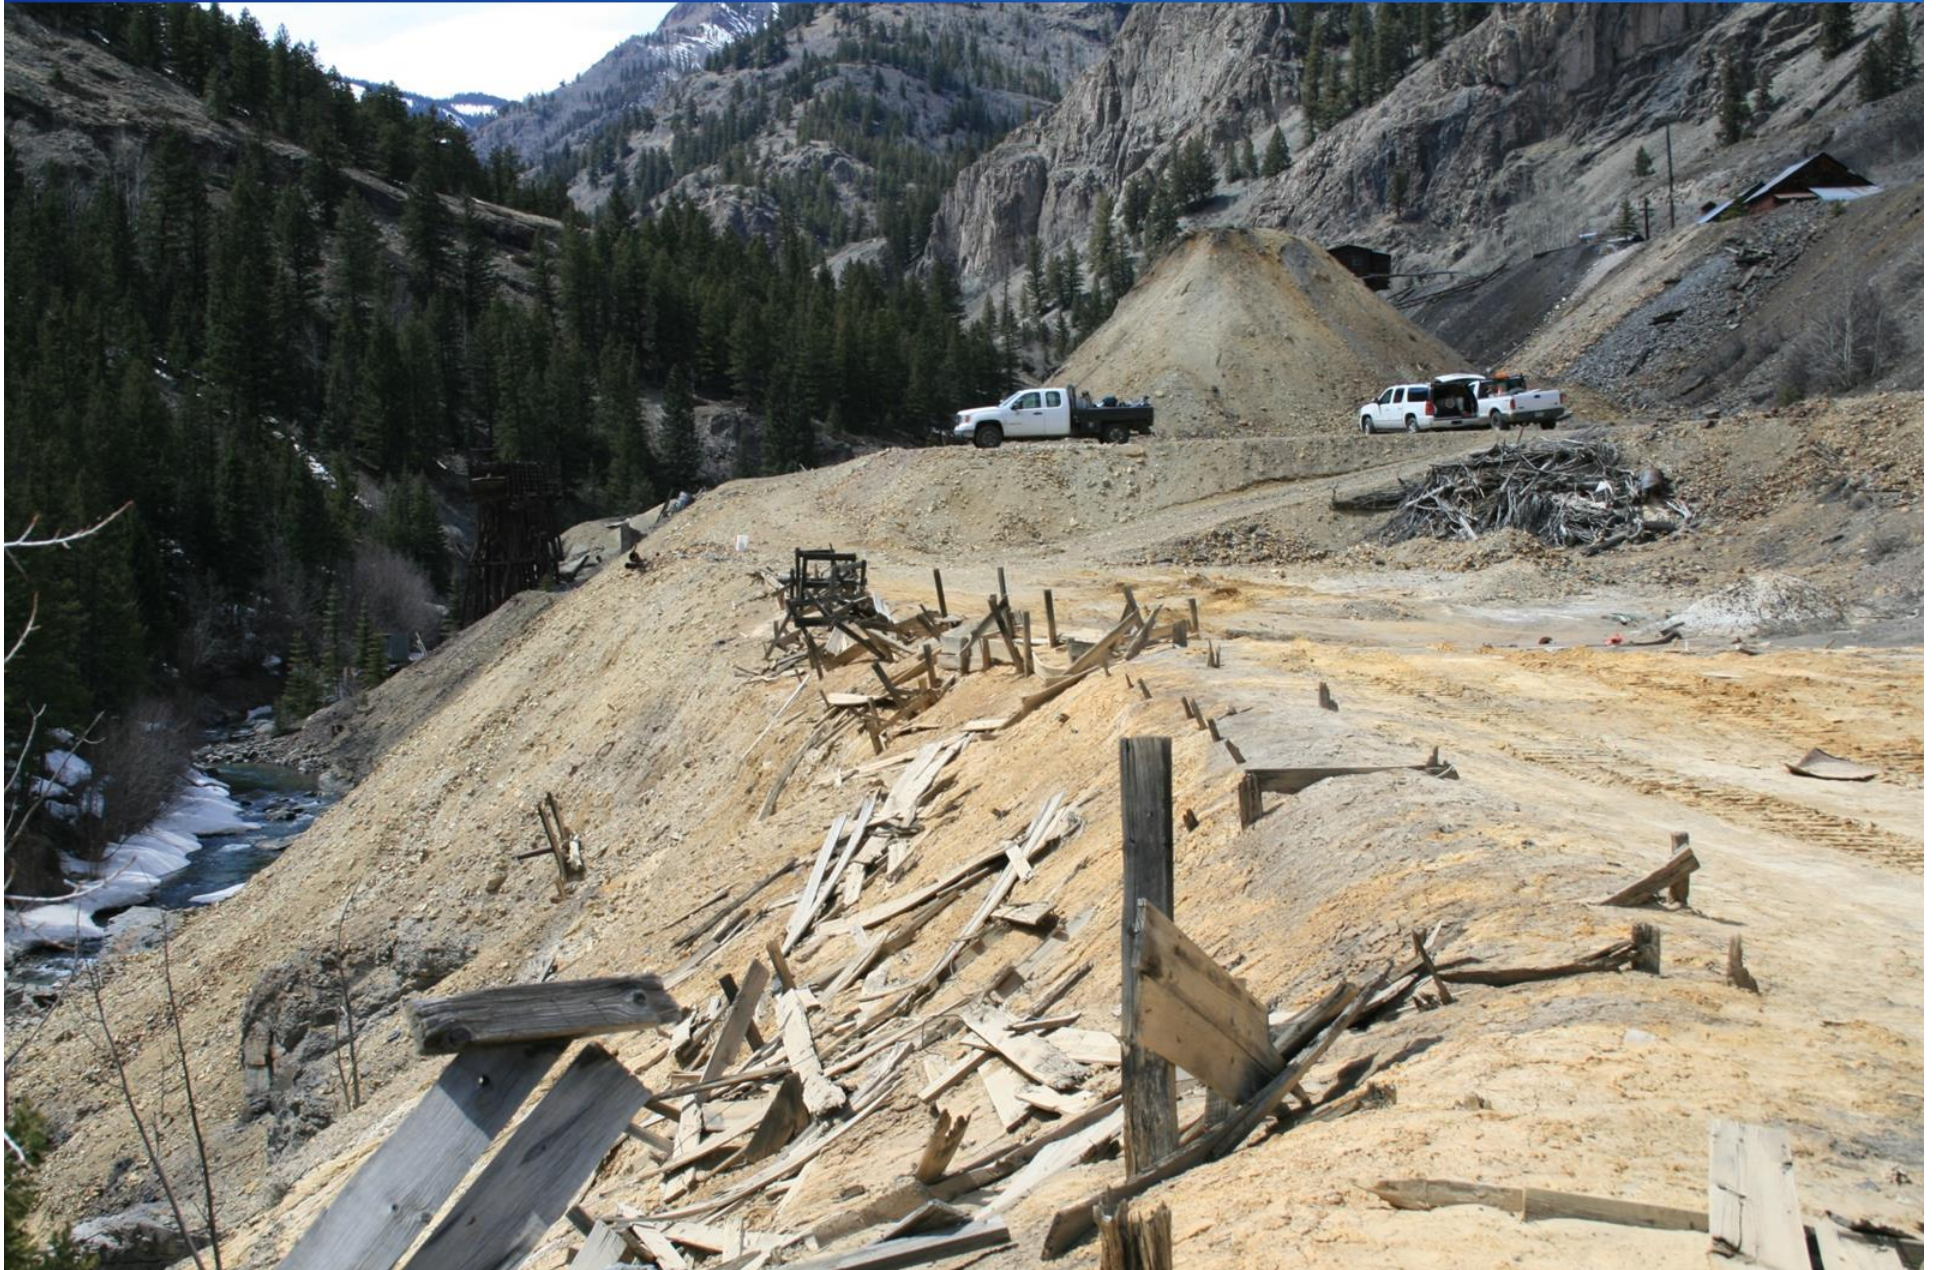
Plan to stack 70 ft of fill on this slope

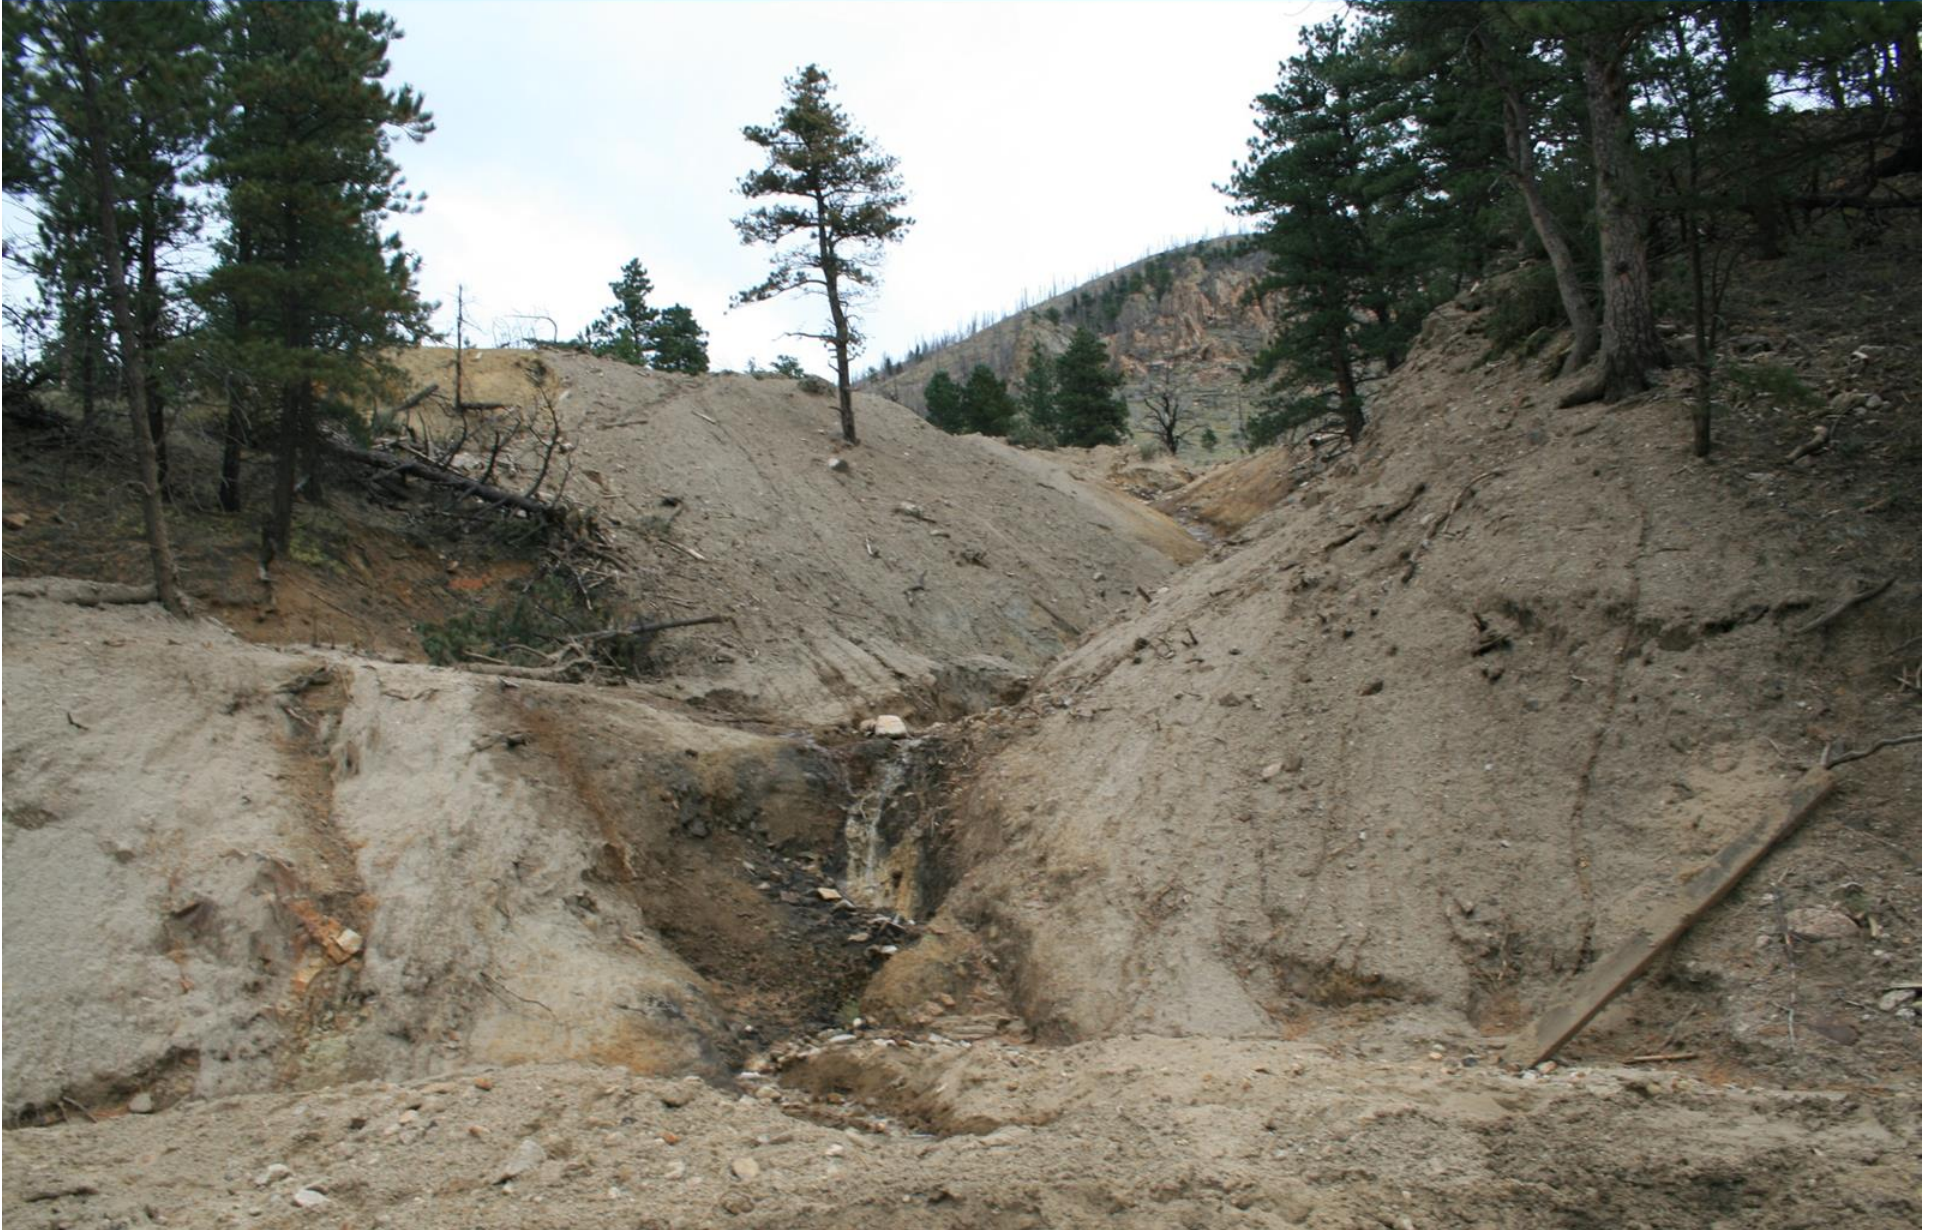
Colorado Floods Scoured Gulches
