Emergency Response at the Ute Ulay Mine Tailings Site, Lake City Colorado

Michael J. Gobla, P.E.

U.S. Department of the Interior
Bureau of Reclamation

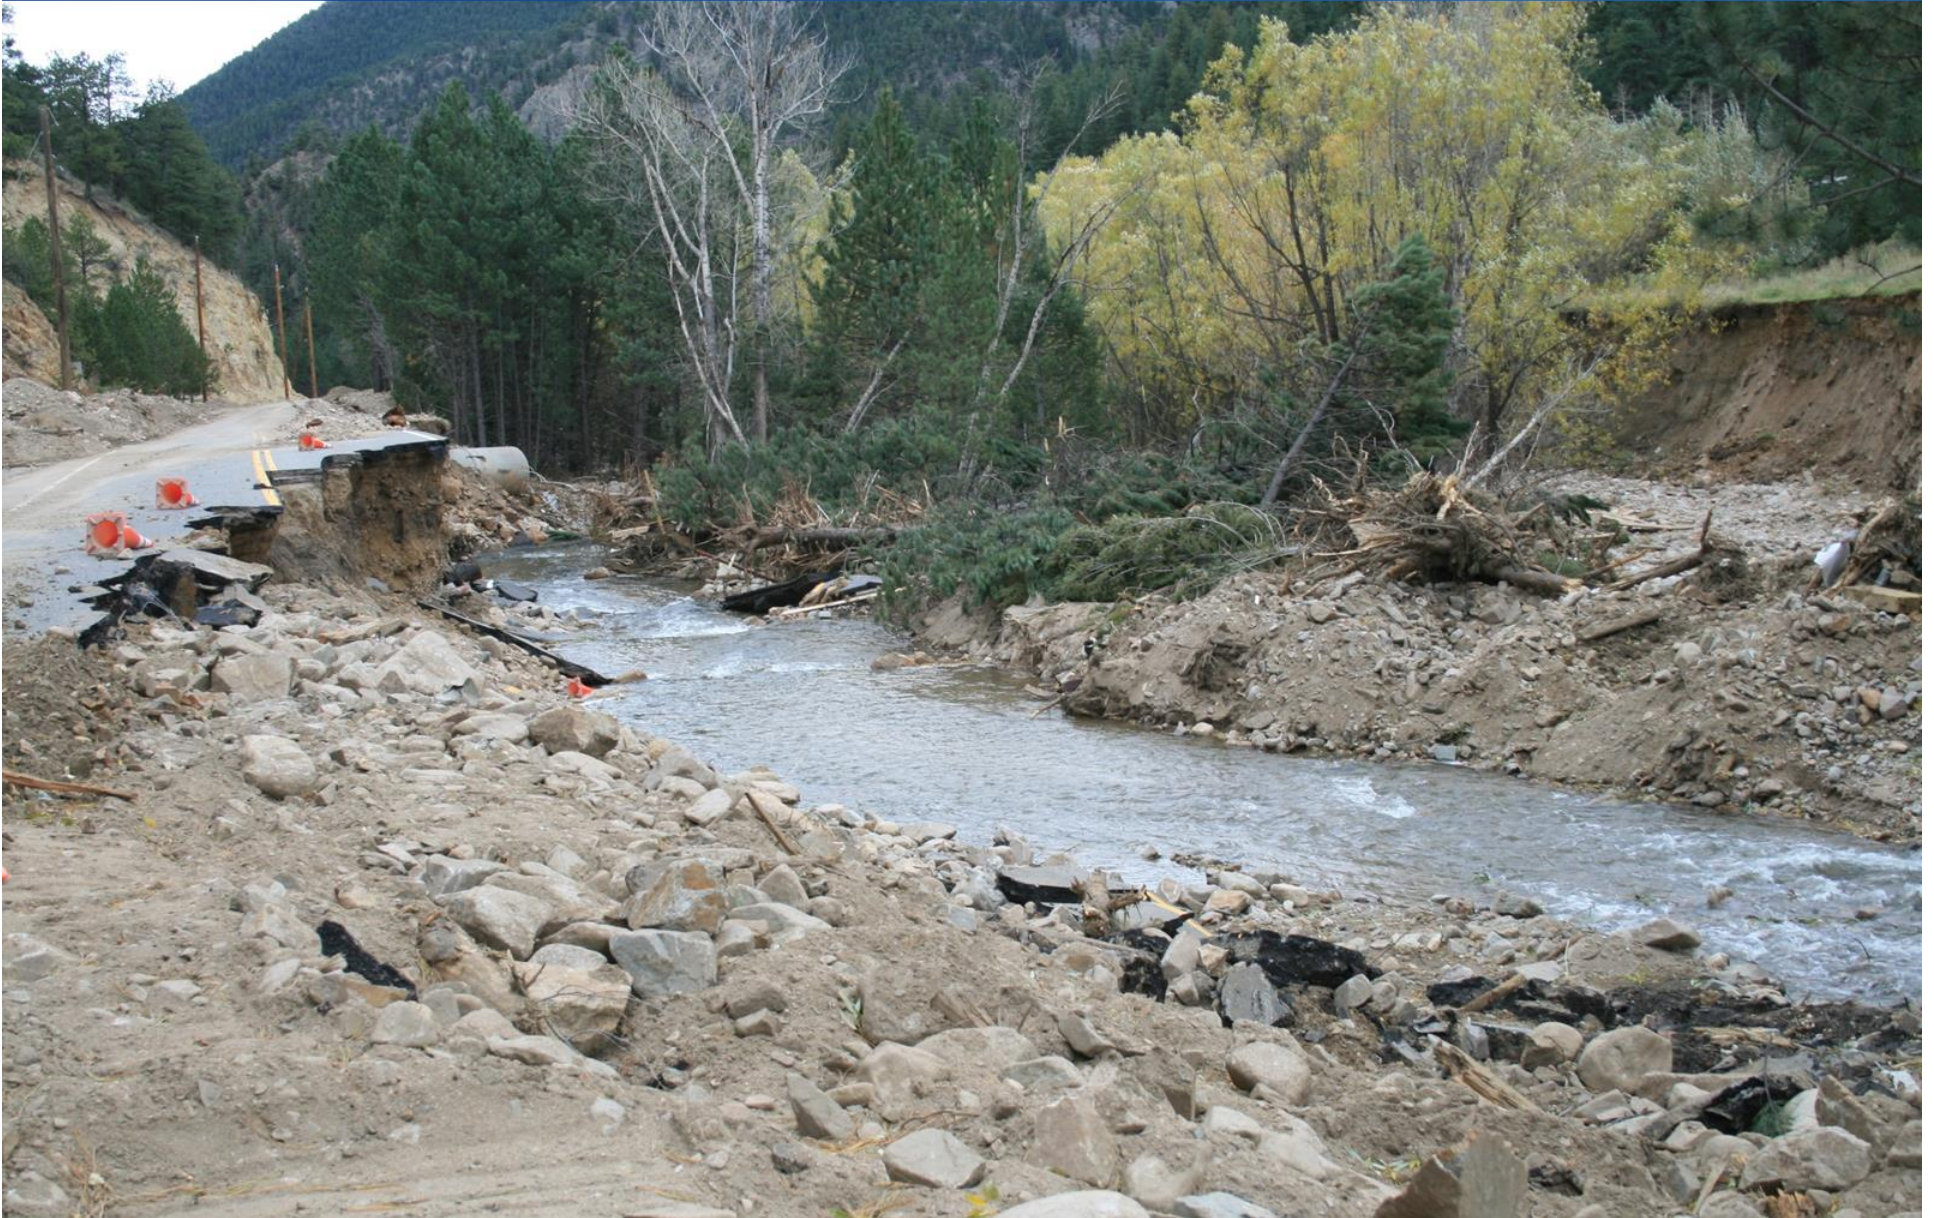
Erosion of Highway and Tailings
