Wood Gulch Mine Long-Term Closure

Humboldt-Toiyabe National Forest

Located 80 miles north of Elko, Nevada

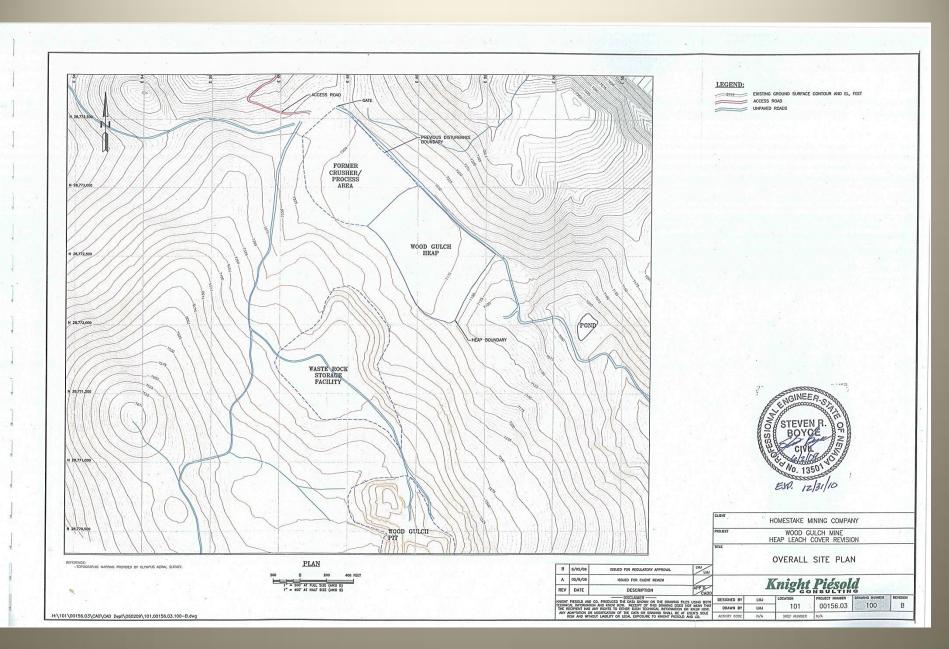
2008 excavation locations to look at the liner edge

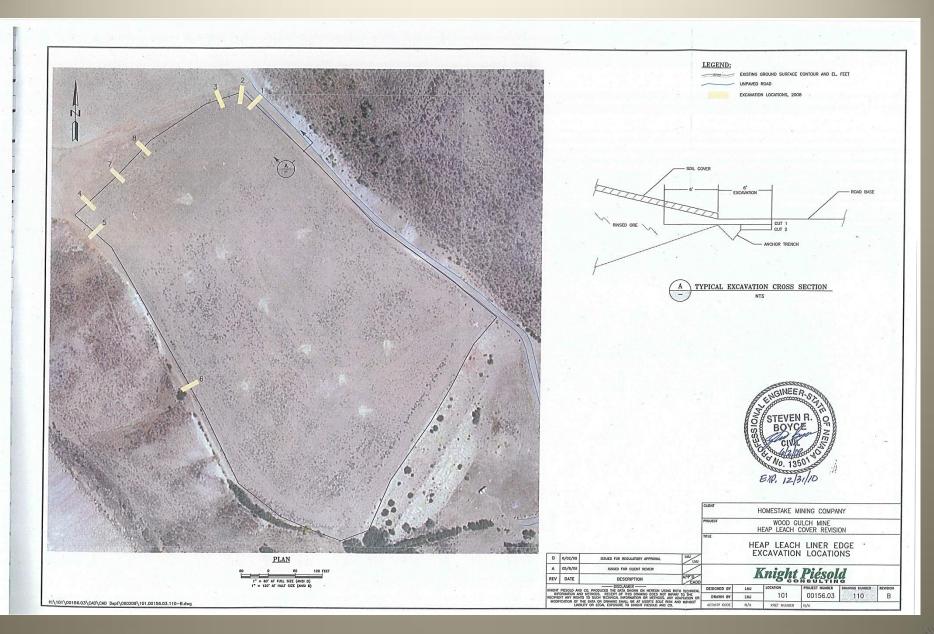
Exposing the liner on the west side

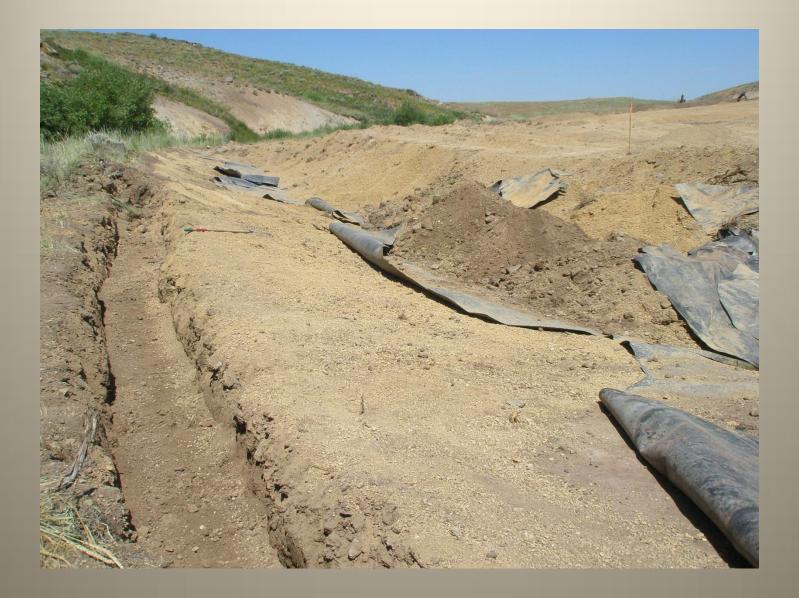
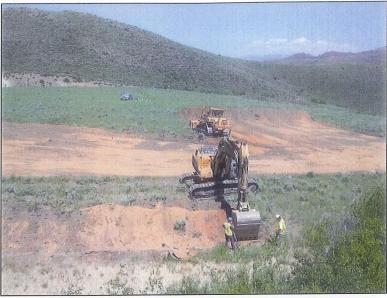
Photo 1. Exposing existing liner edge and dozer stripping topsoil.

Exposing the liner edge and removing the growthmedium in the background

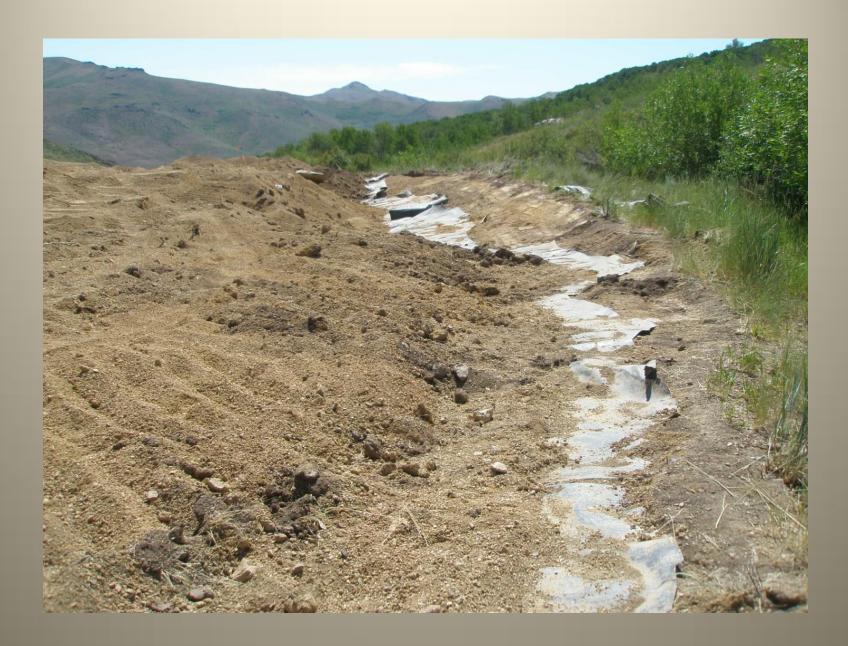
Preparing to extend the liner on the edge

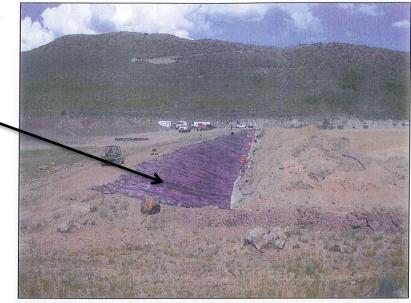
Photo 3. Extending smooth HDPE liner from existing edge to natural grade along north side of heap.

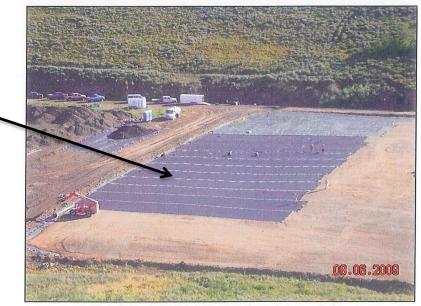
Photo 4. 60-mil HDPE Drainliner™ deployment along north side.

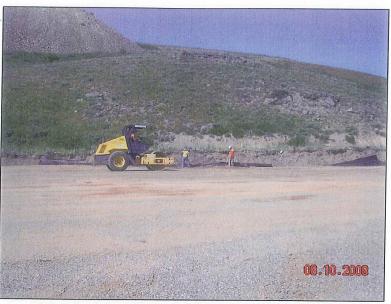
Photo 5. Smooth drum rolling regraded surface prior to HDPE liner deployment

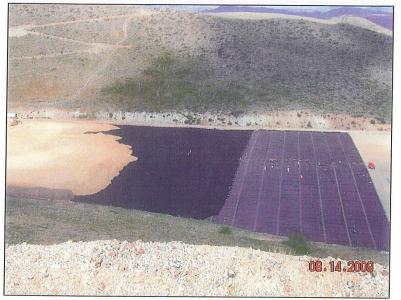
Photo 6. HDPE liner, geofabric and cover fill placement on regraded heap, looking east.

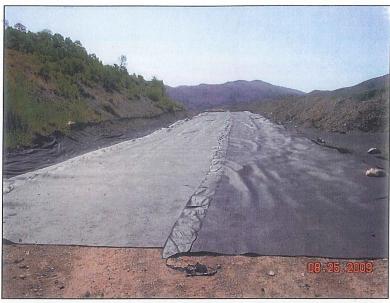
Photo 7. Geocomposite and geofabric placed along road and east drainage, looking south.

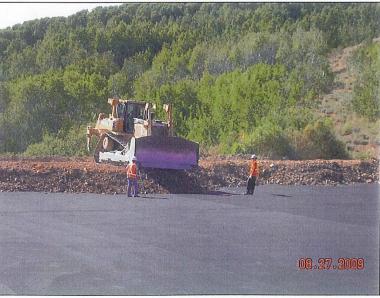
Photo 8. Spotters used during cover fill placement.

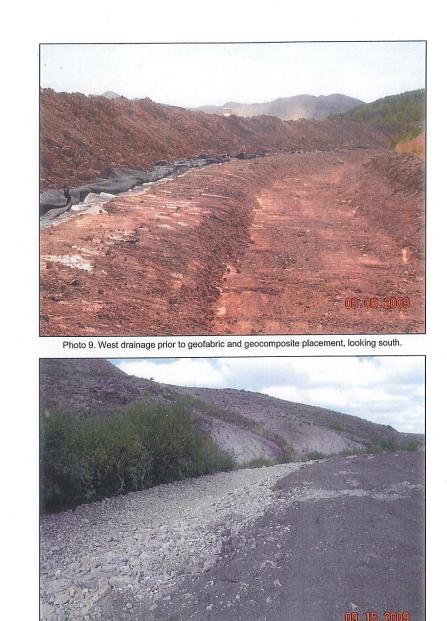
Photo 10. West drainage completed, looking north.

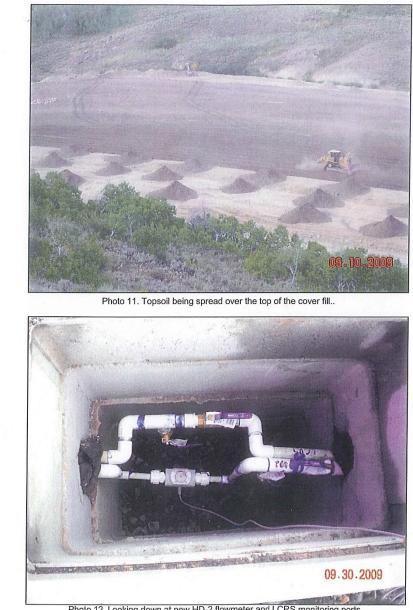
Photo 12. Looking down at new HD-2 flowmeter and LCRS monitoring ports.

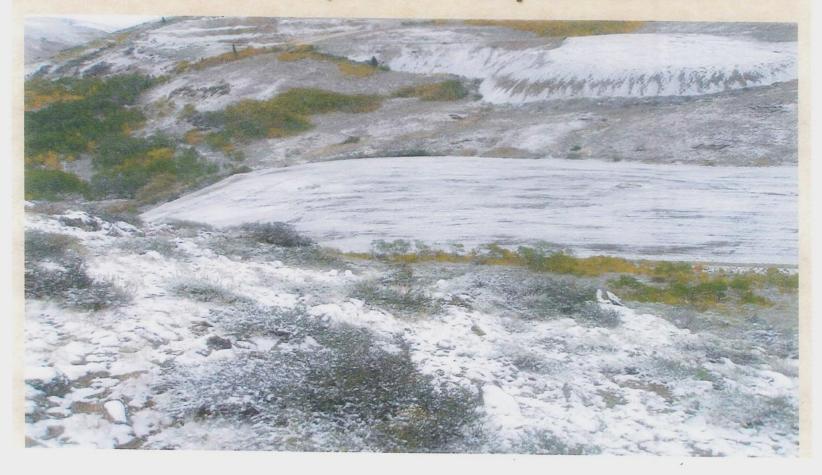
2010 inspection of the west drainage

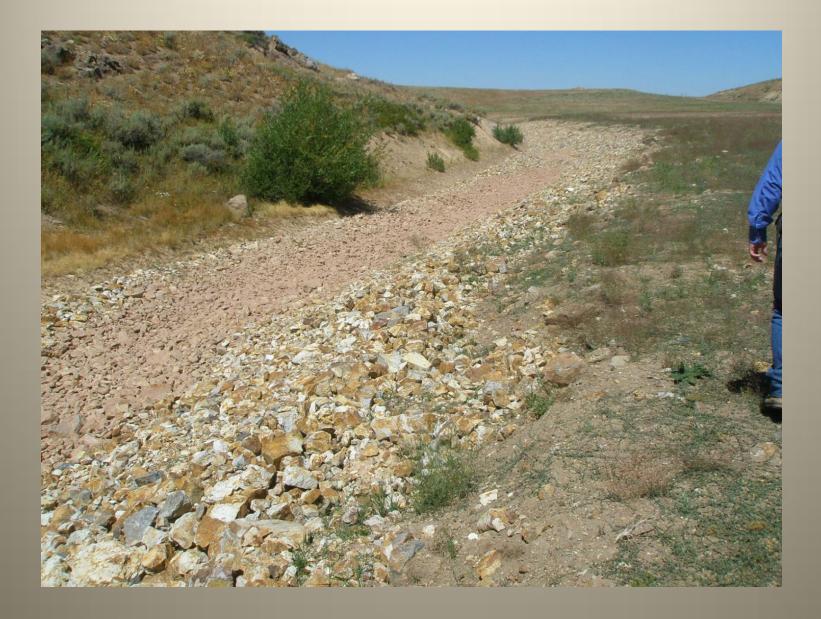
Sparse vegetation in 2010
