Small Miner Issues NW Colombia

*For MDOC Conference
May 2016*

*Michael Burnside
USFS (retired)*

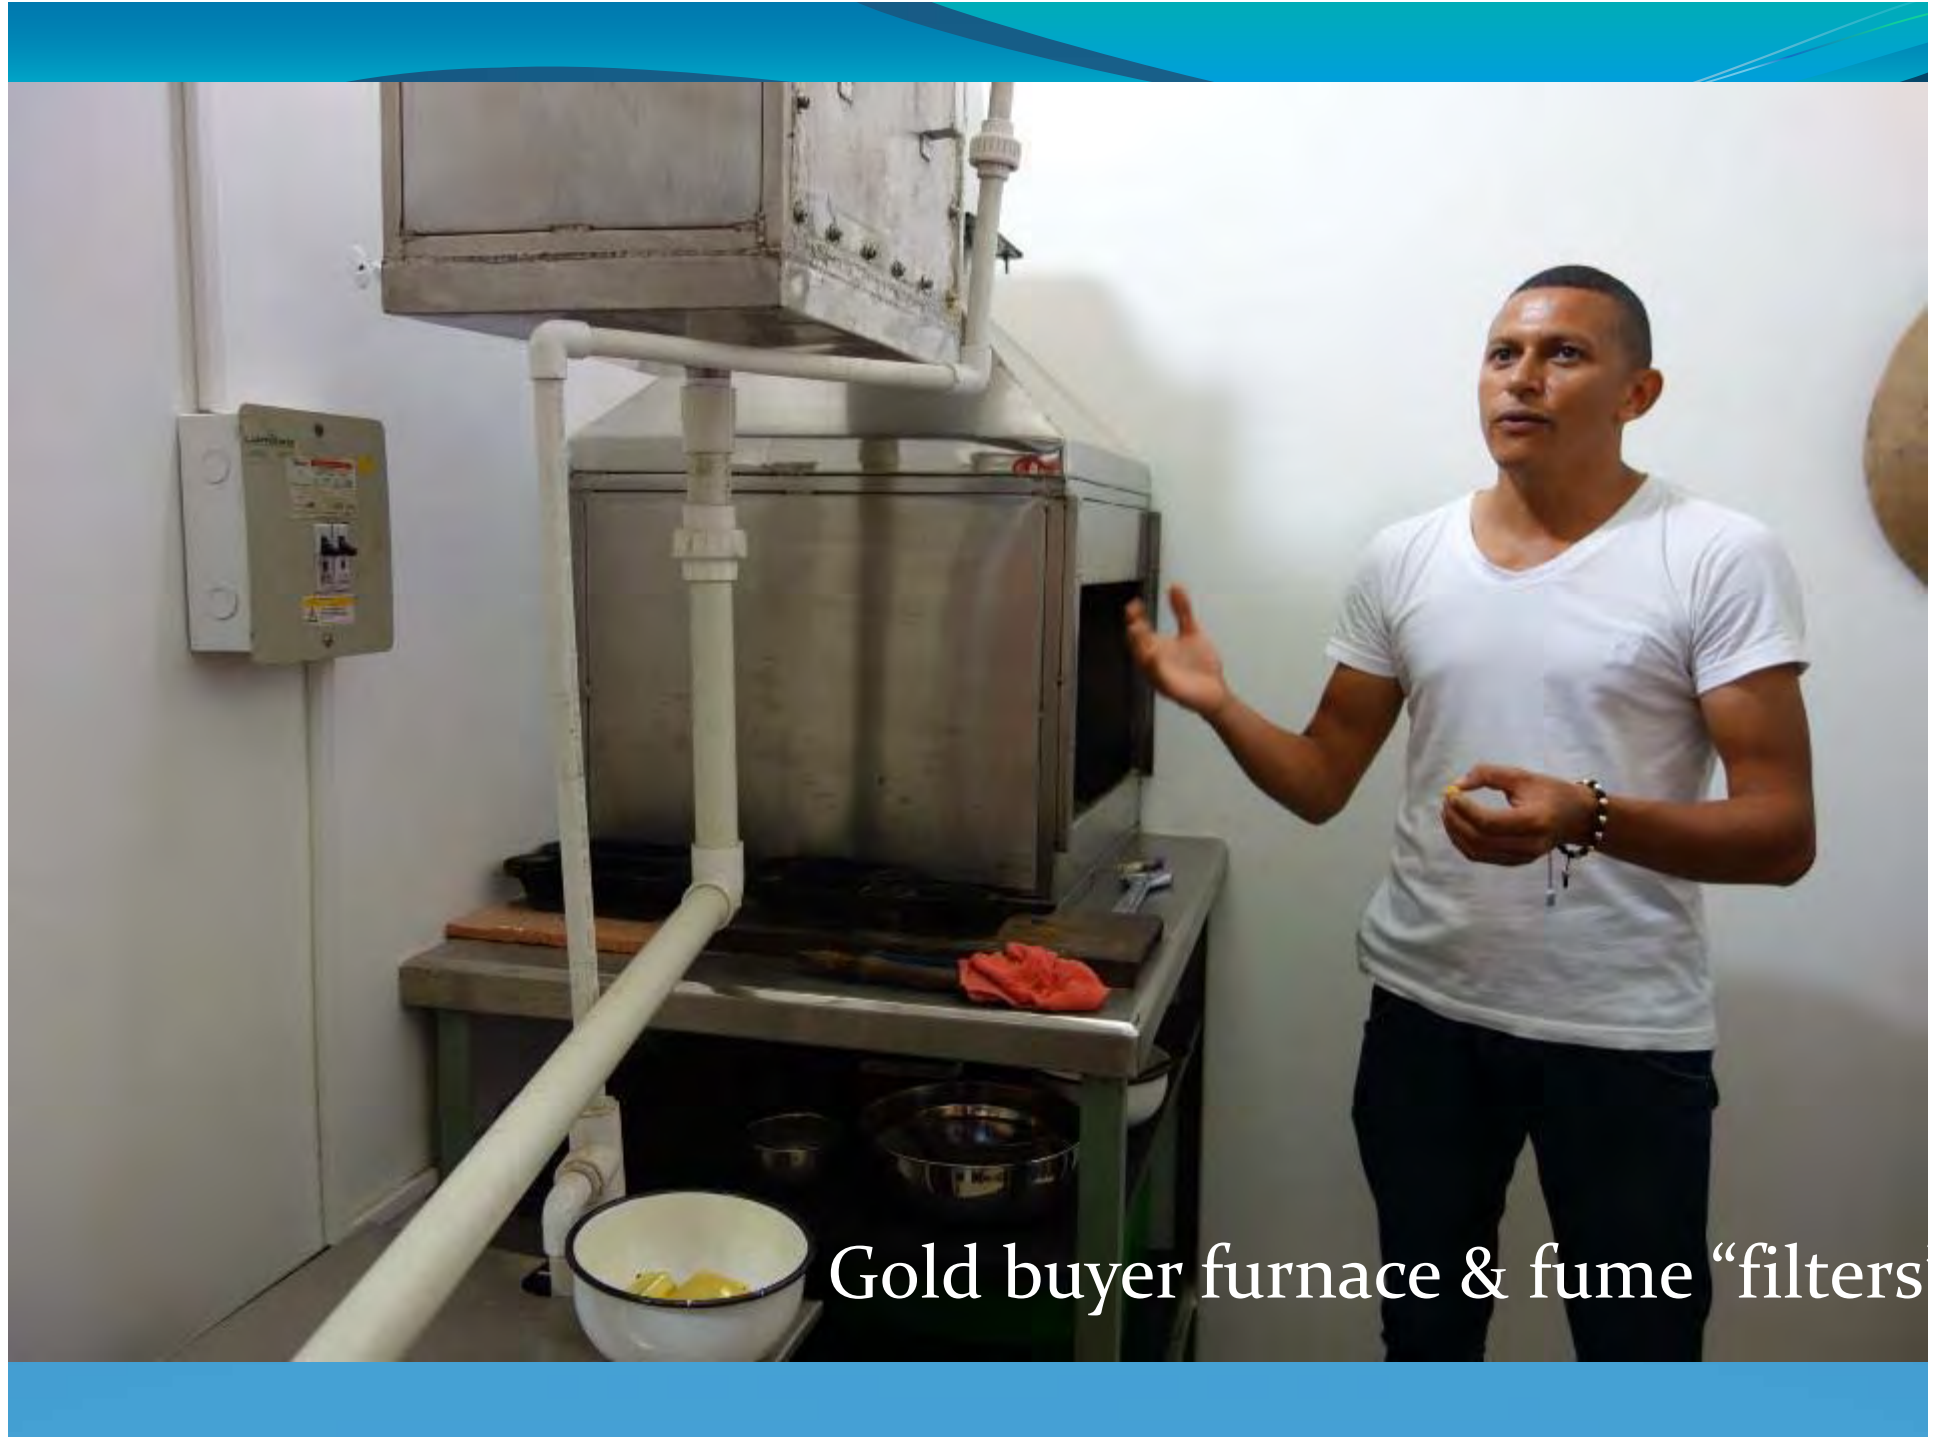
Gold buyer furnace & fume “filters”

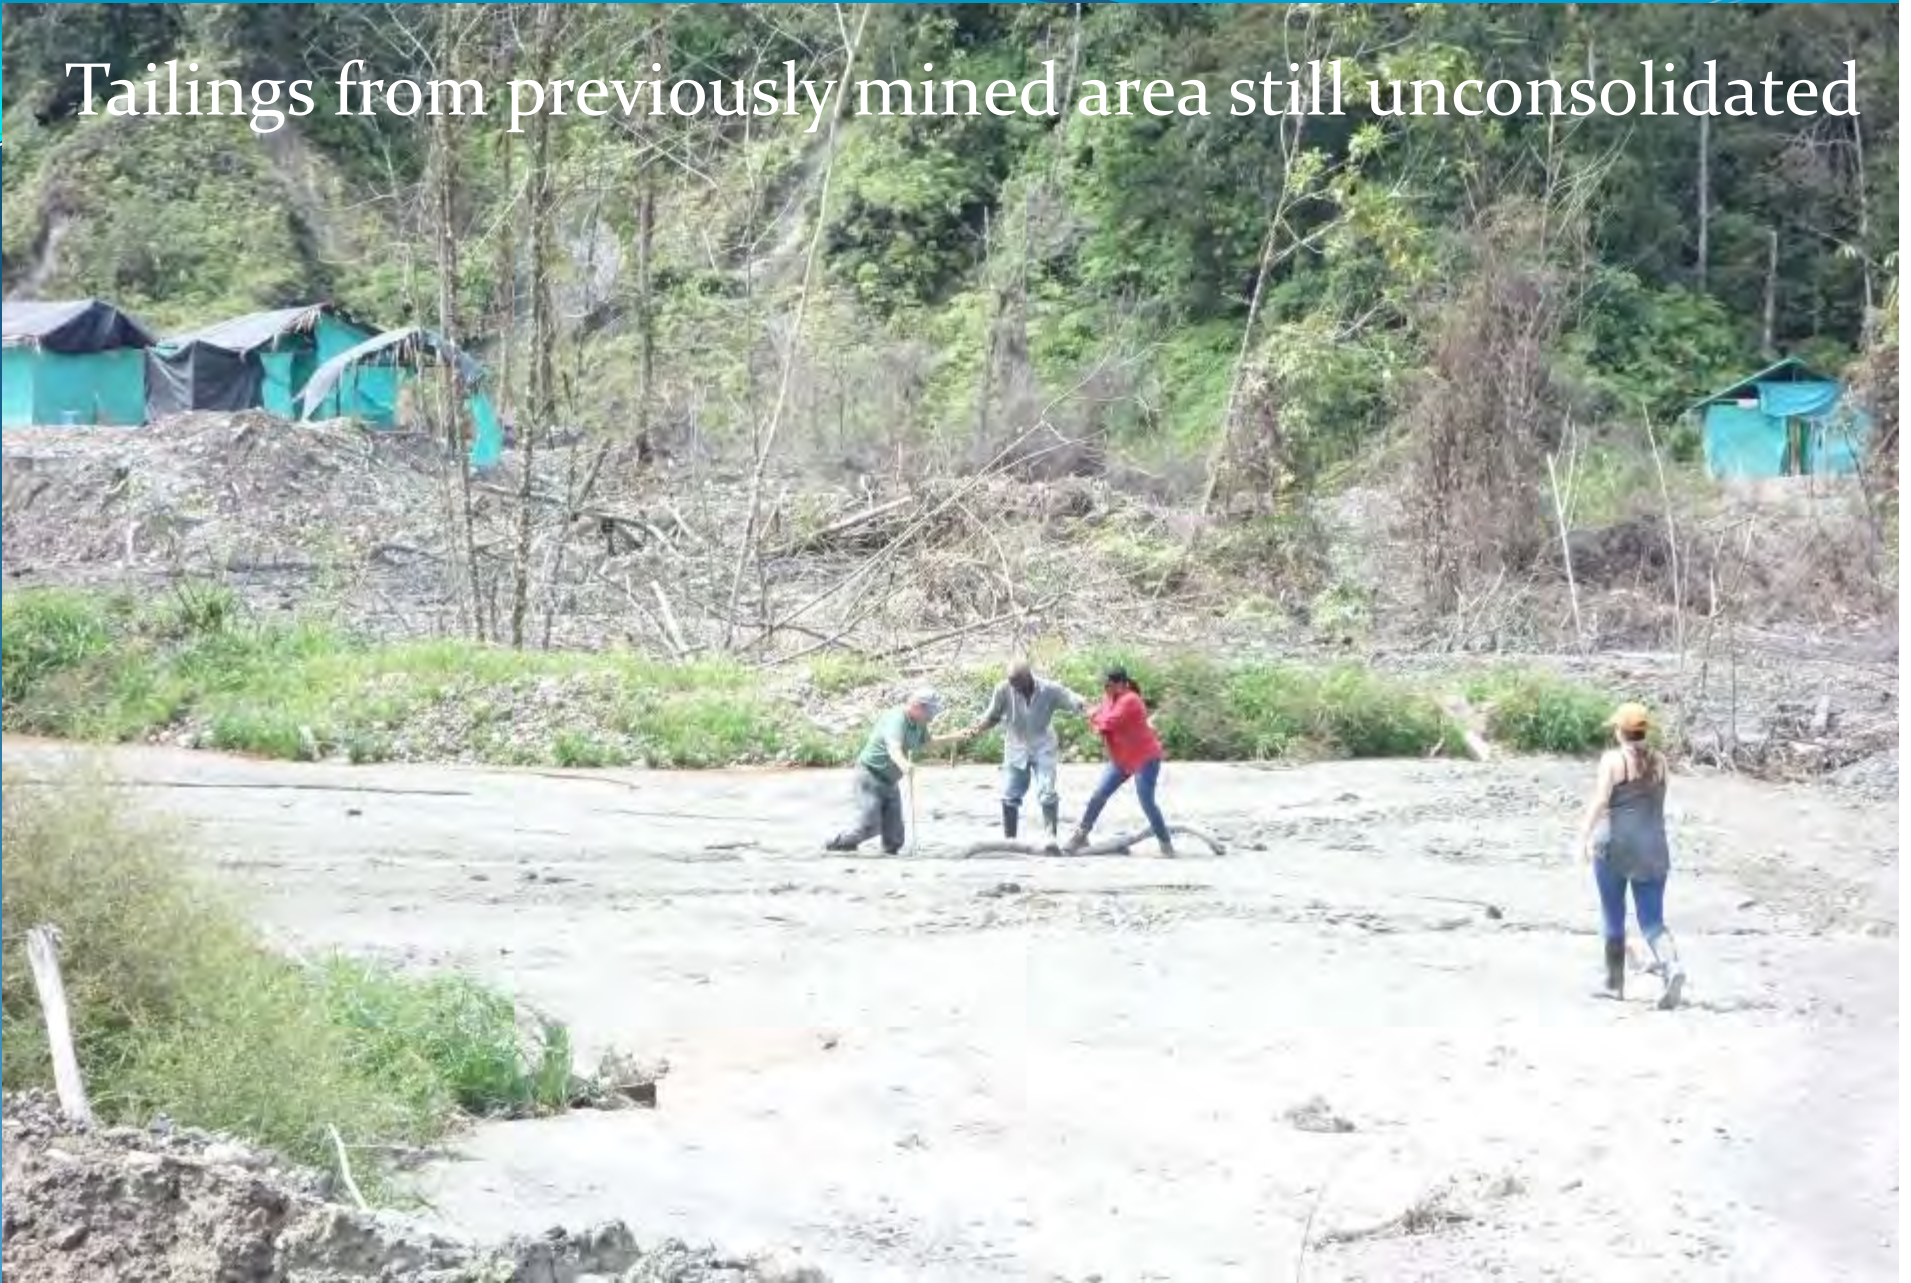
Tailings from previously mined area still unconsolidated
