Revegetation after mine waste removal and metals impacts:

Examples from western Montana floodplains (and uplands)

Tom Parker, Geum Environmental Consulting

Floodplain restoration as part of mine waste cleanups

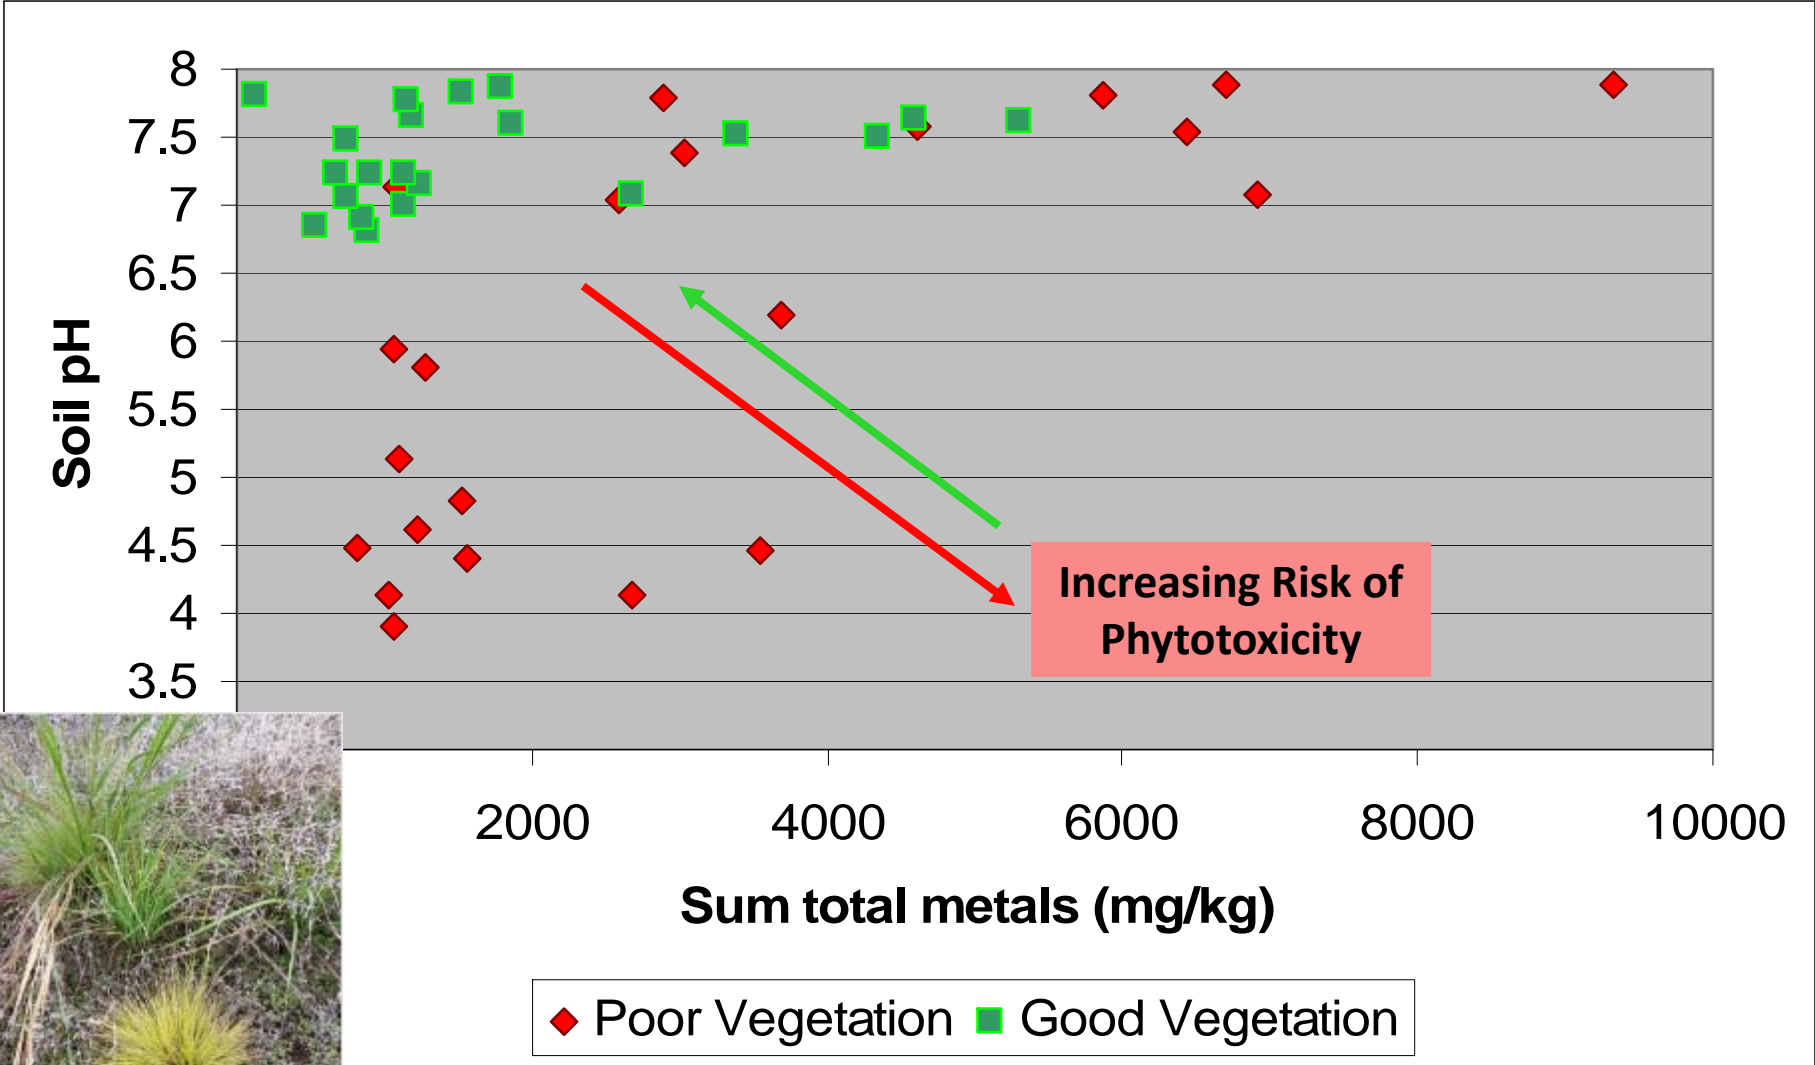
Soil Solution Toxicity to Plants

None: Dominated by Ca, Mg, Na, S, N, P, K, DOC, trace amounts of metals

Phytotoxic: Dominated by metals, low pH, no or low nutrients

Remediated: Some soluble trace elements, near neutral pH, nutrients replaced, lime addition adds Ca, Mg

Can be toxic to sensitive species depending on levels

Increasing Chance of Successful Reclamation

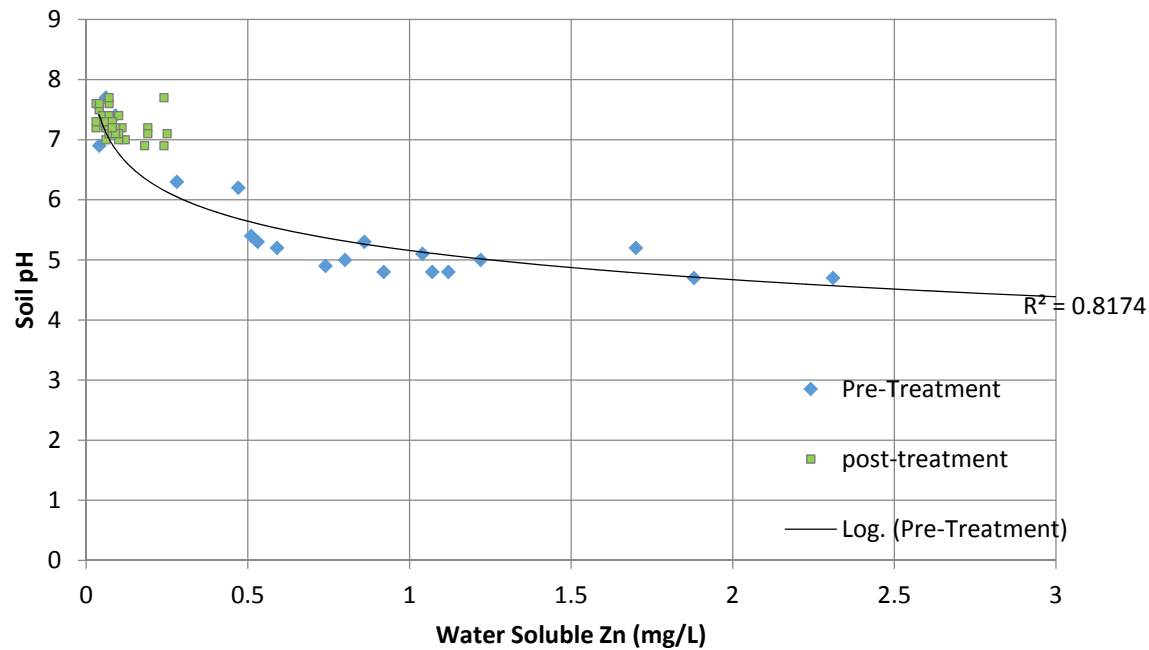
East Side Pasture Project,
Water Soluble Zinc before and after treatment

Water Soluble Zinc Before and After Soil Treatment with Lime and Compost

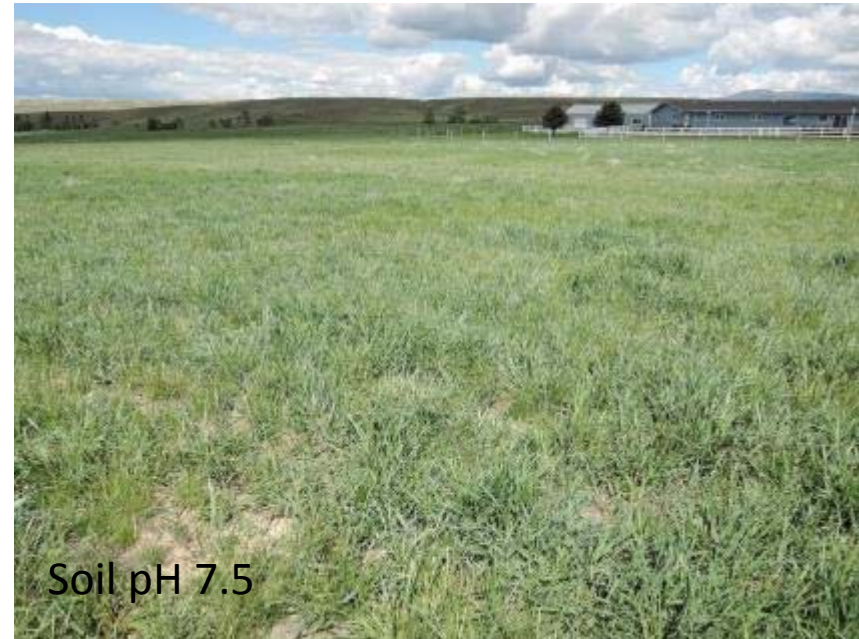
After reclamation using lime and organic matter (May 2016)...seeded May 2015
