Riley Pass Uranium Mine Site - Off to a Good Start

**Mary Beth Marks
USDA Forest Service**

RILEY PASS URANIUM MINES

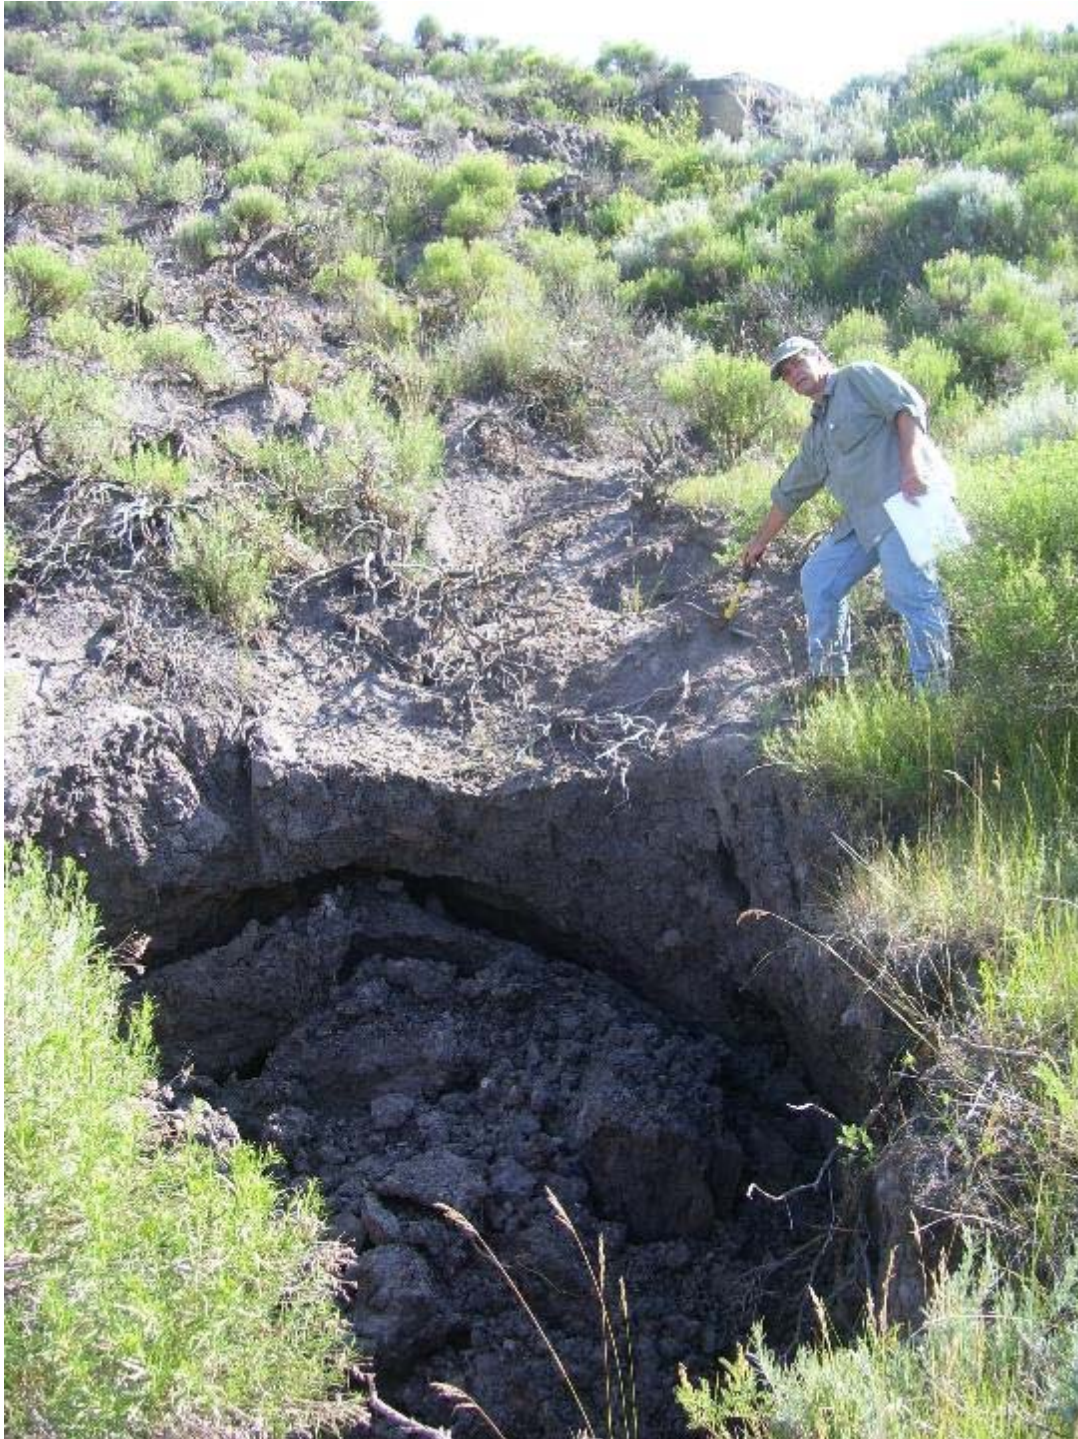
Soil piping throughout spoils material

Northeast Drainage Channel – Bluff B

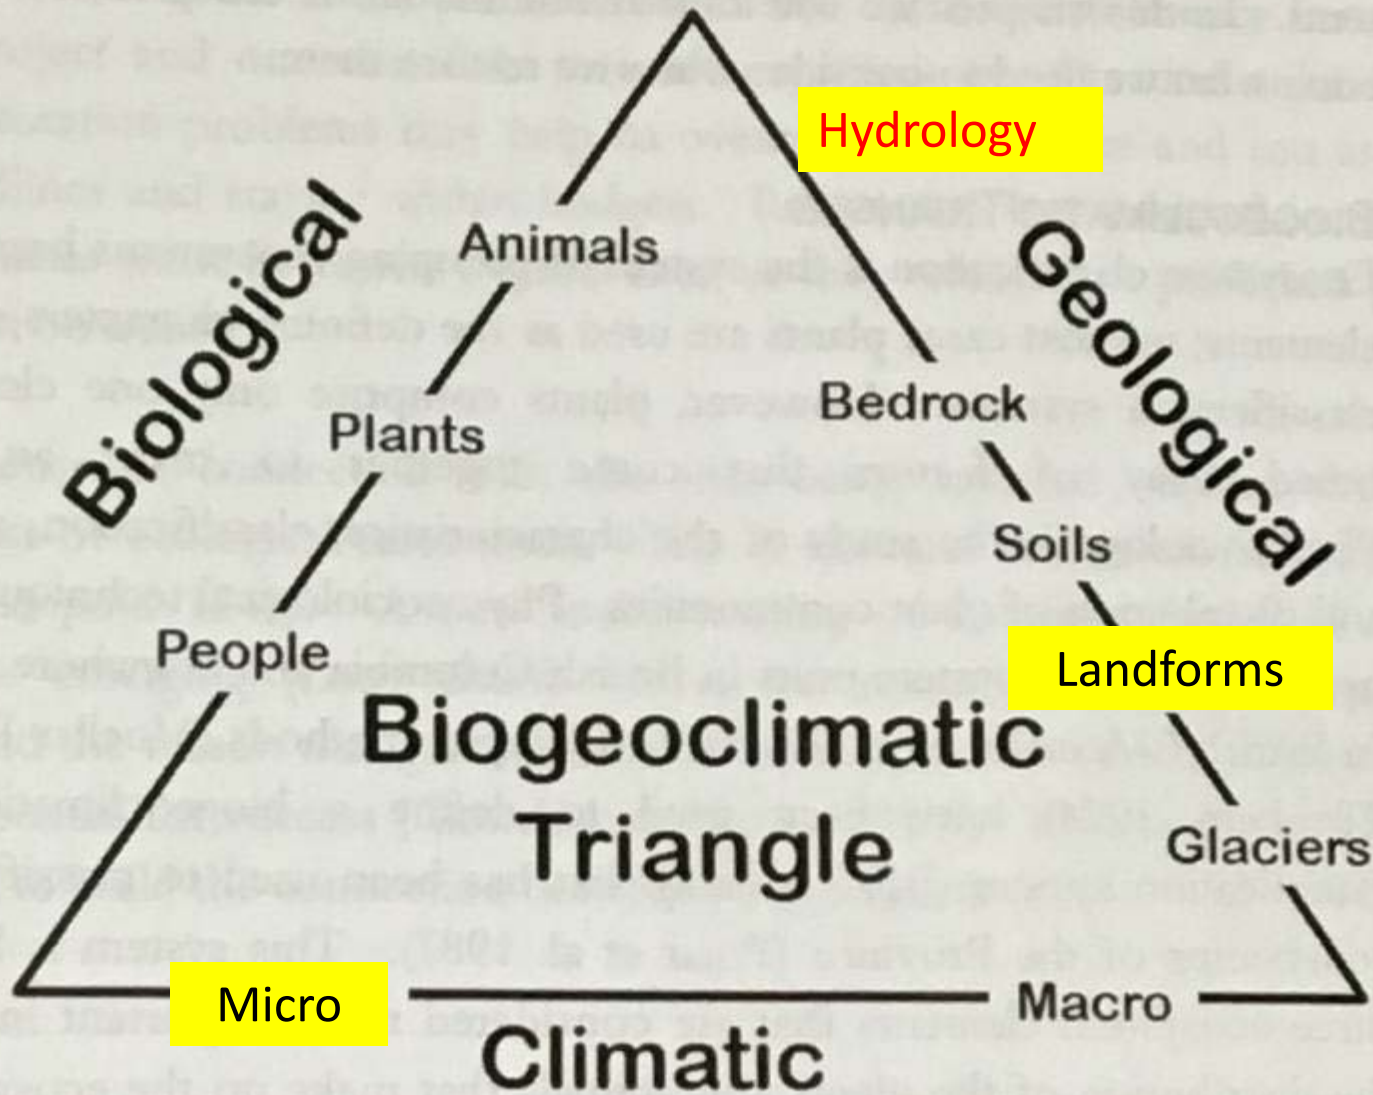
Figure 2-1. Biogeoclimatic triangle showing the elements that are needed for effective restoration planning.

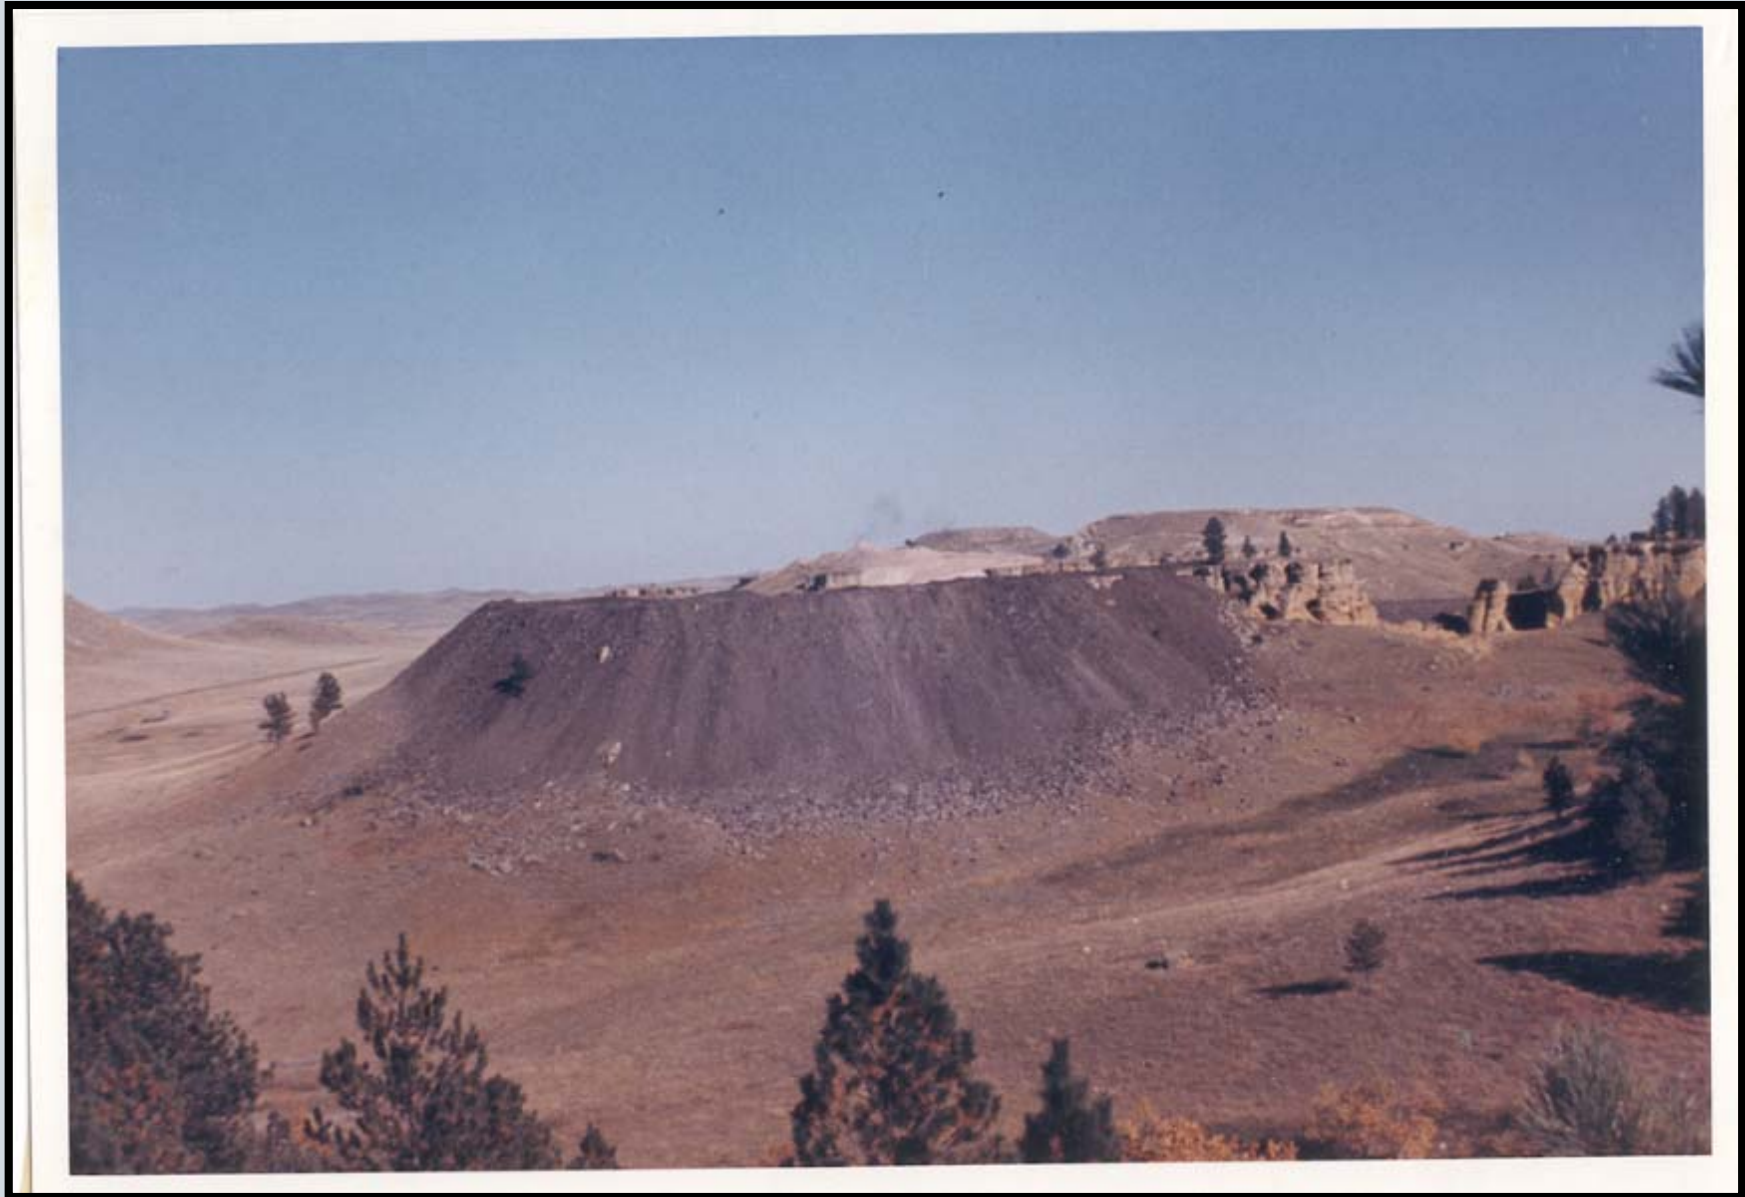
Bluff G – During Mining - 1964

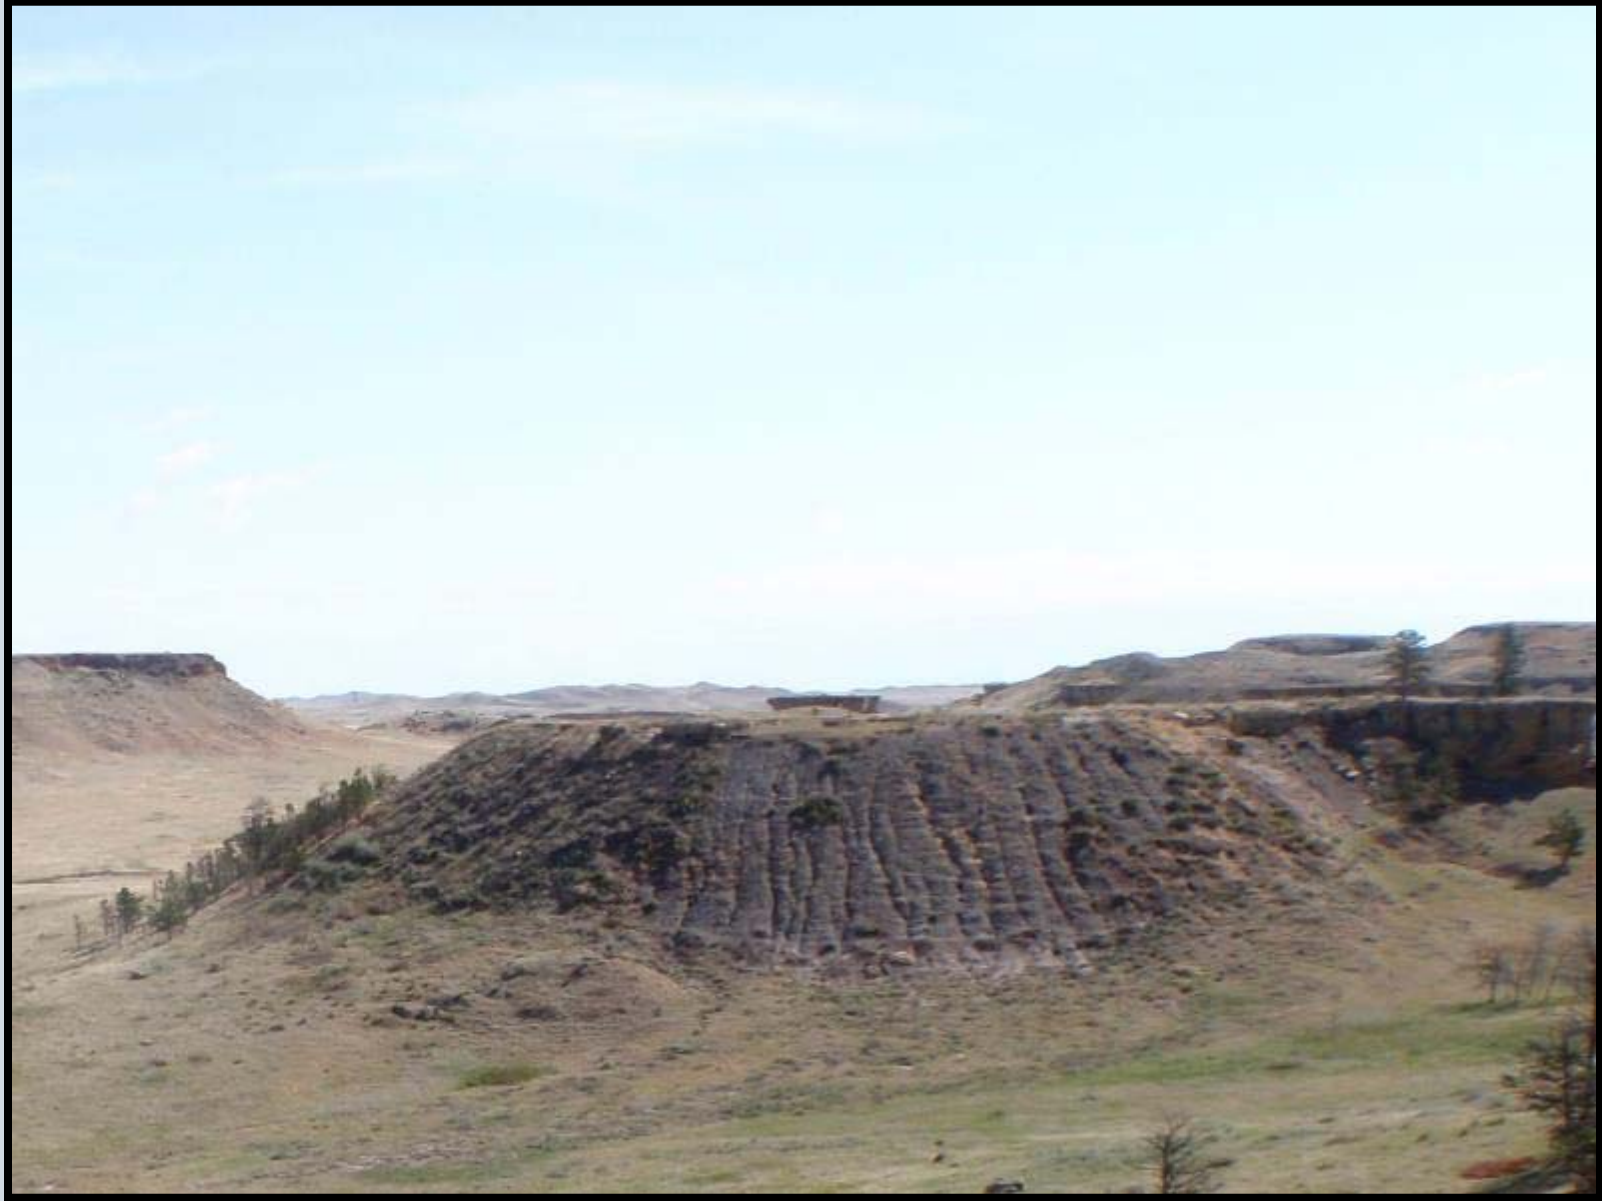
Bluff G – Post Mining - 2012

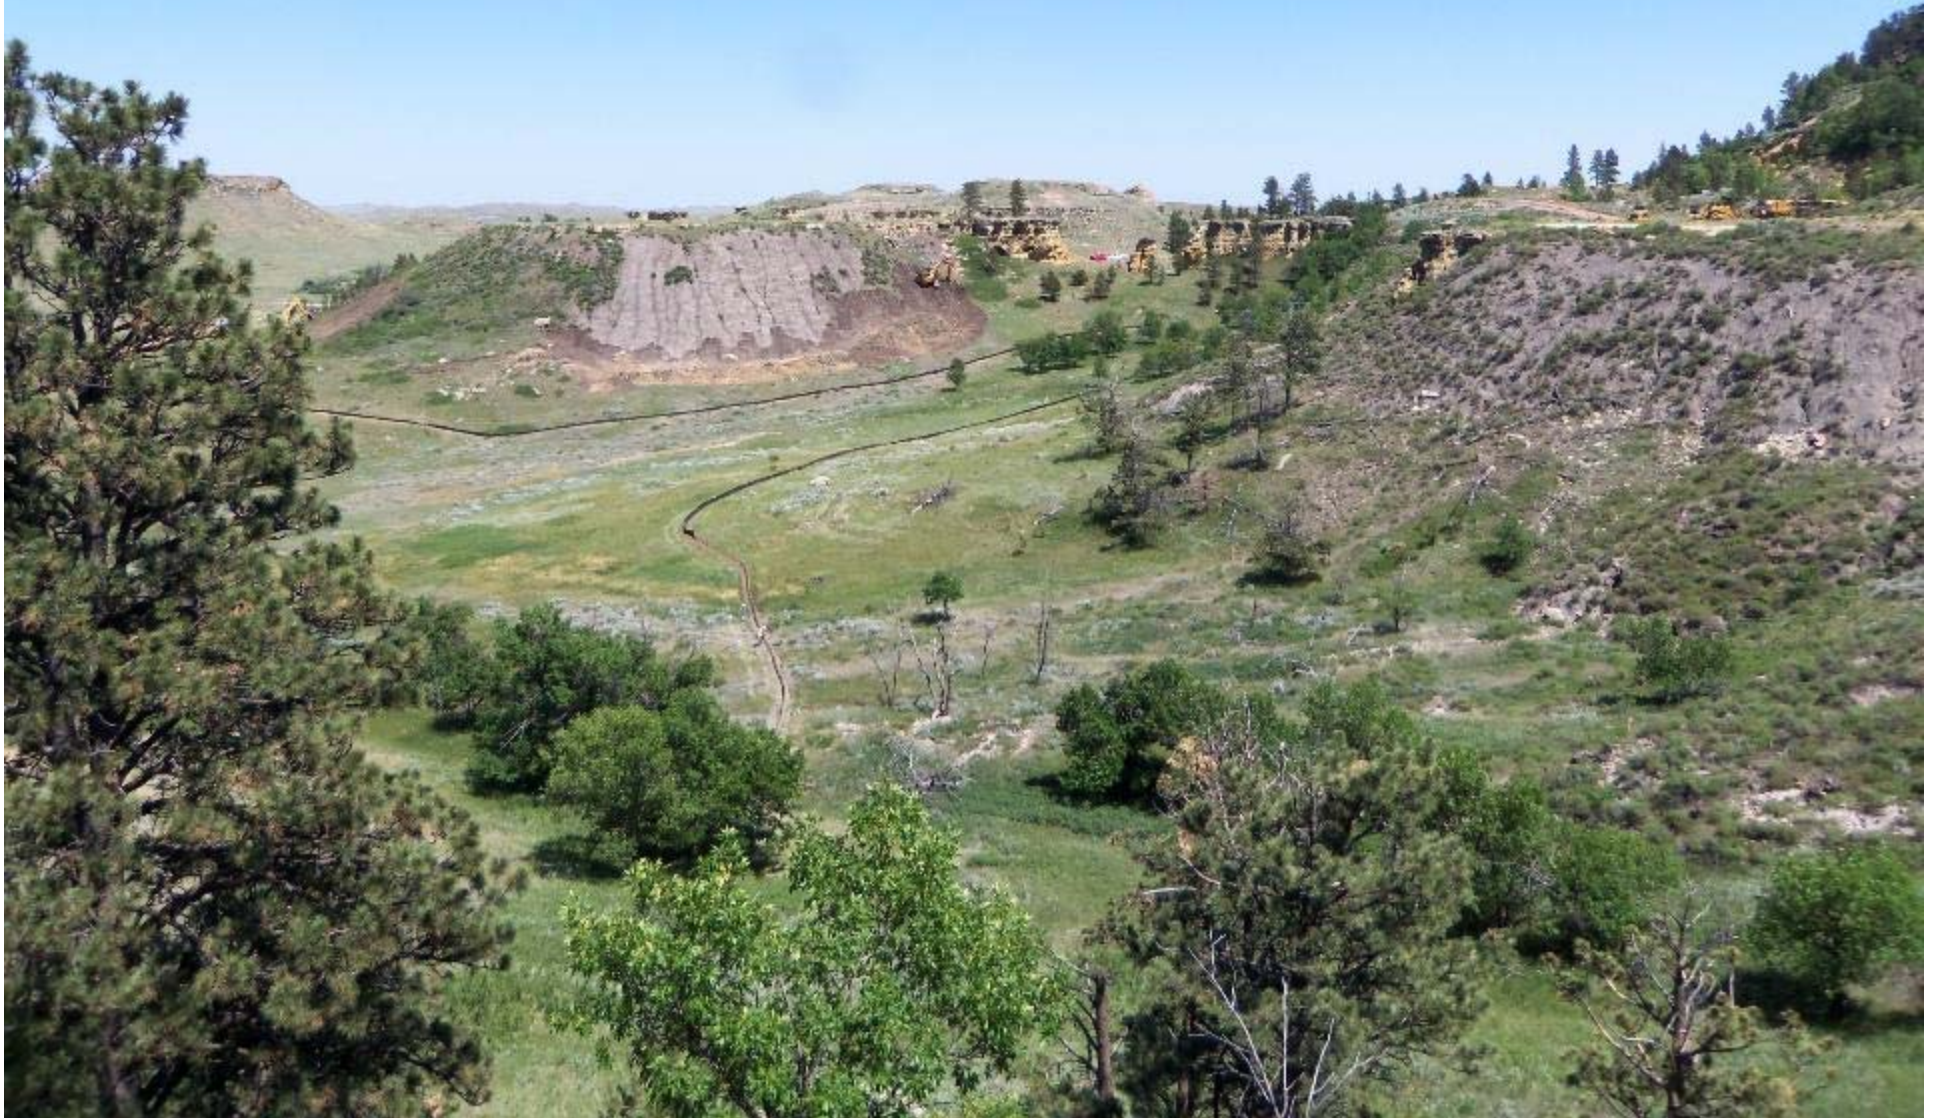
Sediment control fence

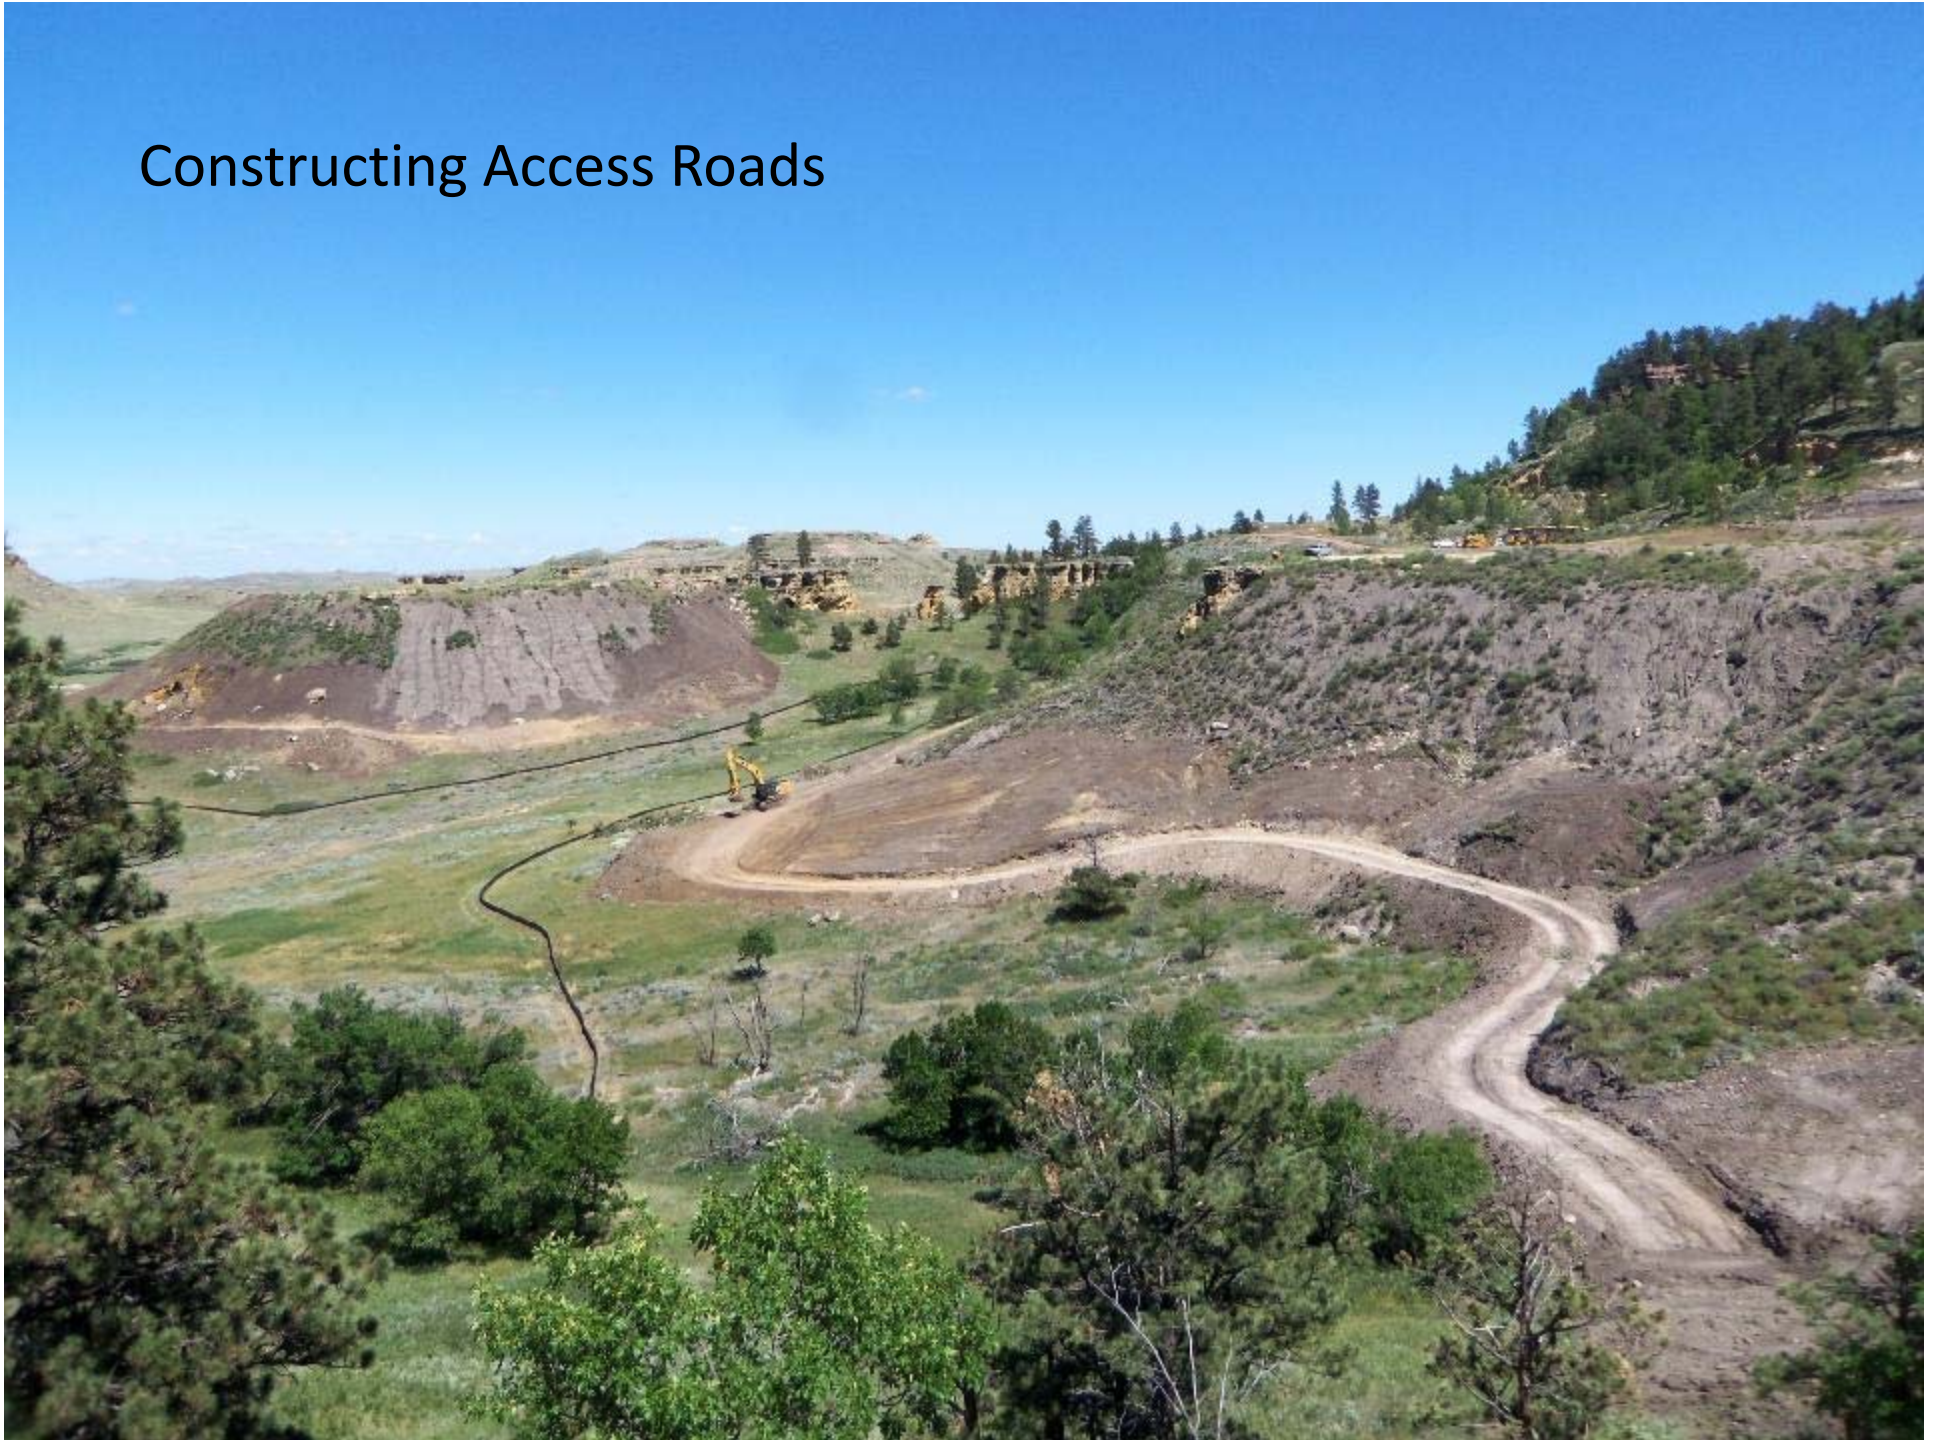
Constructing Access Roads

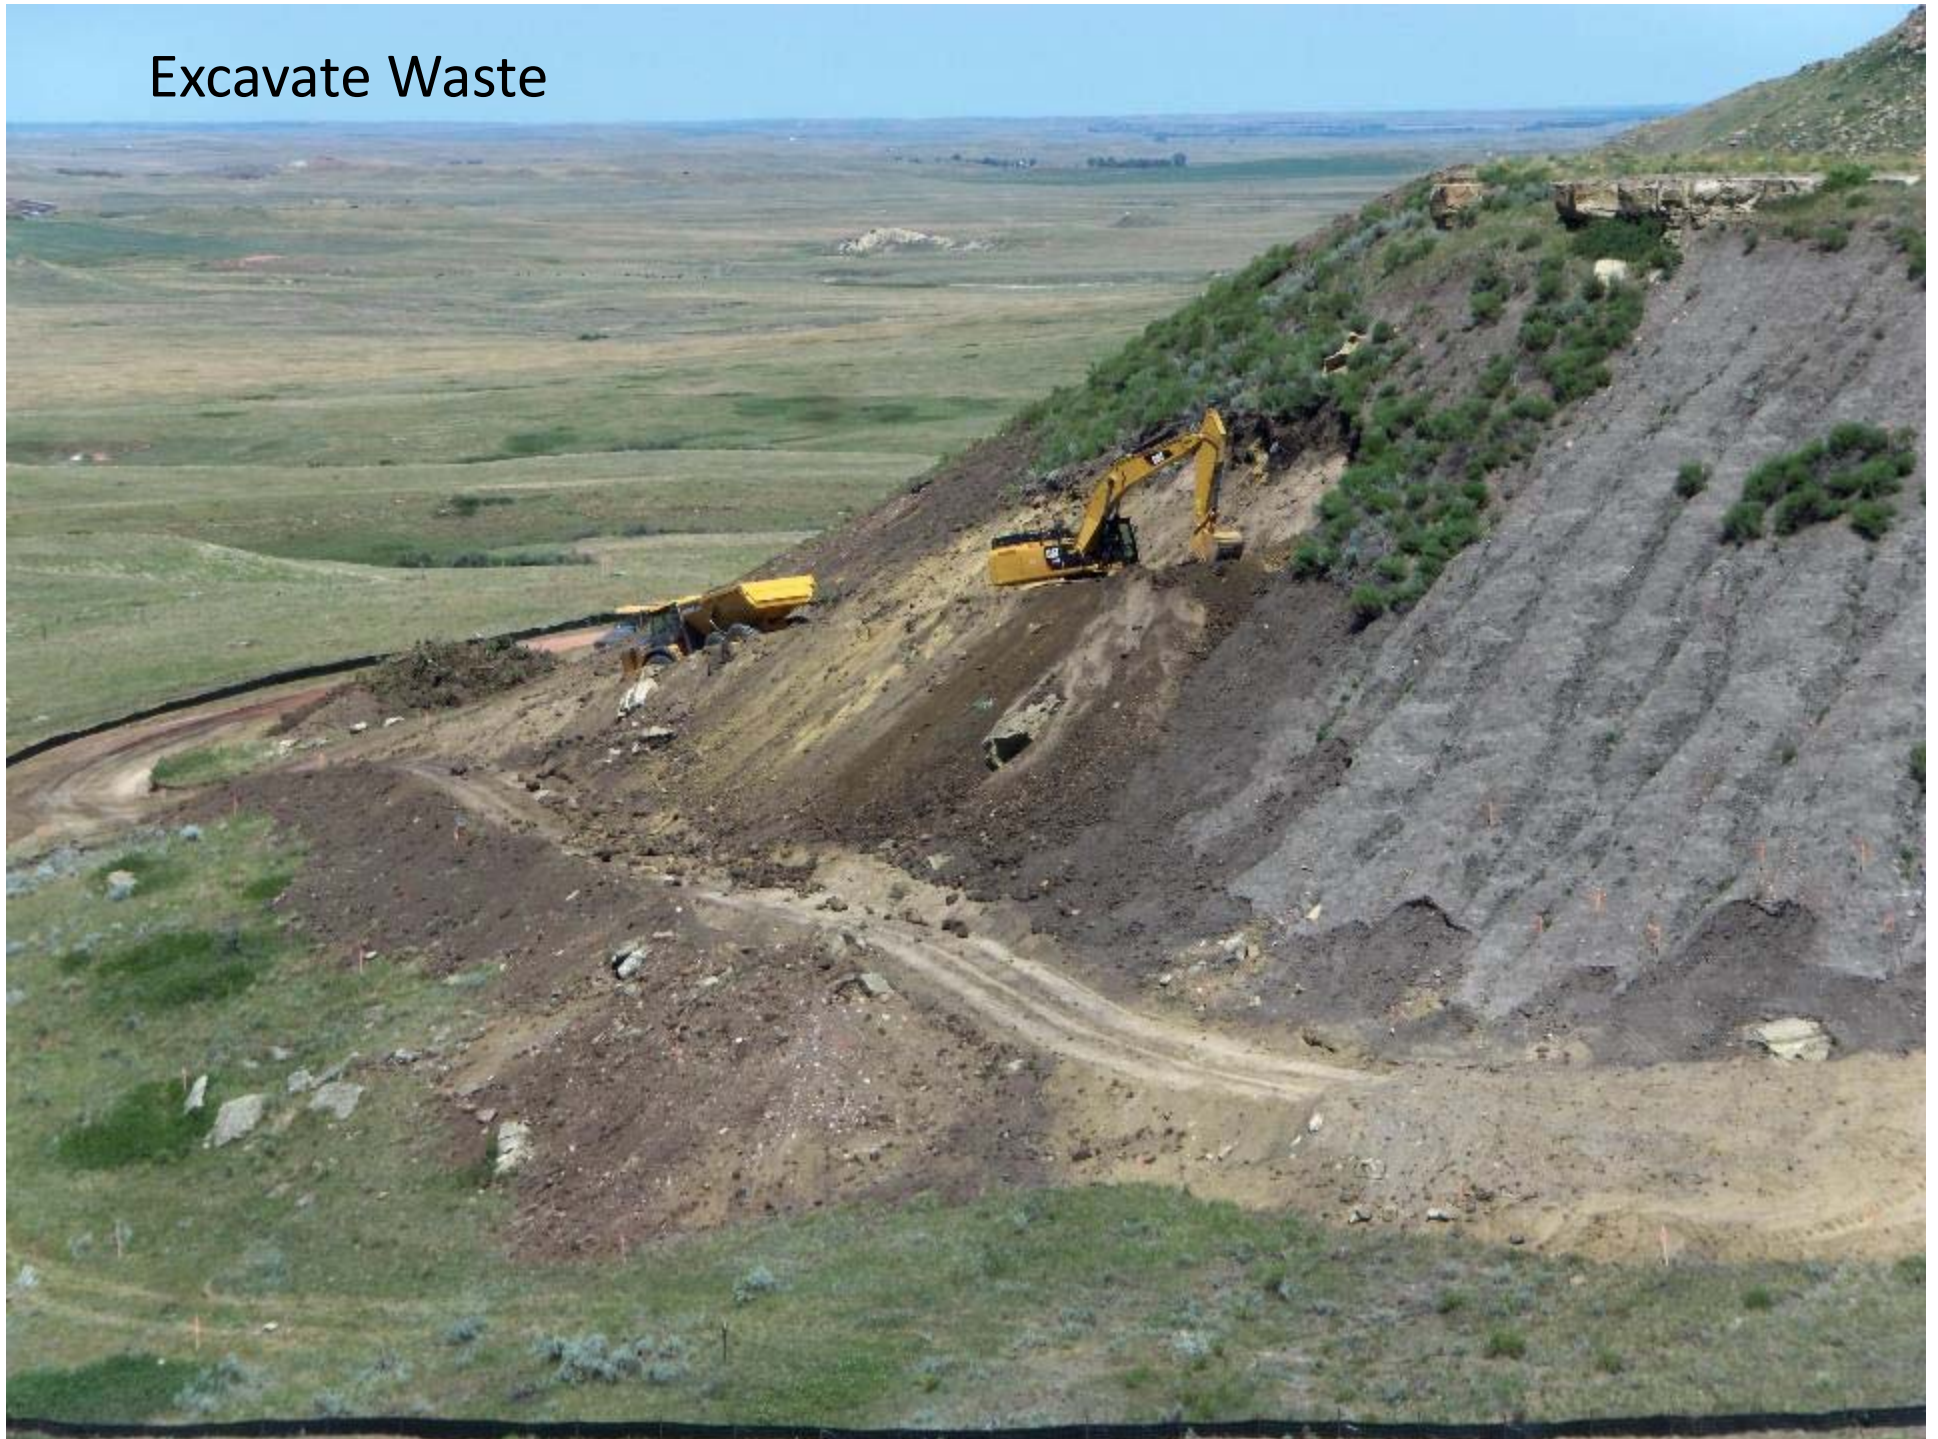
Excavate Waste

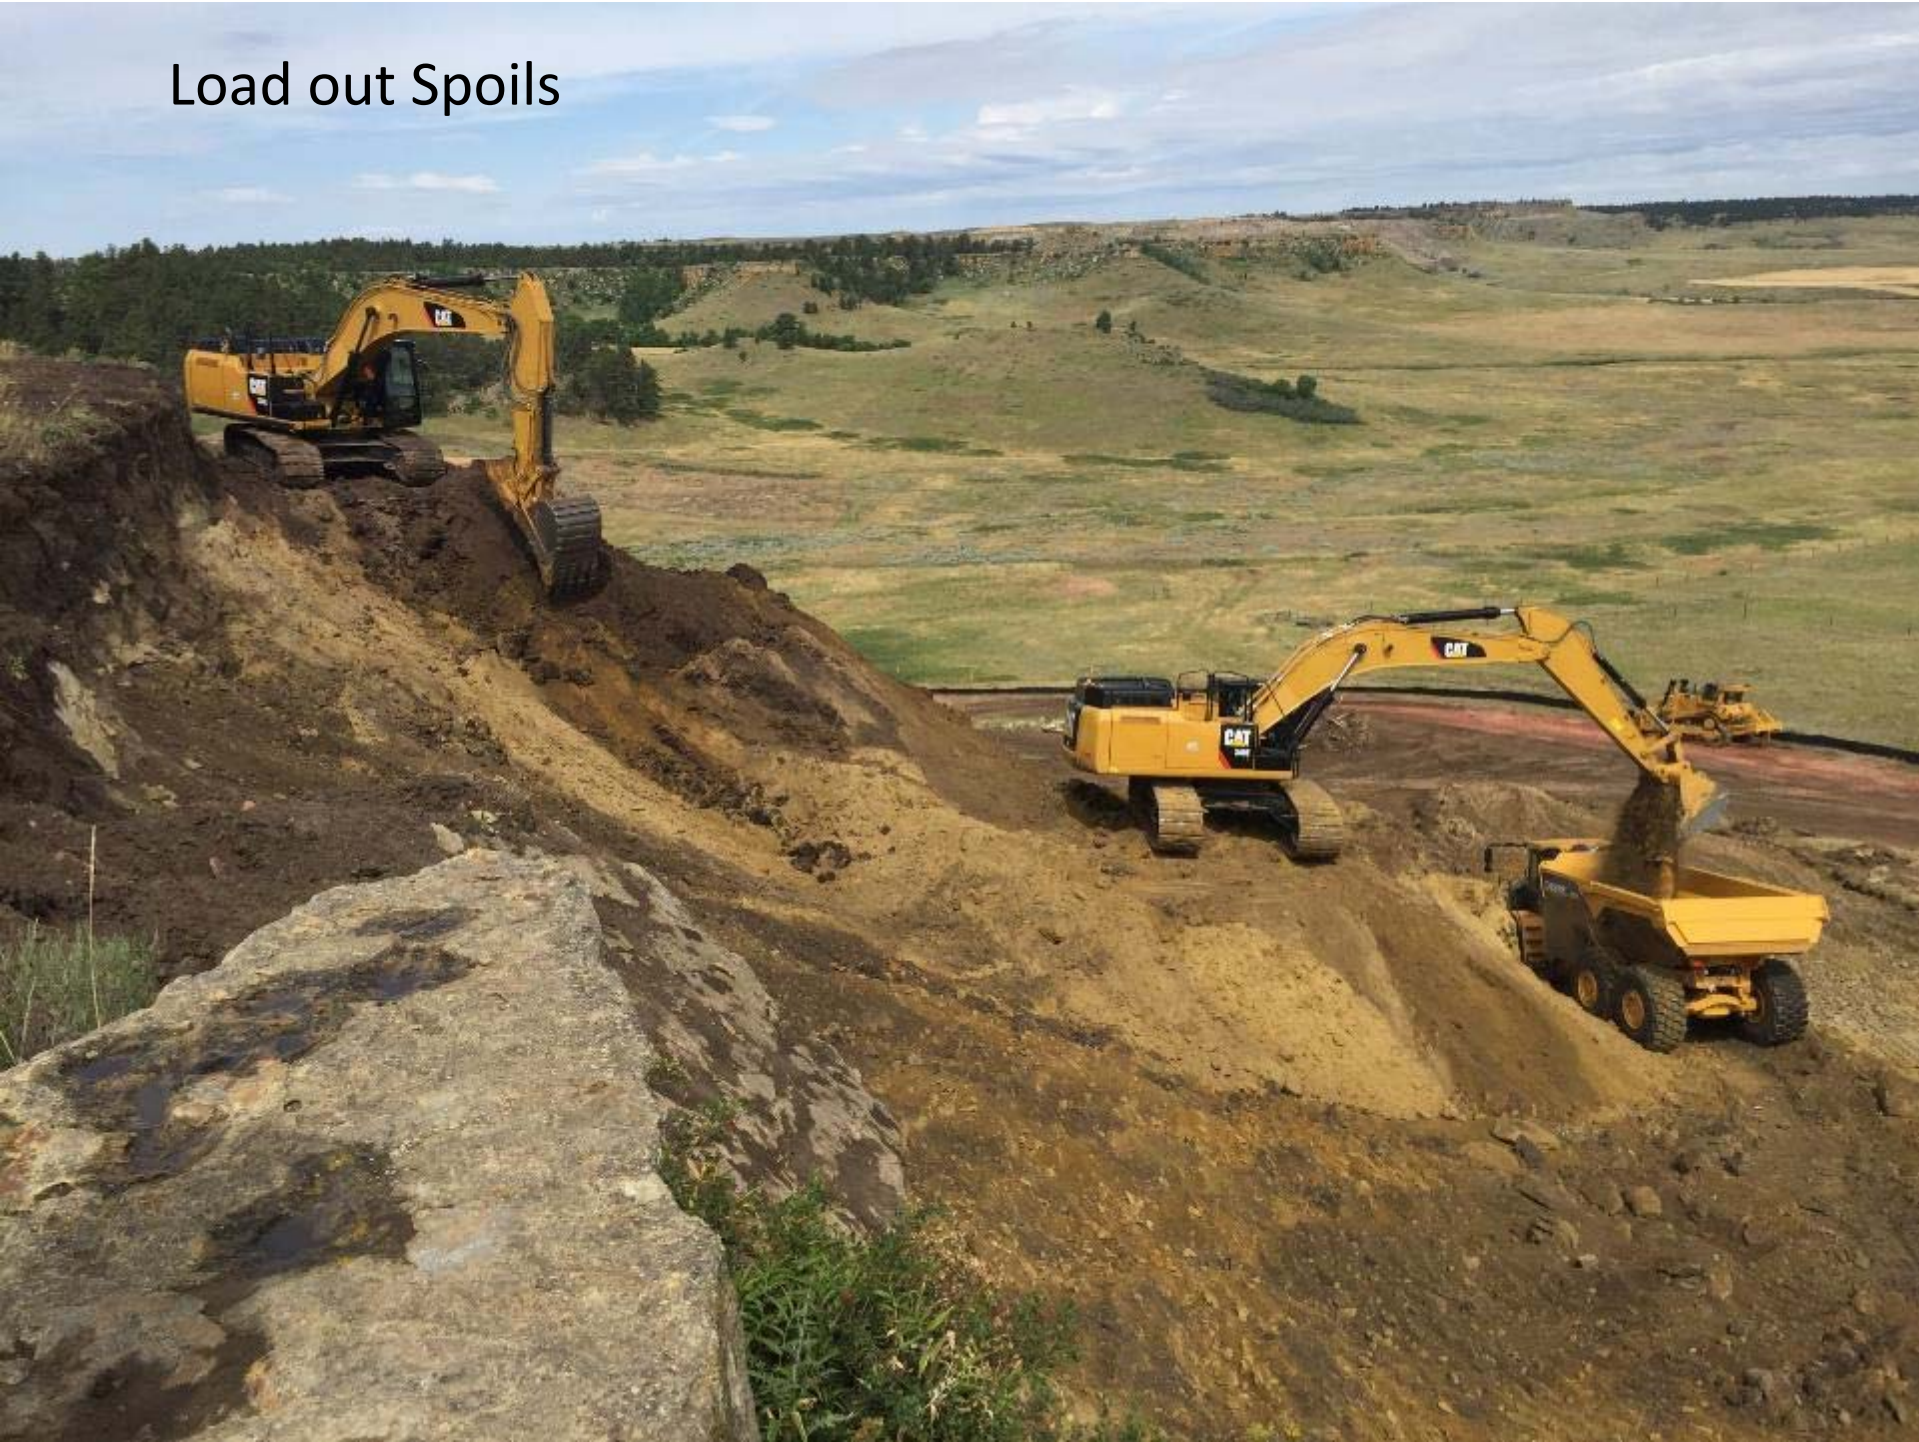
Load out Spoils

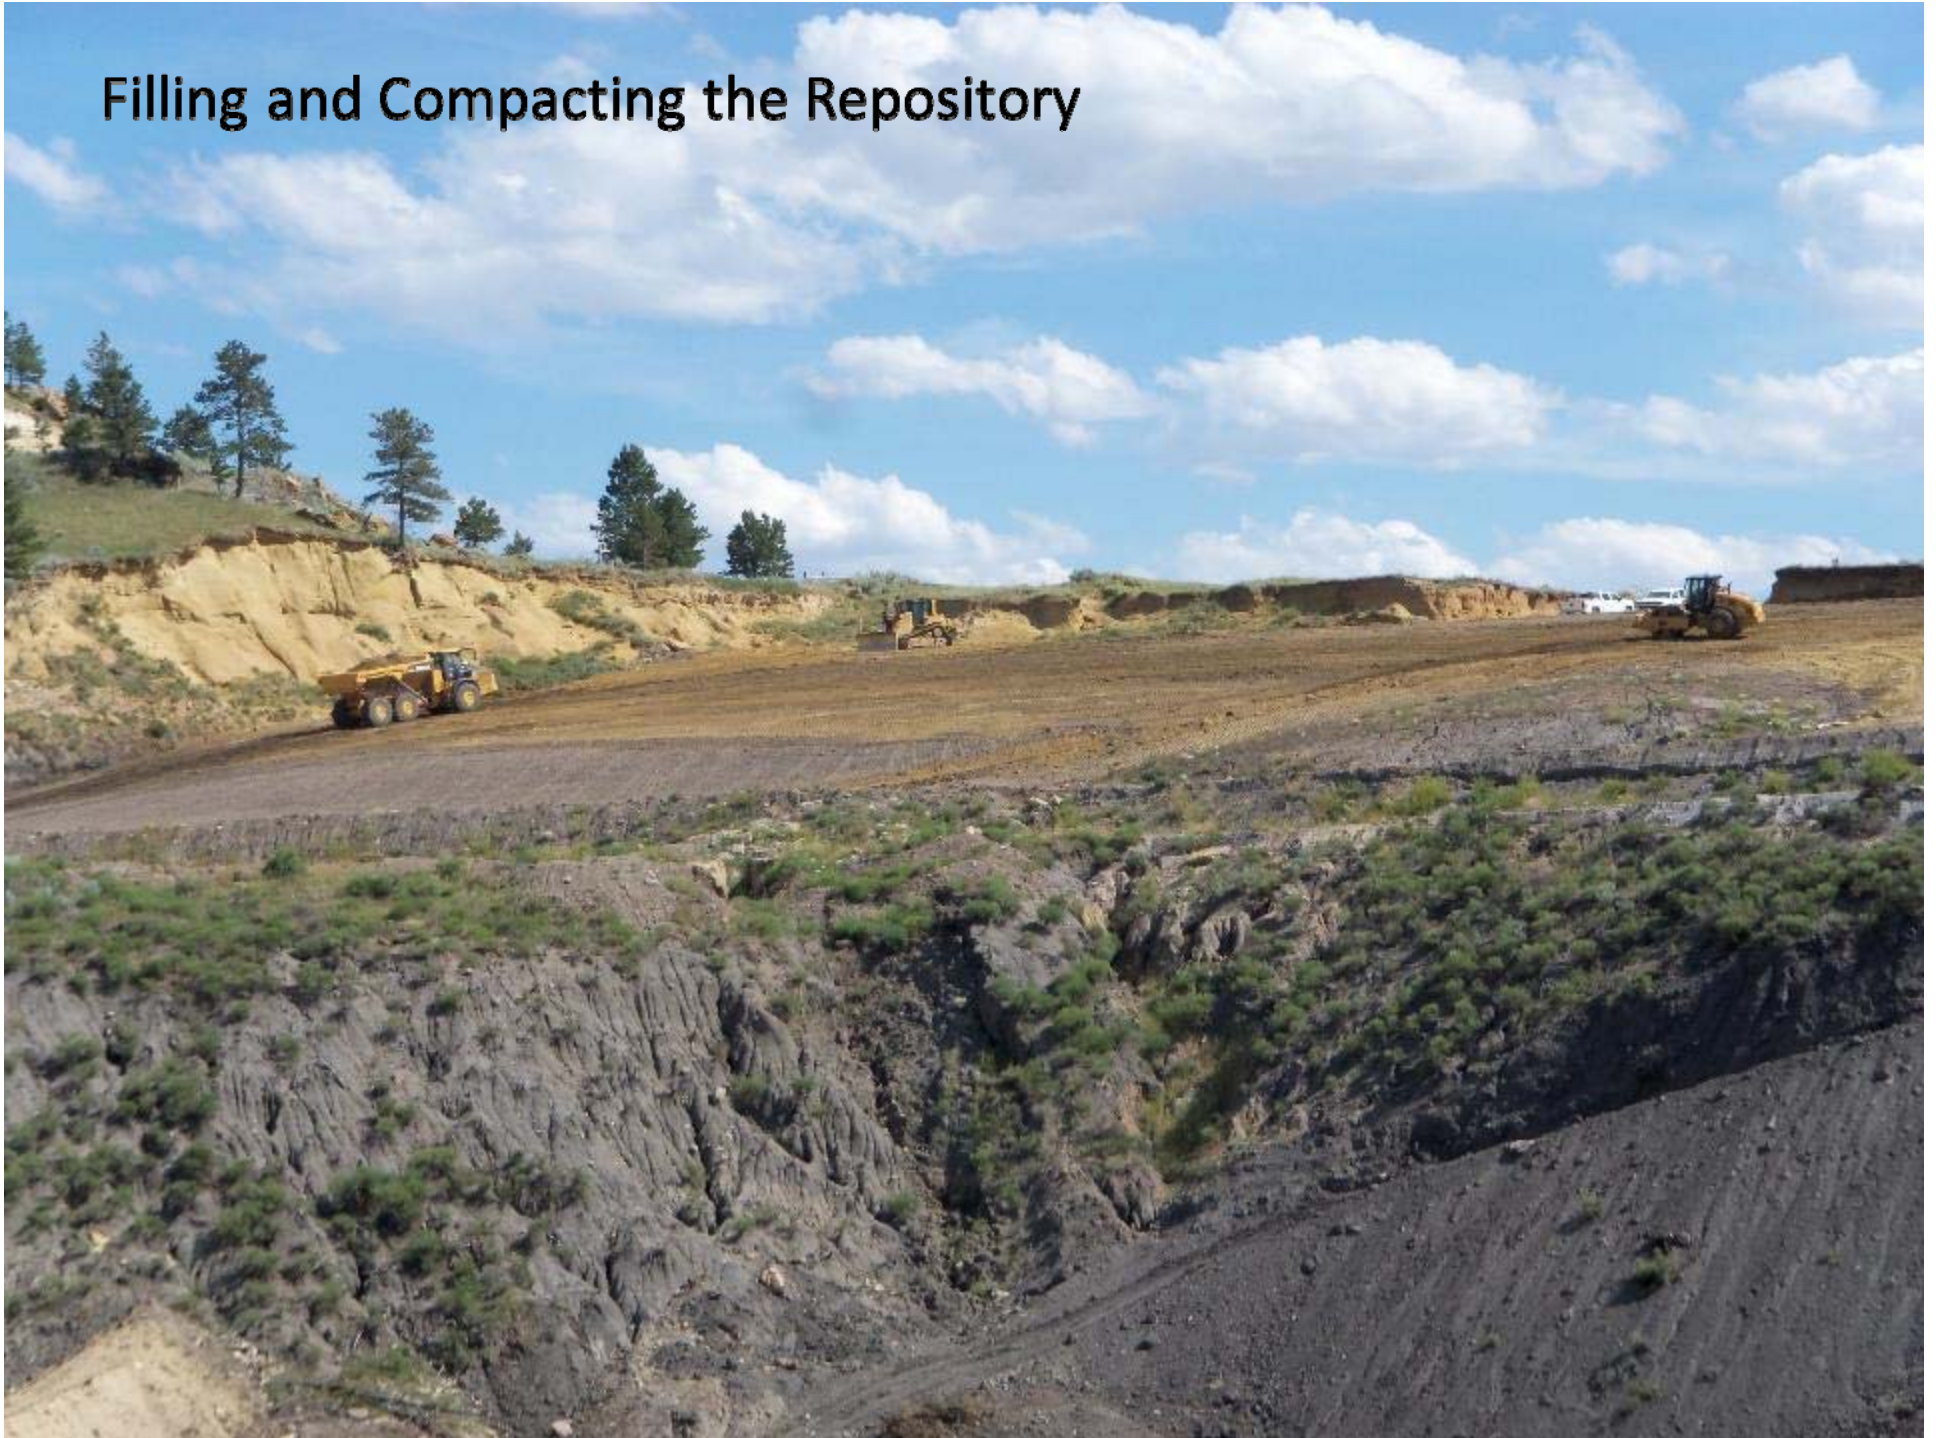
Filling and Compacting the Repository

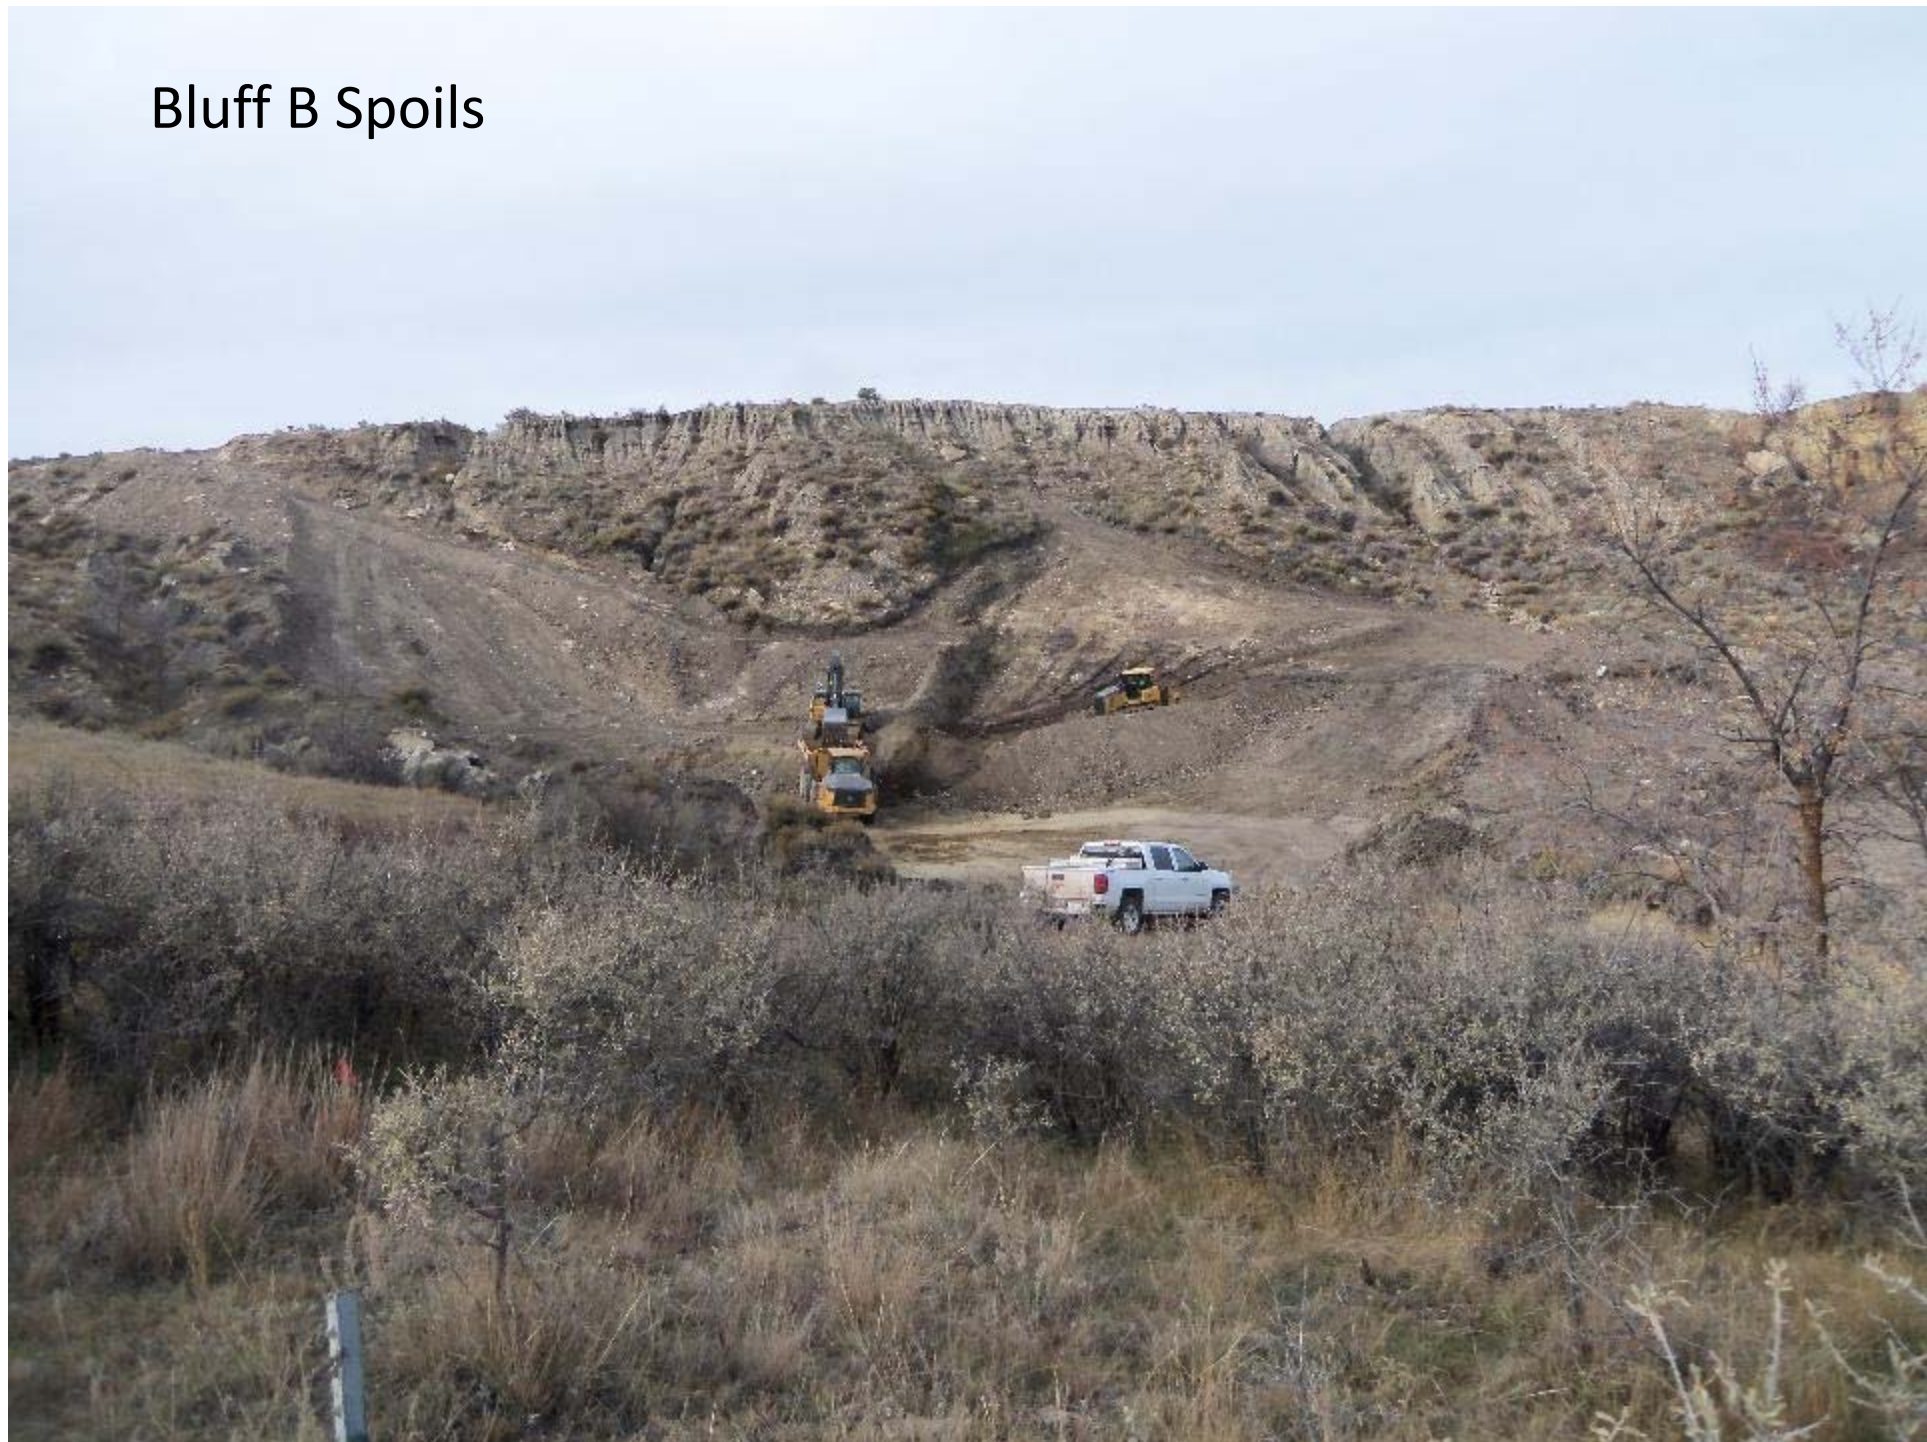
Bluff B Spoils
