Riley Pass Uranium Mine Site - Off to a Good Start

**Mary Beth Marks
USDA Forest Service**

RILEY PASS URANIUM MINES

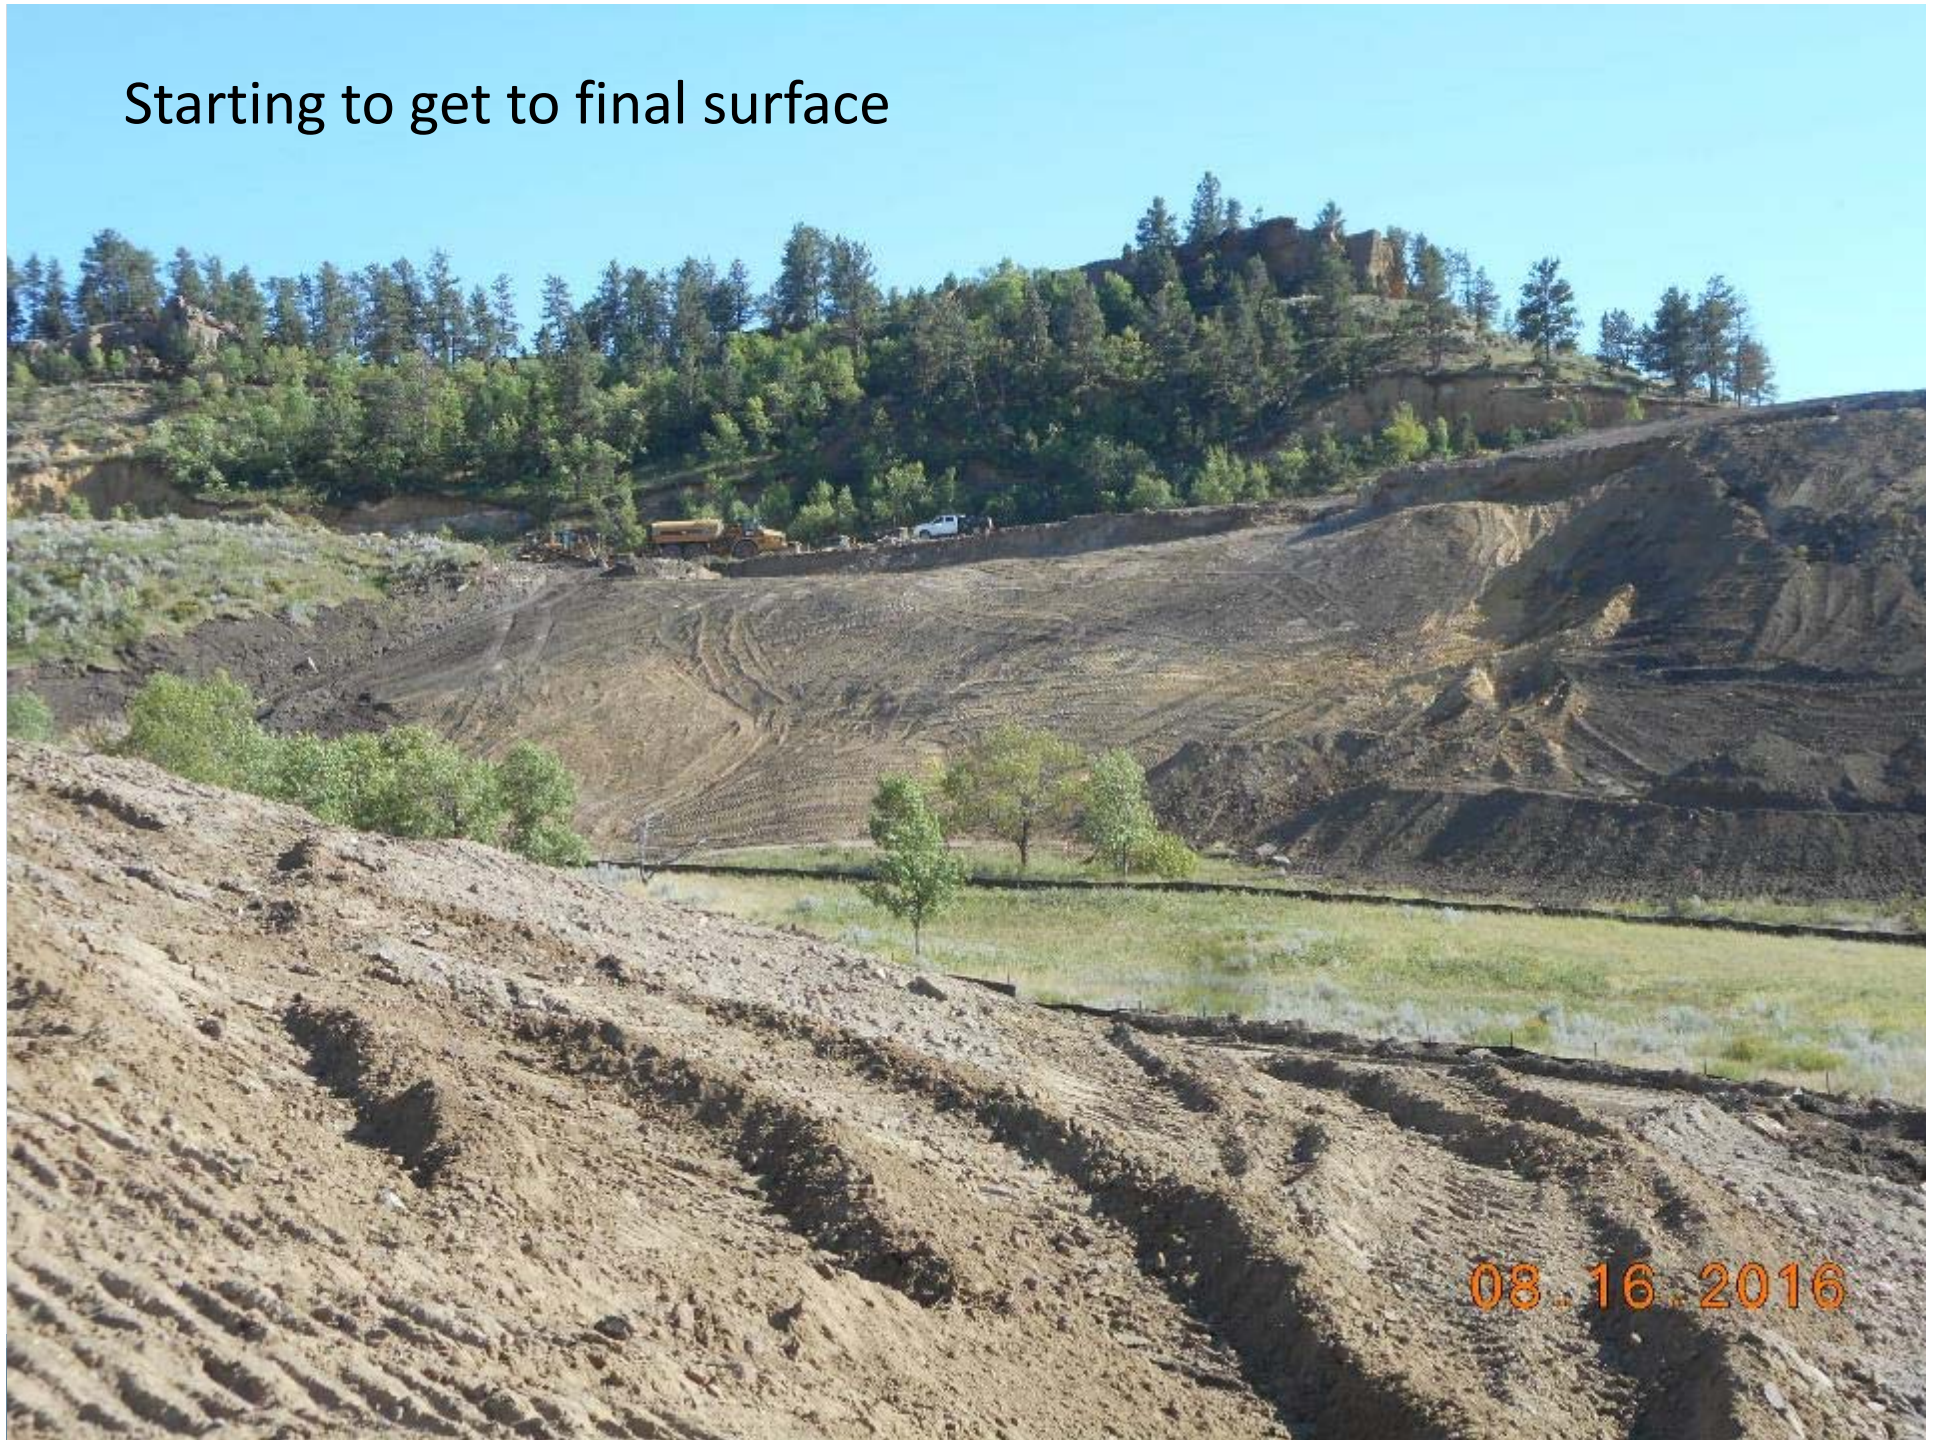
Starting to get to final surface

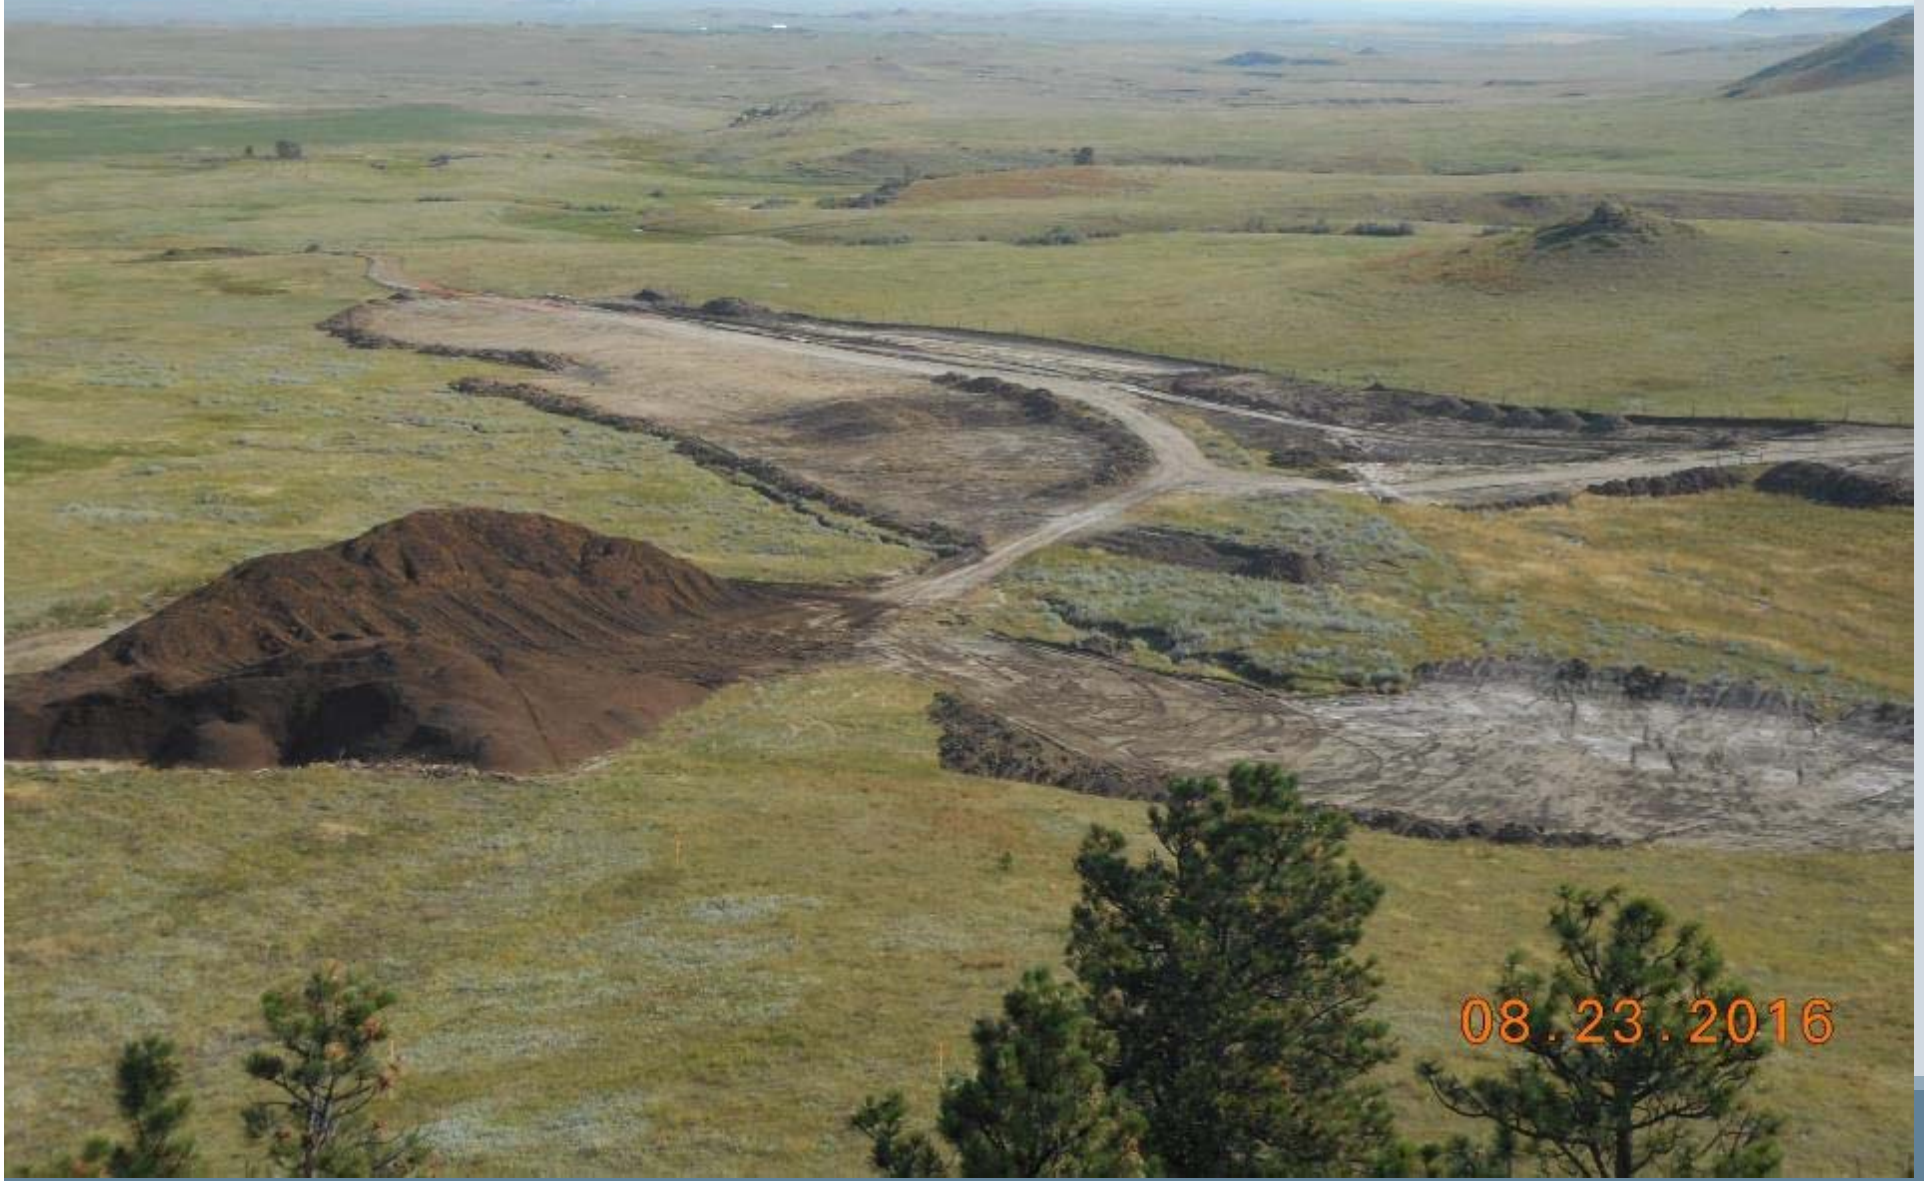
Cover Soil and Compost

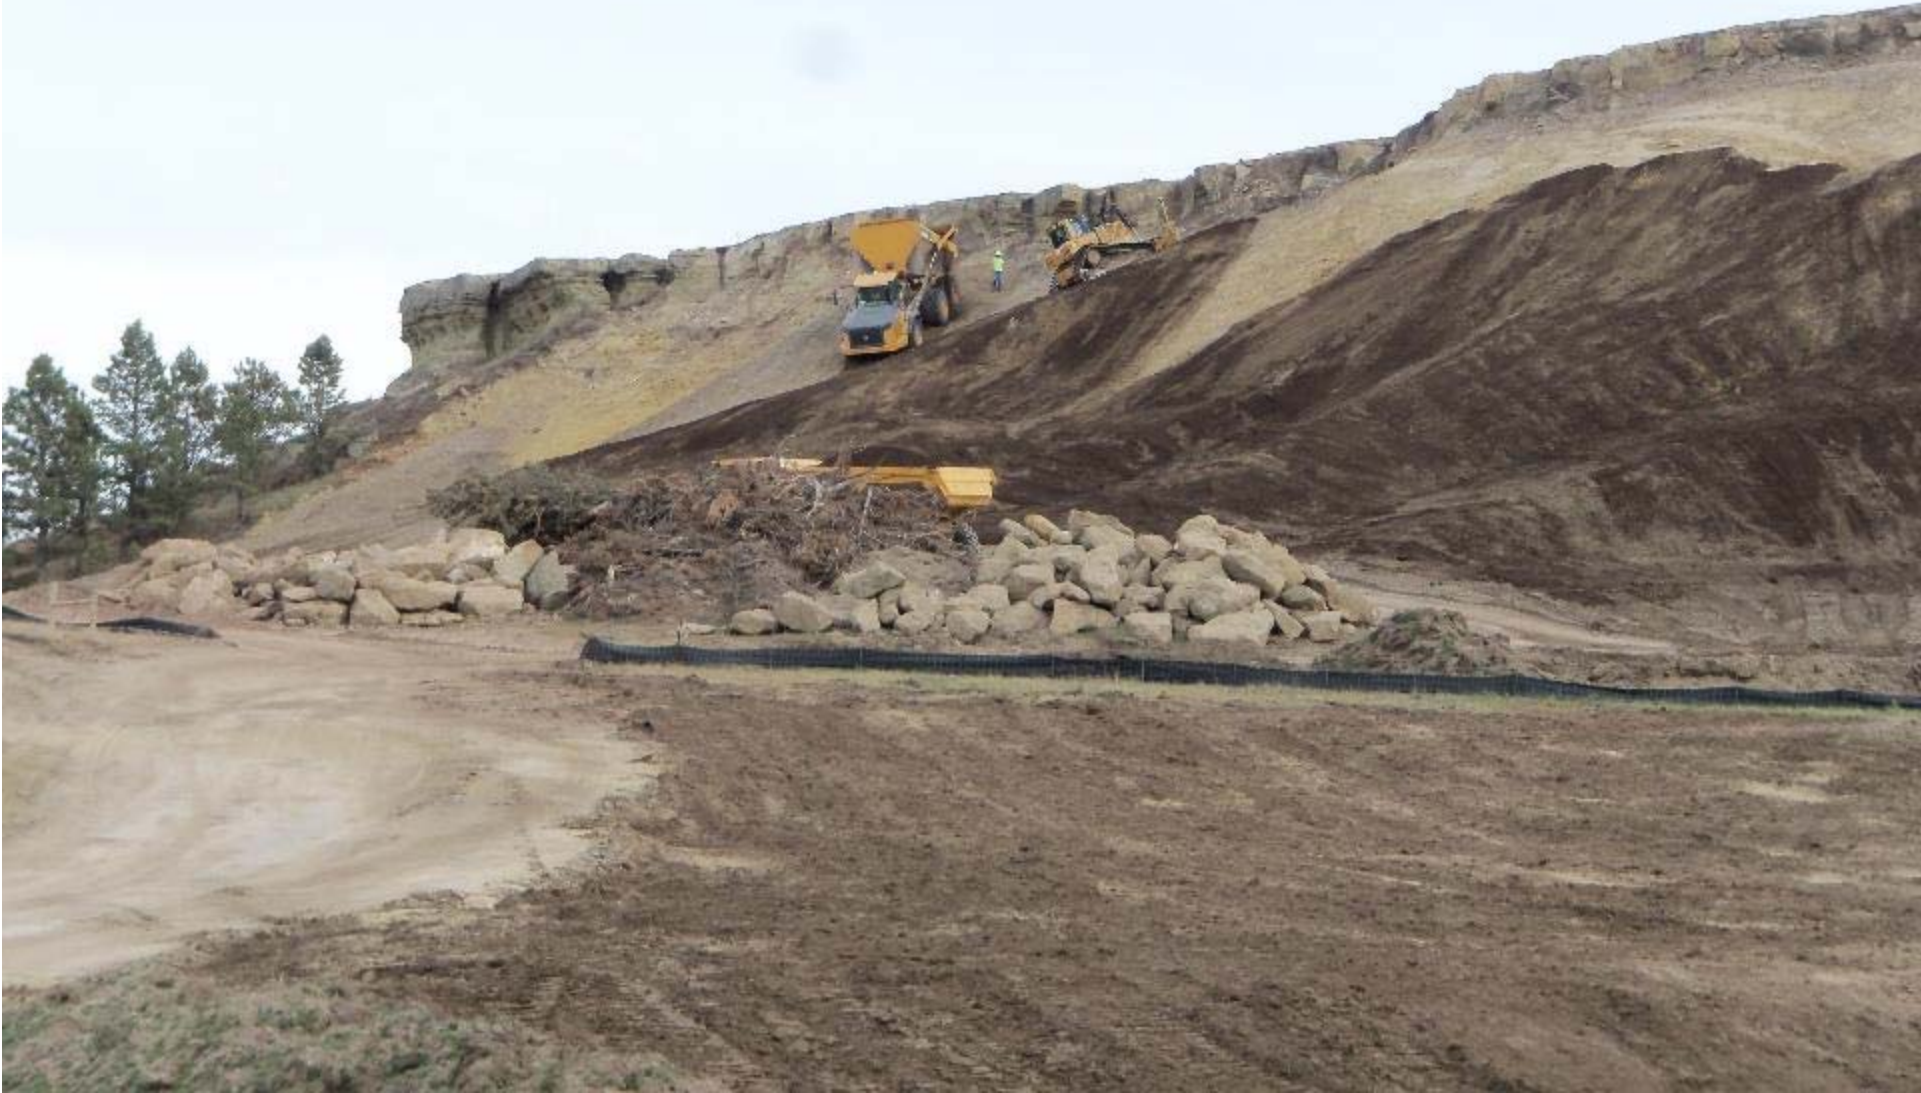
Placing Cover Soil

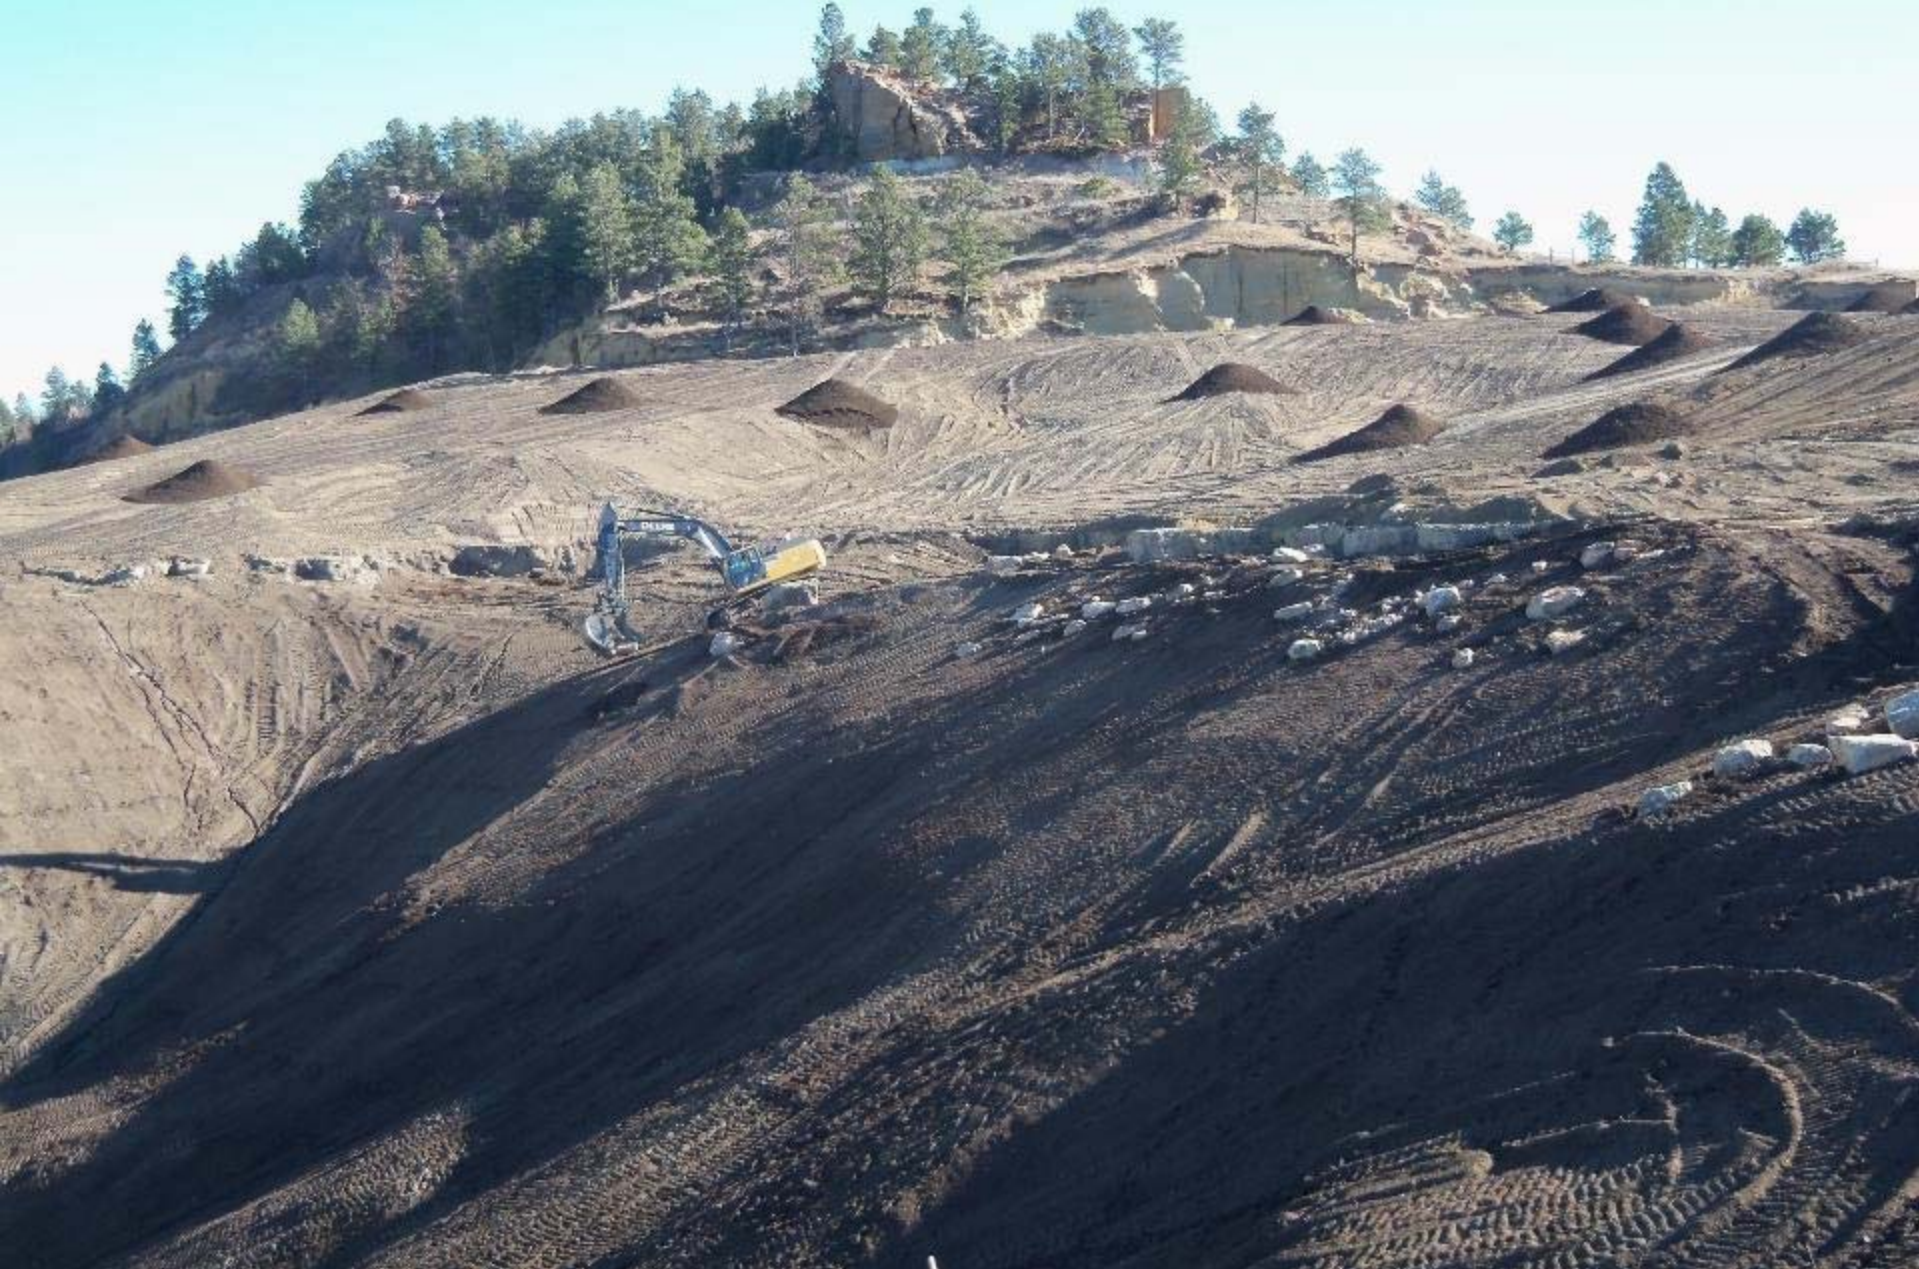
Placing Compost and Rocks

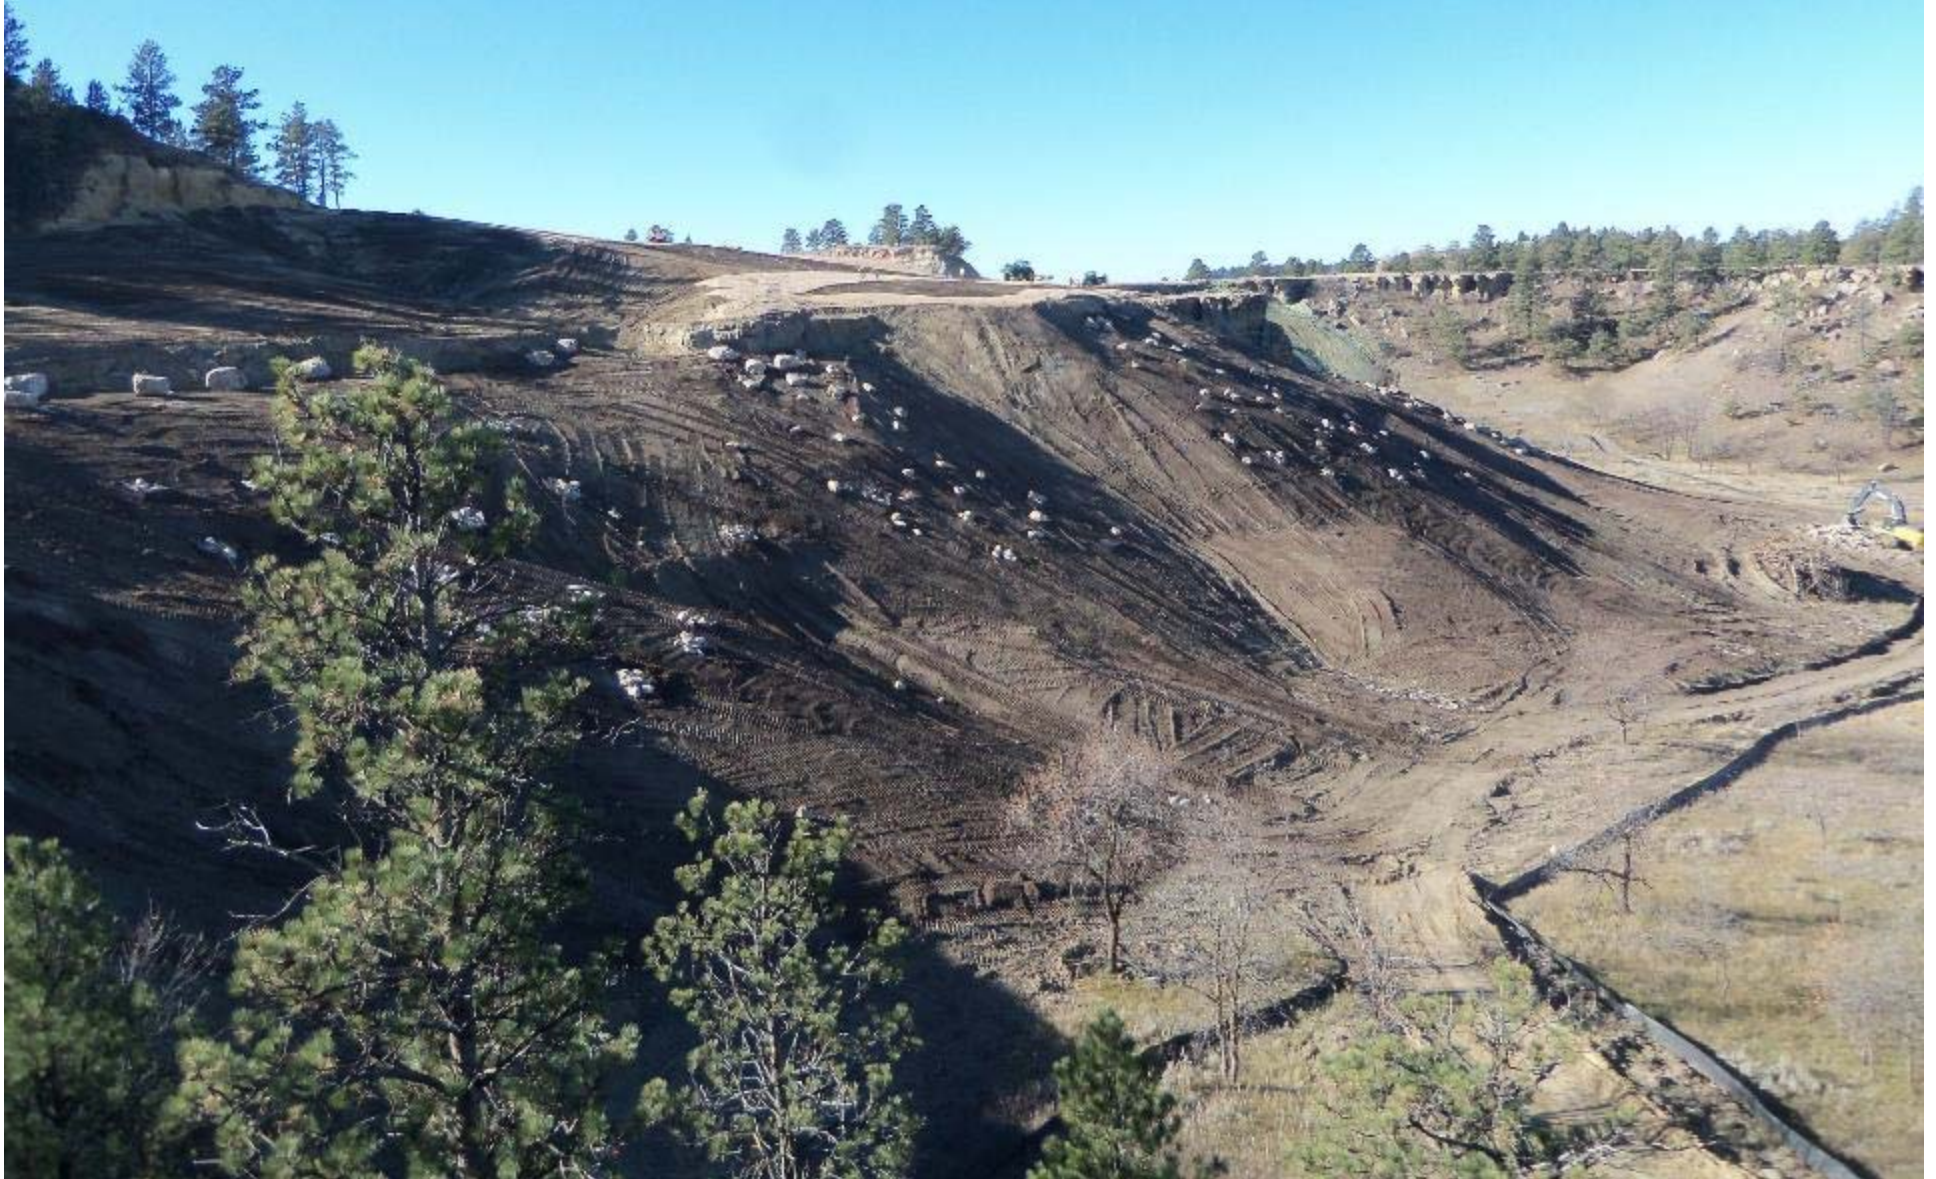
Finished Slopes – Beginning to place Erosion Mat

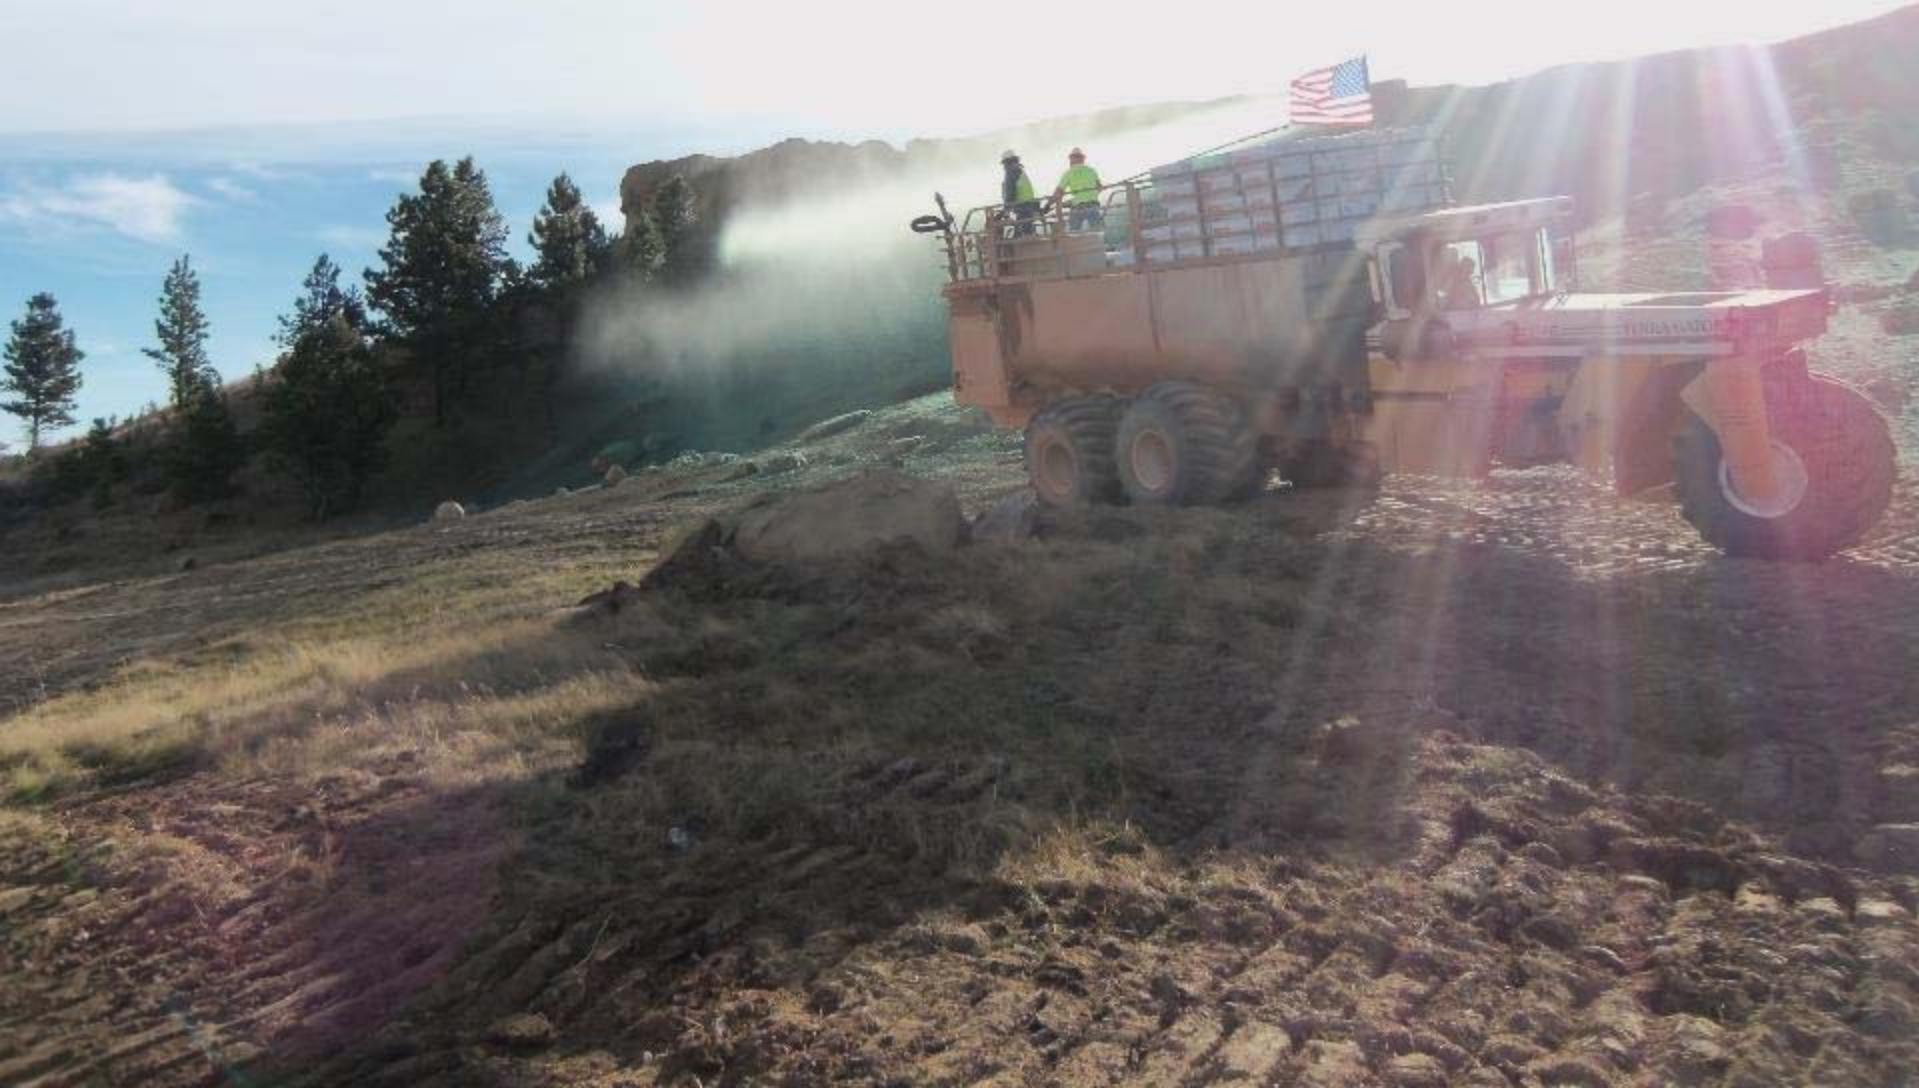
Applying Bonded Fiber Matrix

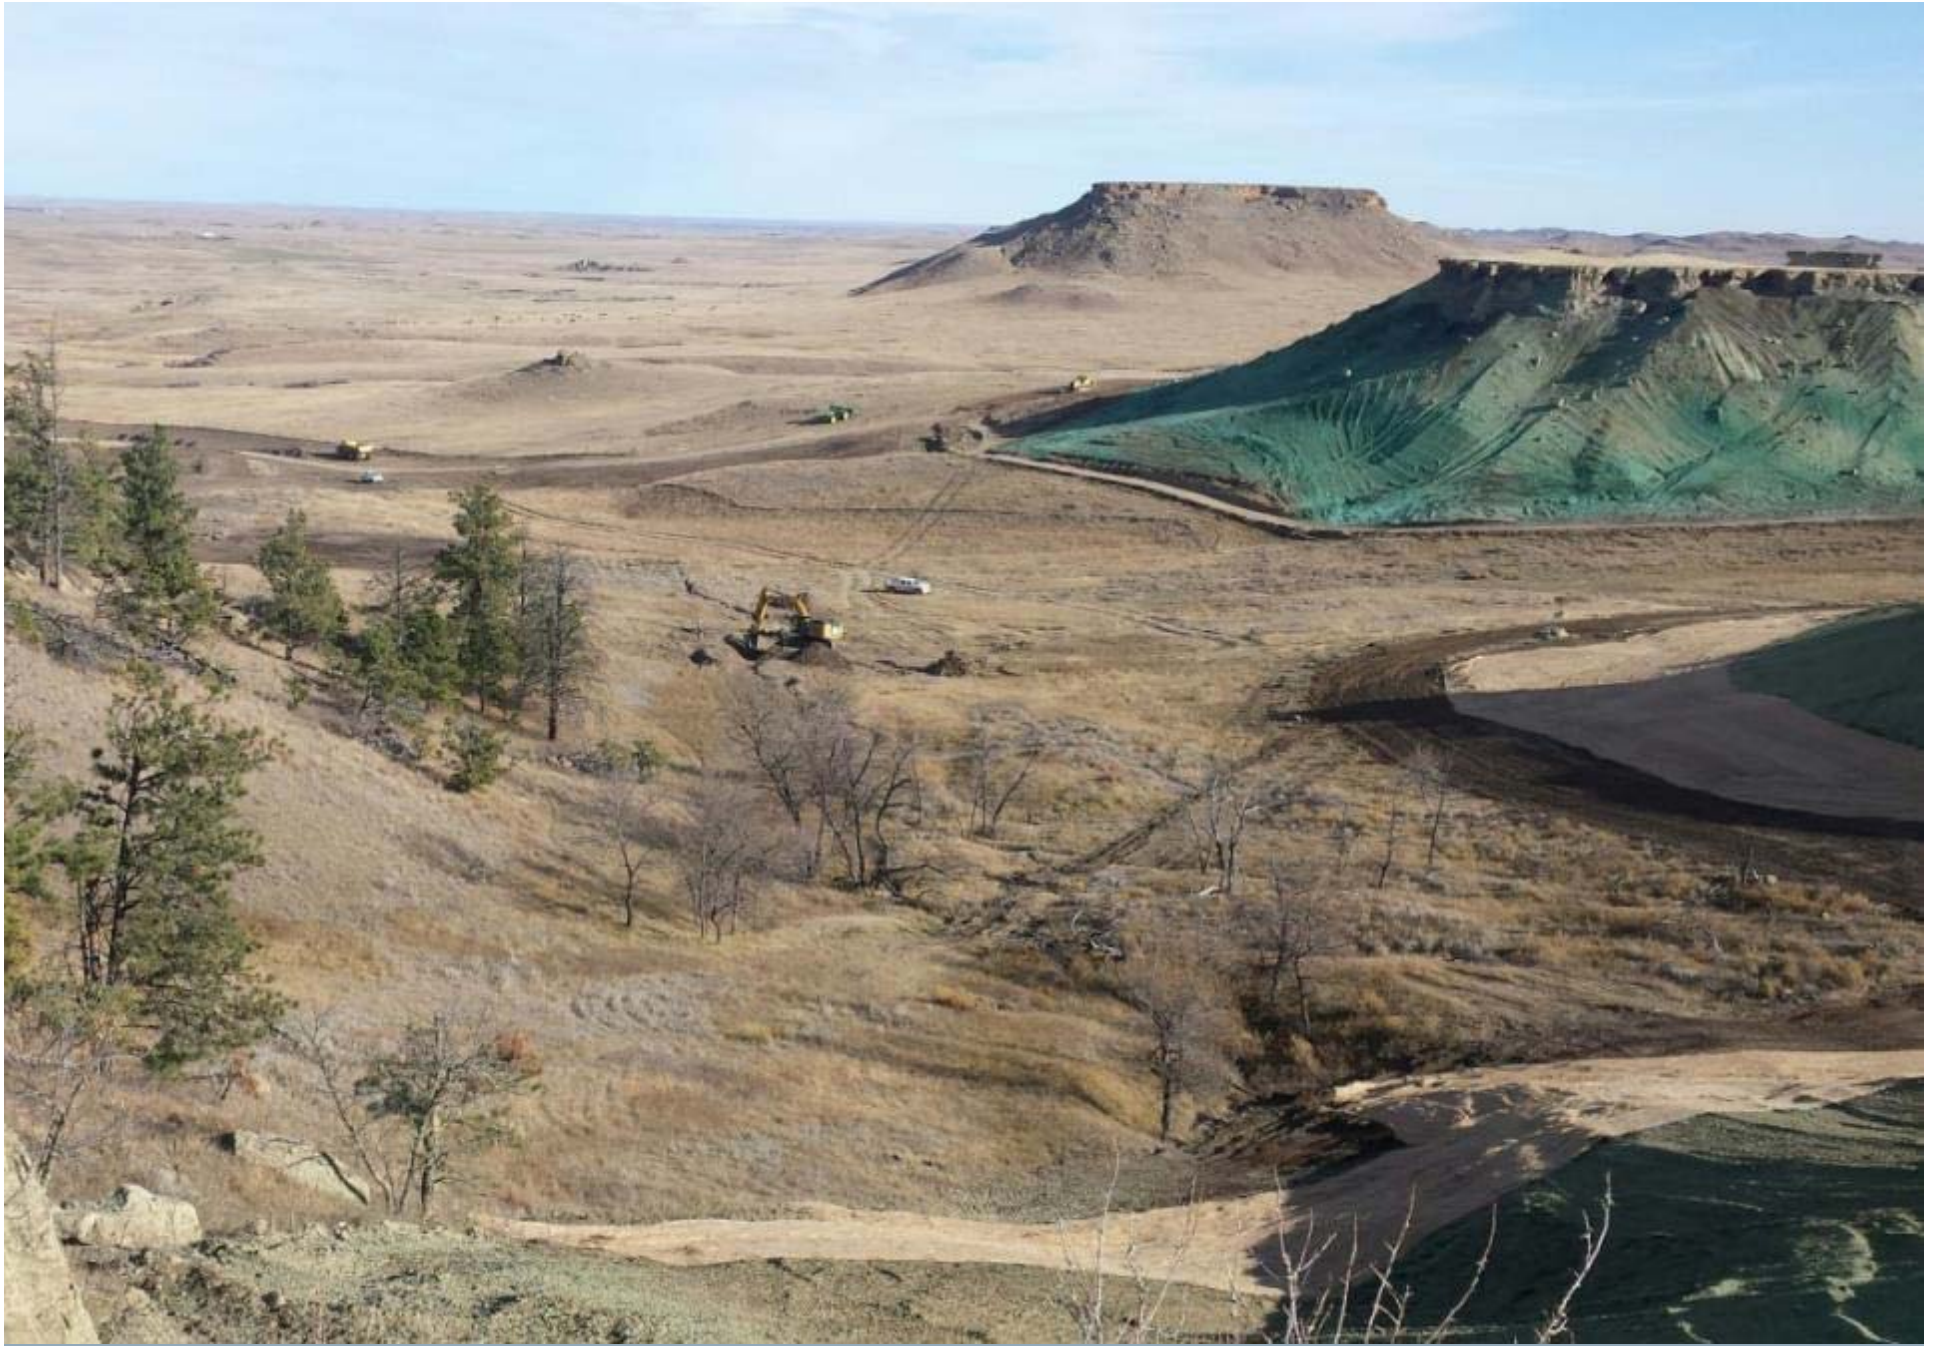
Channel Check Dams

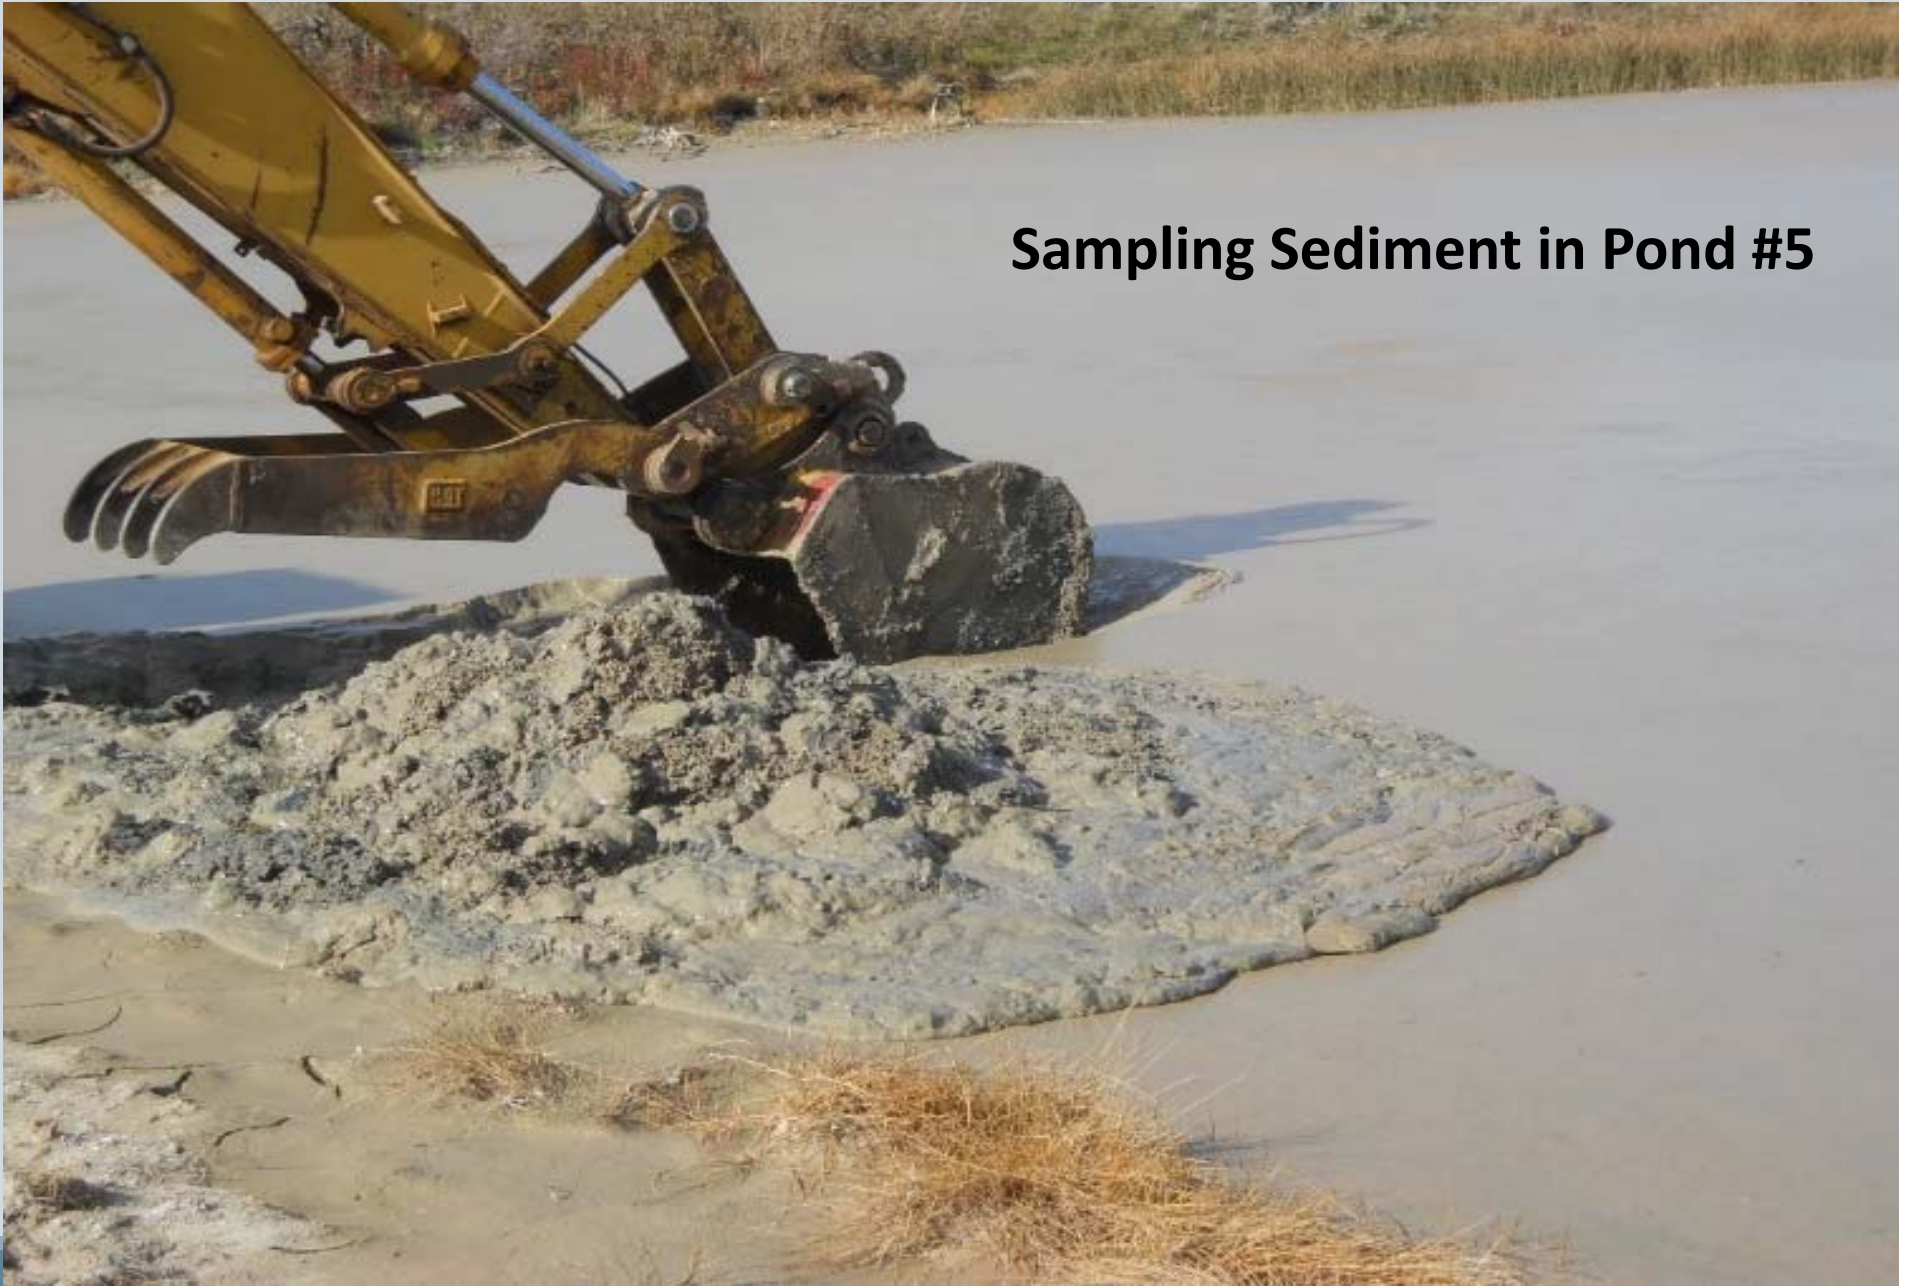
Sampling Sediment in Pond #5
