# ACID MINE DRAINAGE SOURCE AREA INVESTIGATIONS : 2011-2013

## LANDUSKY MINE SITE, MONTANA

HydroSolutions Inc

May 1, 2014

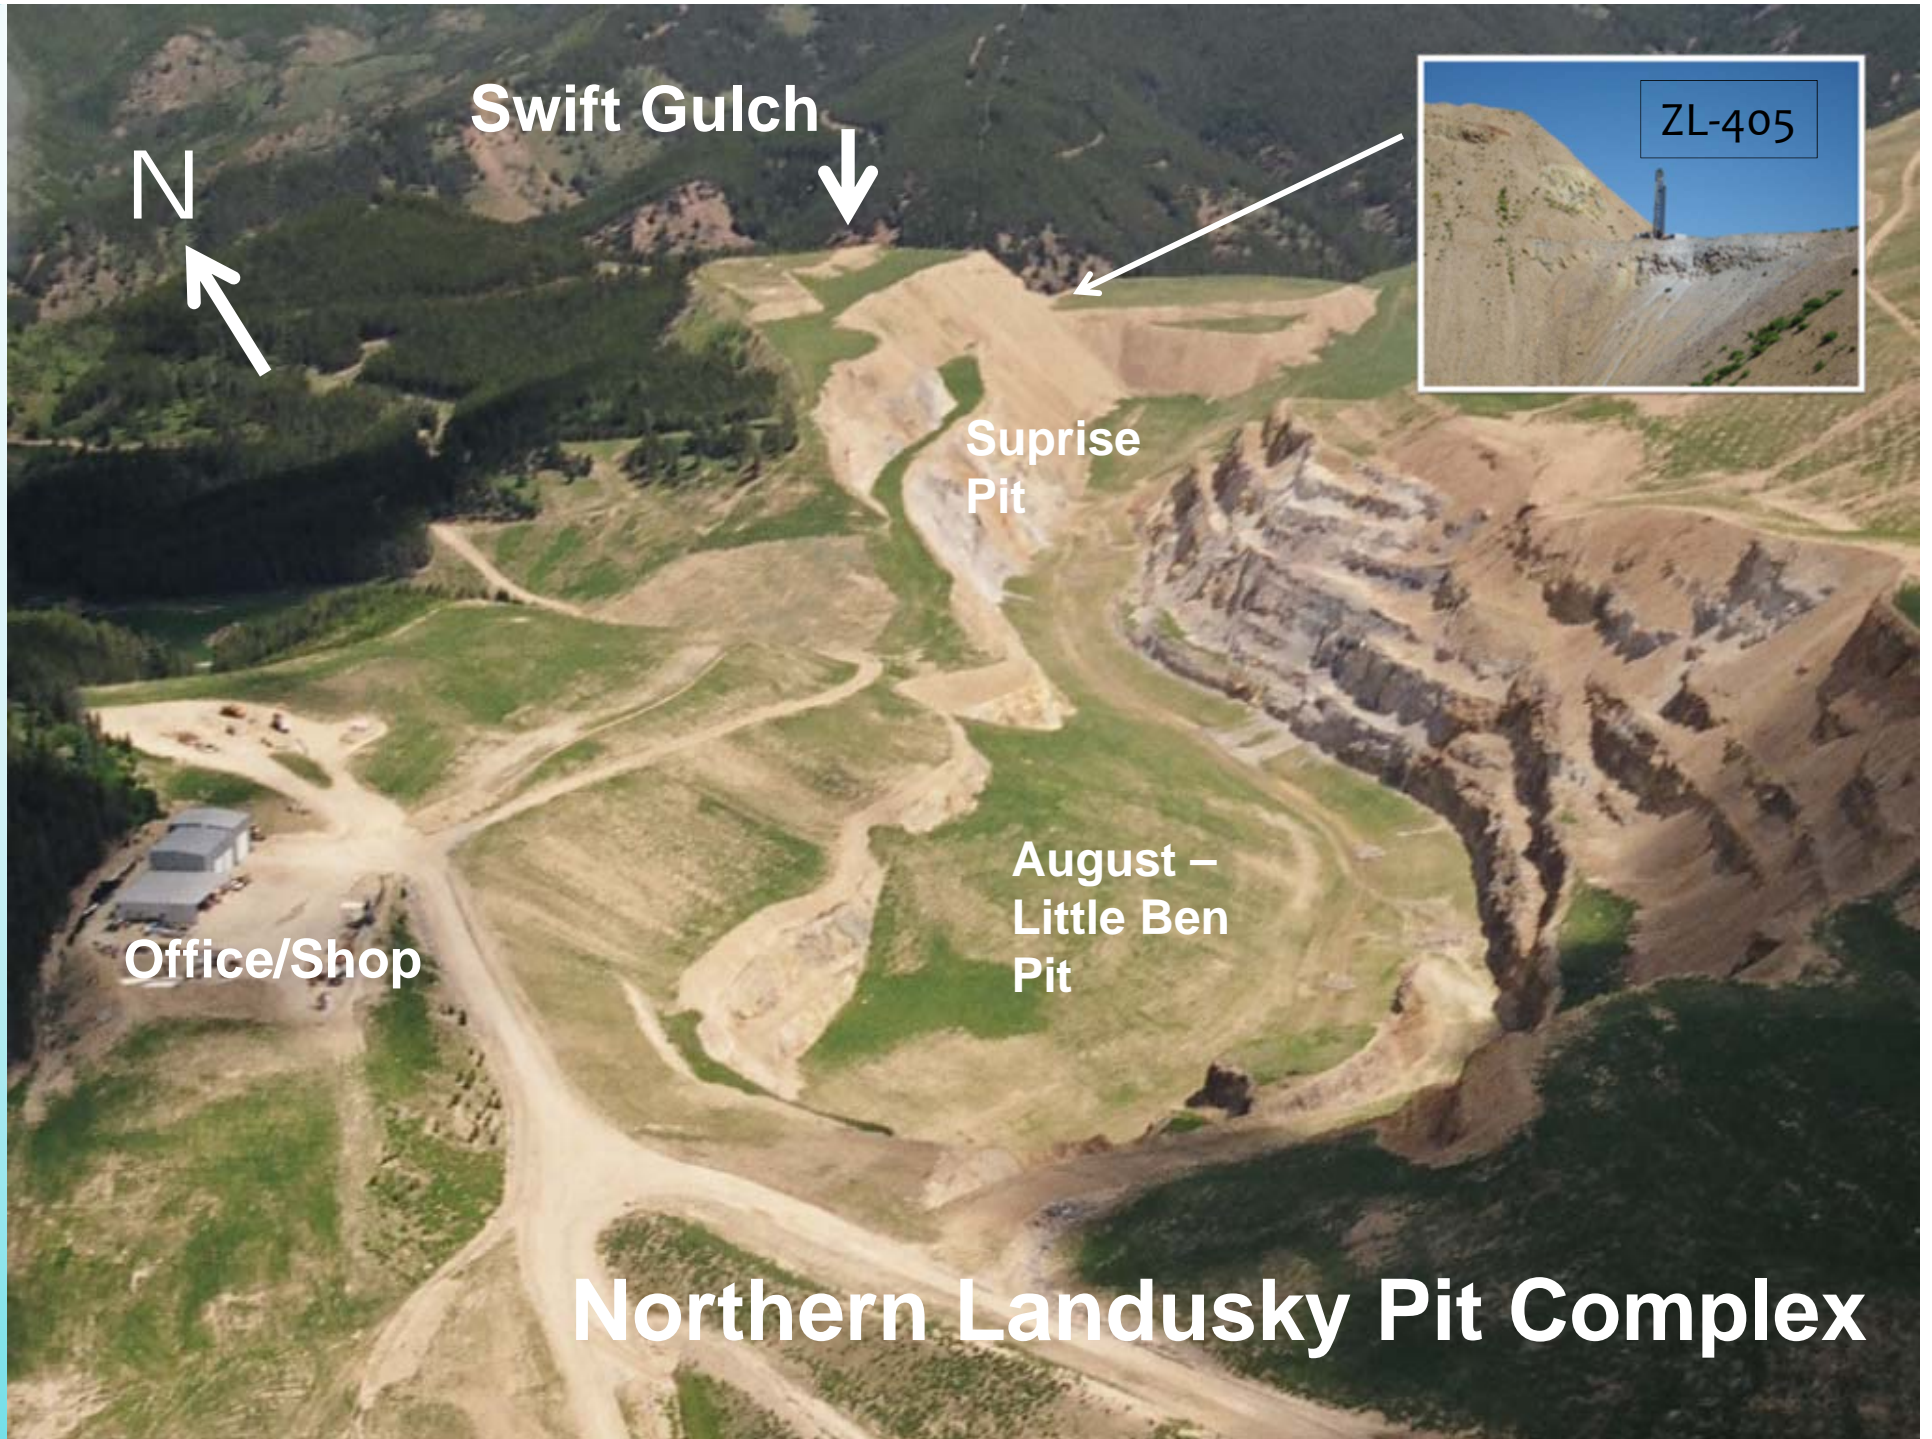
Generalized Geology of the Landsky Mine (Modified from Gabelman et al 2005; Hydrogeophysics 2008)

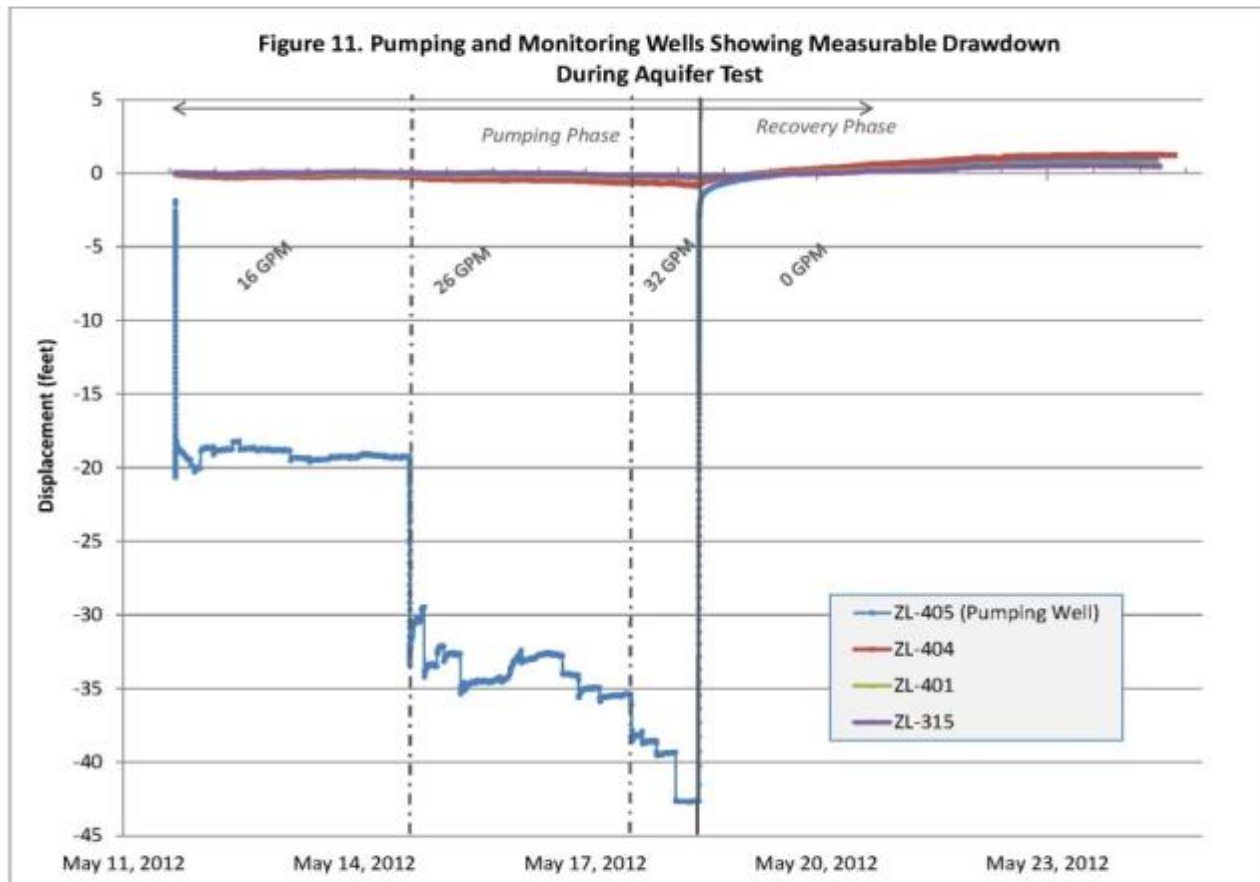
# Pumping and Monitoring Well Drawdown during Aquifer test

- \* Calculated transmissivity values from the aquifer test ranged from 439 to 630 feet<sup>2</sup>/day, representative of the bulk aquifer (comparable to 2008 48-hour test)
  - \* Calculated hydraulic conductivity - 8 to 50 feet per day
- \* At early pumping times, the flow is dominantly linear with water entering the fracture system from the aquifer at the same rate per unit area
- \* As pumping test progresses, flow pattern changes from linear to radial with more discharge derived from the aquifer matrix

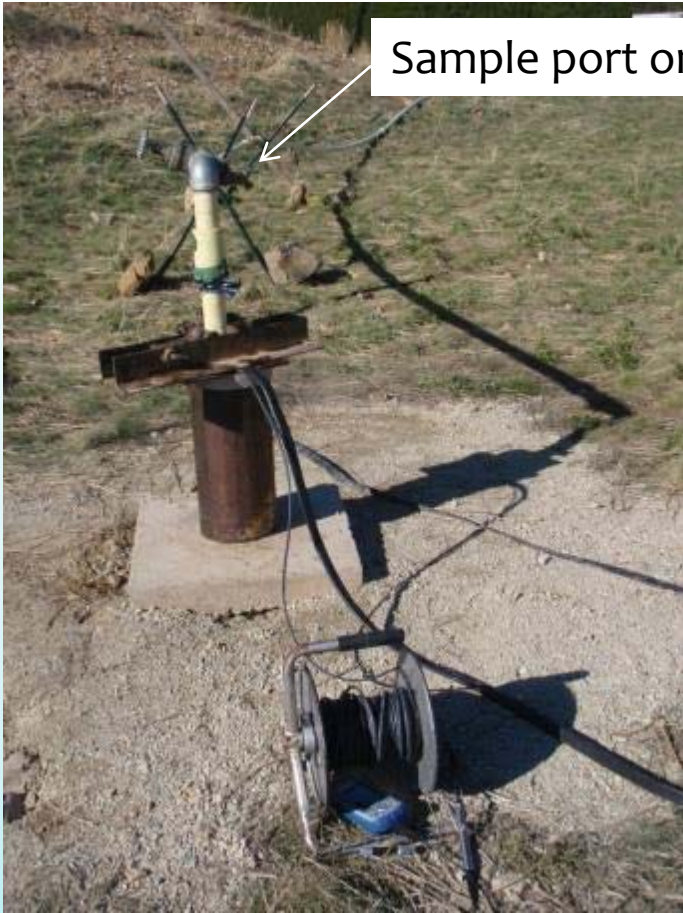
Sample port on ZL-405

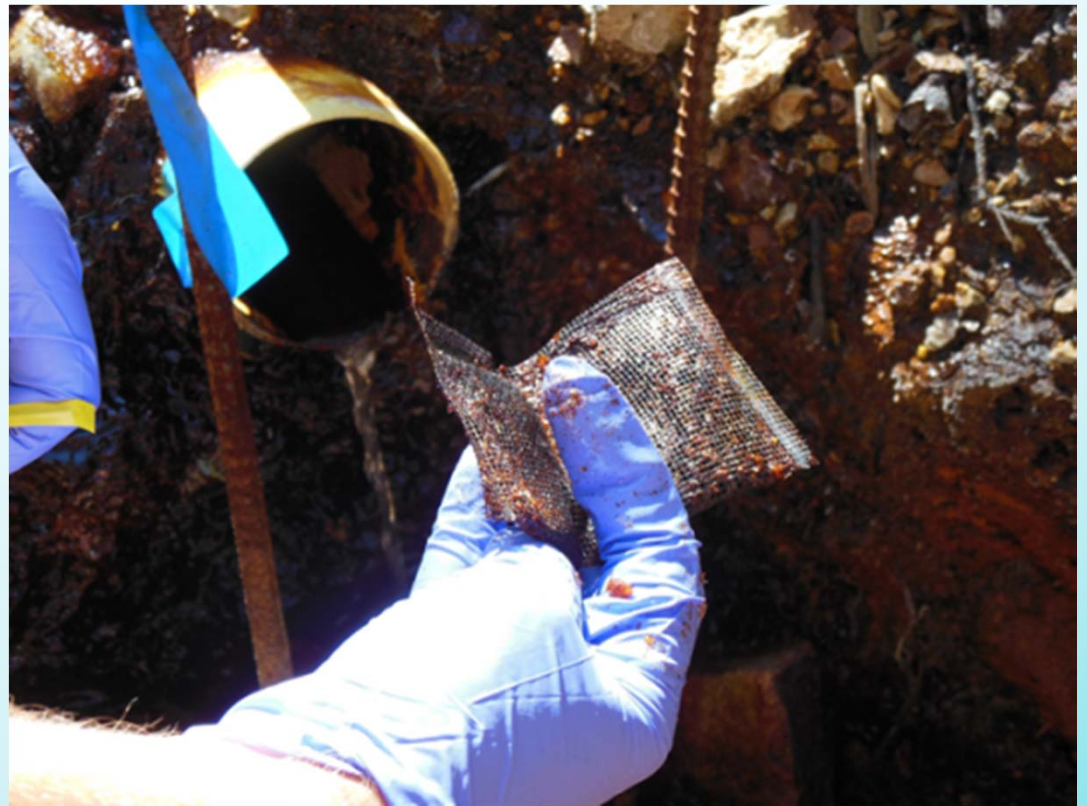
Activated carbon sampling packet

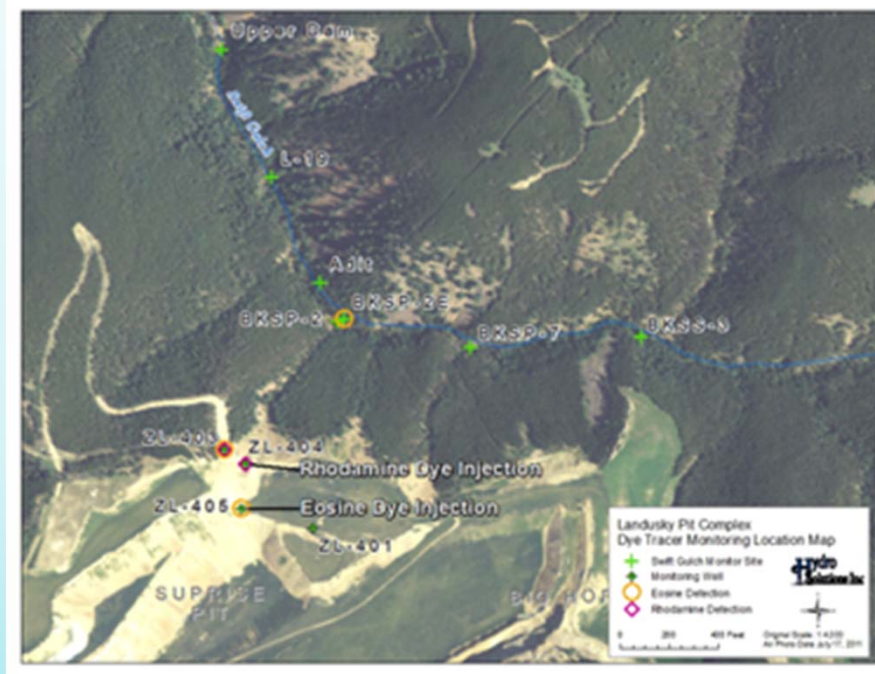
# Forced Gradient Dye Tracer Test Results

- \* Rhodamine breakthrough in ZL-405 in 12 hours
- \* No detection of Rhodamine WT in Swift Gulch after one year
- \* Rhodamine was detected in matrix well ZL-403

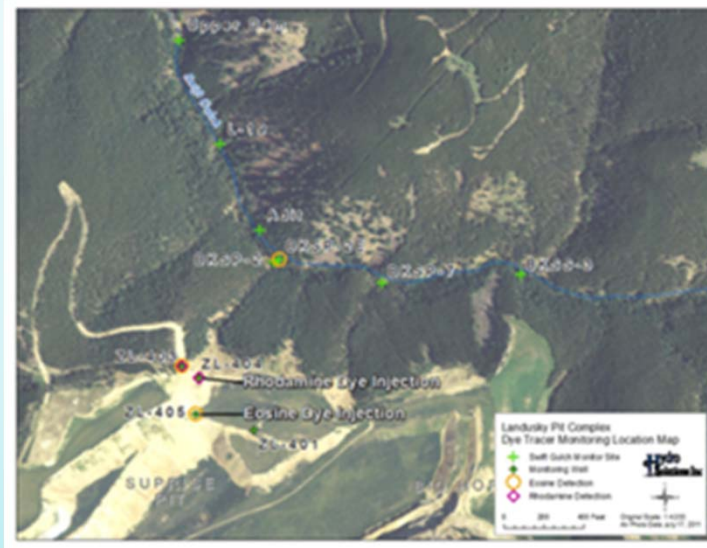
# Natural Gradient Dye Test Results

- \* Eosine detected in BKSP-2E within 3 months (one time detection)
  - \* (Travel time was estimated at 2 to 10 months)
- \* Eosine detected in downgradient/cross gradient matrix monitoring well ZL-403 within 12 months

- \* Dye attenuation likely occurred somewhere in the pathway
- \* Dye tracer detection in Swift Gulch was very low concentration and likely too diluted to be detected in other Swift Gulch sample locations
- \* Delayed arrival of eosine seen in downgradient matrix well is as expected
- \* Interaction of the fractures and matrix is evident
- \* Rapidly disintegrating quality of downgradient matrix water samples provides evidence for the connection
- \* Matrix and shear zones need to be considered as “one whole package” as the remedial alternatives are developed and considered
- \* Continual deterioration of the matrix may present new long term geochemical and water quality remediation challenges

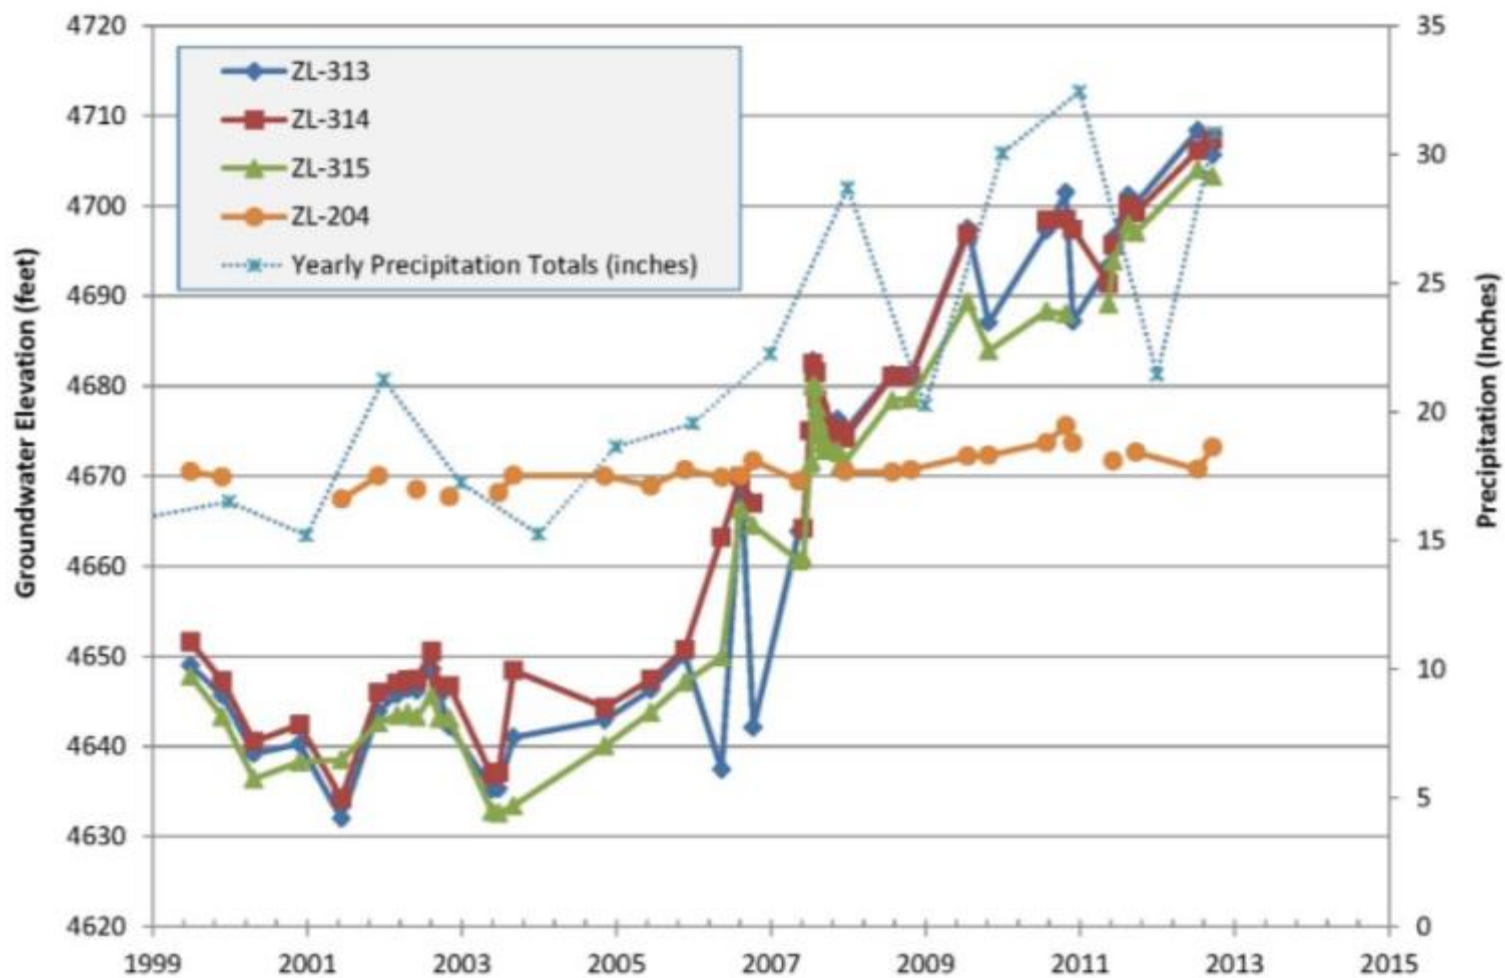
# Historical Groundwater Levels

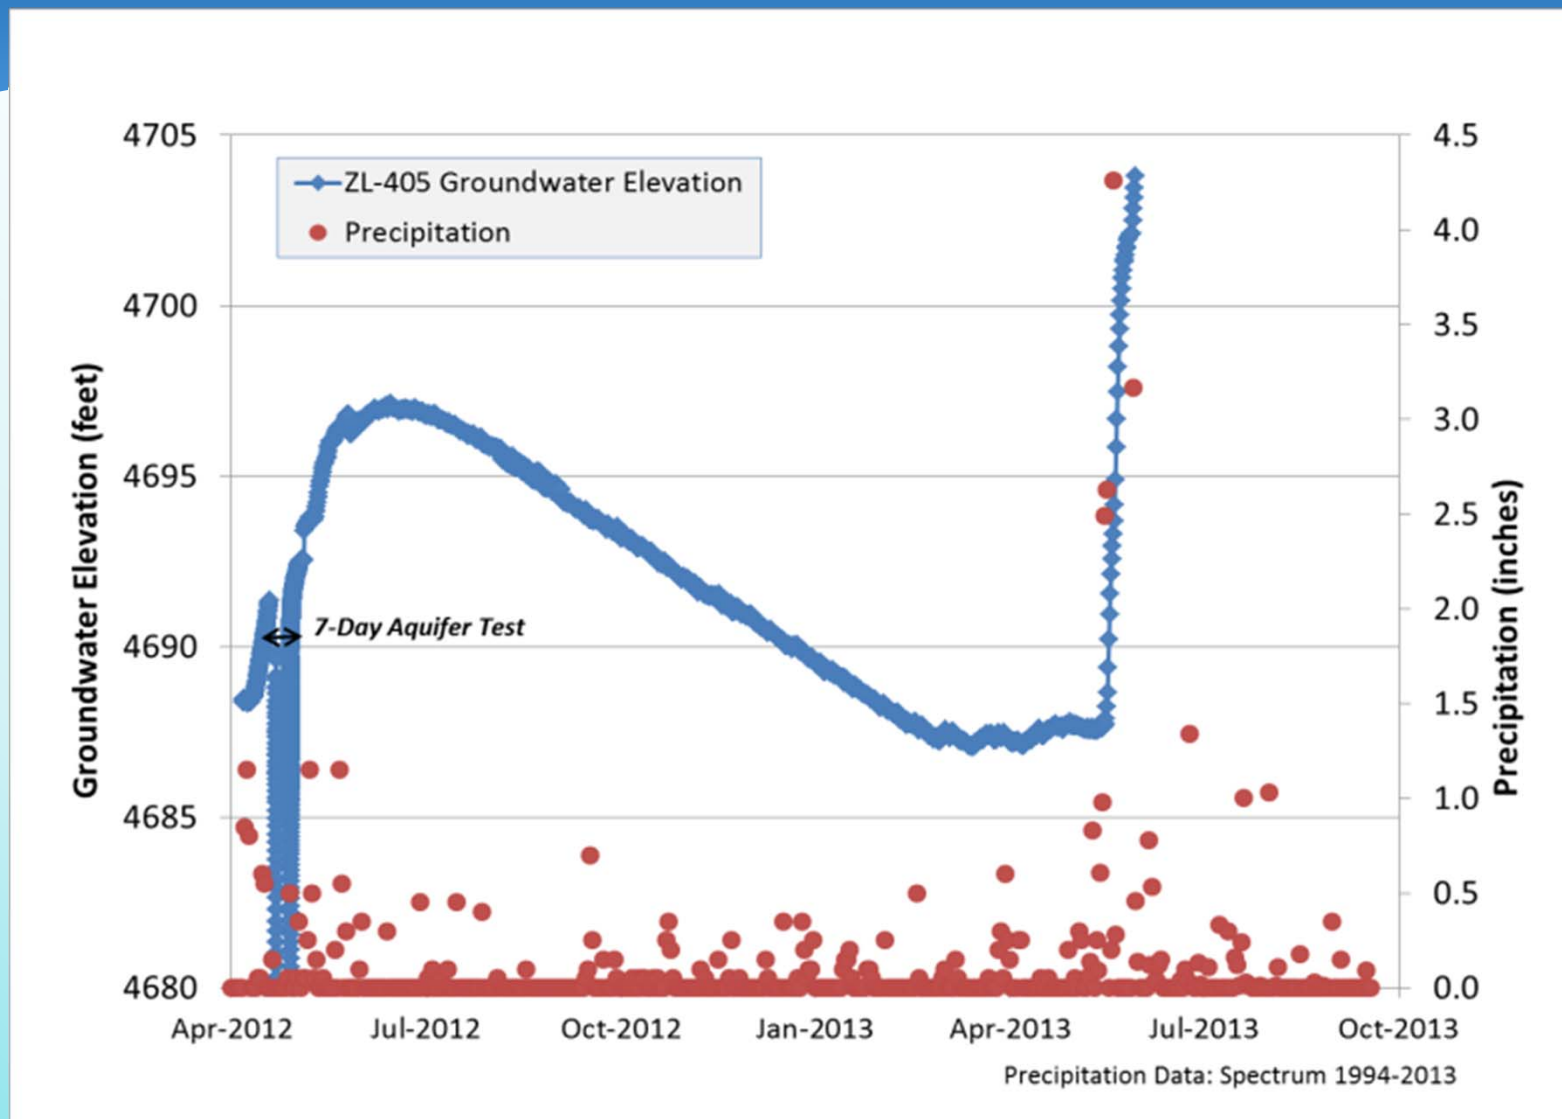
# Hydrograph for Monitoring Well ZL-405

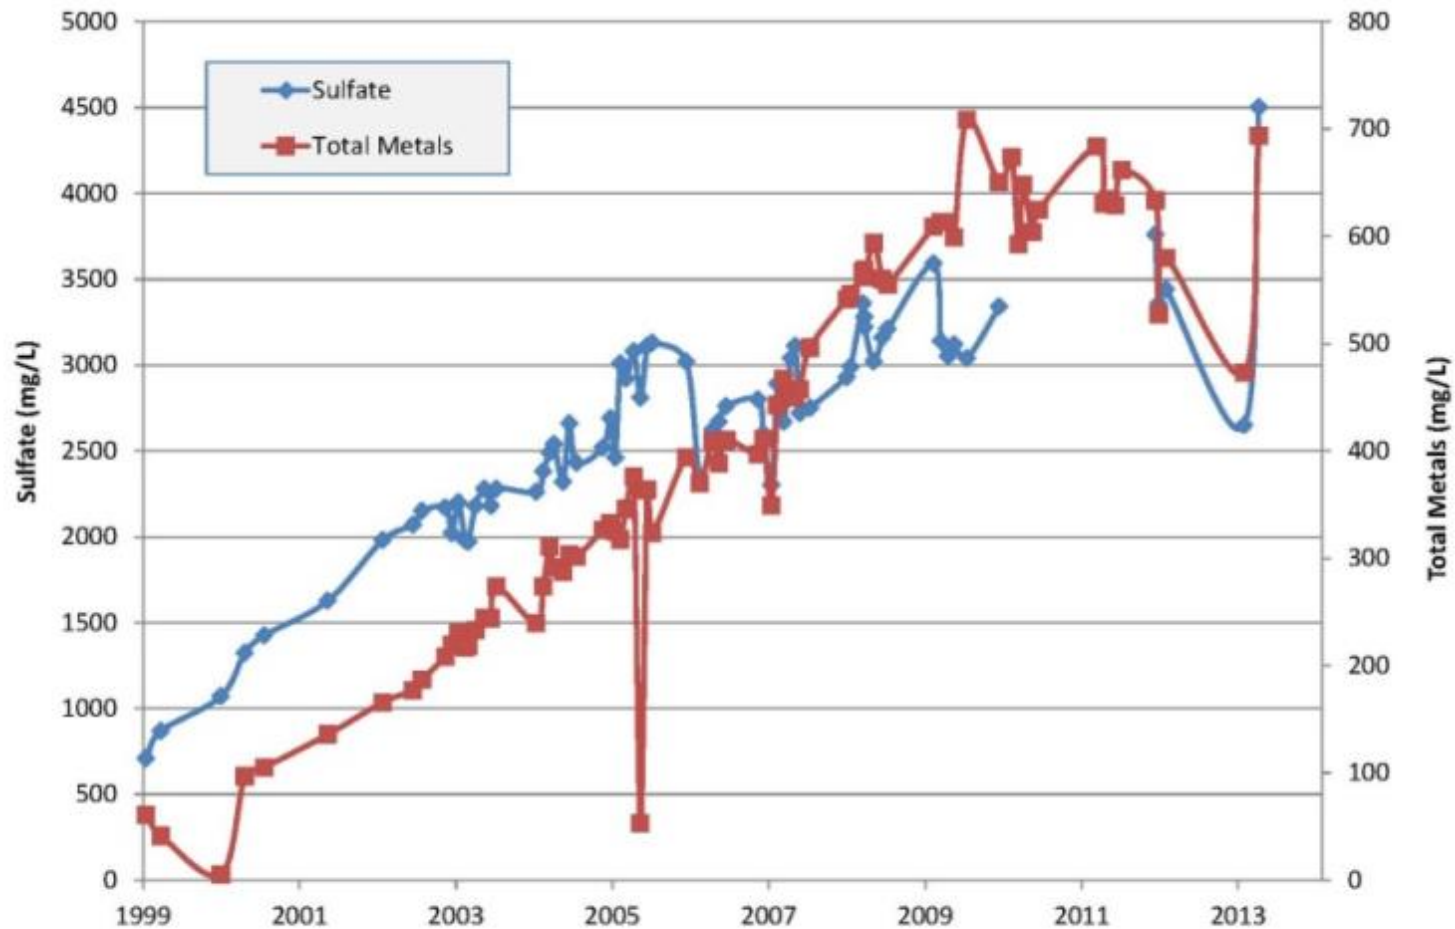
# Sulfate and Total Metal Concentrations of Spring BKSP-2E

- \* In general, over time, metals and sulfate concentrations have been increasing and pH has been decreasing in Swift Gulch and groundwater from the northern Landusky Pit monitoring wells
- \* Groundwater associated with the Niseka Shear appears to be undergoing geochemical degradation due to continual AMD contributions
- \* The uranium isotopic results indicate that the monitoring wells associated with the Niseka Shear are mainly AMD water with the same isotopic signature found in the August-Little Ben pit

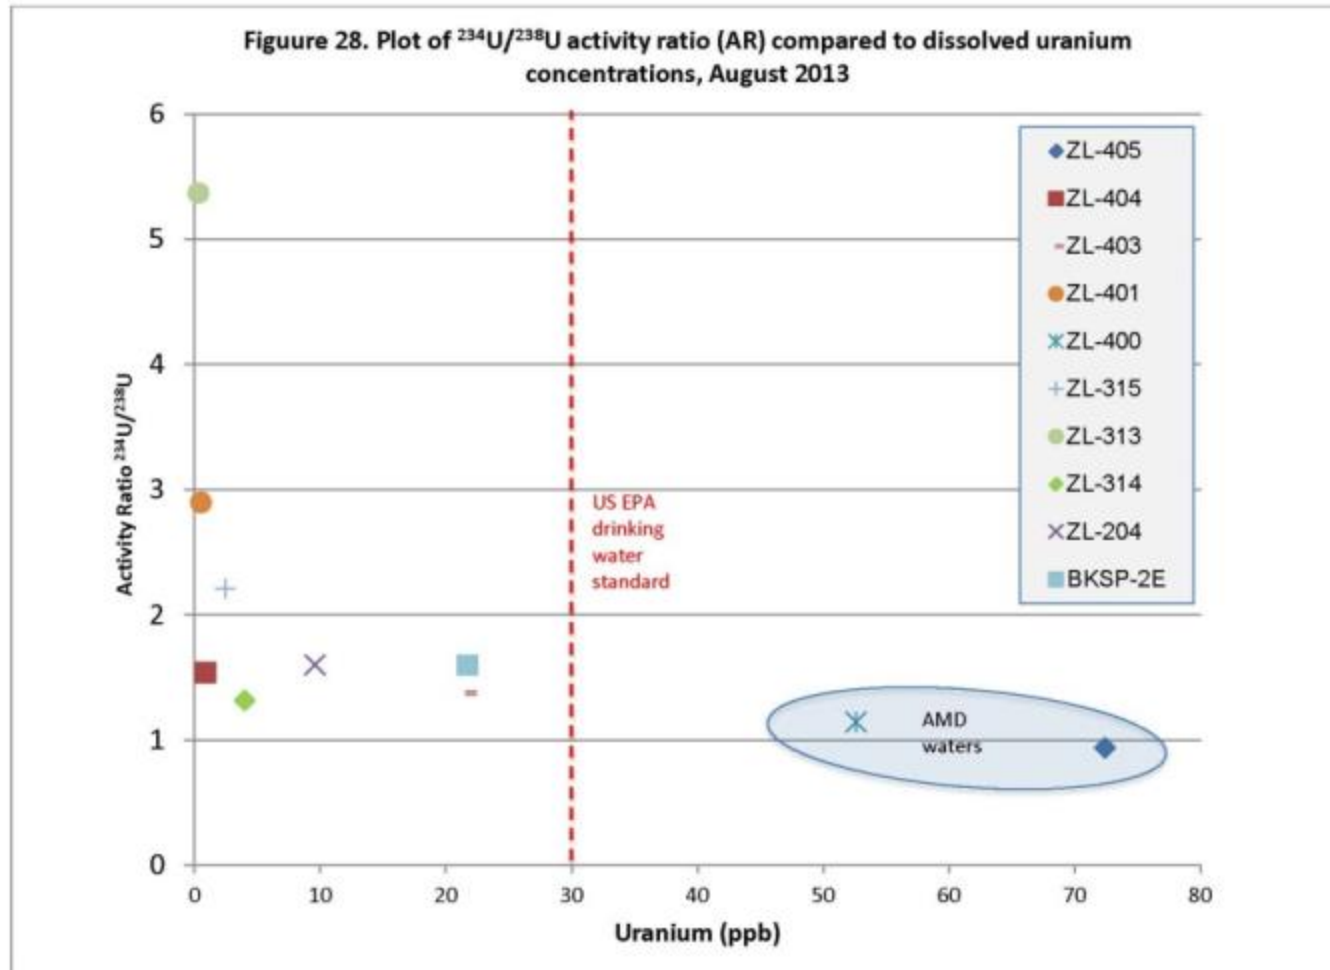
# Plot of $^{234}\text{U}/^{238}\text{U}$ activity ratio (AR) compared to dissolved uranium concentrations, August 2013

- \* Wells completed in the same fracture system showed different isotopic signatures but similar seasonal variations
- \* The different isotopic signatures are attributed to additional deep groundwater mixing as the fracture system extends further from the Landusky Pit Complex
- \* The high AR results for the deeper groundwater well ZL-313, and very low aluminum, sulfate, and iron concentrations, suggest that the deeper groundwater is less affected by AMD water
- \* AMD does not appear to extend into the adjacent King Creek drainage basin

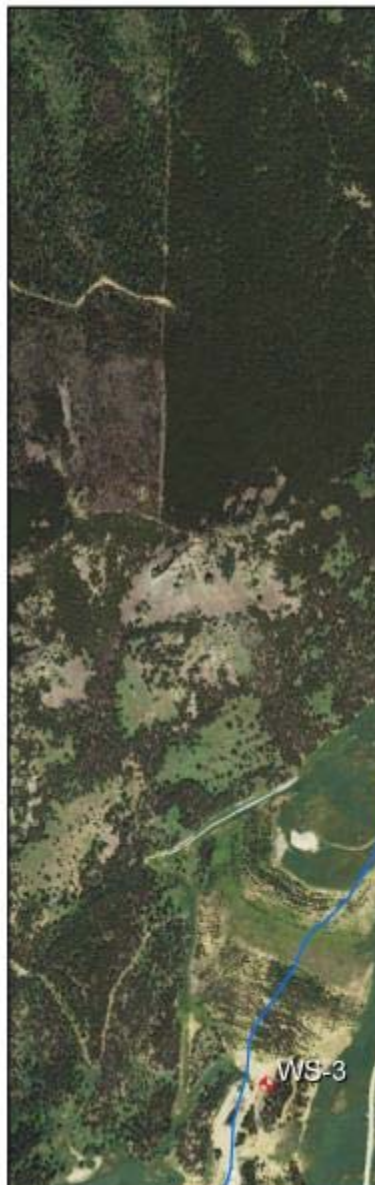
# Historic and Current Water Levels for Monitoring Wells Associated with Artesian Well WS-3, Opened April 9, 2014

- \* Installation of large-diameter pumping wells in the Landusky Pit Complex
  - \* Assessing the chemistry directly within the reclaimed pits
  - \* Provide wells for remedial alternative pilot testing directly in the source areas
- \* Water management of Artesian Well WS-3 and monitoring water level response in the Landusky Pit Complex
- \* Volume control within the Landusky Pit Complex to reduce volume of AMD to Swift Gulch
- \* In-Situ bio-treatment source control
