# Best Practices for physical hazard closure at underground mines

Mine Design, Operations & Closure  
Conference

2010

Fairmont Hot Springs, MT

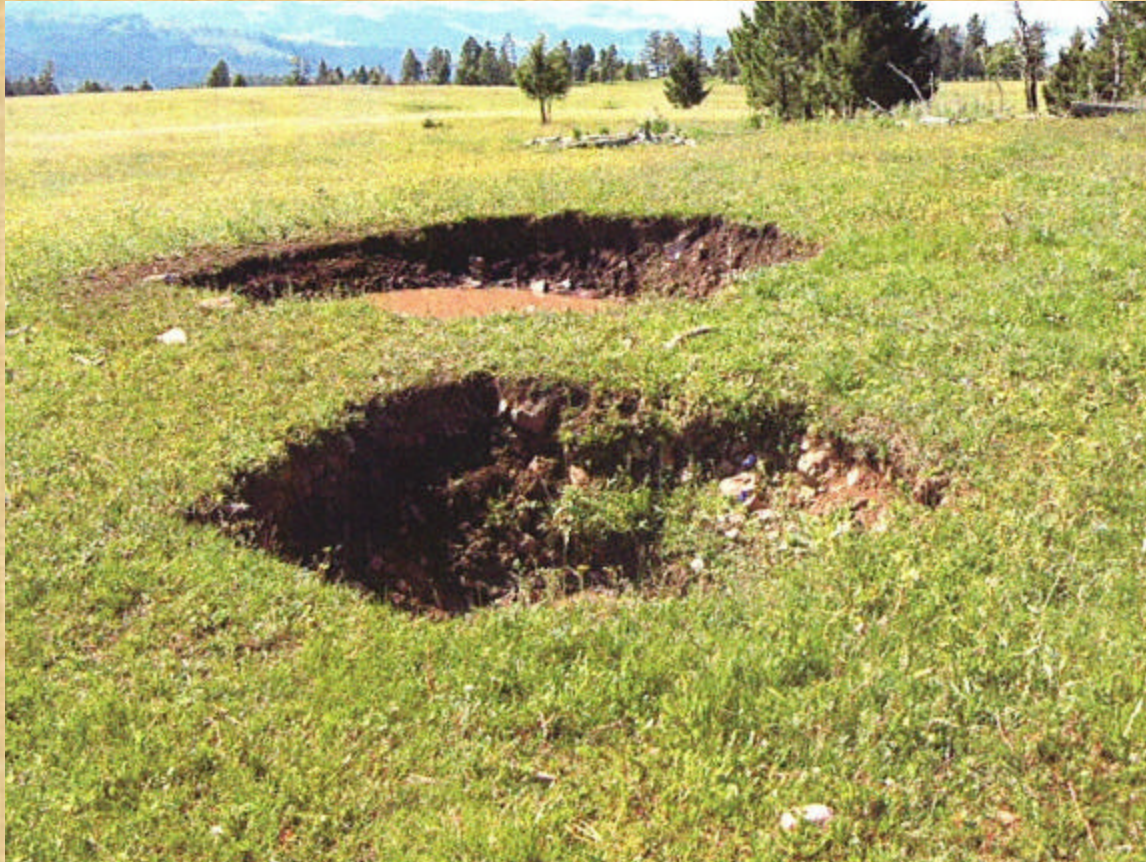
**Attempt to shoot down hanging wall to close an adjacent subsidence**

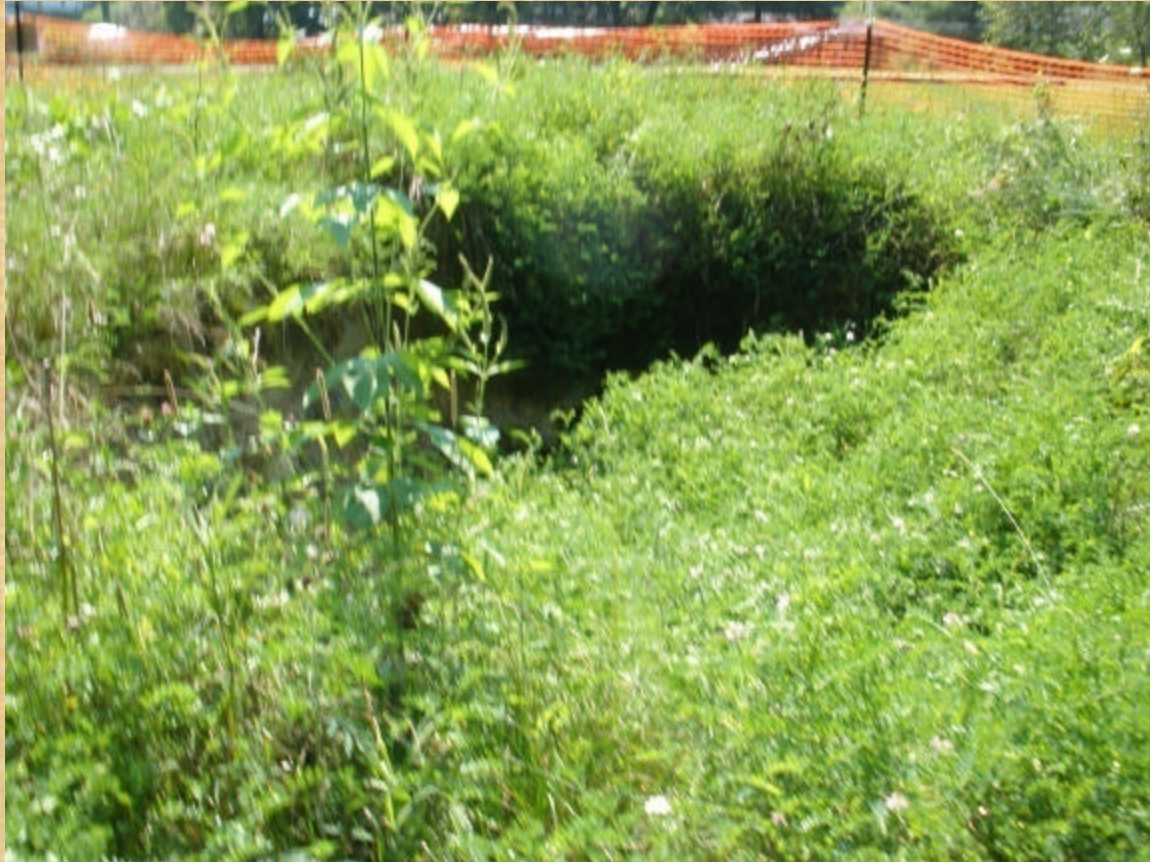
**Previously backfilled shaft**

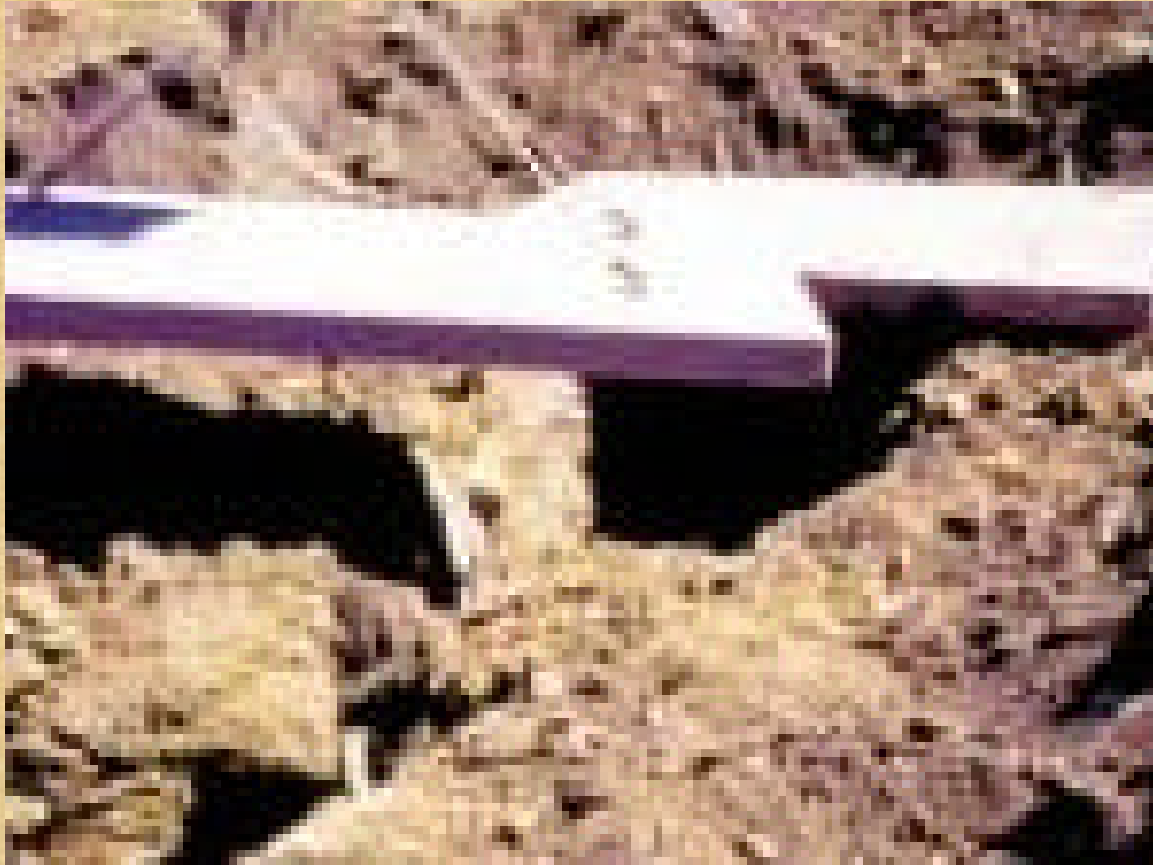
## **Pre-cast bridge decks**

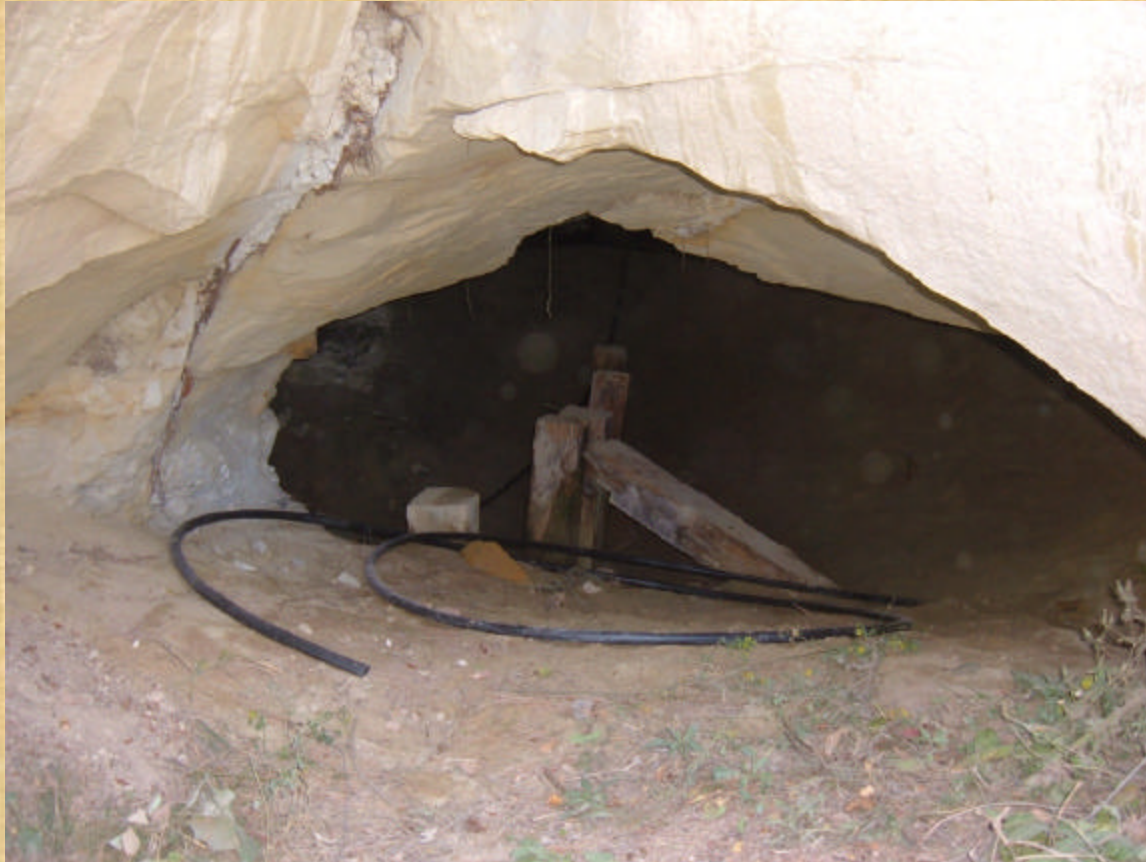
**Adit prior to closing with foam**

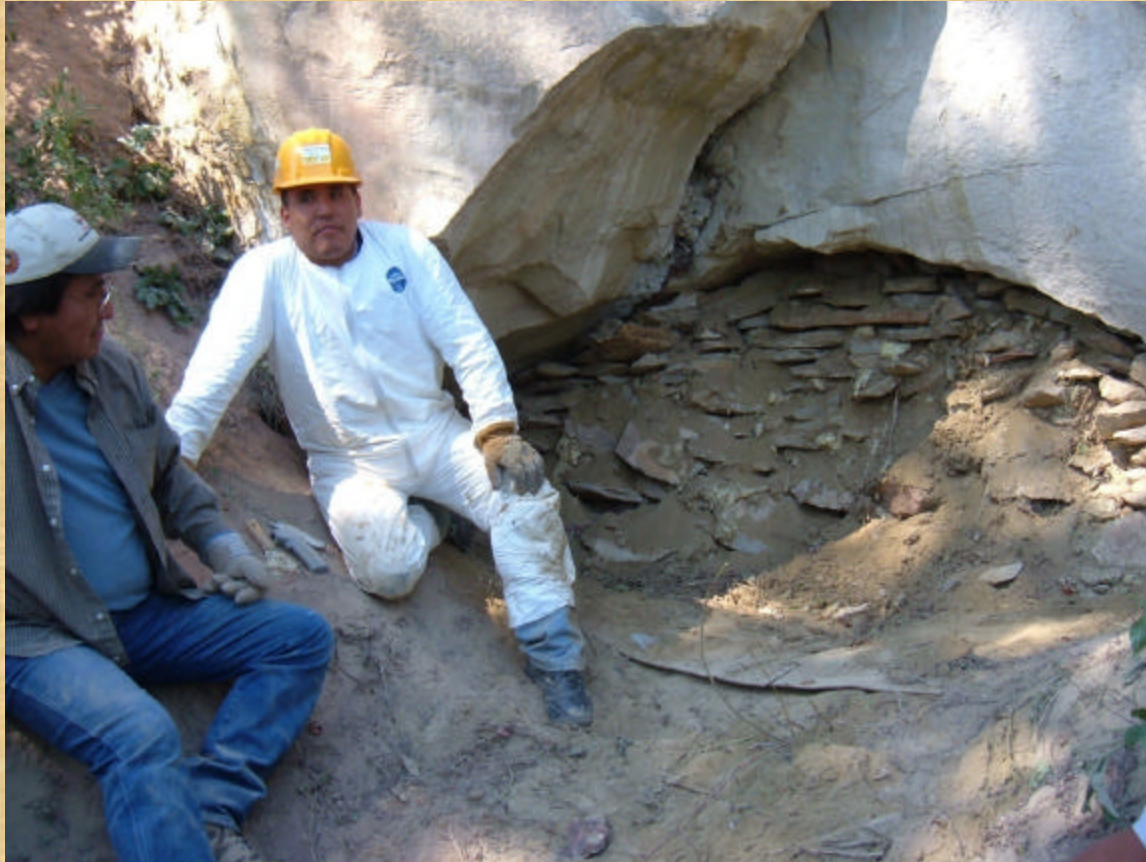
**Closed and foam covered with rock**

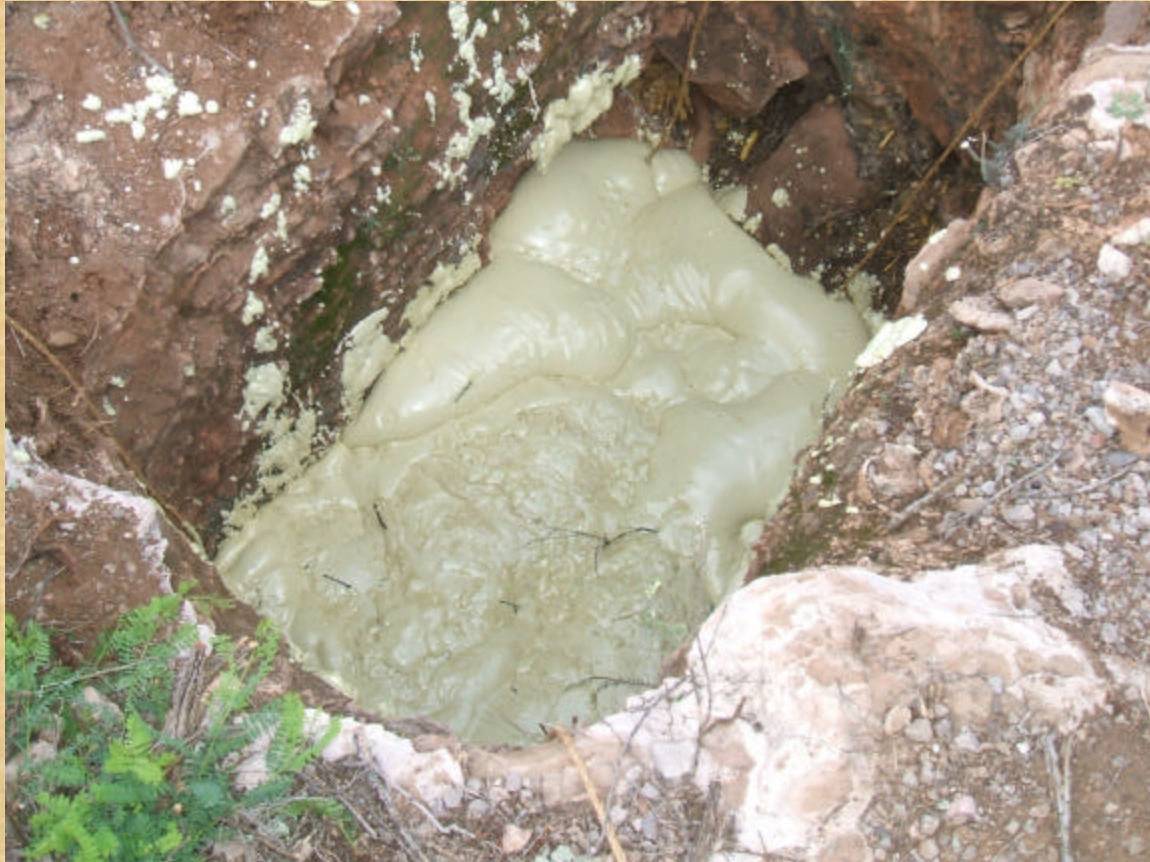
**Shaft being filled with foam**

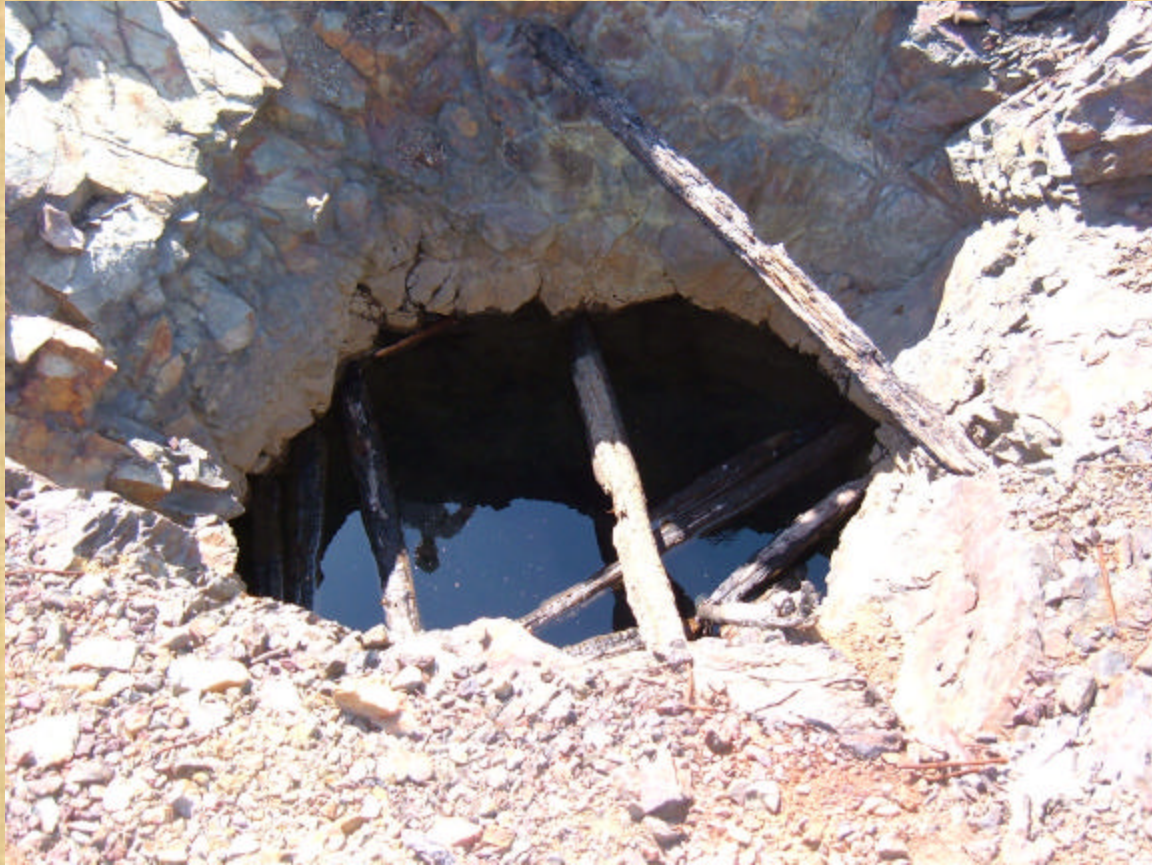
## **Water filled shaft**

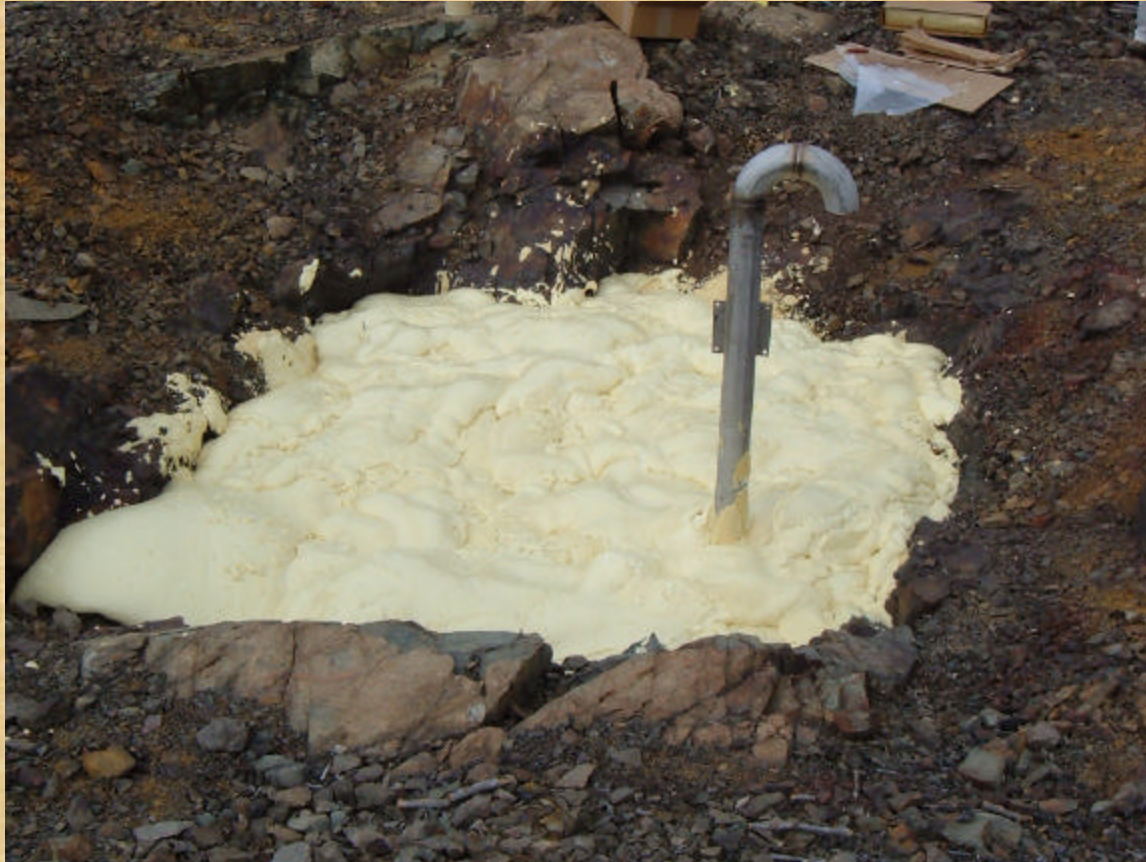
## **Foam placed directly on water**

Plug was later covered with rock

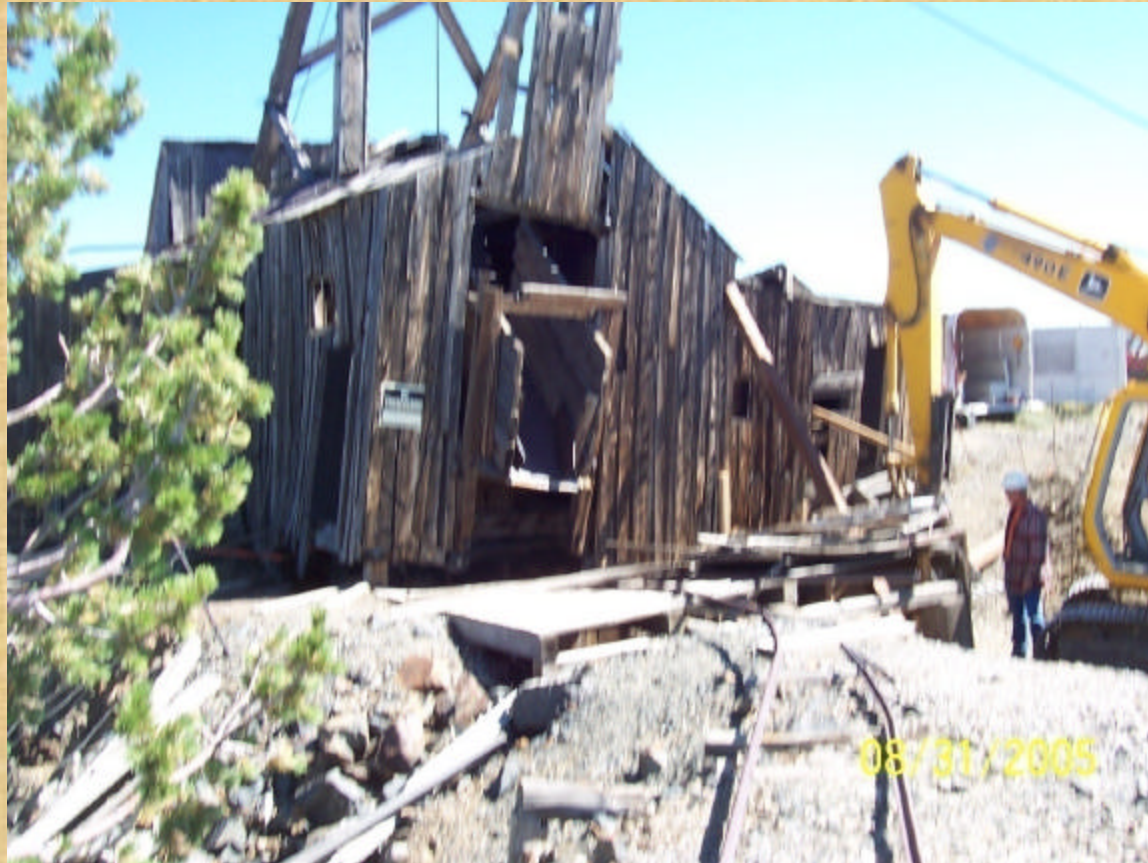
## Historic shaft house over timbered shaft

Stabilized with foam and concrete without moving the structure

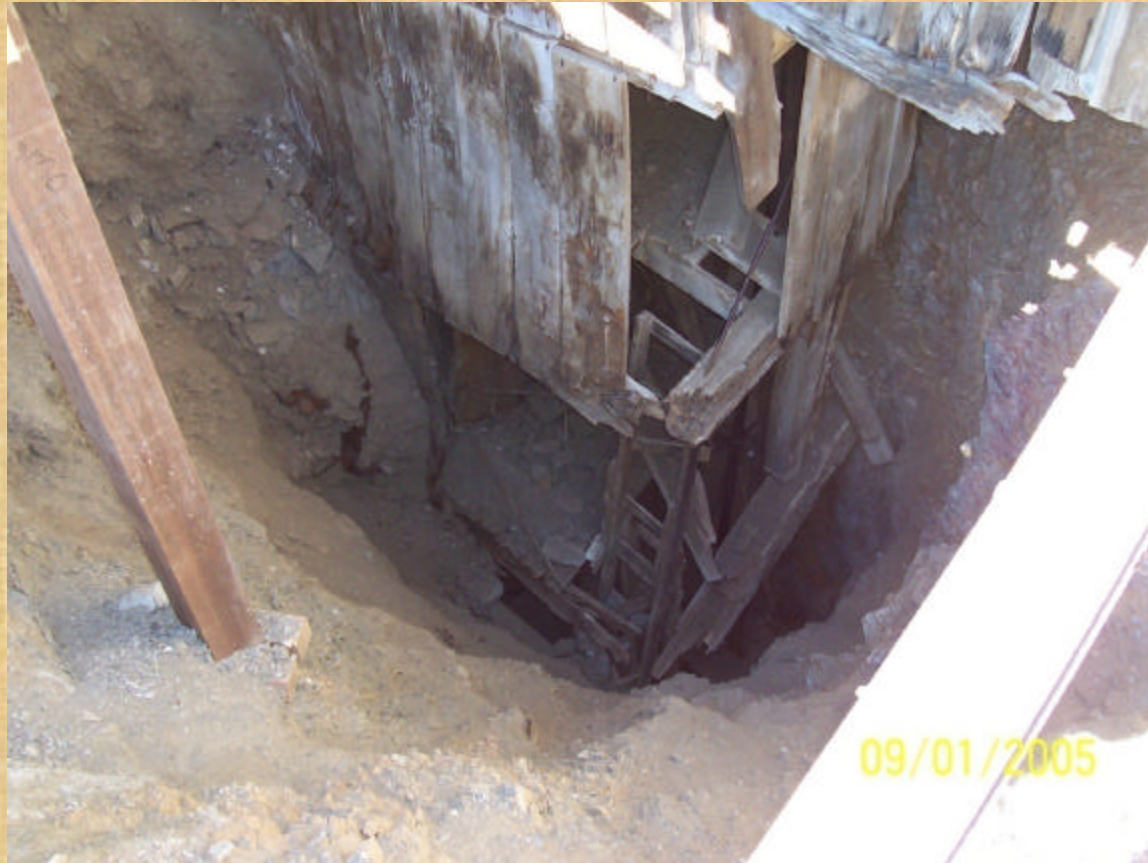
**Shaft timbers exposed and cleaned with water hose**

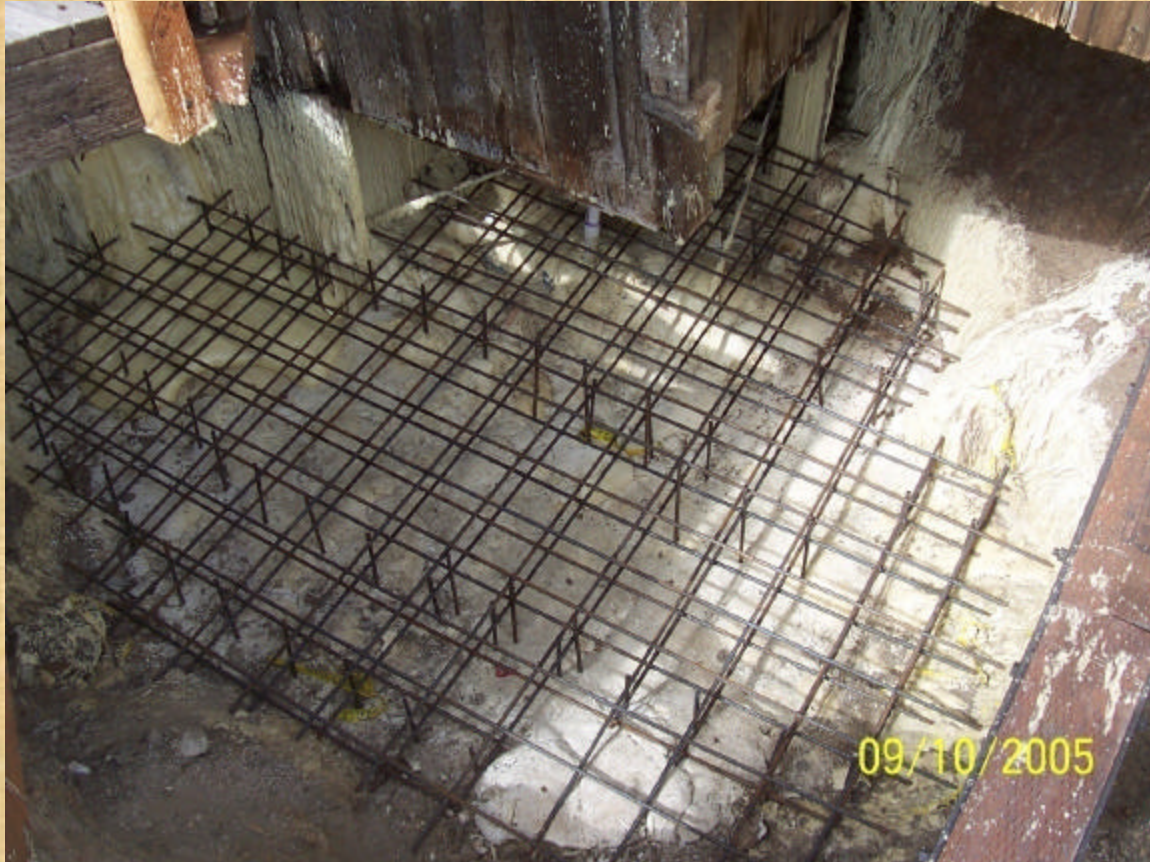
## Rebar over foam plug

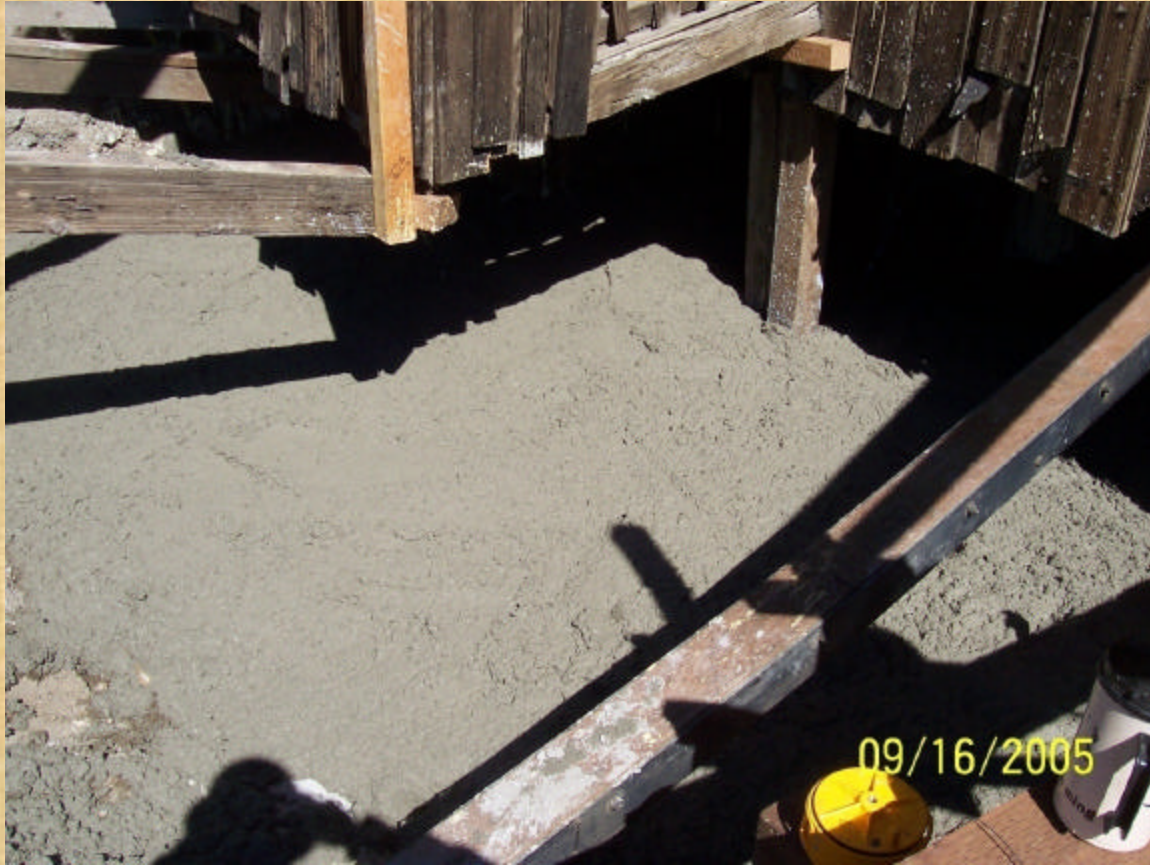
**Concrete pad prior to backfill with soil**

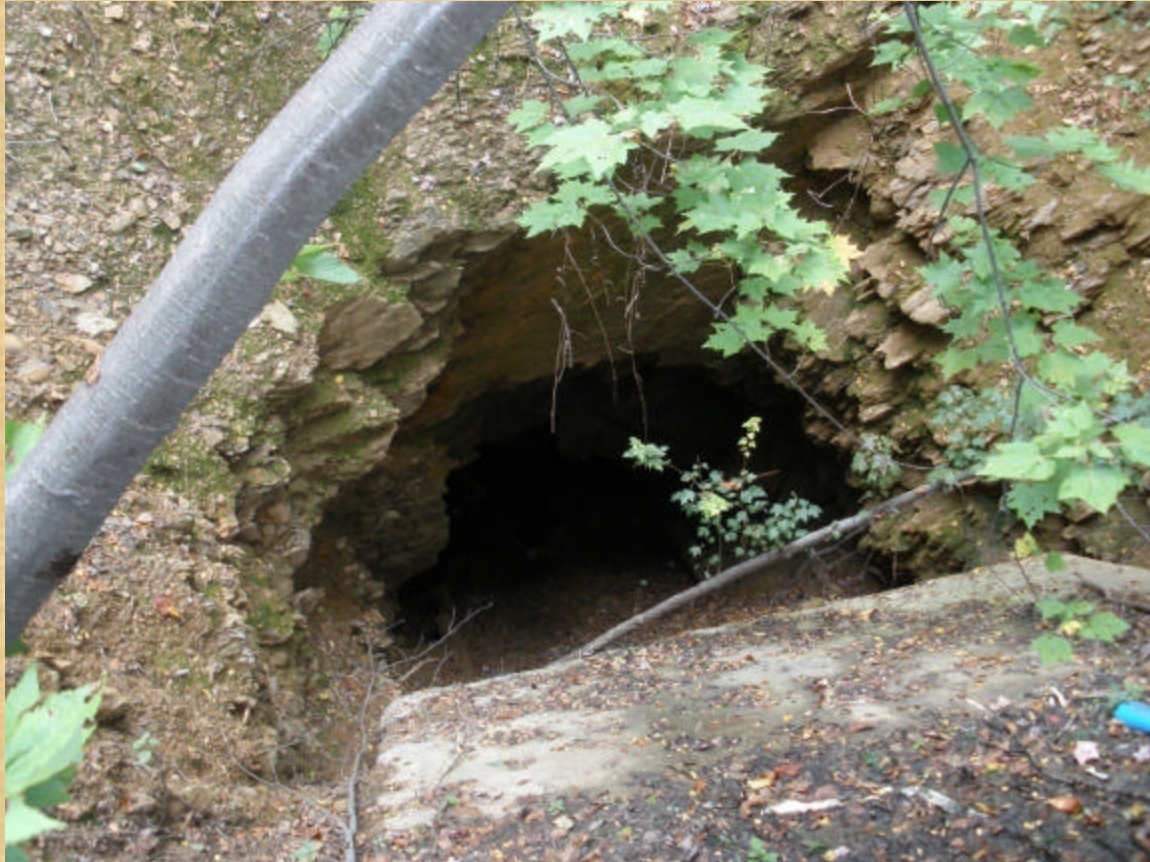
## **Subsidence at inby end of box portal**

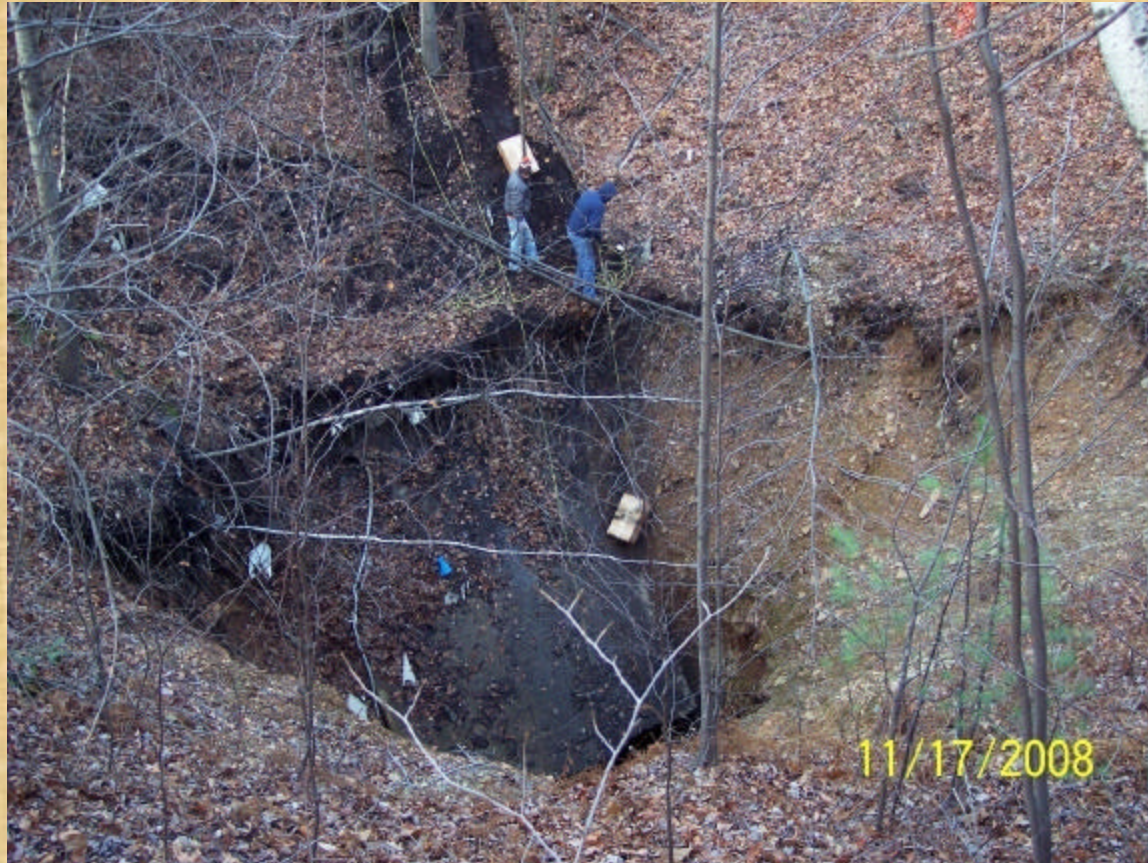
## Surface manifestation of same feature

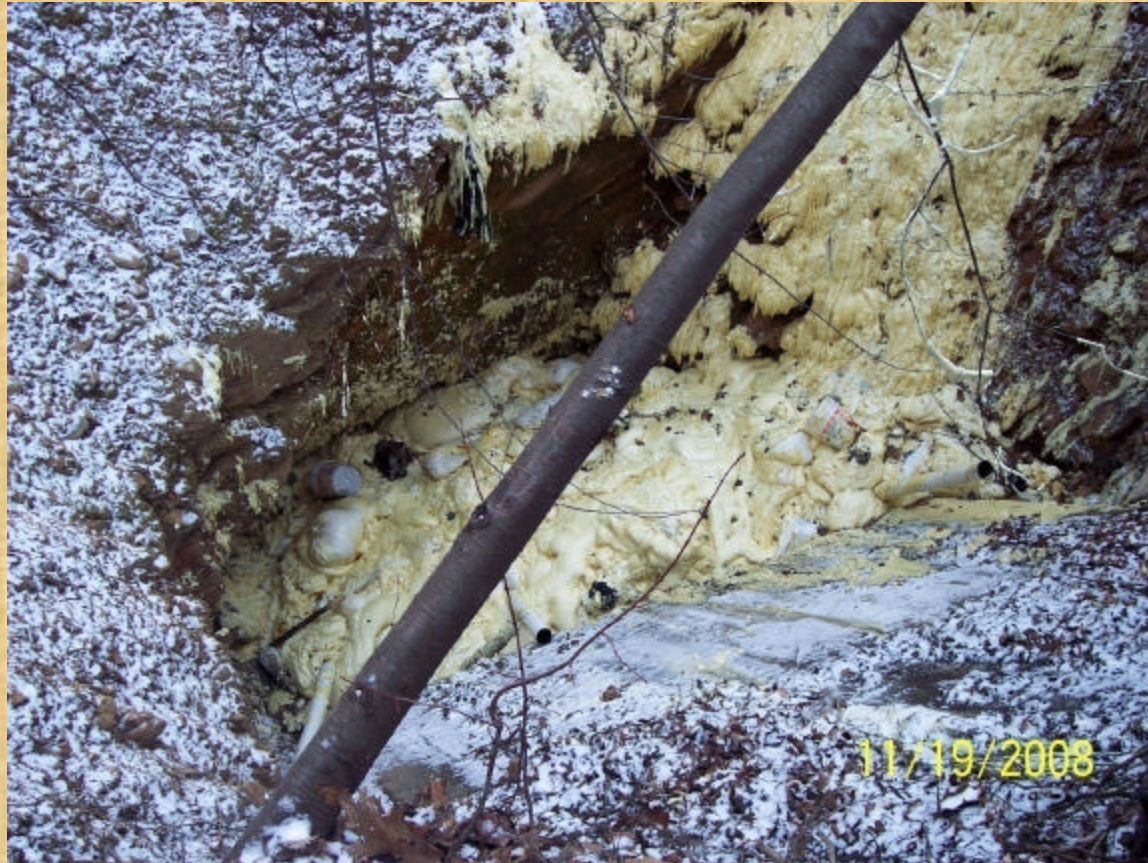
**Foam used to close slope, support backfill**

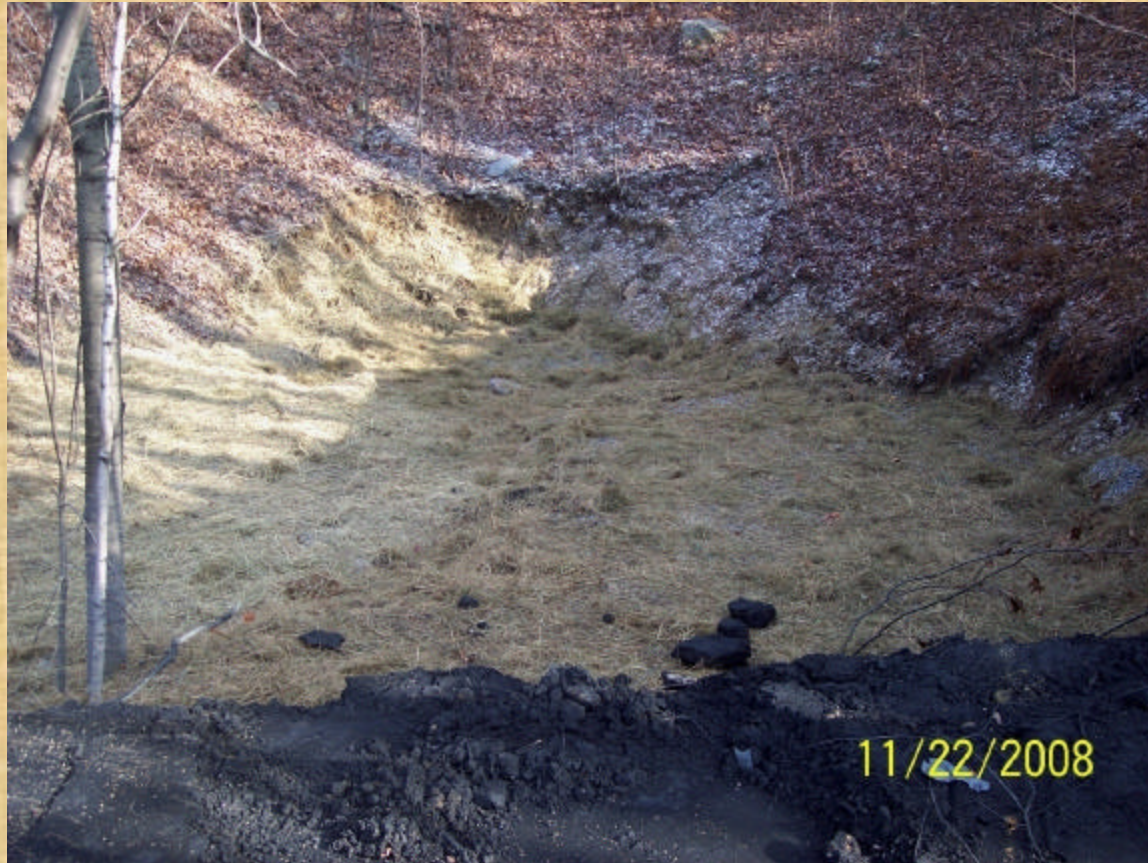
## Final grading and seeding

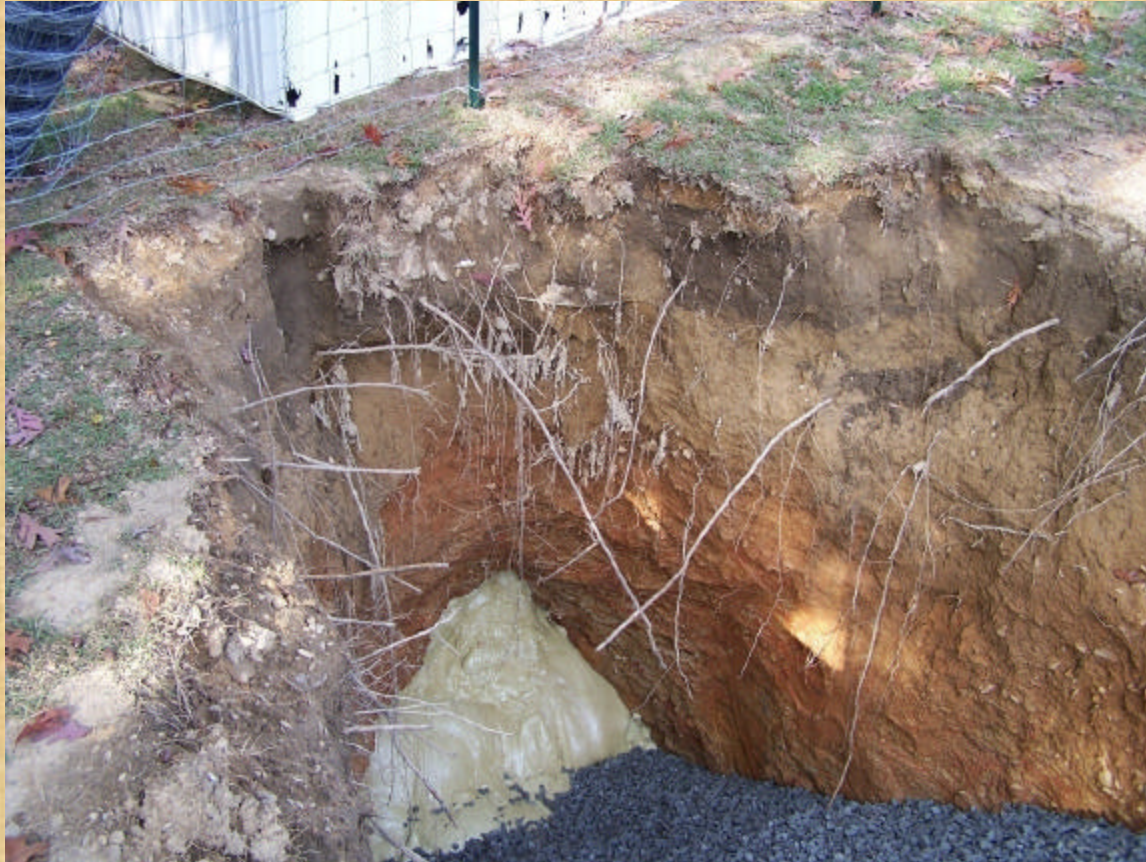
## **Foam under a garage**

Foam will prevent further erosion, keep fill from migrating and support corner of structure

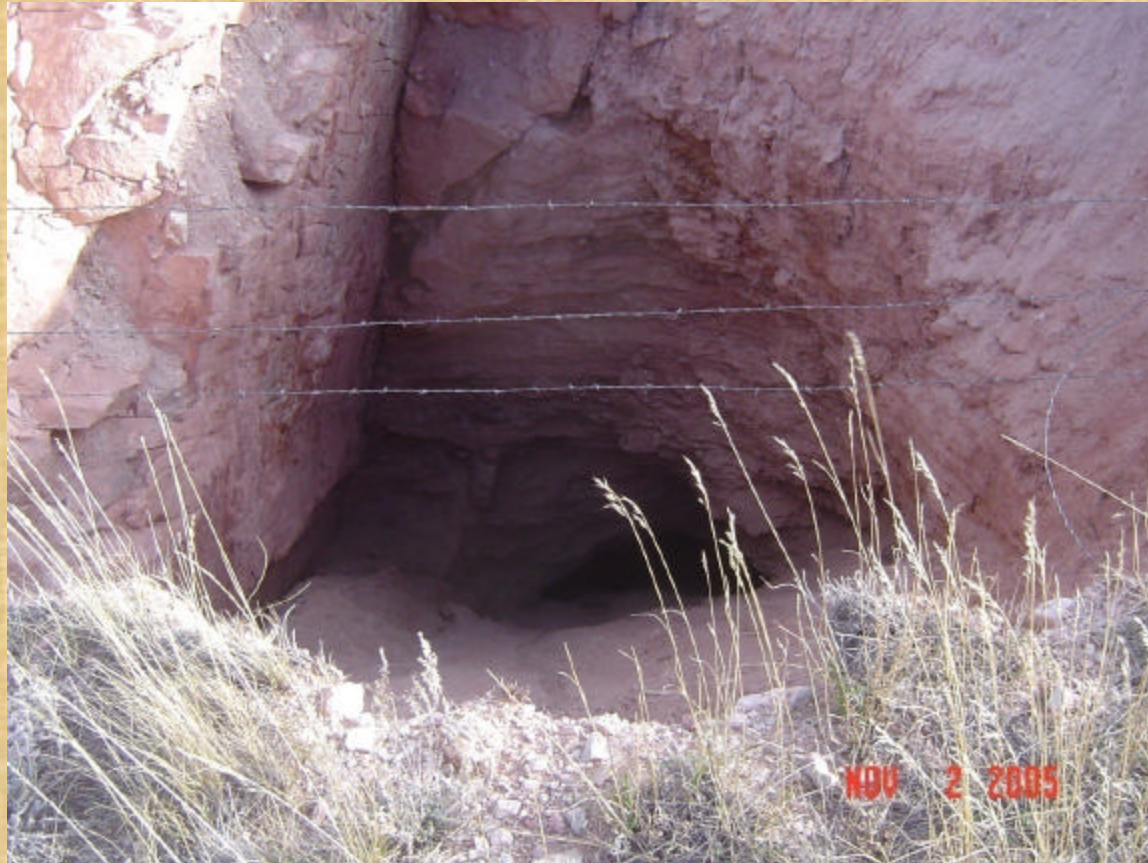
## **Slot raise opening into a large stope**

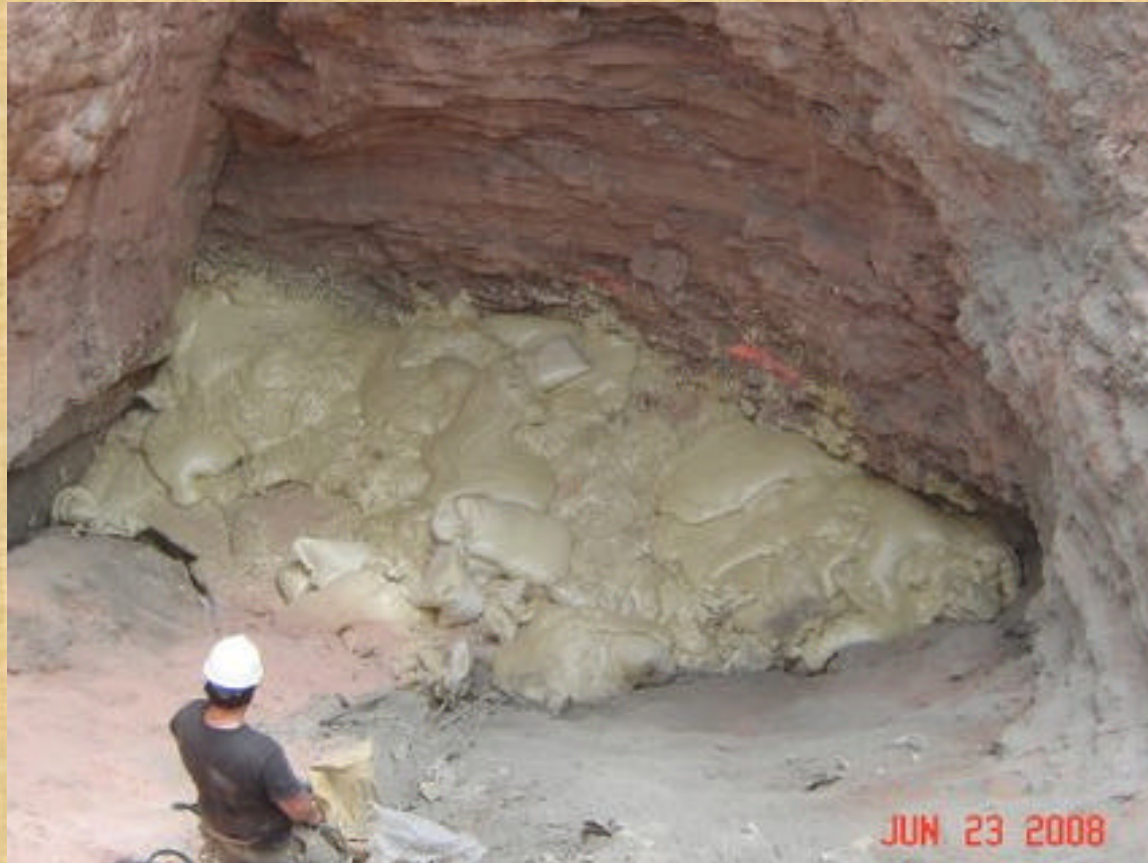
**Foam wedge or “cork” placed in throat of raise**

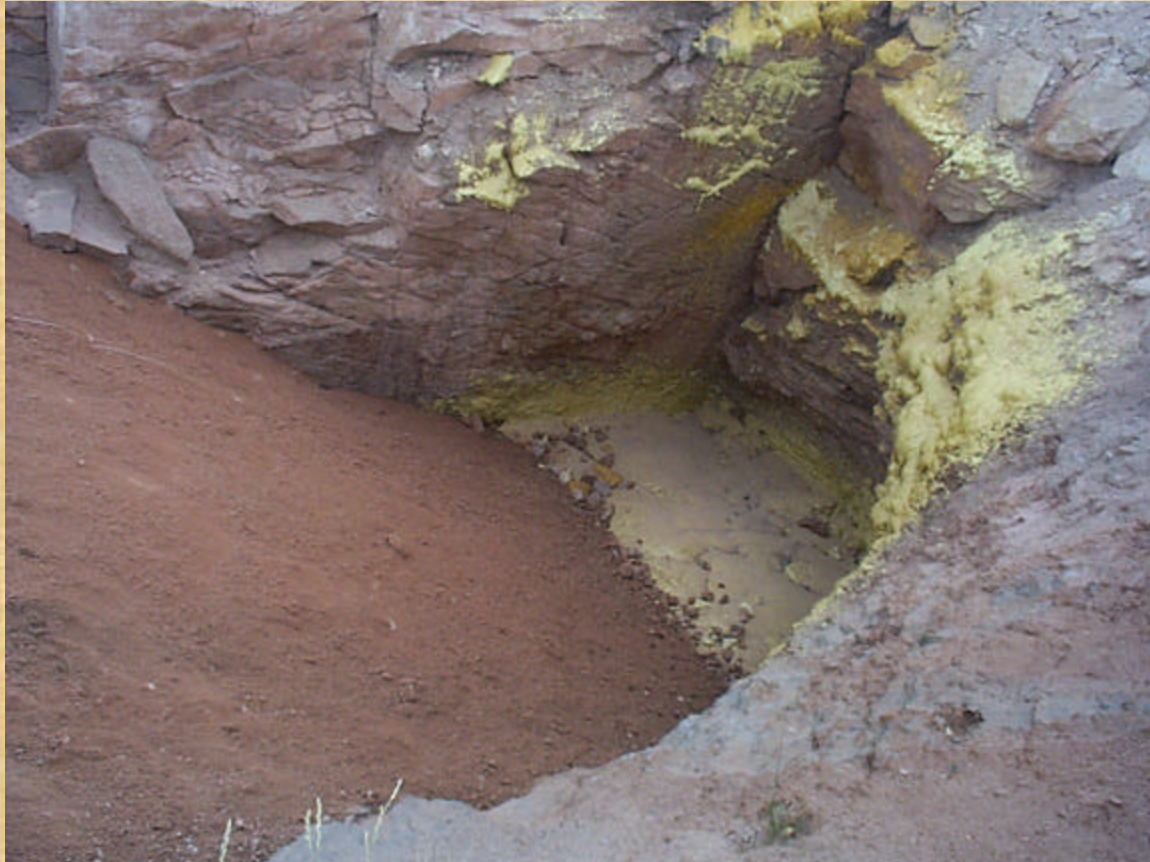
**Fill placed over foam**

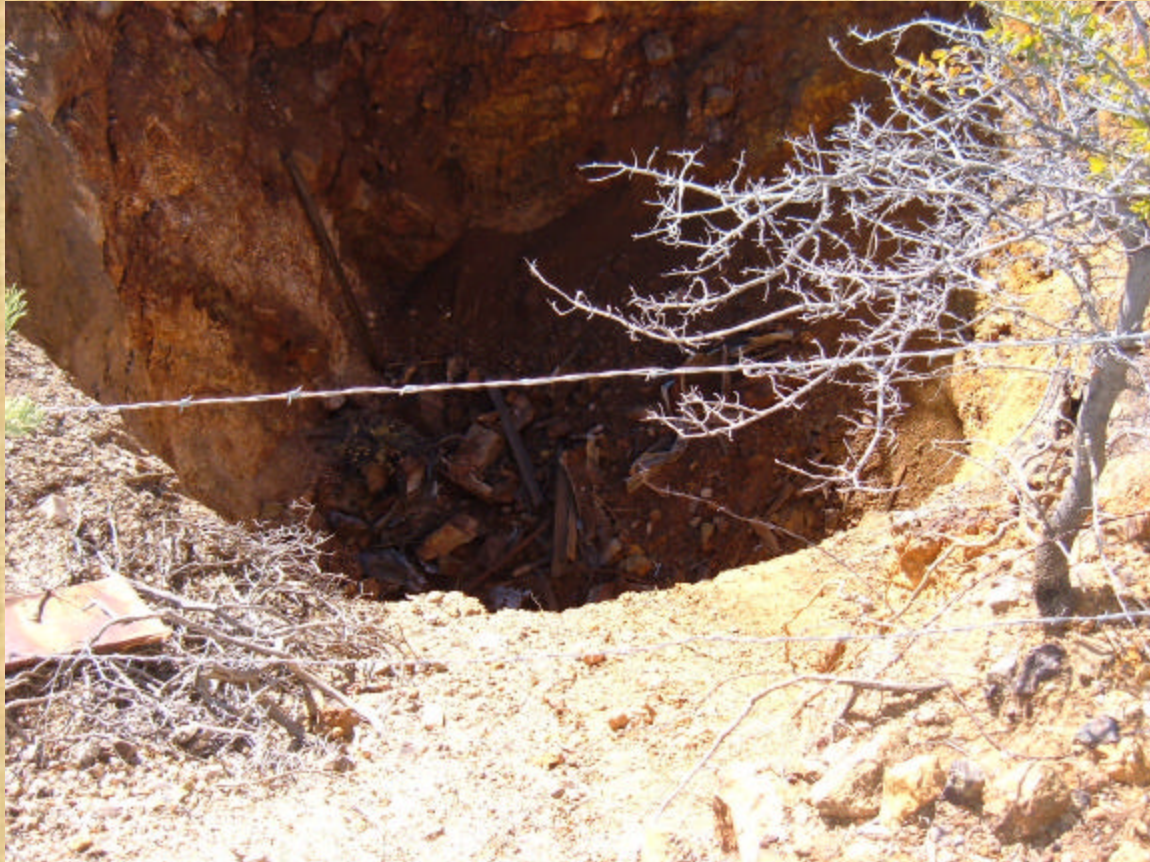
## **Shaft with debris plug**

Could be closed in a similar manner to previous shaft. Foam will not displace debris plug, but will support concrete and reduce erosion.

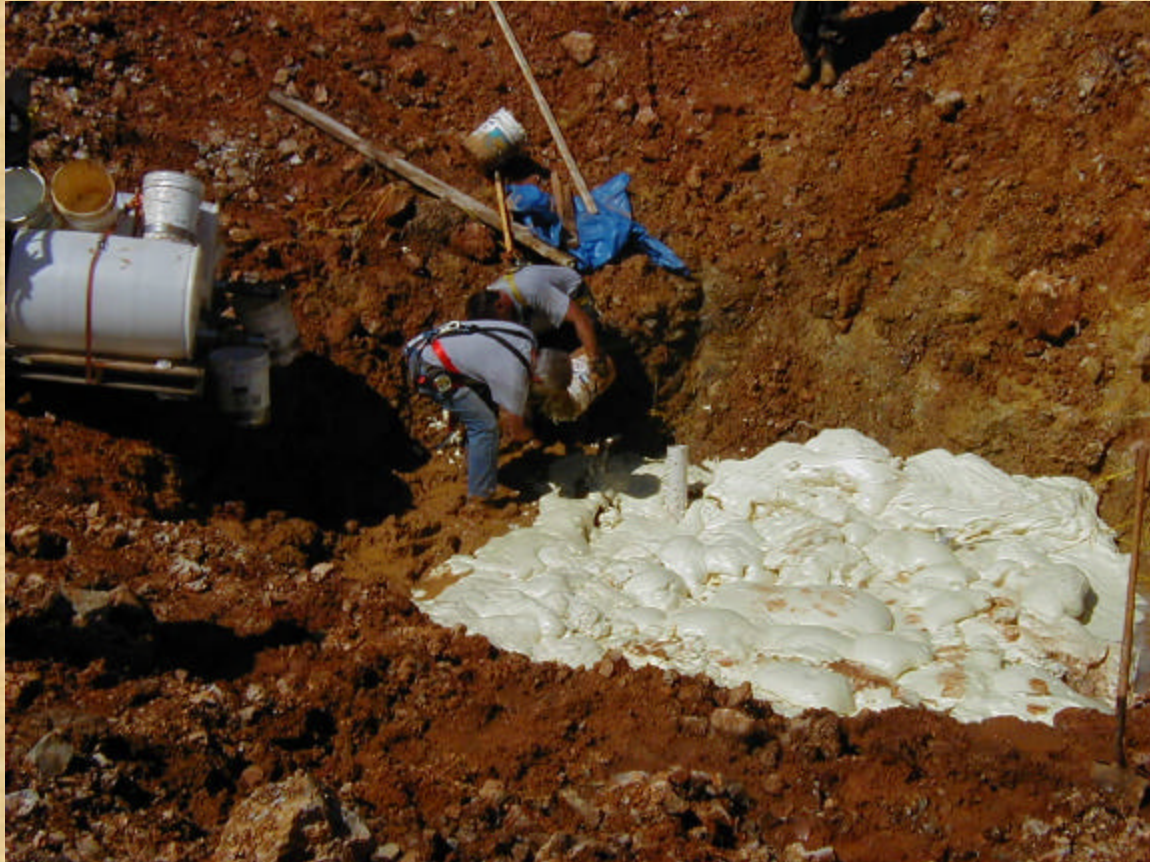
## Foam to underform concrete

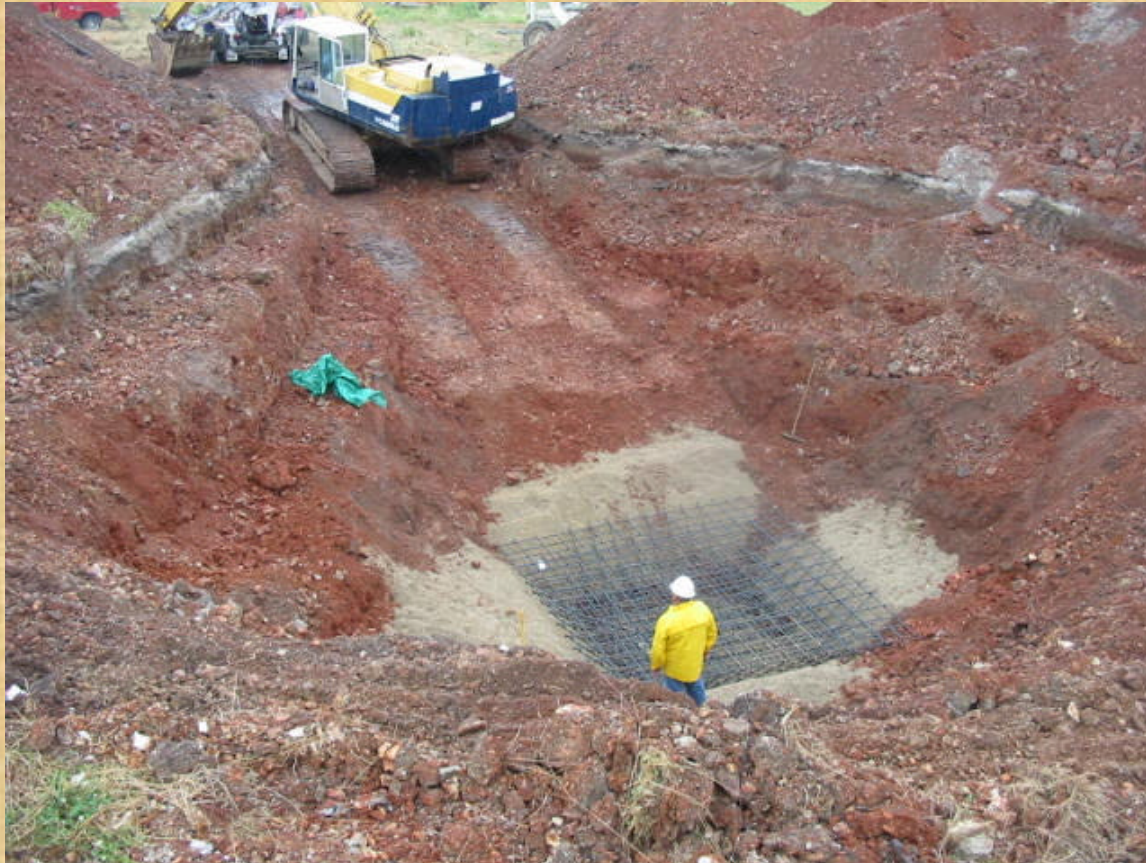
## Rebar mat over foam plug
