# Best Practices for physical hazard closure at underground mines

Mine Design, Operations & Closure  
Conference

2010

Fairmont Hot Springs, MT

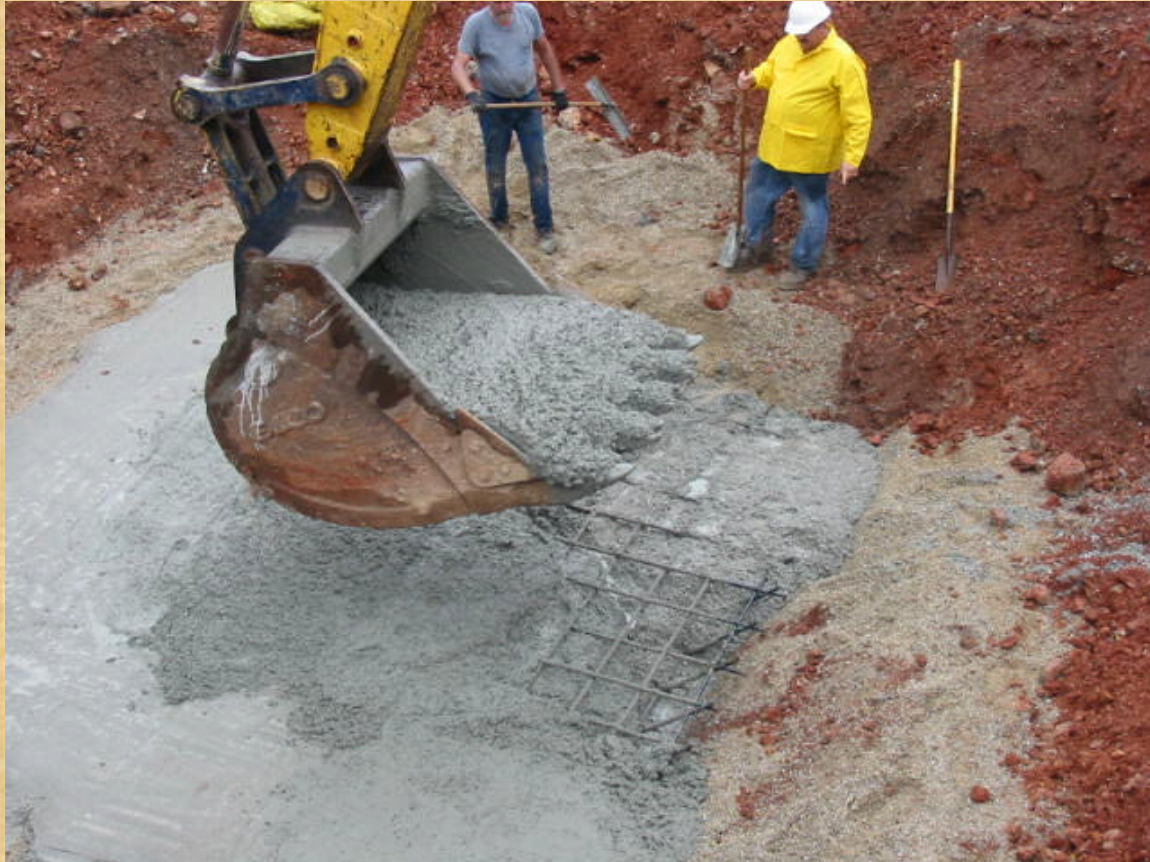
## **Concrete monolithic plug over foam**

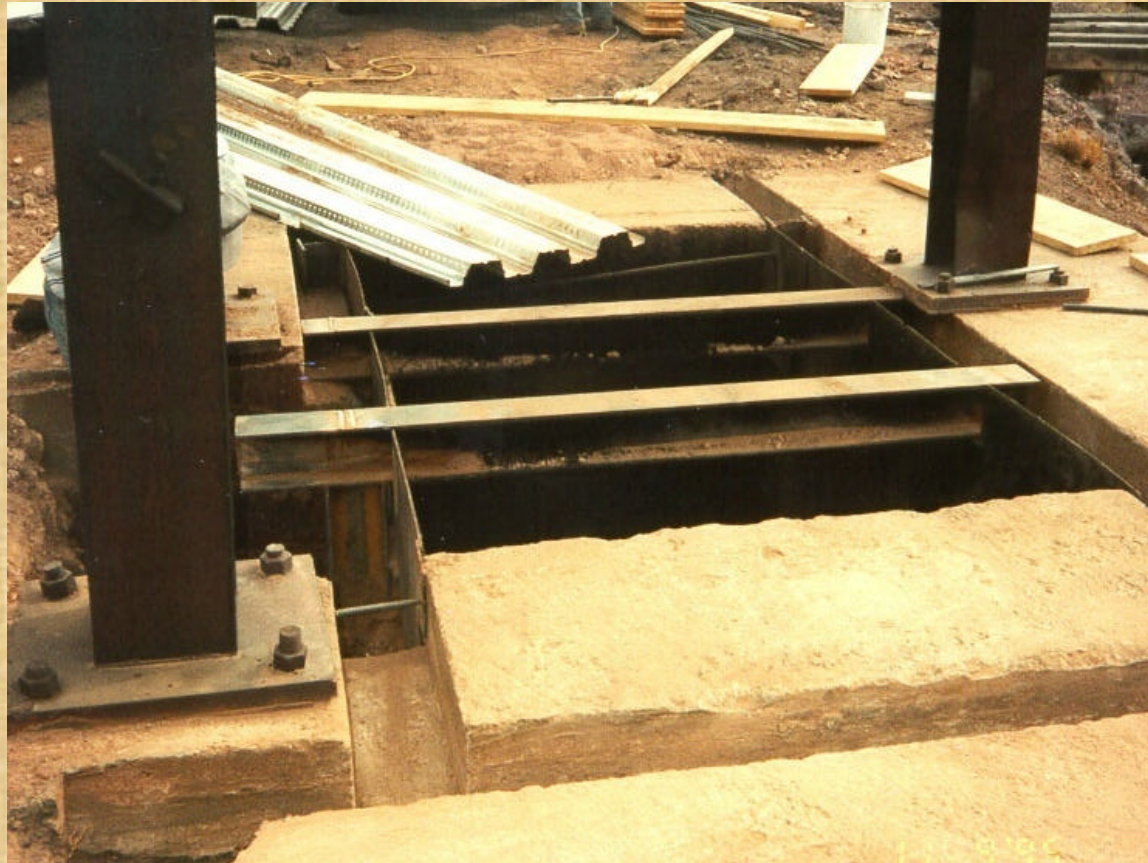
## Shaft and headframe with concrete pad

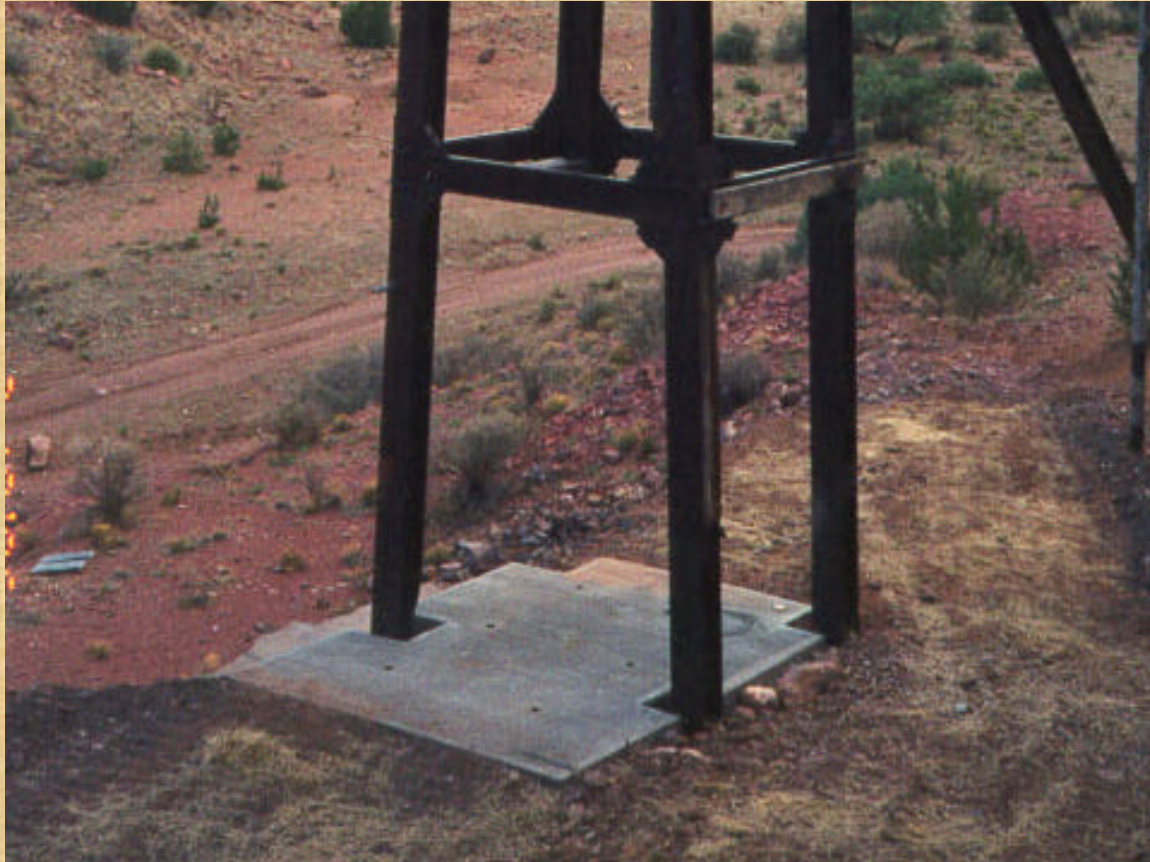
**Concrete plug in place**

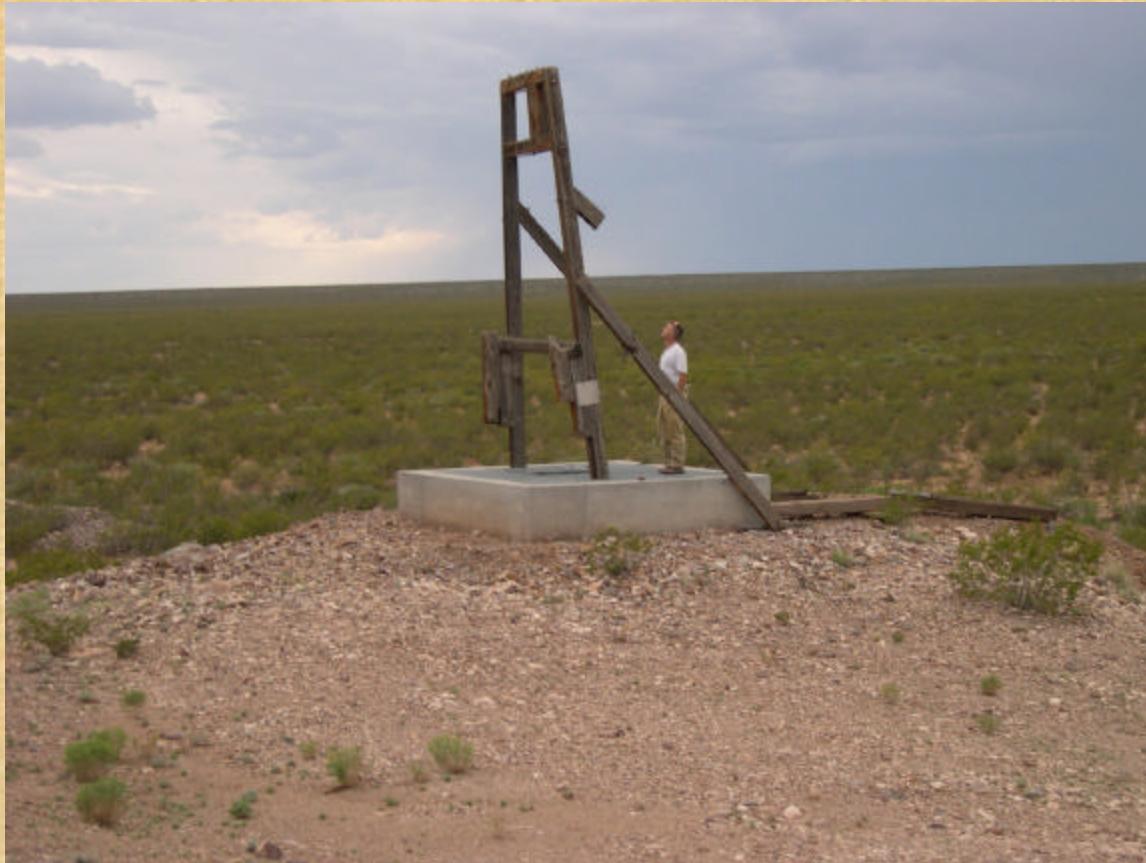
**Similar closure, blends in well with landscape**

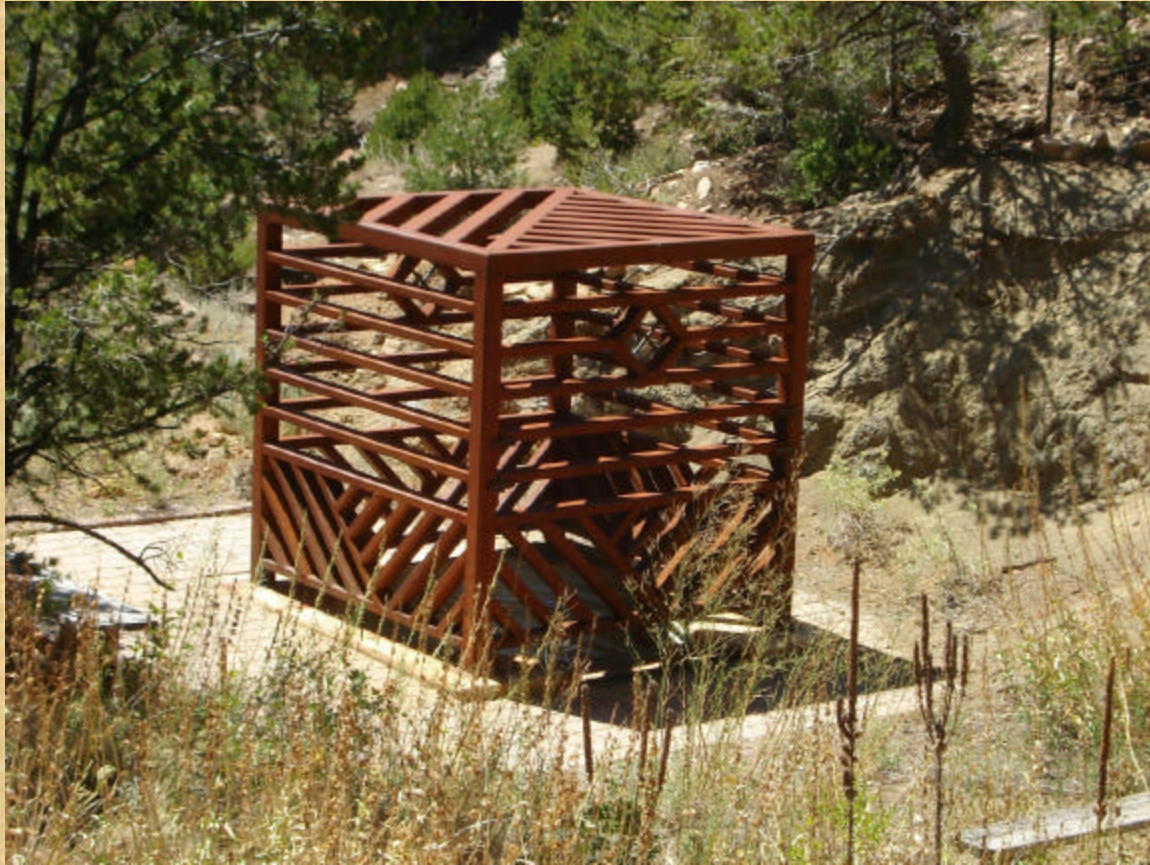
## **Bat cupola**

Culvert foamed in shaft, cupola placed on pad around shaft collar

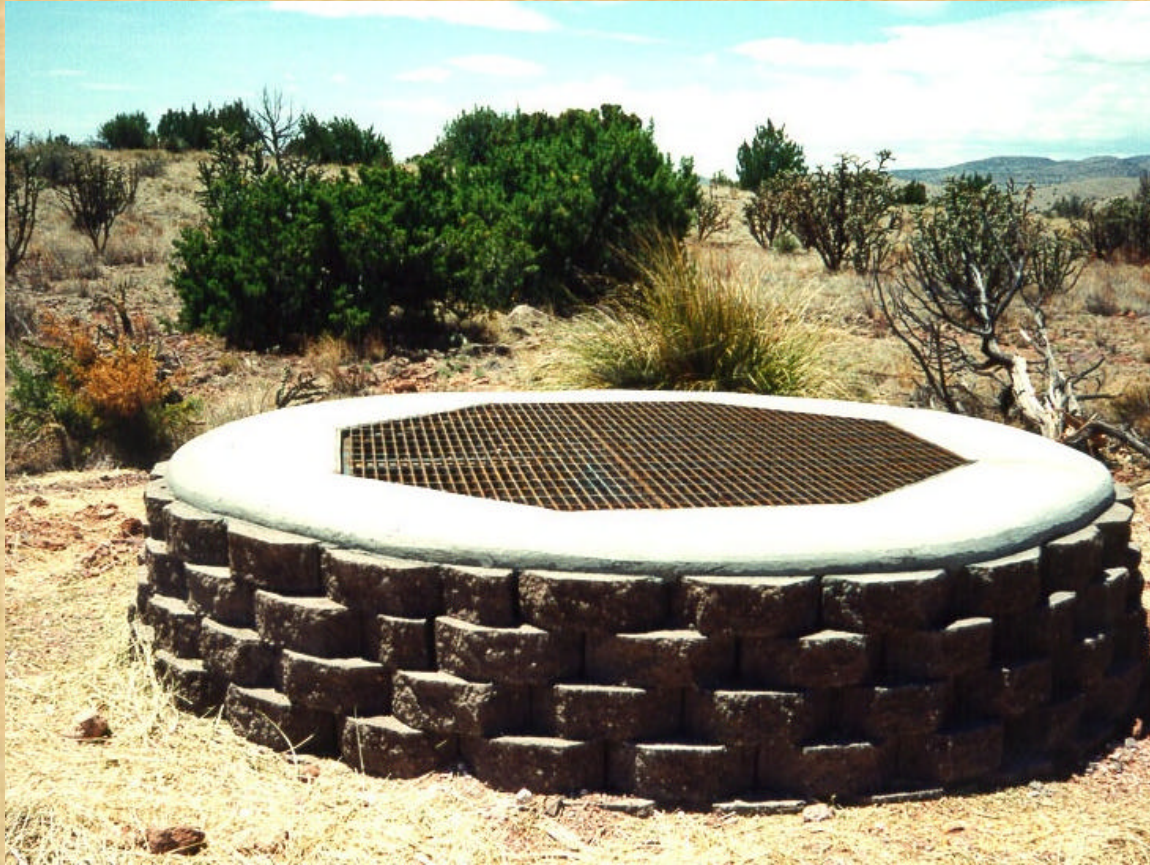
## Shaft with culvert and grating

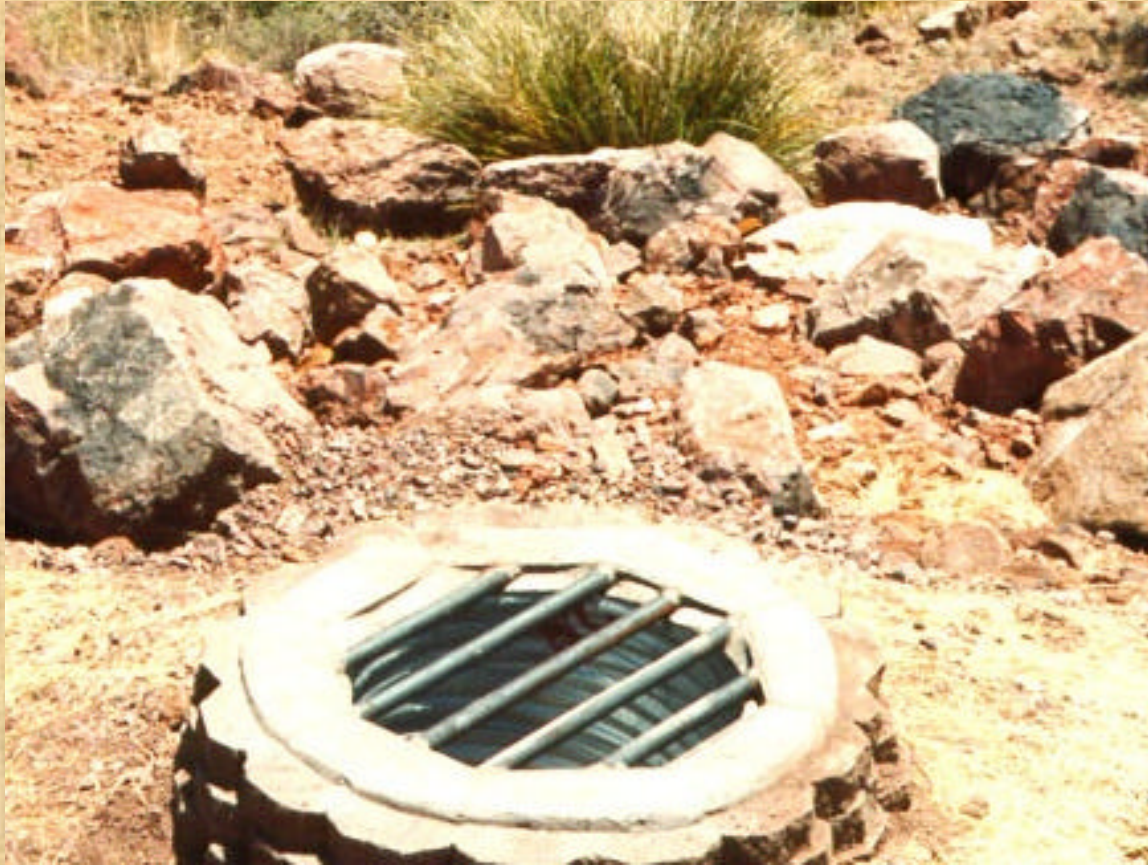
## **Another shaft with culvert and gate**

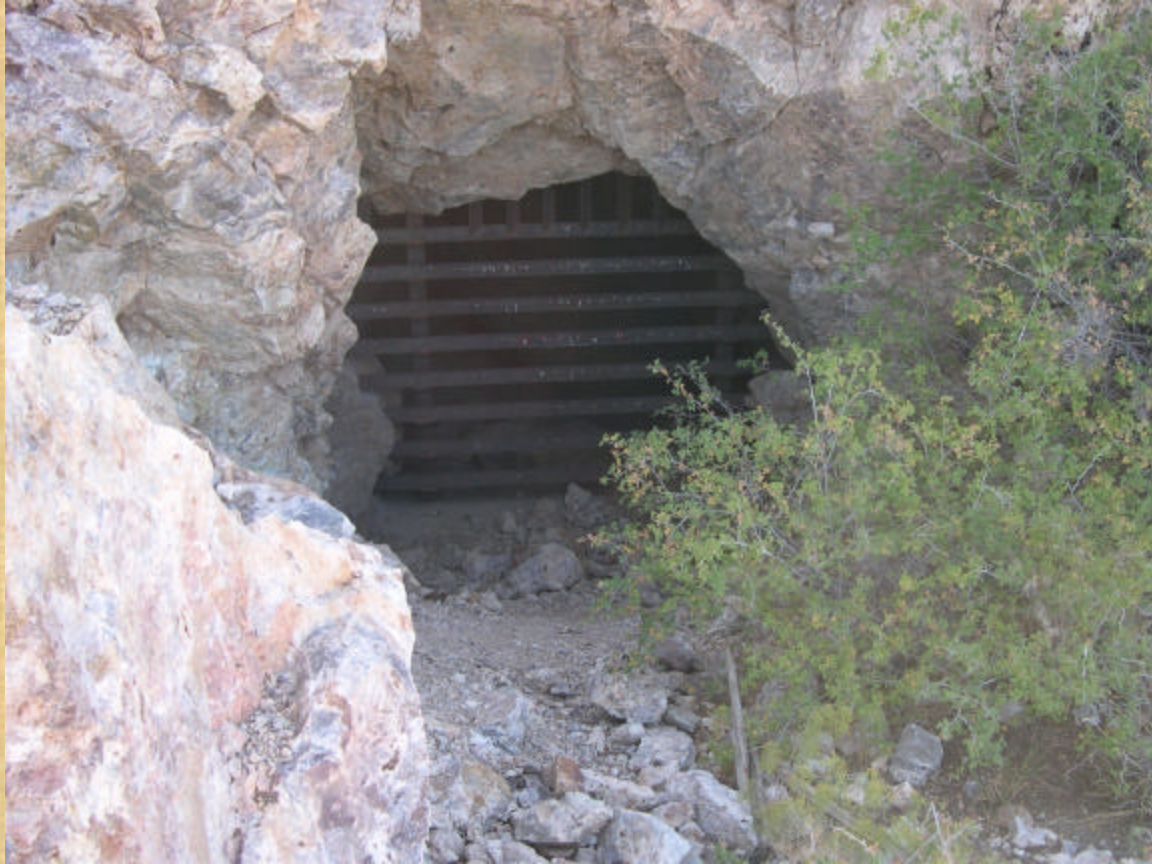
## **Full gate in adit**

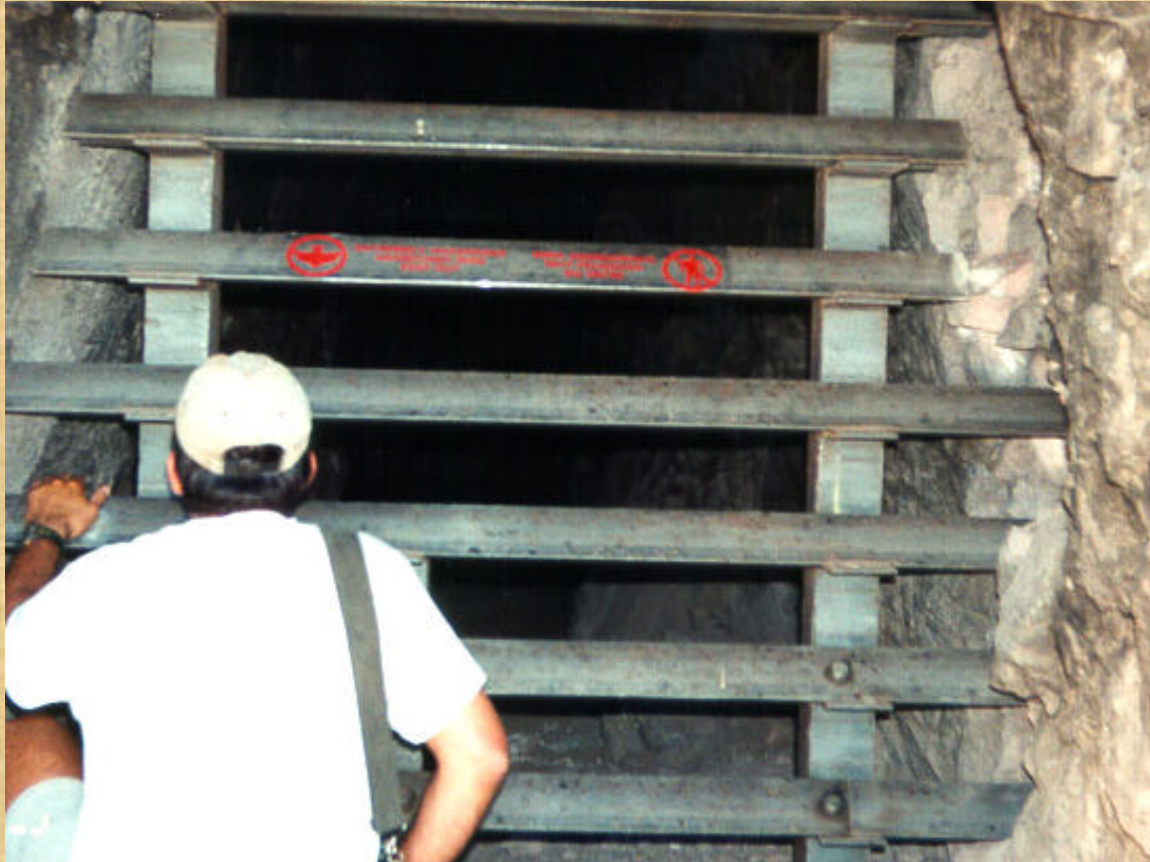
## **Full gate in adit**

Note removable bars

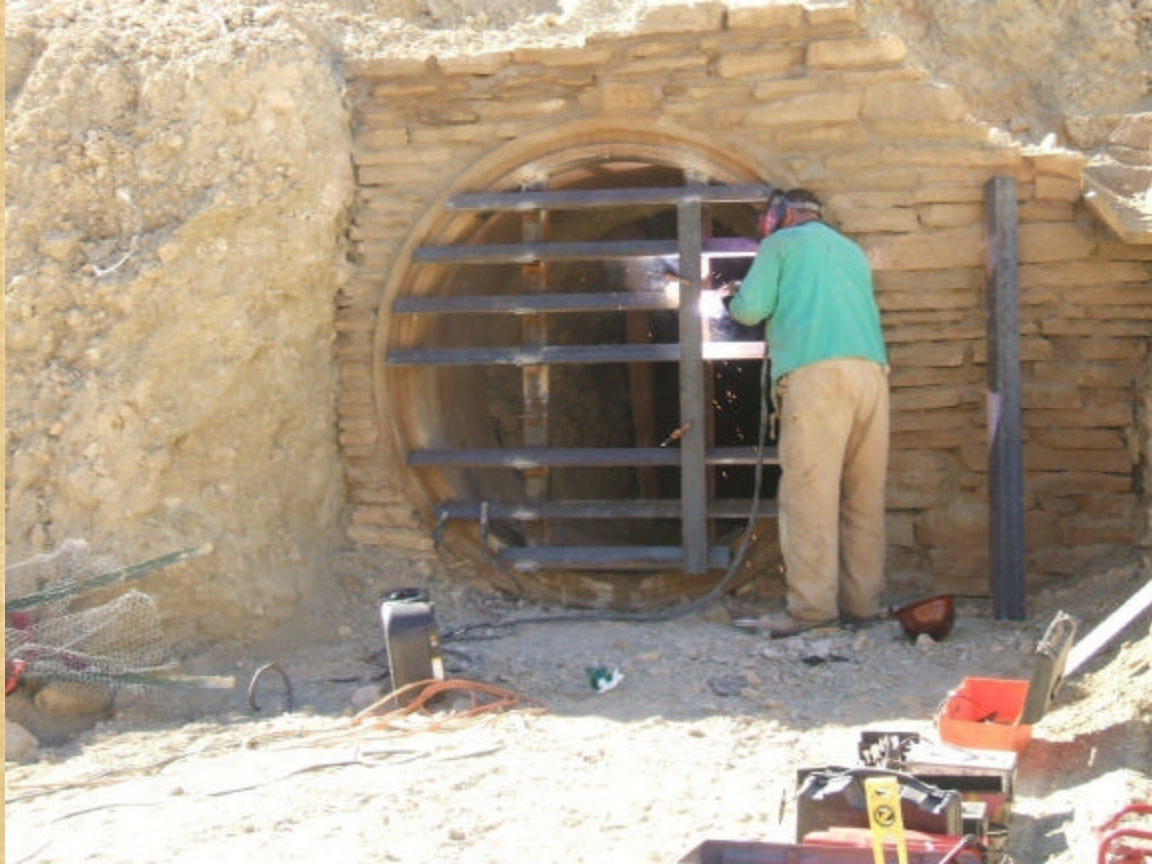
## Gate in concrete pipe

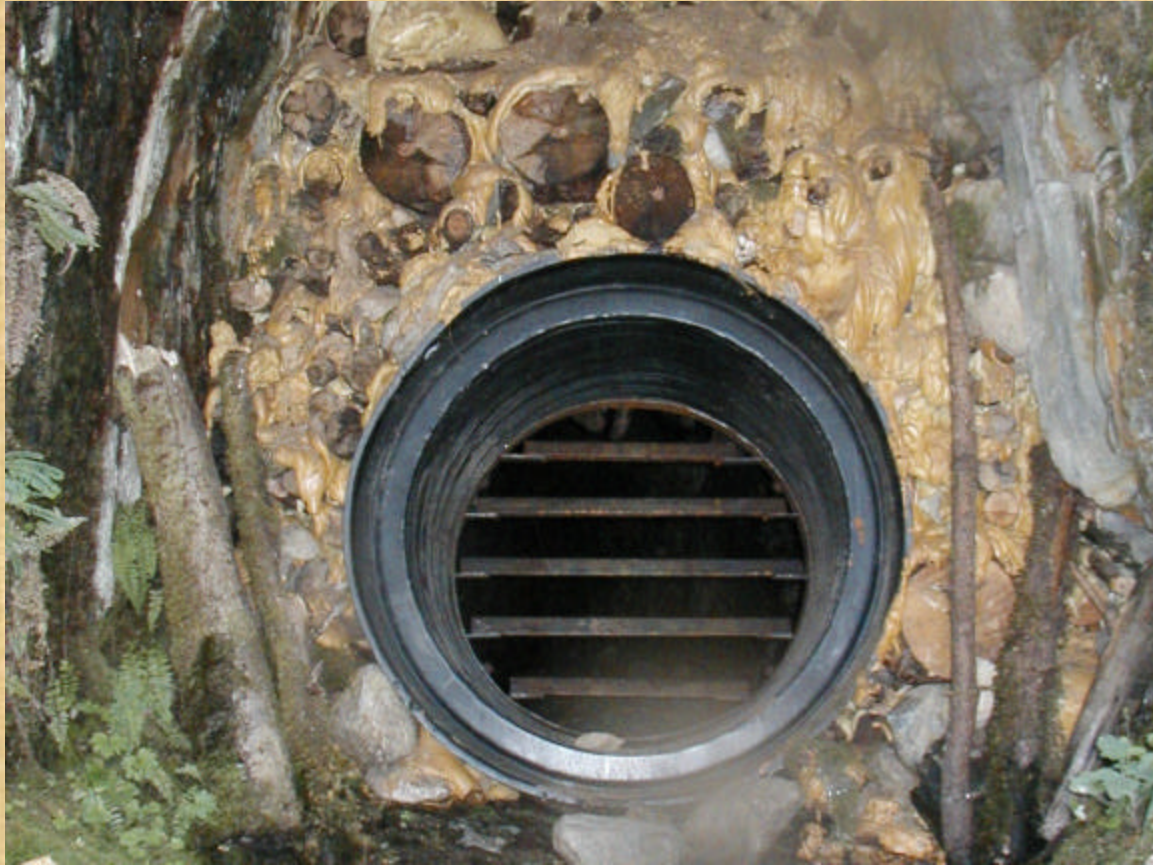
## Gate in HPDE culvert

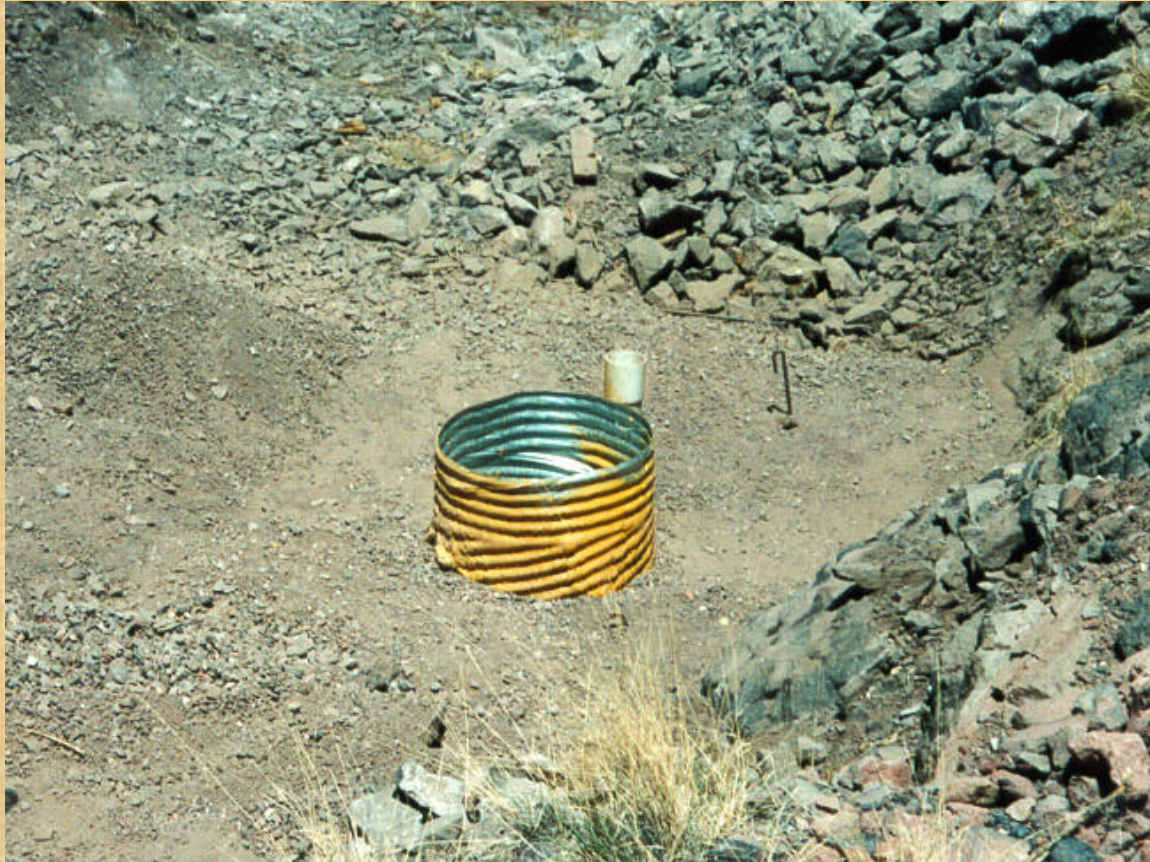
## **Culvert foamed in shaft with drain pipe**

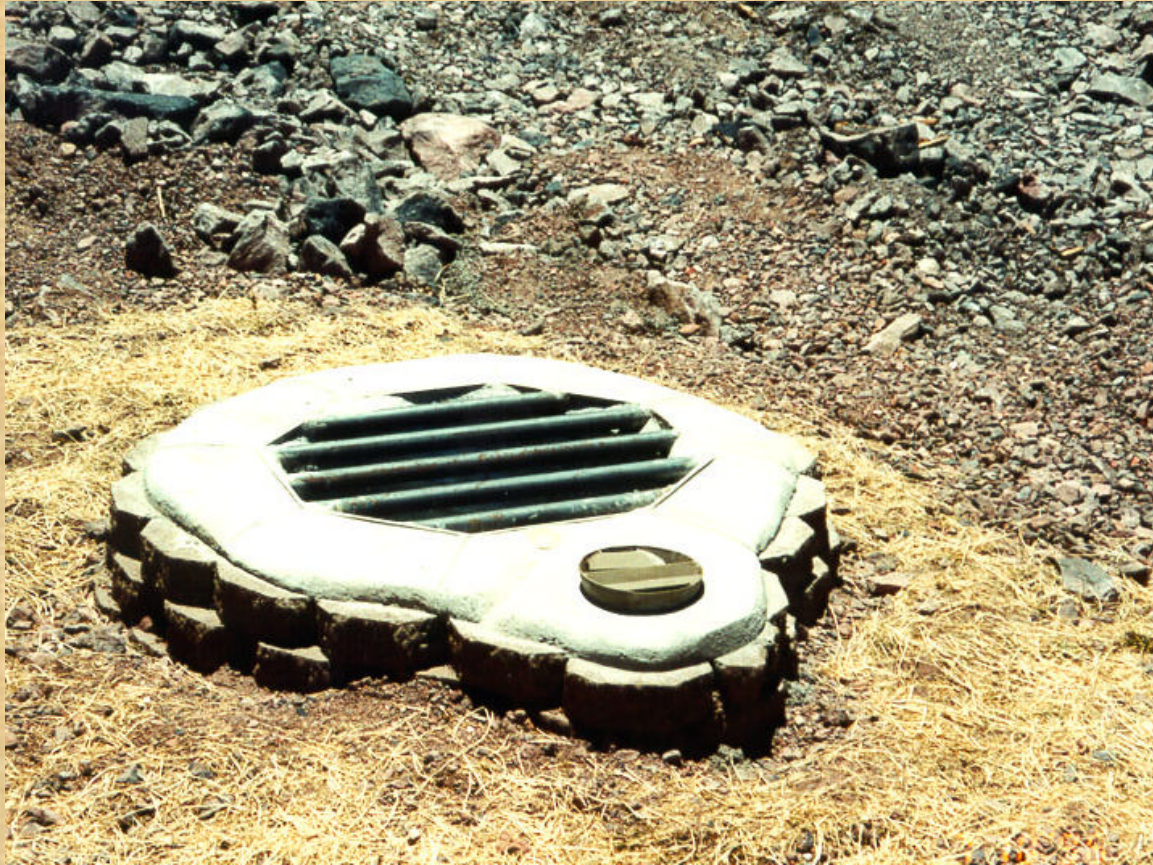
## Gate at grade

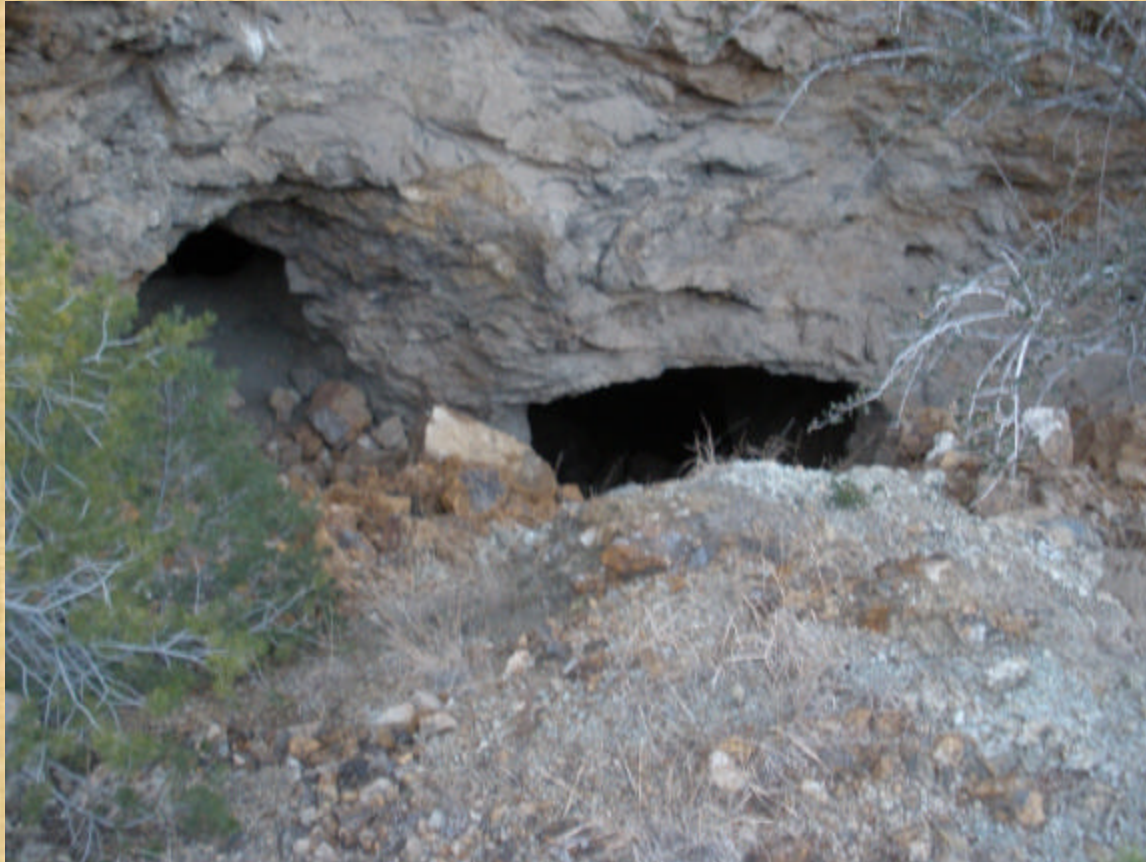
## **Multiple openings along scissor fault**

Might be suited to cable net, steel mesh or tires

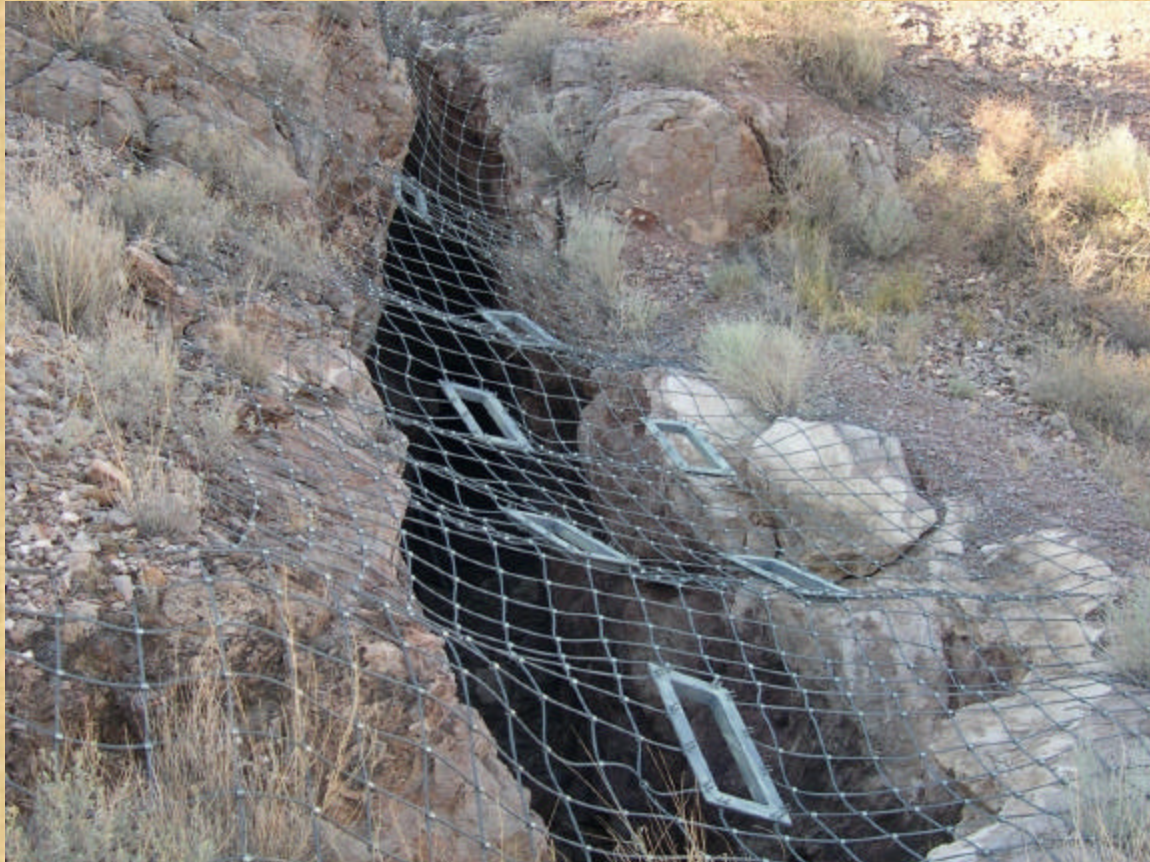
## **Cable net with bat windows**

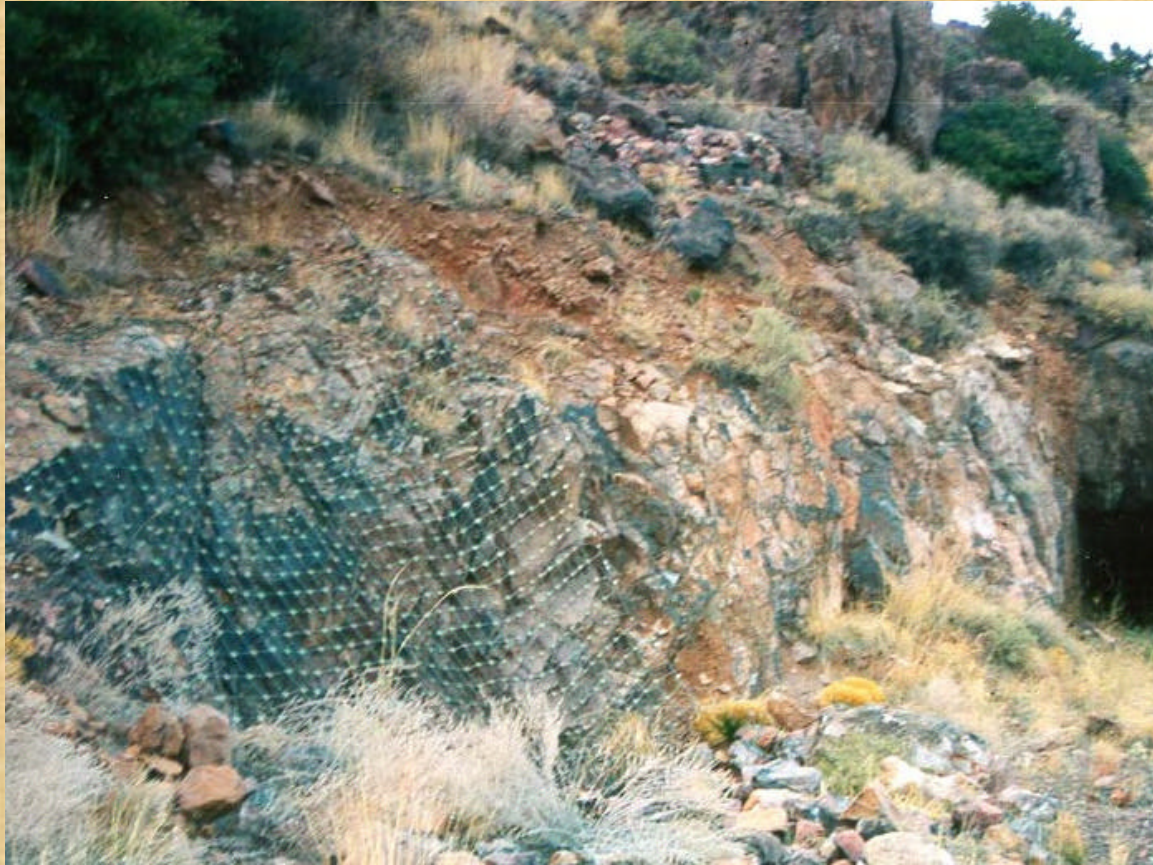
## **More cable net**

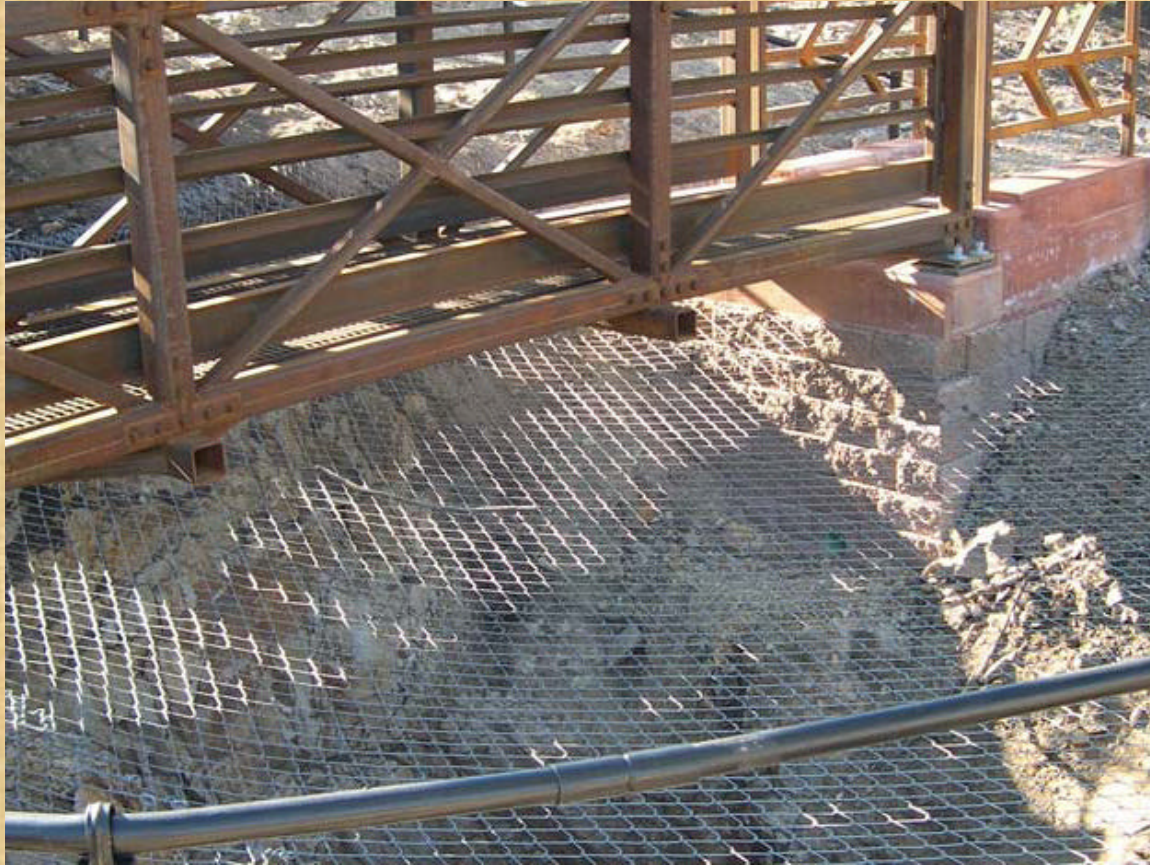
## **Steel mesh over shaft with observation bridge**

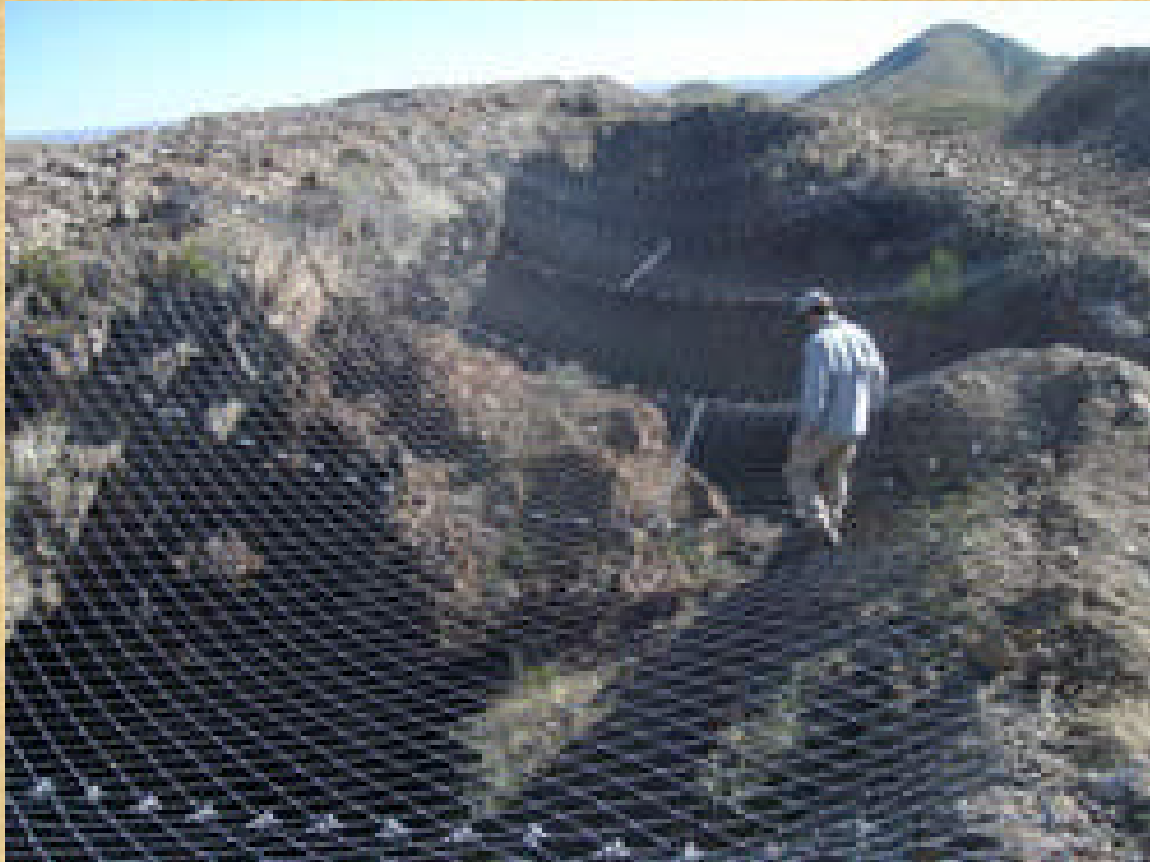
## **Steel mesh over stope**

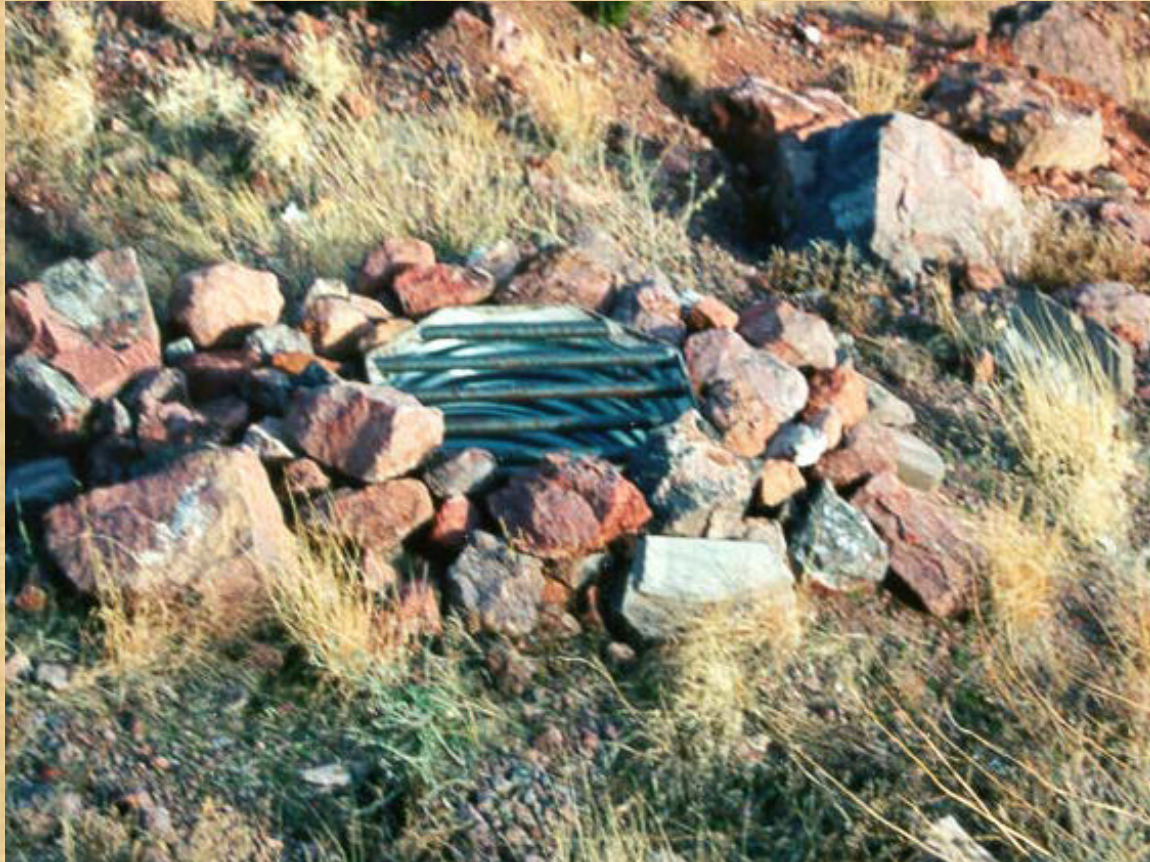
## **Culvert gate in shaft with rock backfill**

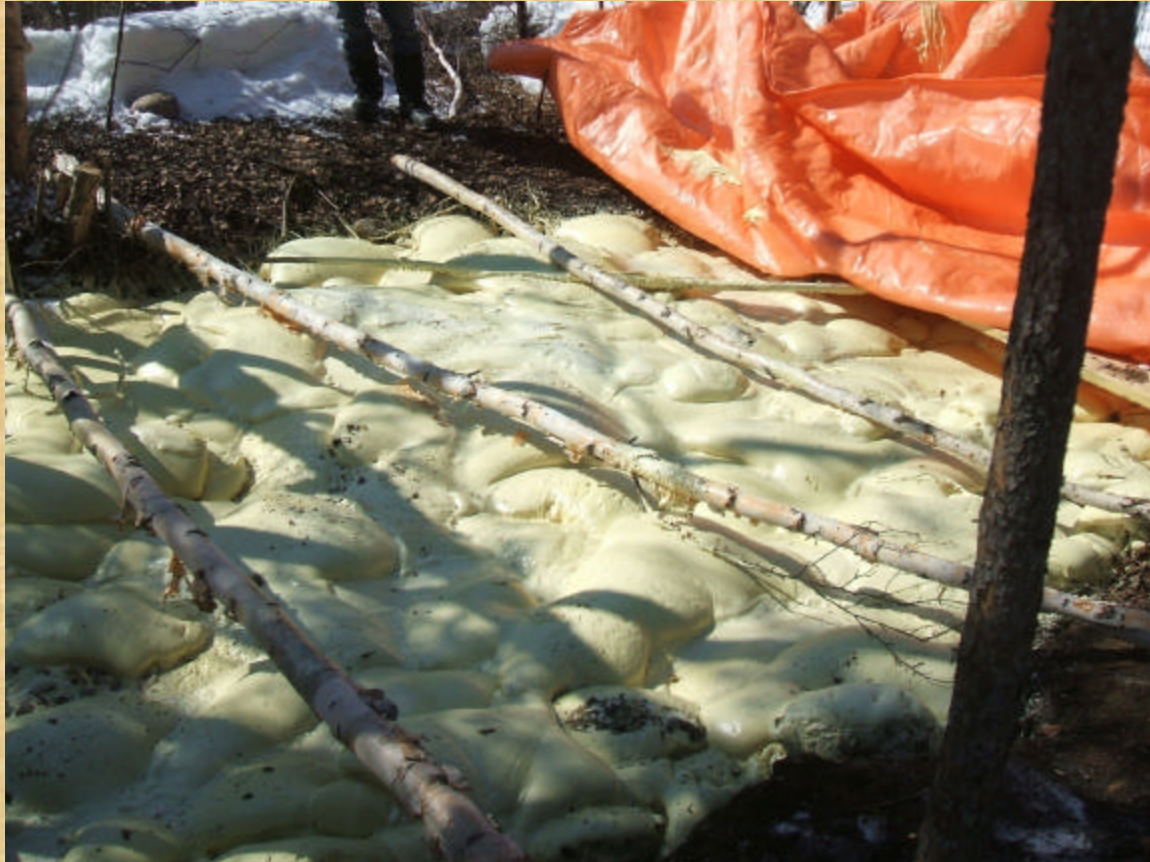
**Shafts with all waste rock encapsulated in foam**

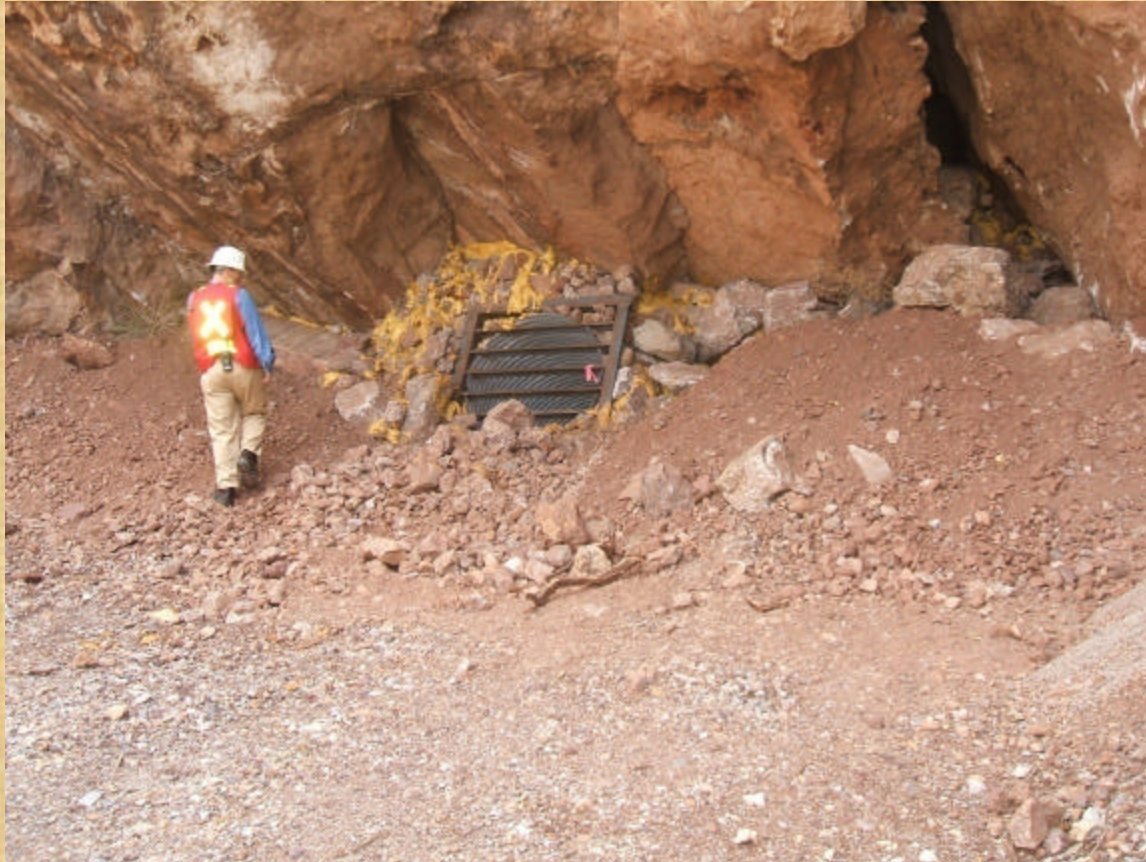
## **Culvert and gate in an inclined stope opening**

Culvert provides ventilation into a tourist mine

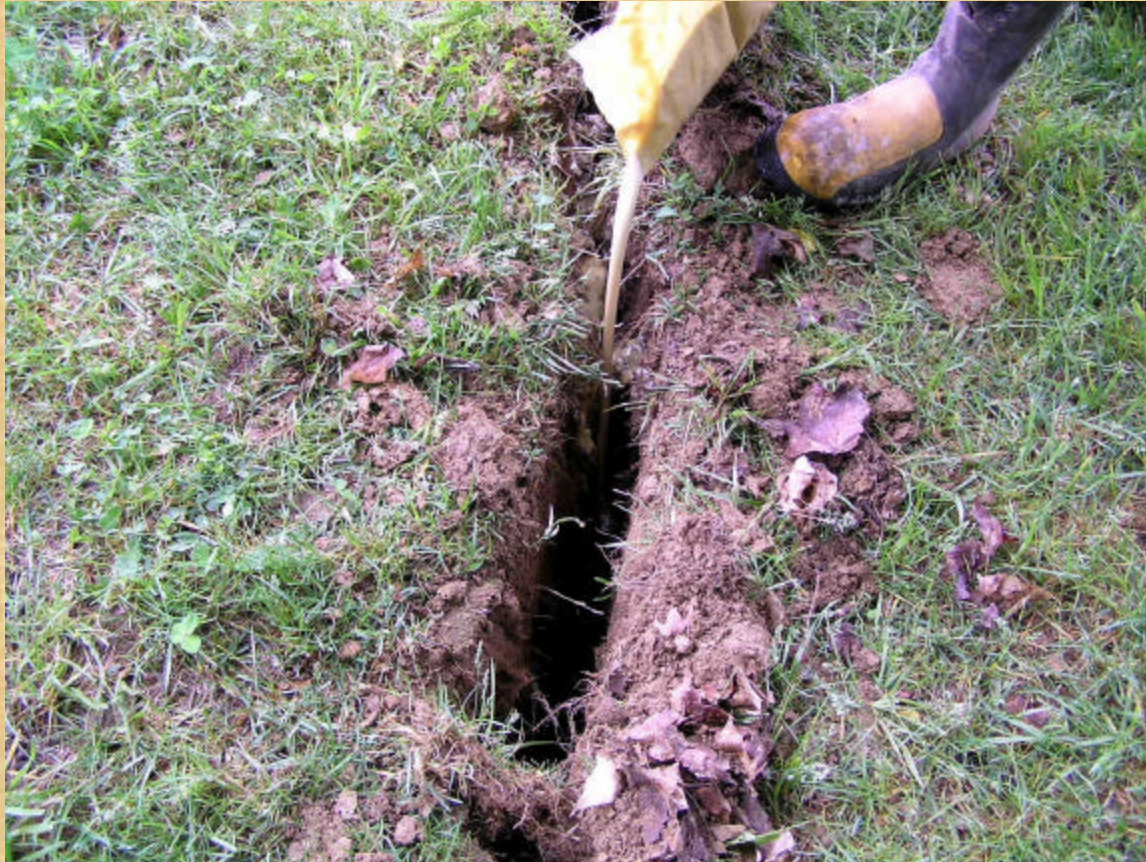
## **Pouring foam directly in subsidence crack**

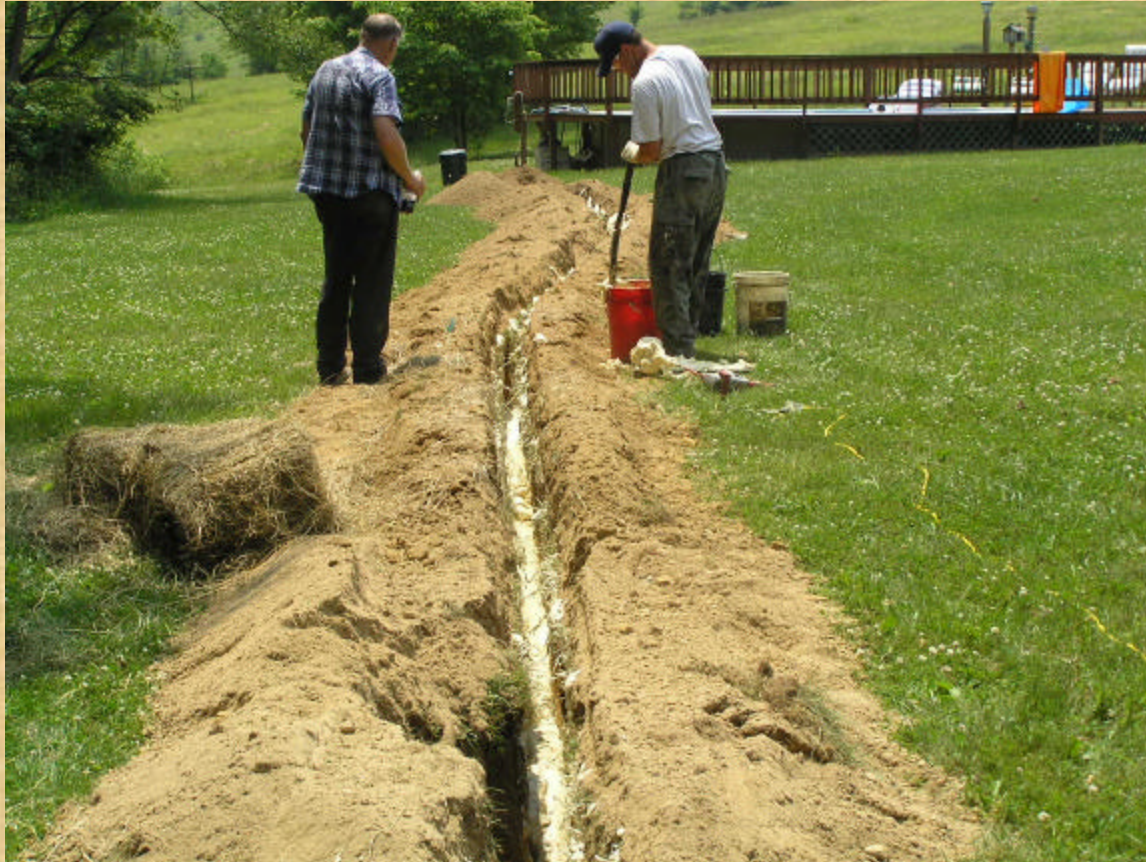
**Subsidence cracks over coal mine, cleaned out and foamed**
