# Best Practices for physical hazard closure at underground mines

Mine Design, Operations & Closure  
Conference

2010

Fairmont Hot Springs, MT

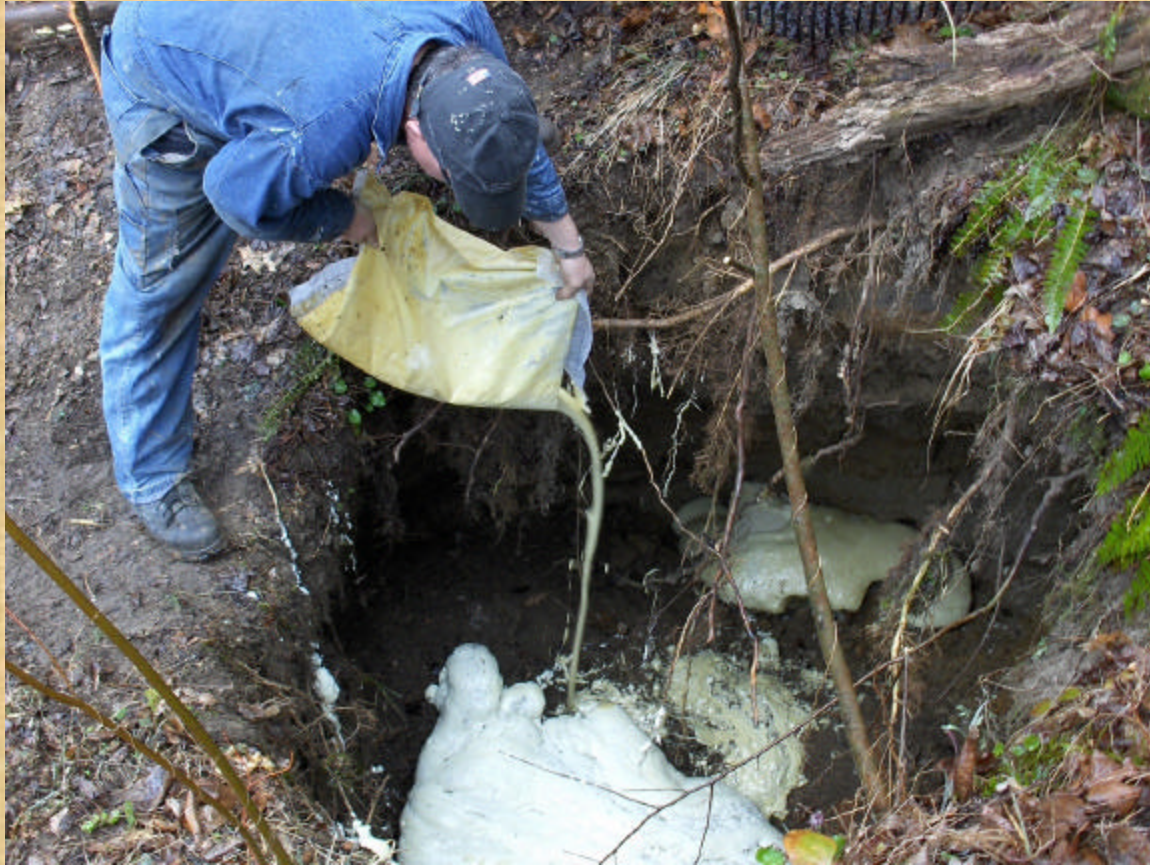
## **Intersection cave subsidence**

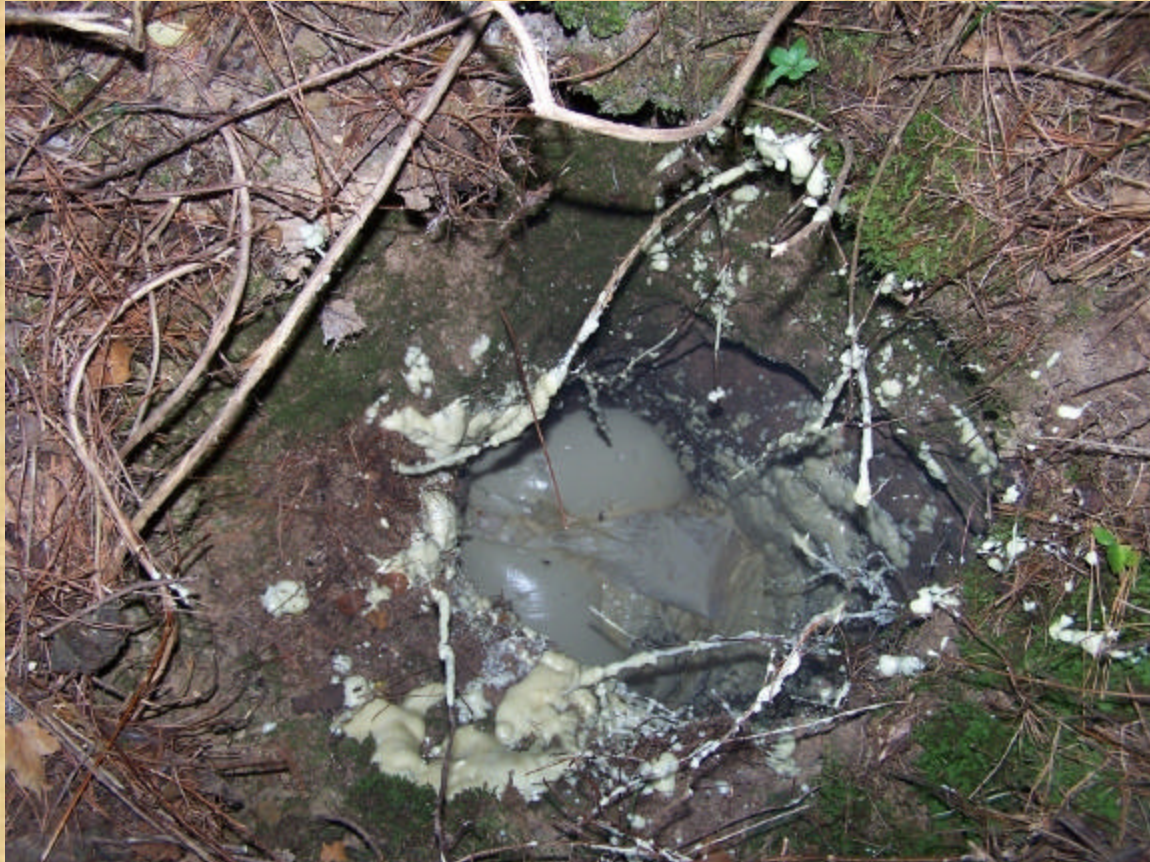
## **Small chimney type subsidence**

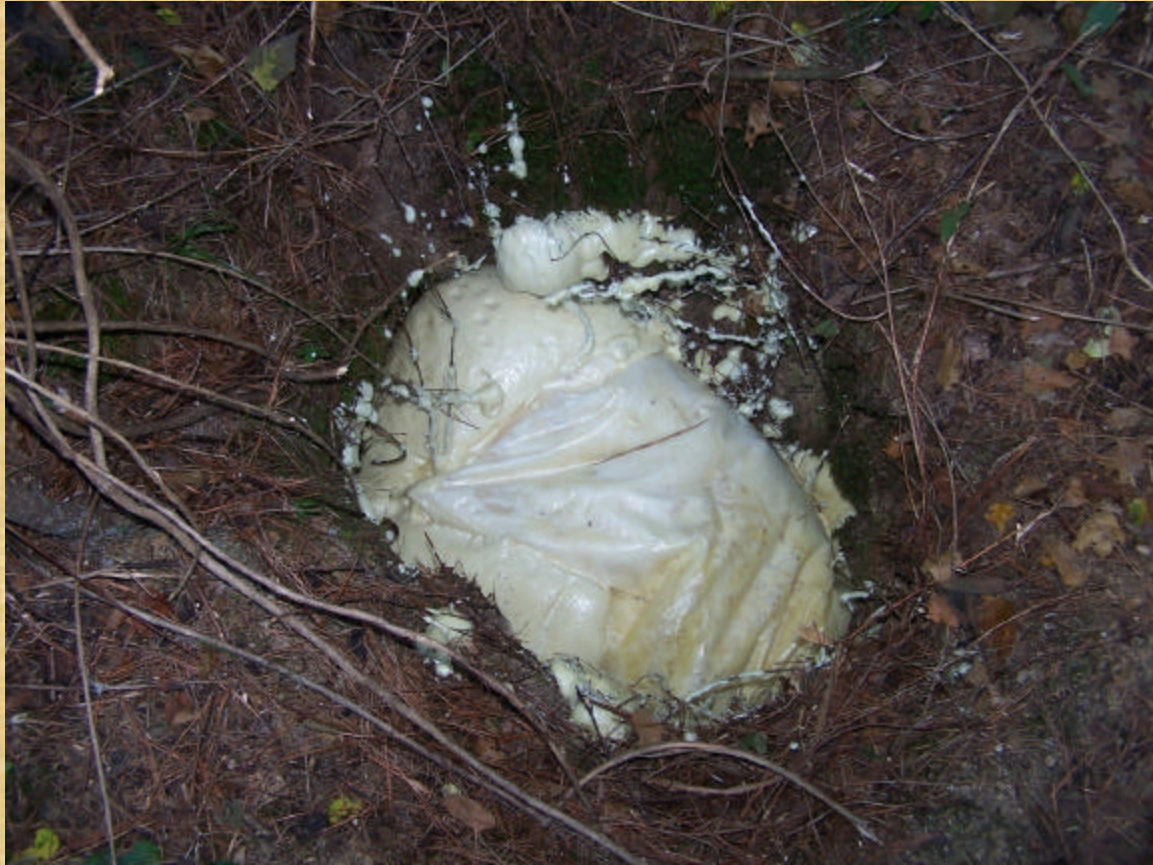
## **Foam prior to backfill**
