Surface Reclamation of the Captain Jack Mill Superfund Site

May 8, 2019

Introduction – Captain Jack Mill Superfund Site

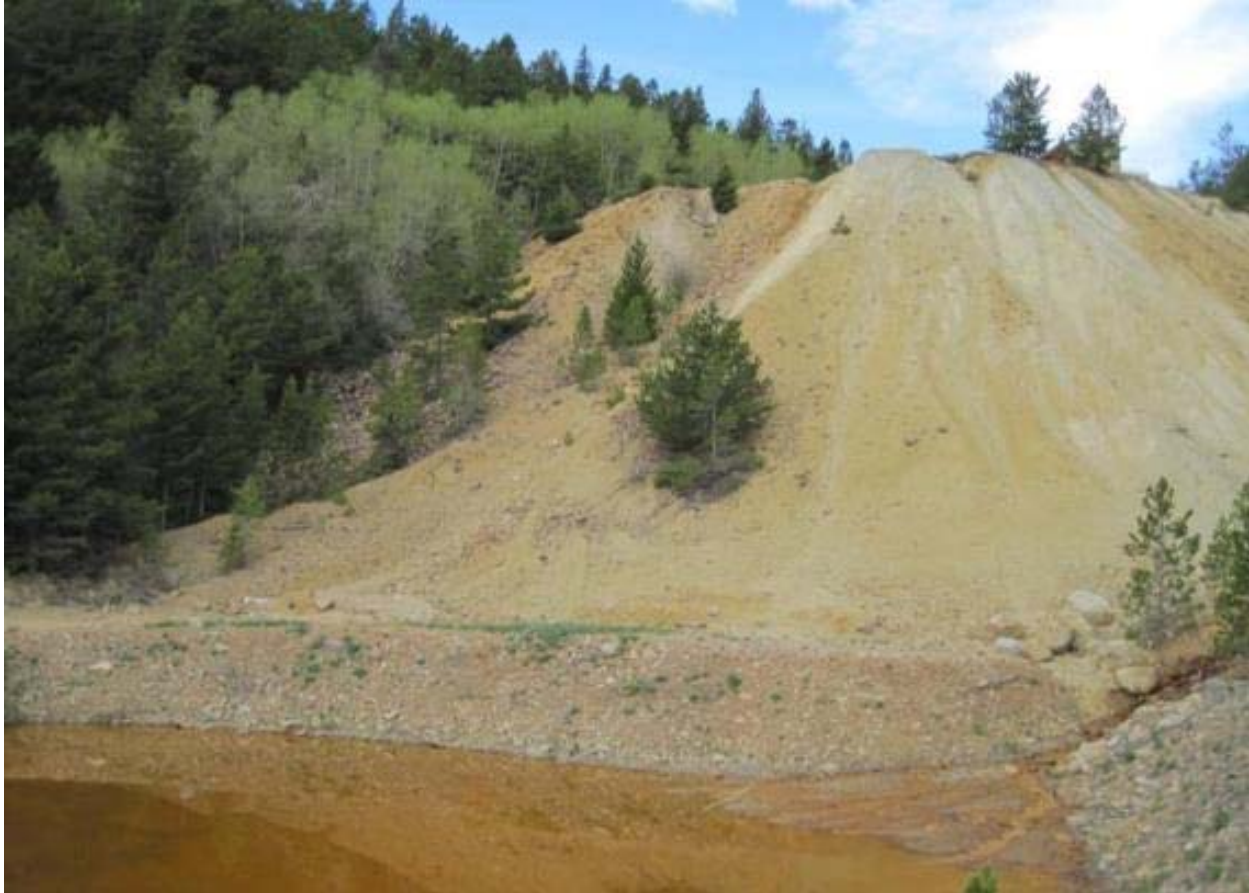
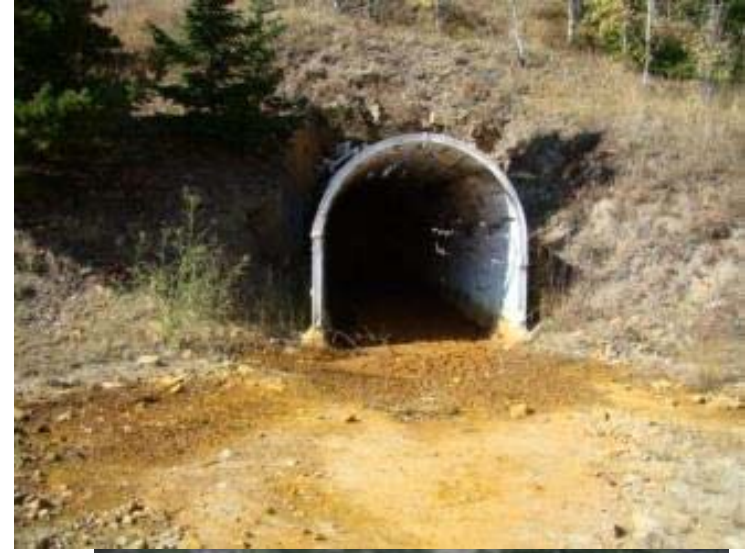
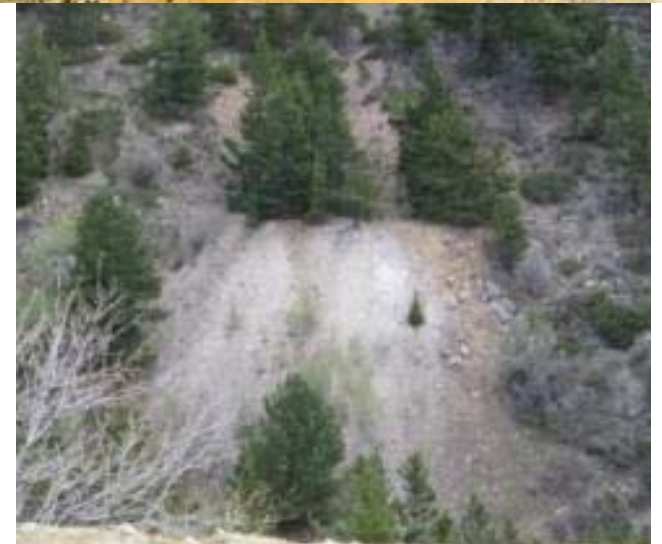
Site Conditions - Big Five Mine Dump

Erosion (Head-cutting), Stormwater & Adit Discharge (Infiltration), Direct Exposure

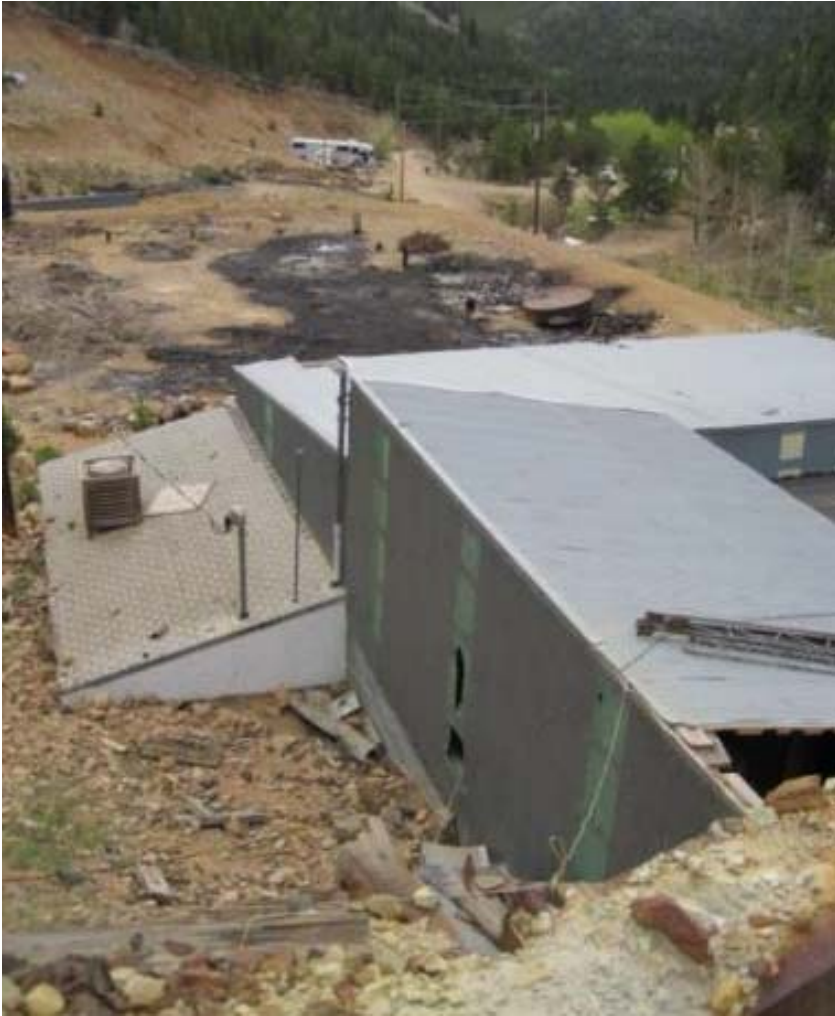
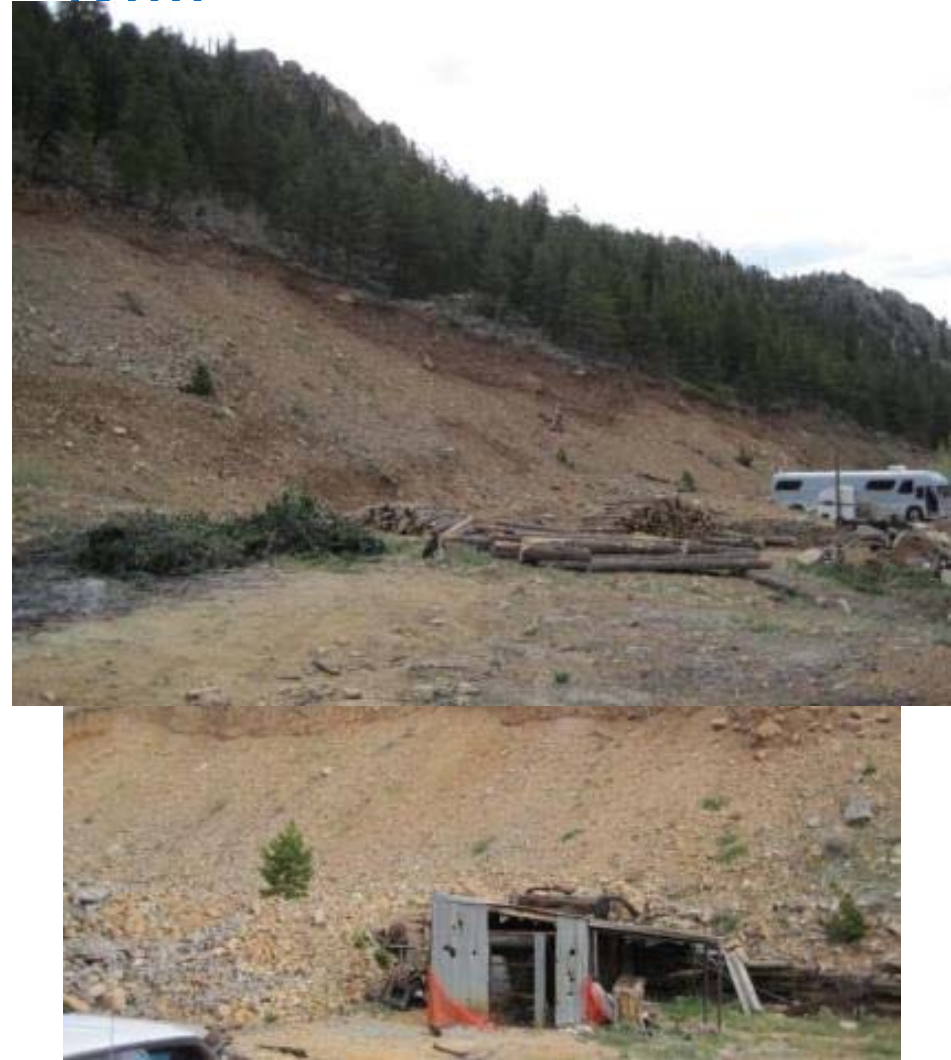
Site Conditions - Black Jack Adit & Captain Jack Mill

Former Mill & Tailings Ponds & Adit, Direct Exposure, Boulder County Borrow Area

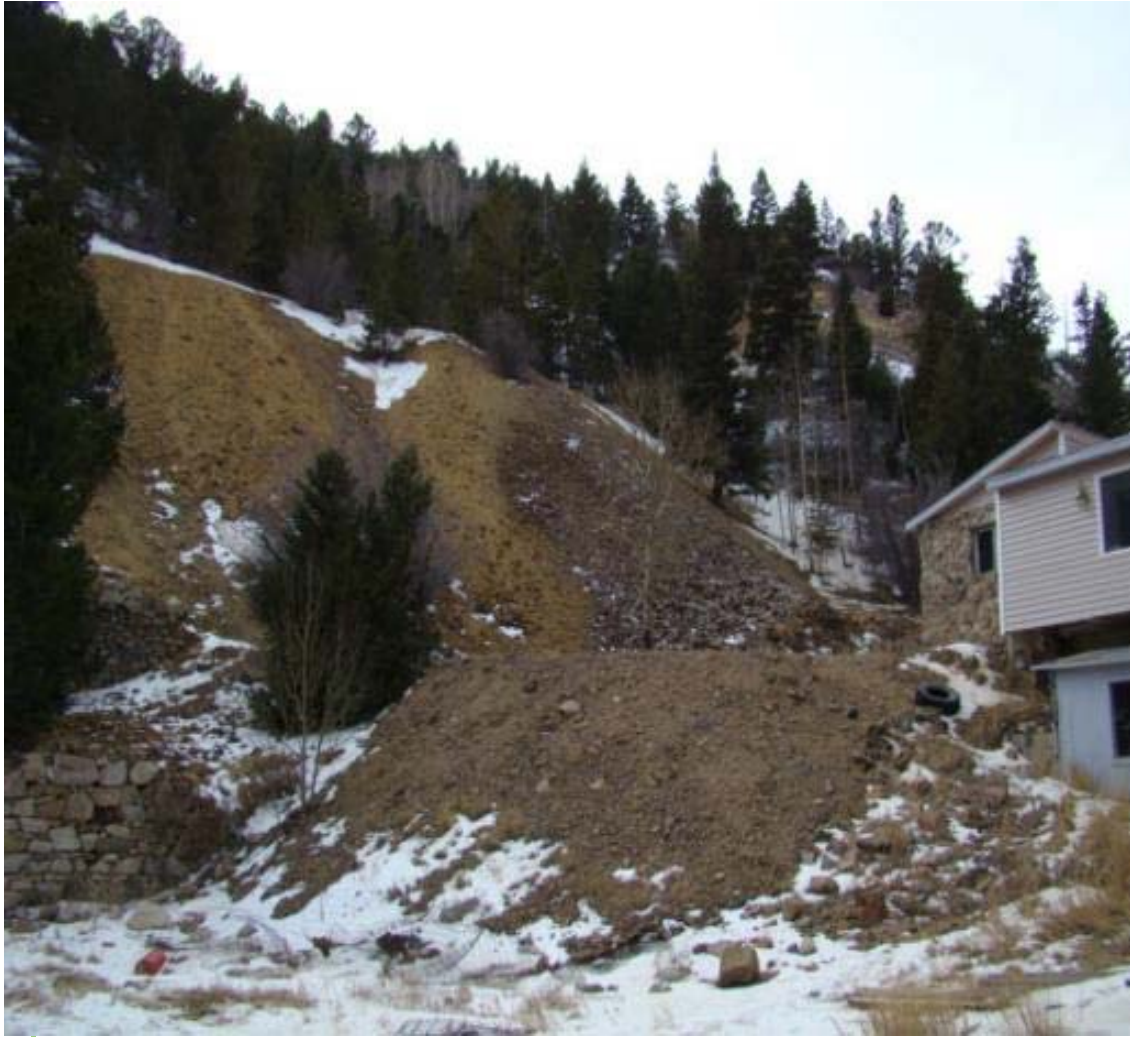
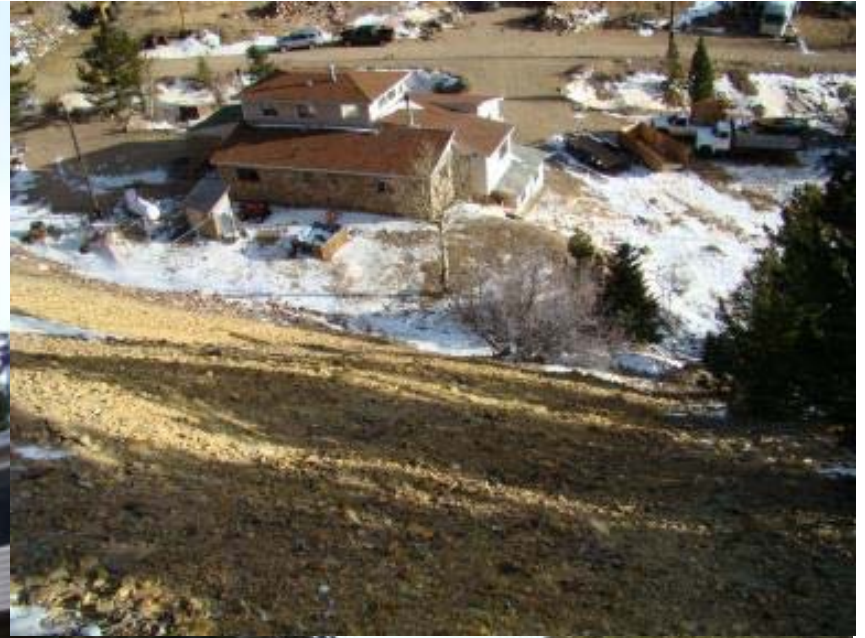
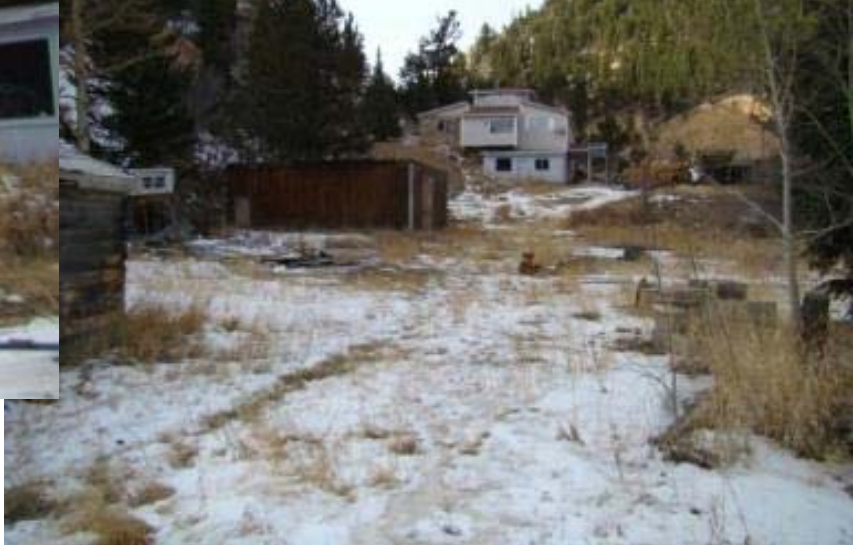
Site Conditions - Residential Property & Philadelphia Mine

Erosion, Direct Exposure

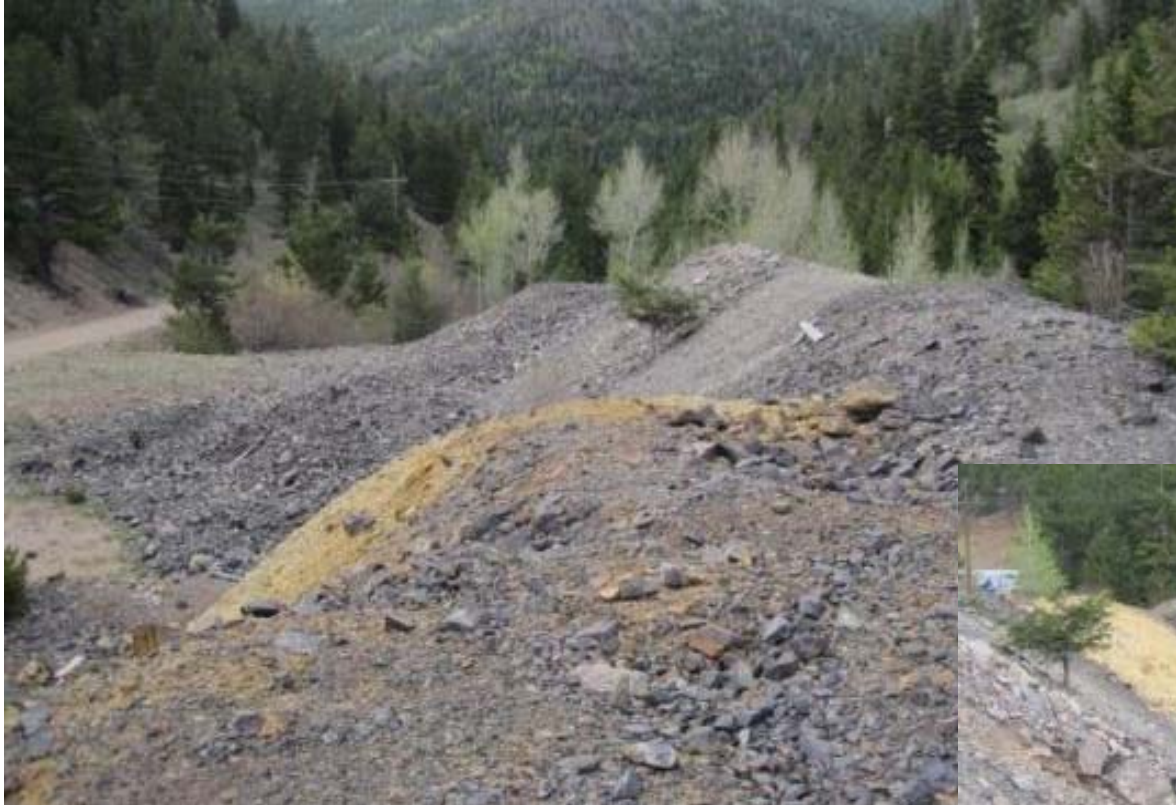
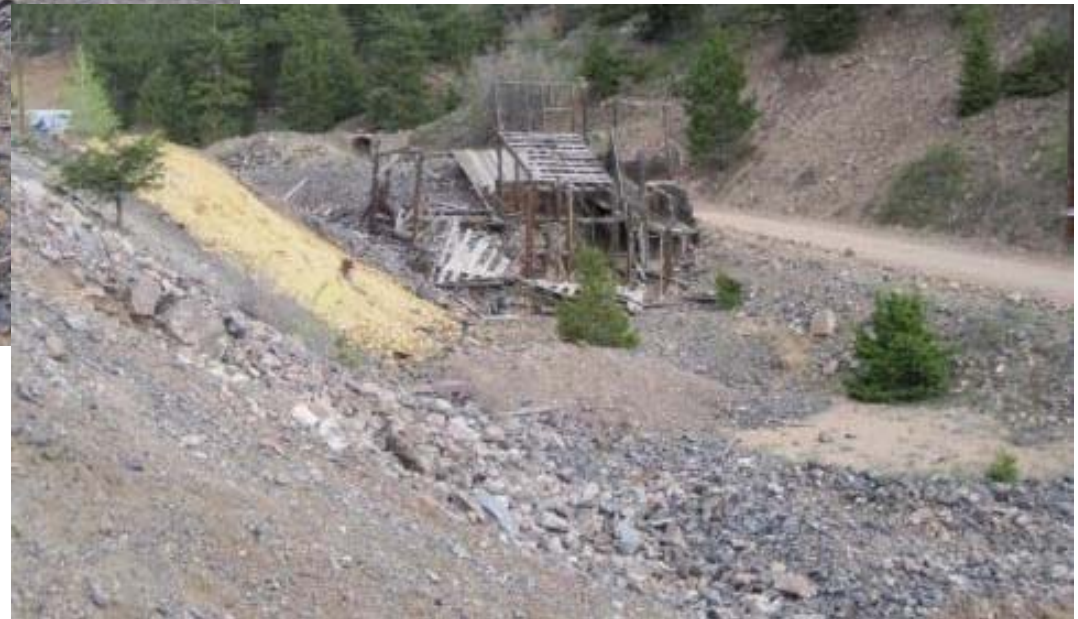
Site Conditions – White Raven Mine

Erosion, Direct Exposure

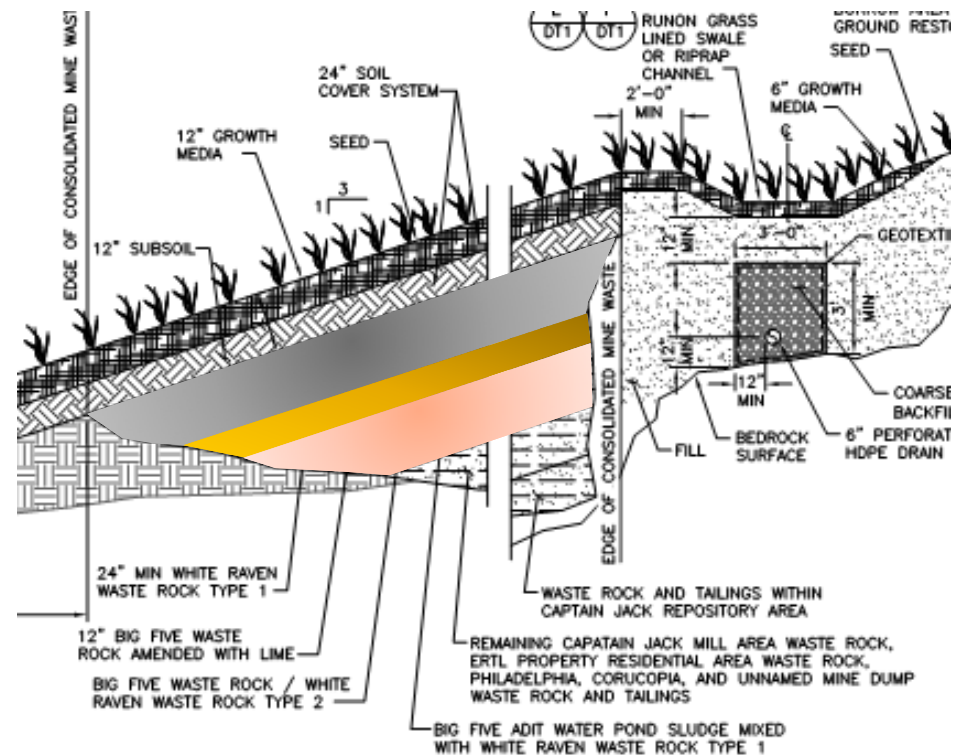
- Steep slope reclamation
 - Mine dump removal
 - Parent ground amendment and seeding
 - Erosion controls and habitat
- Acid-generating waste stabilization
 - Lime amendment
 - Repository layering
 - Galena-containing coarse waste rock placed over lime-amended wastes
 - High-neutralizing capacity (NP)
 - Coarse rock provides capillary break

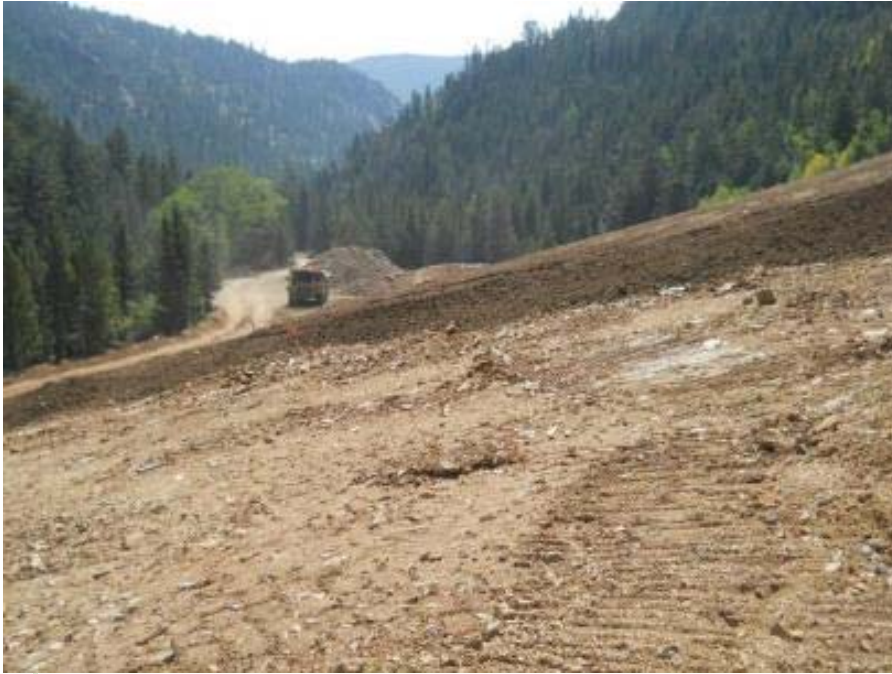
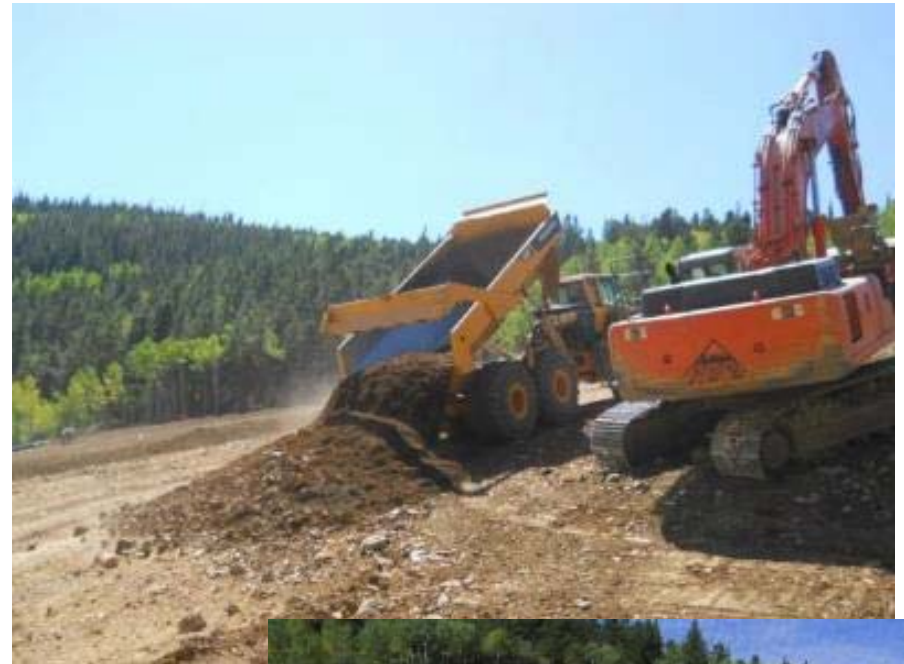
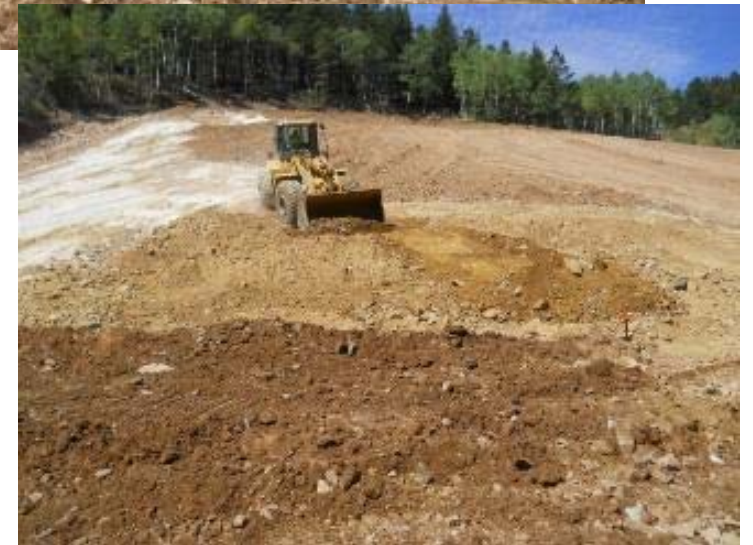
Remedial Action – Big Five Mine Dump

- 18,500 CY excavation and consolidation at Captain Jack Repository
- 12,600 CY regrade in place
- 2-ft soil cover
 - 12" subsoil and 12" growth media

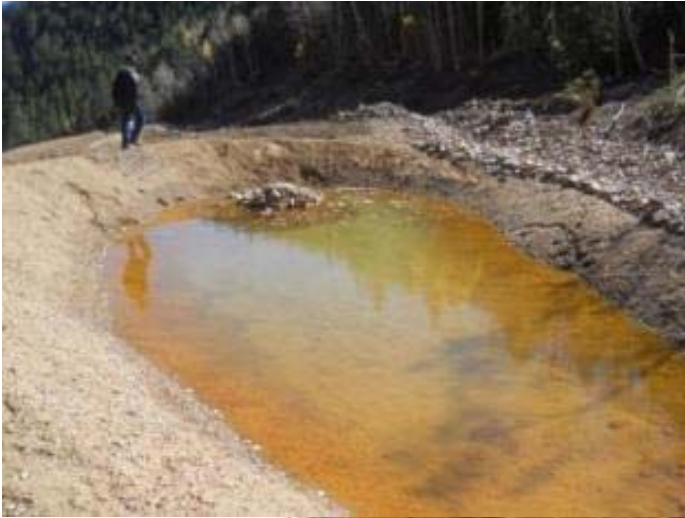
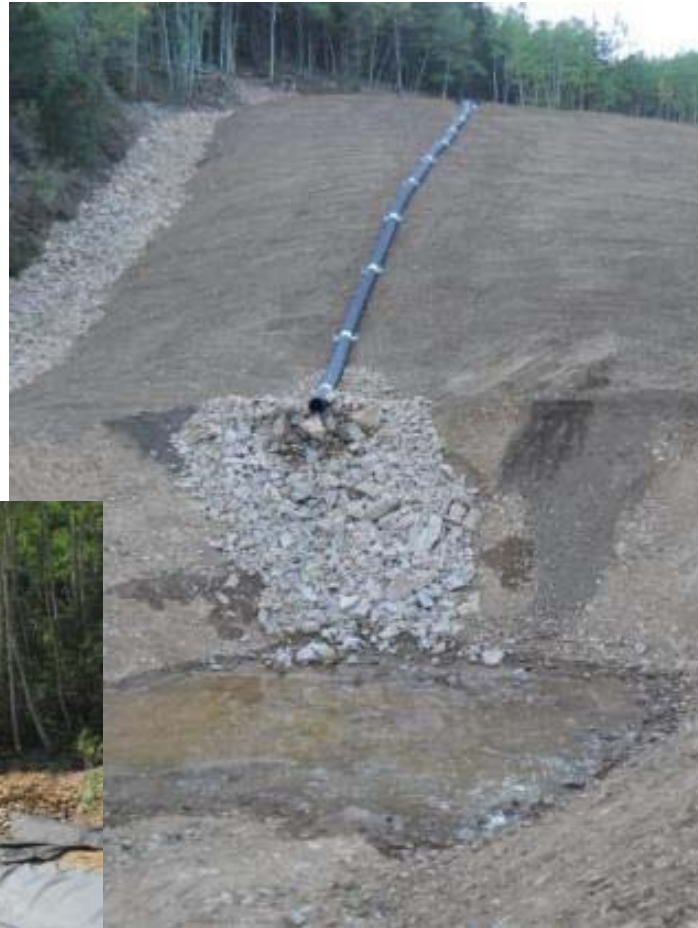
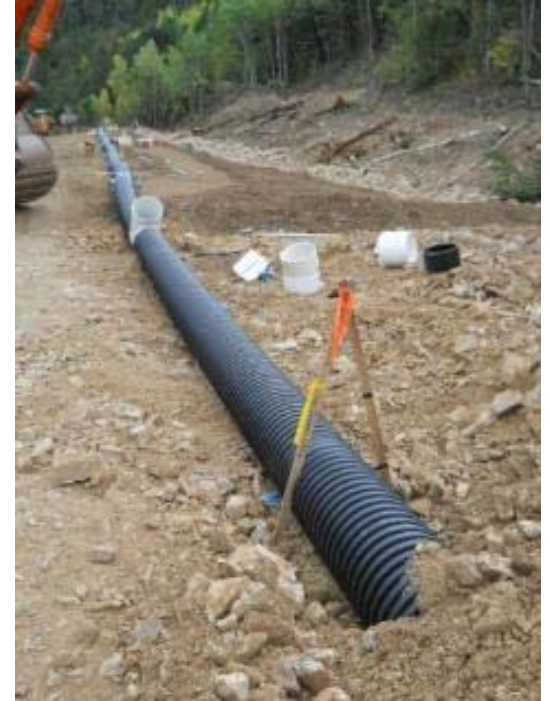
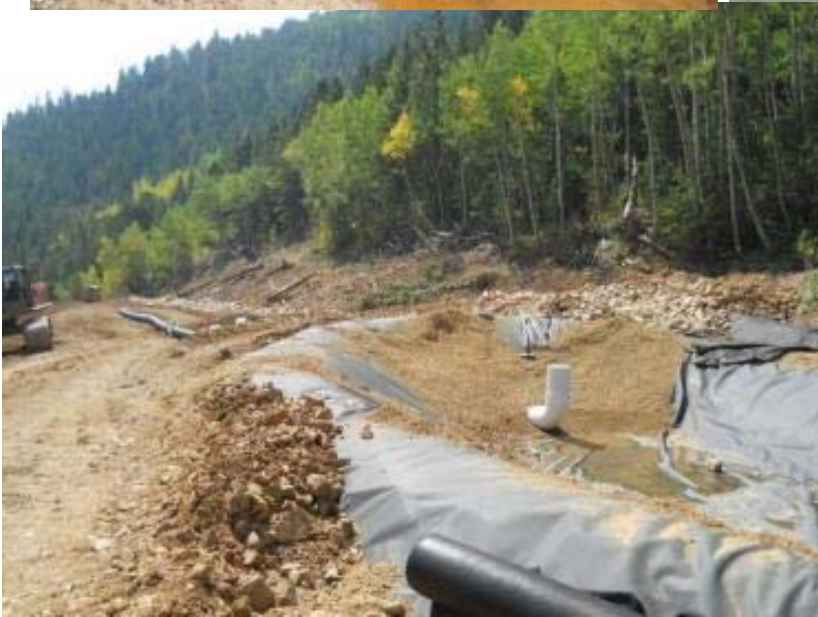
Remedial Action – Big Five Mine Dump

- Adit drainage sedimentation ponds and diversion piping

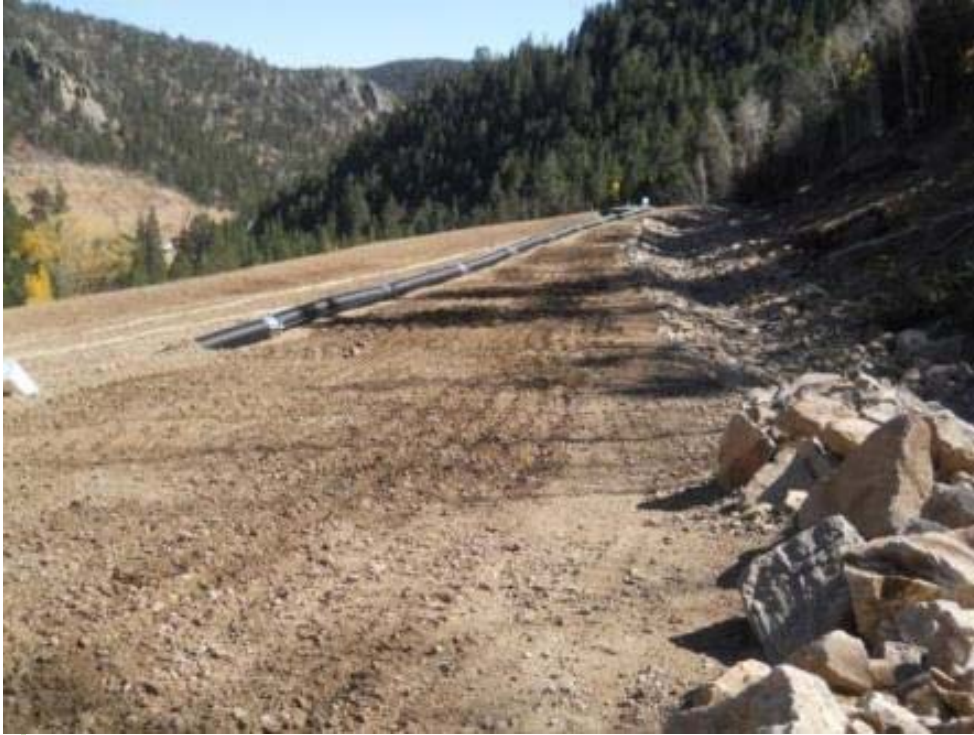
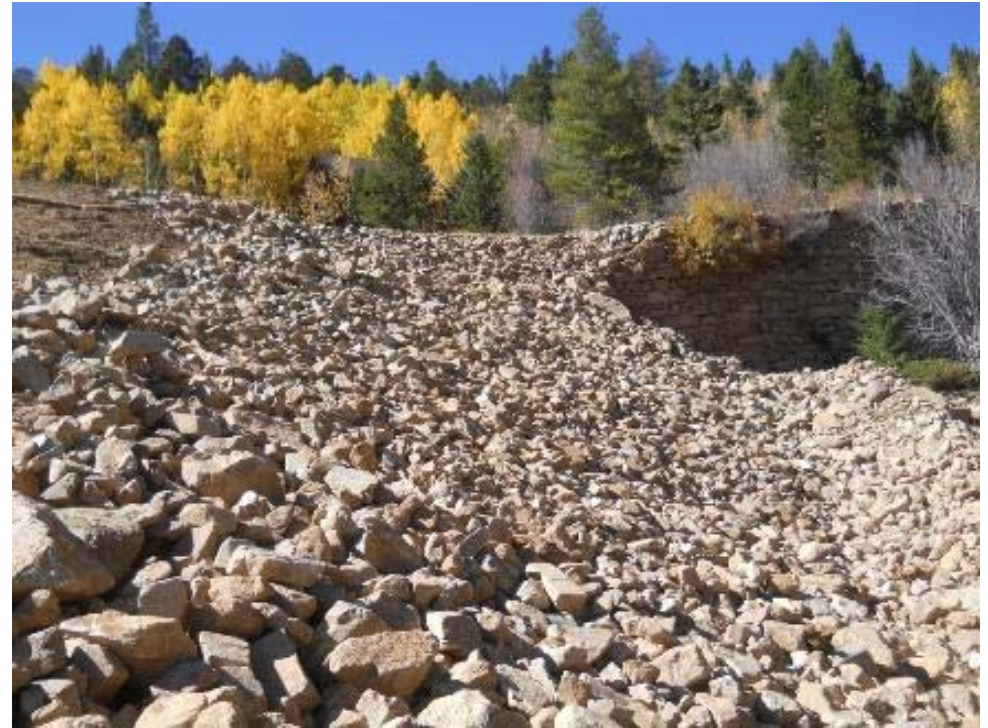
Remedial Action – Big Five Mine Dump

- Runon controls and cultural resources protection

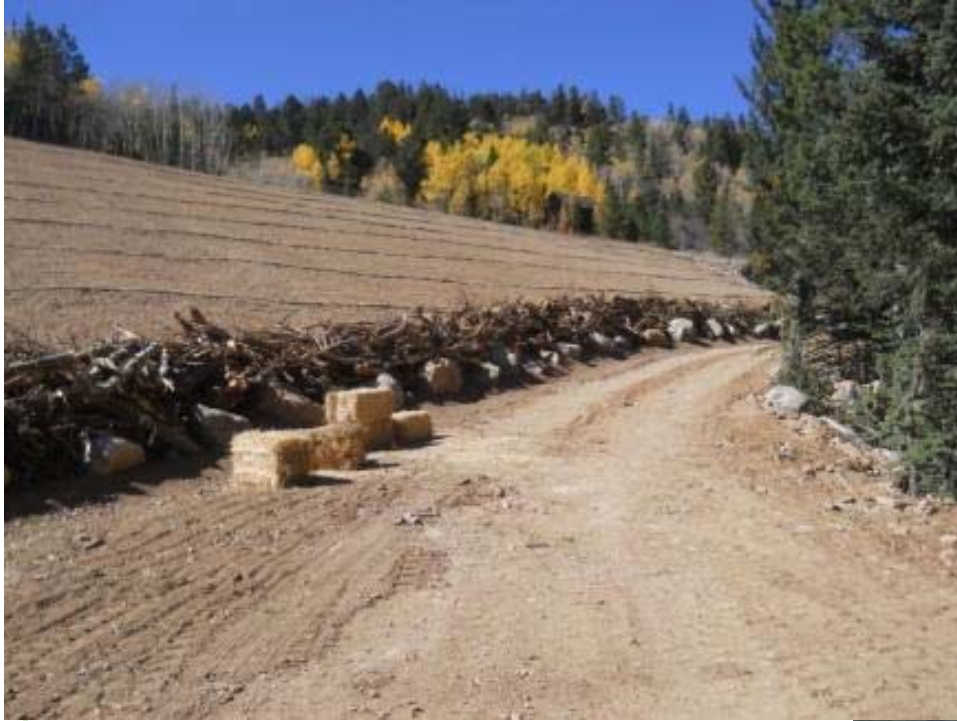
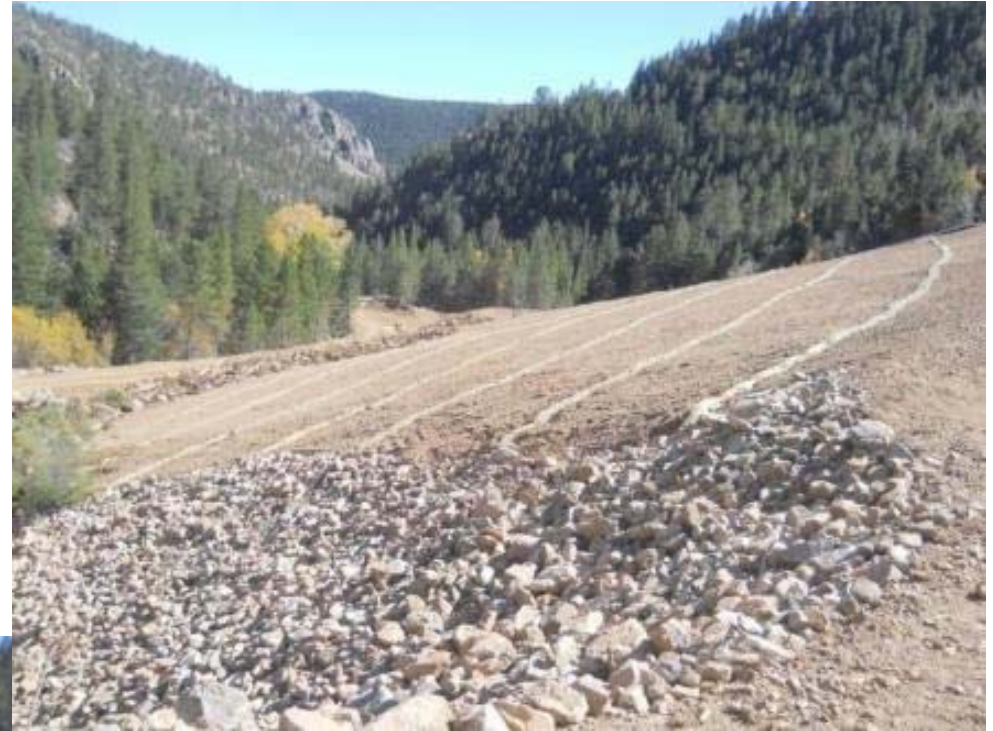
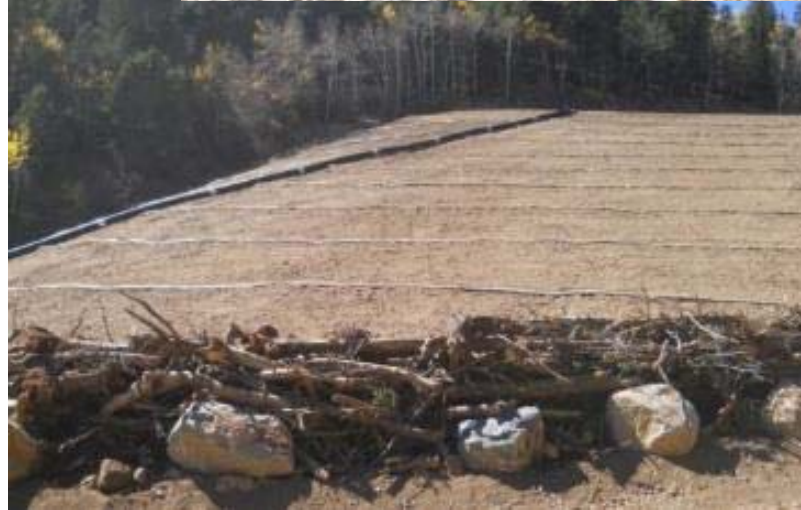
Remedial Action – Big Five Mine Dump

- Access and runoff controls

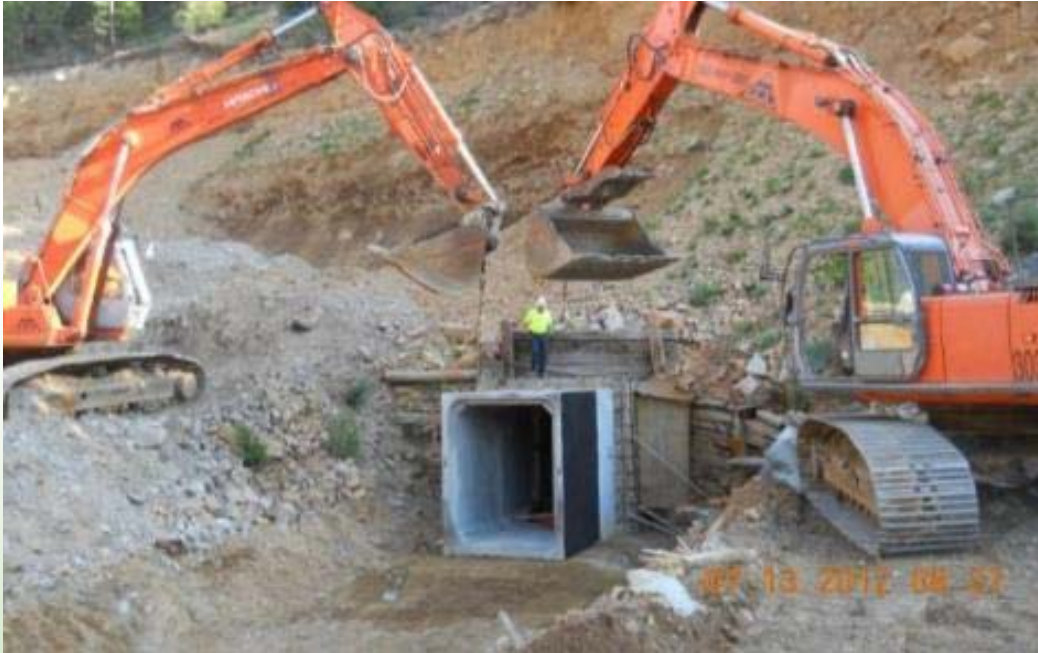
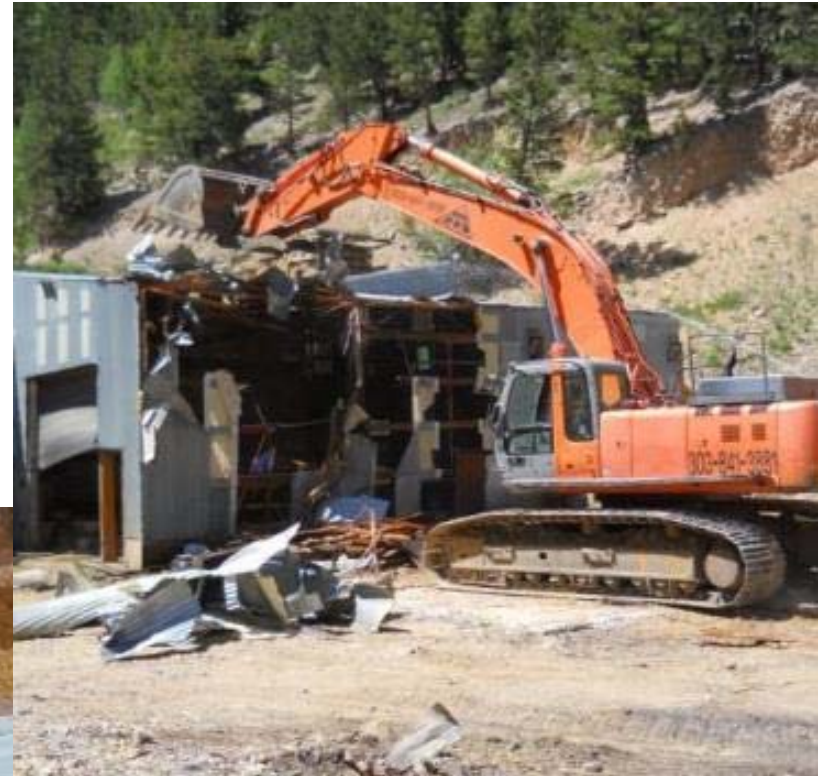
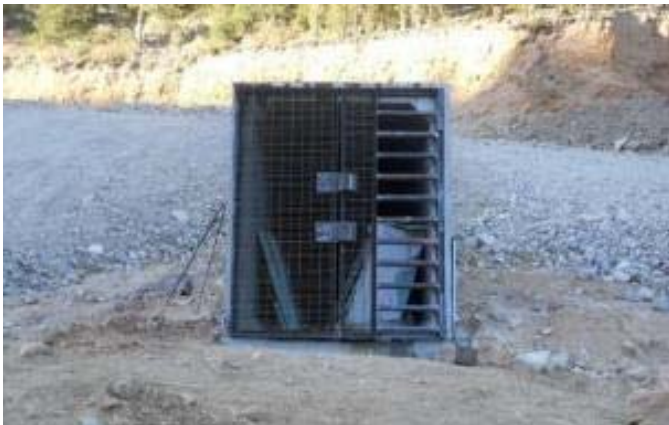
Remedial Action – Captain Jack Repository

- Adit portal extension and mill demolition

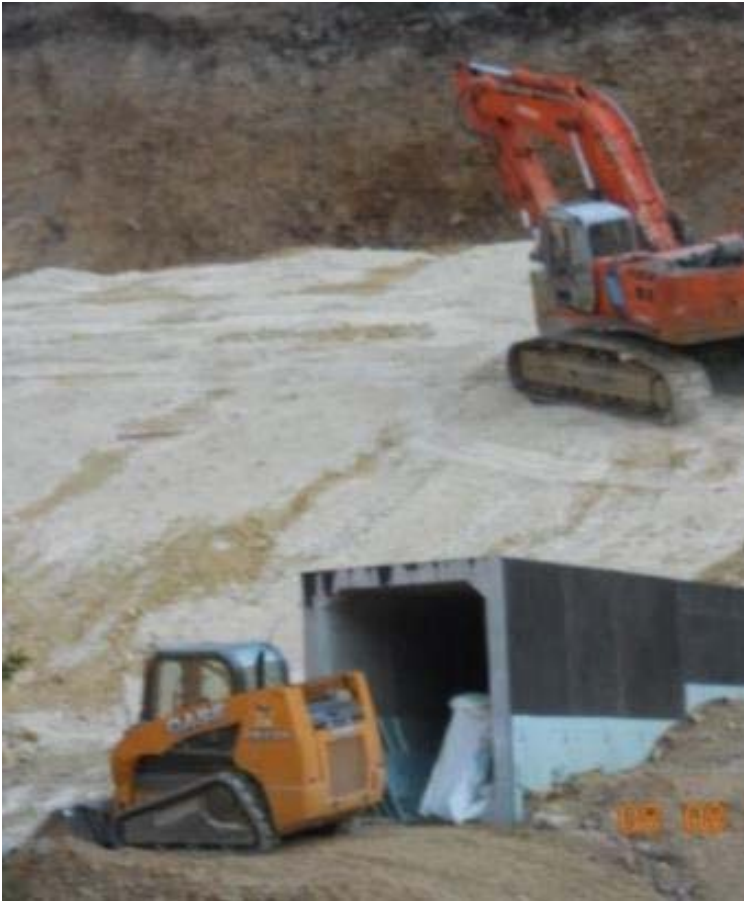
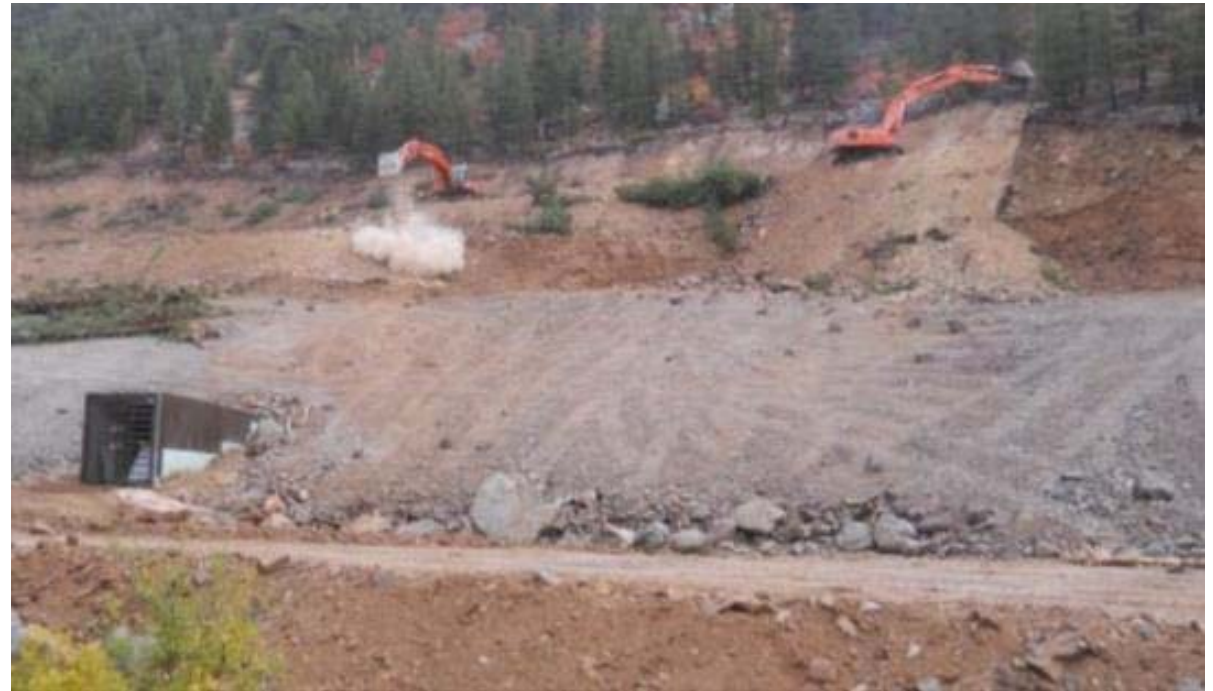
Remedial Action – Captain Jack Repository

- Lime amendment of top 1-foot of Big Five acid generating mine waste

- Minimum 2-foot lift of non-acid generating White Raven mine waste over lime-amended Big Five waste

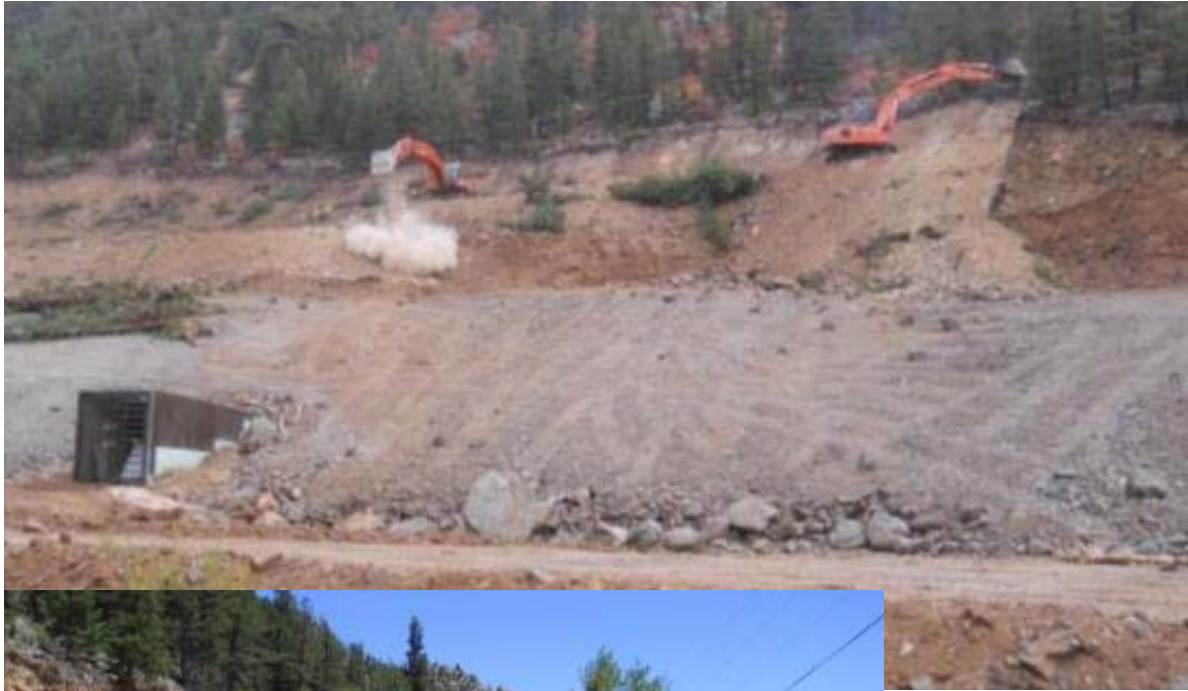
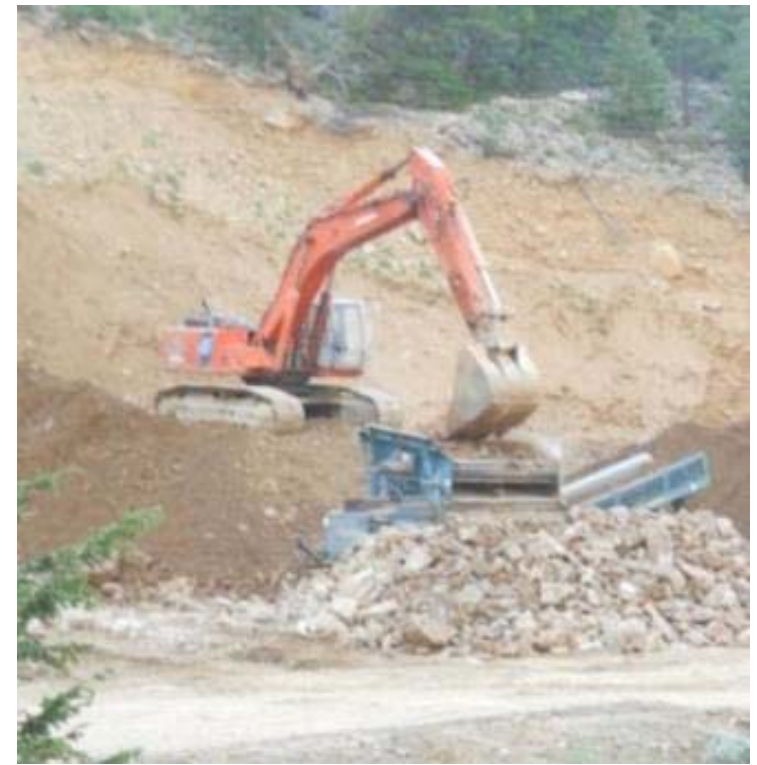
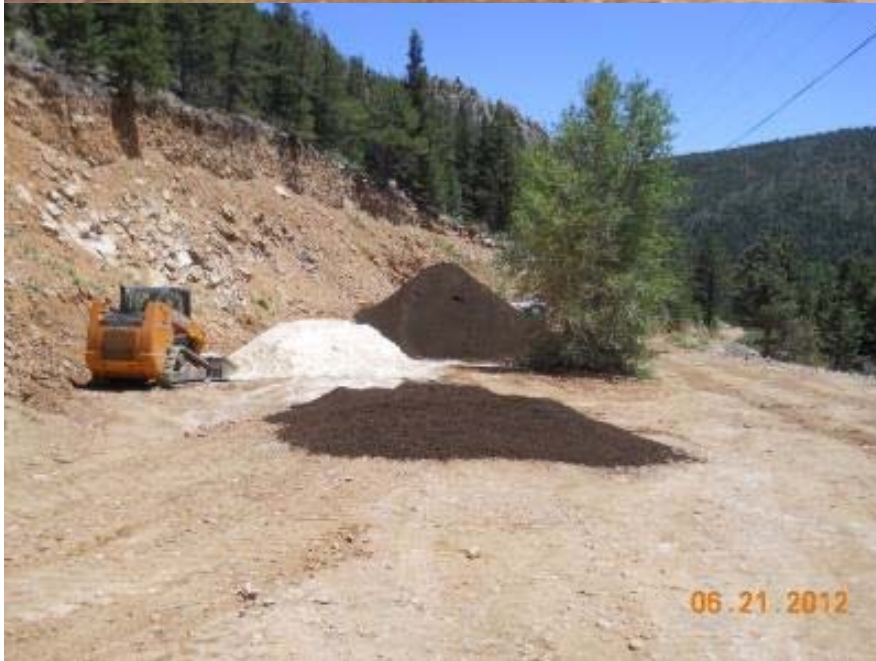
Remedial Action – Captain Jack Repository

- Borrow material excavation and processing
 - Fill, subsoil, growth media, riprap, gravel

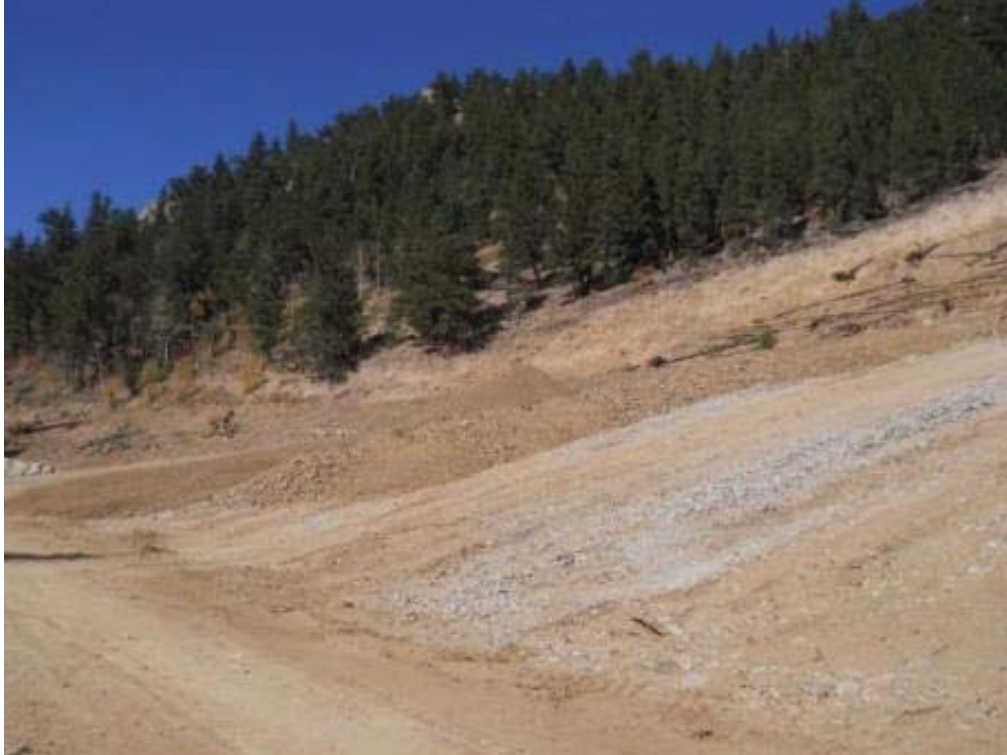
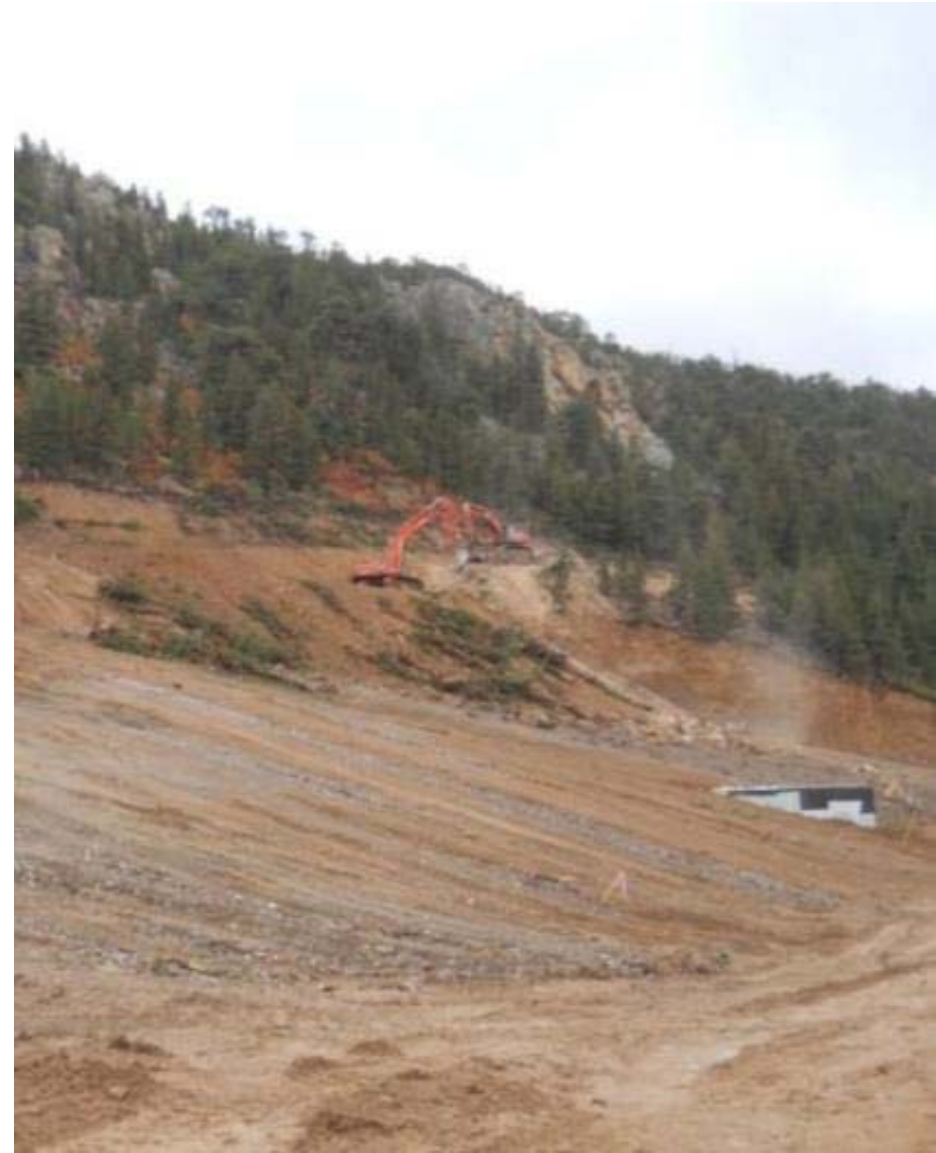
Remedial Action – Captain Jack Repository

- 51,000 CY consolidated mine waste
- 2-ft soil cover
 - 12" subsoil and 12" growth media
