Surface Reclamation of the Captain Jack Mill Superfund Site

May 8, 2019

Introduction – Captain Jack Mill Superfund Site

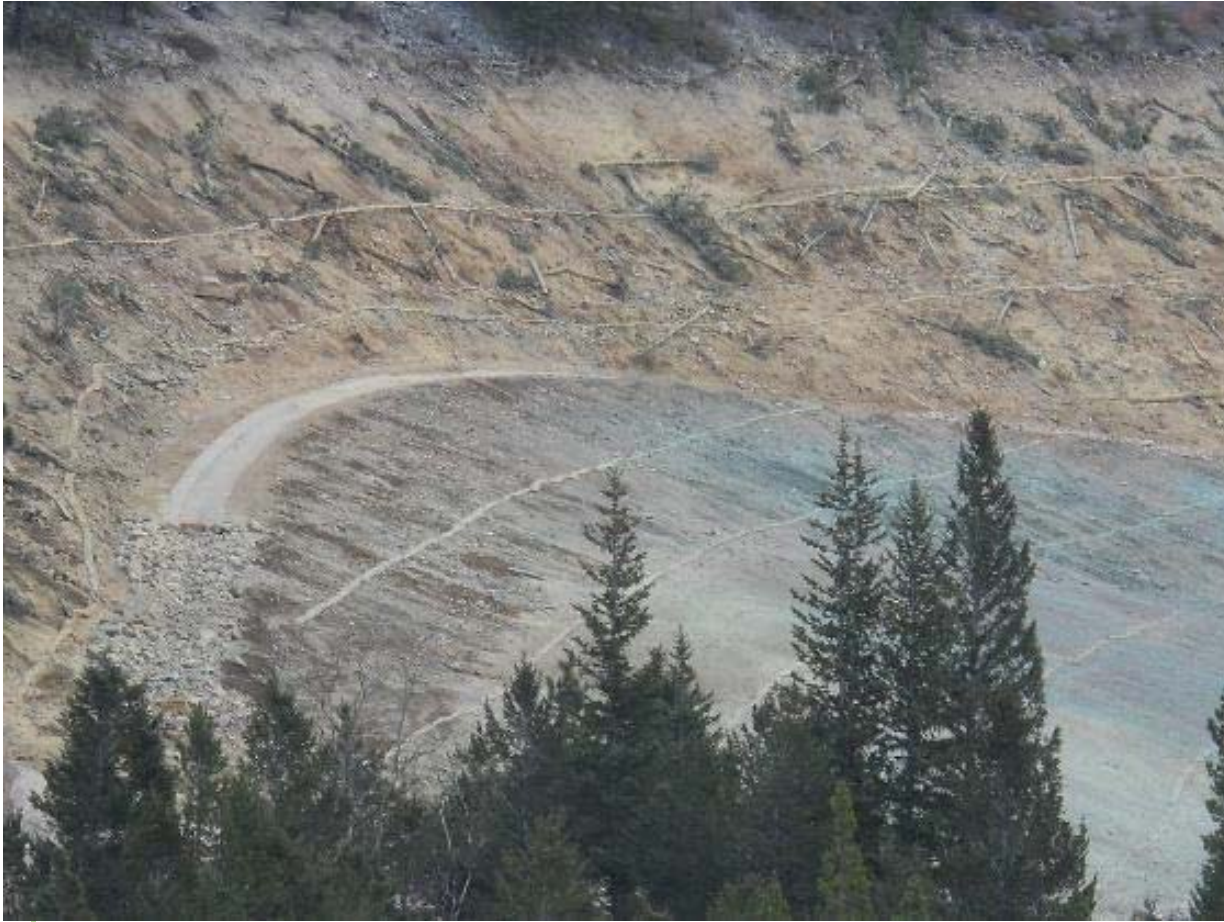
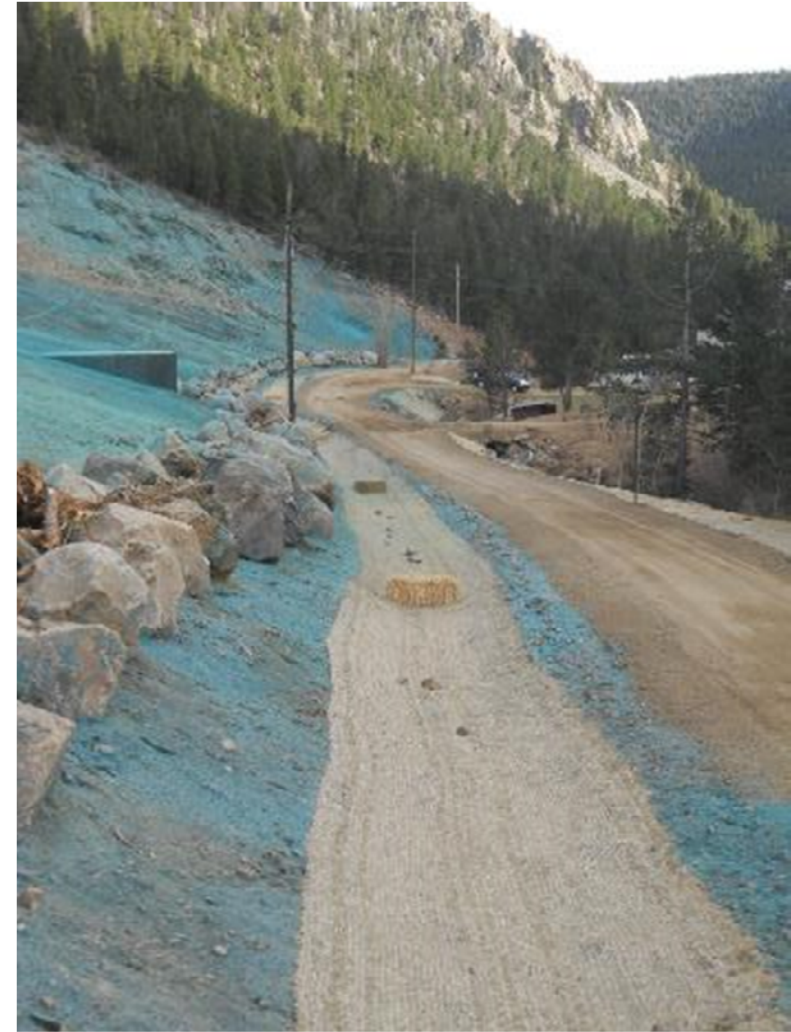
Remedial Action – Captain Jack Repository

- Run-on controls

- Riprap and grass-lined channels
- Subsurface interceptor drain

- Runoff controls

- Grass-lined channel at toe

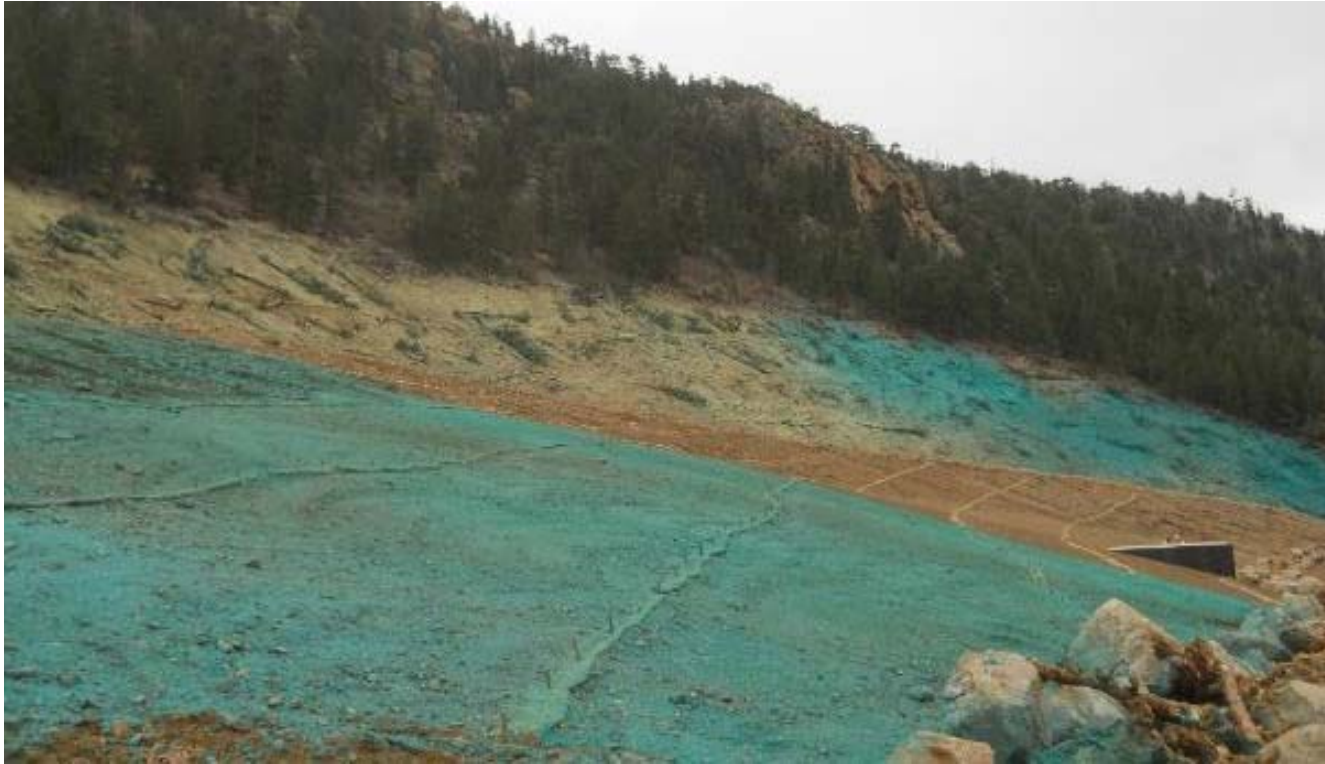
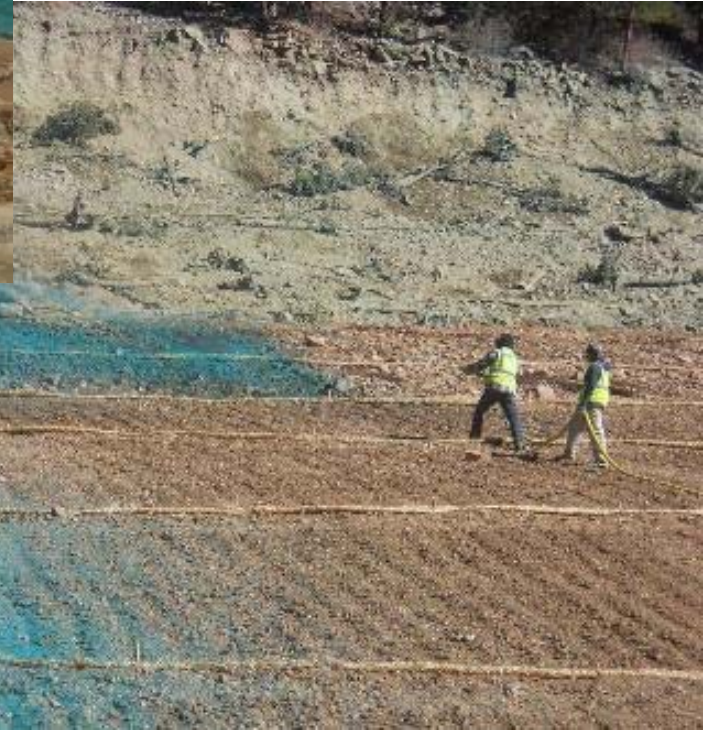
Remedial Action – Captain Jack Repository

- Erosion controls and seeding

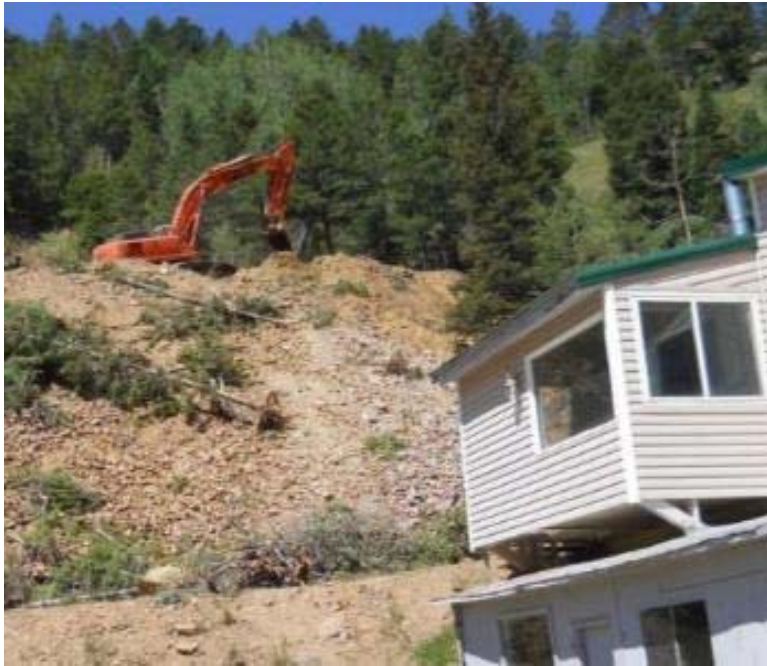
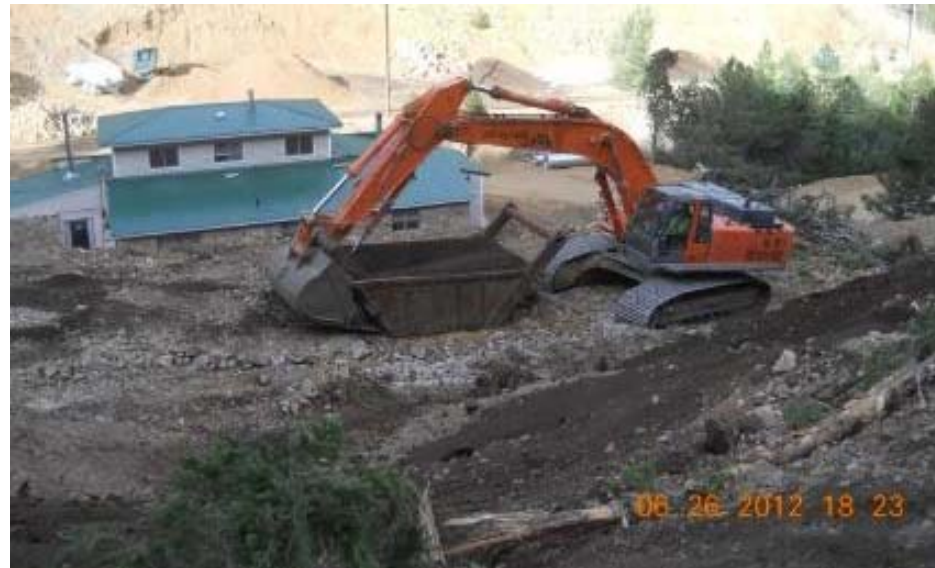
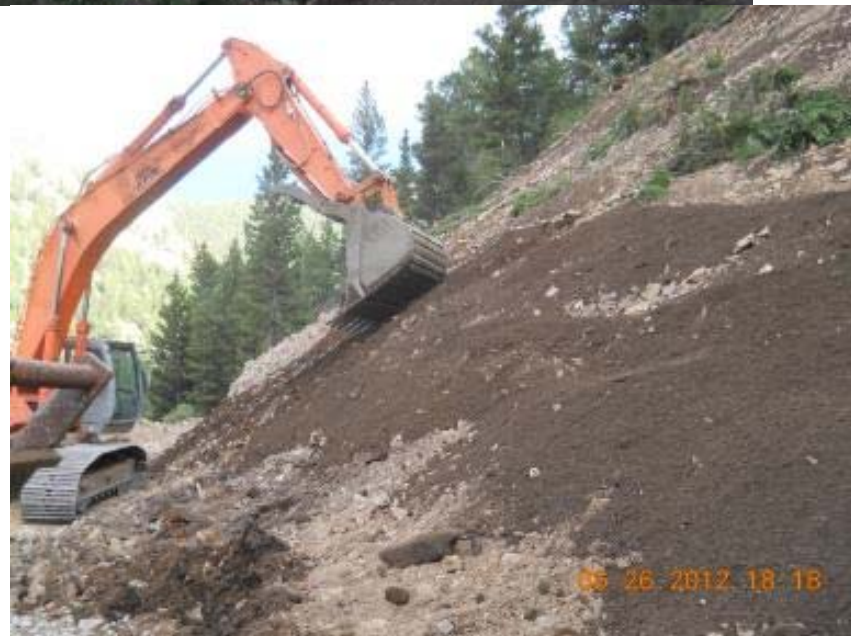
Remedial Action –Philadelphia Mine Dump

- Mine waste excavation, parent ground amendment, slash placement

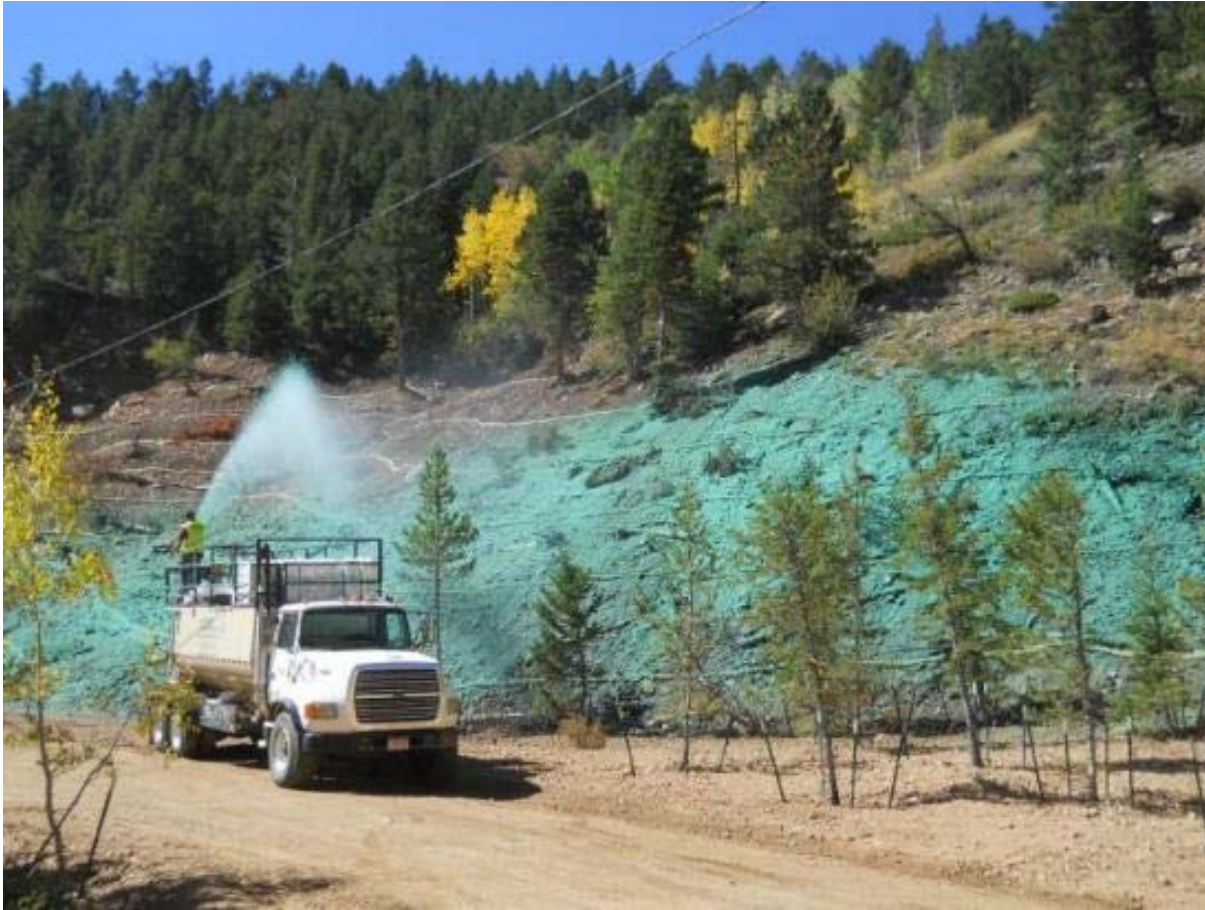
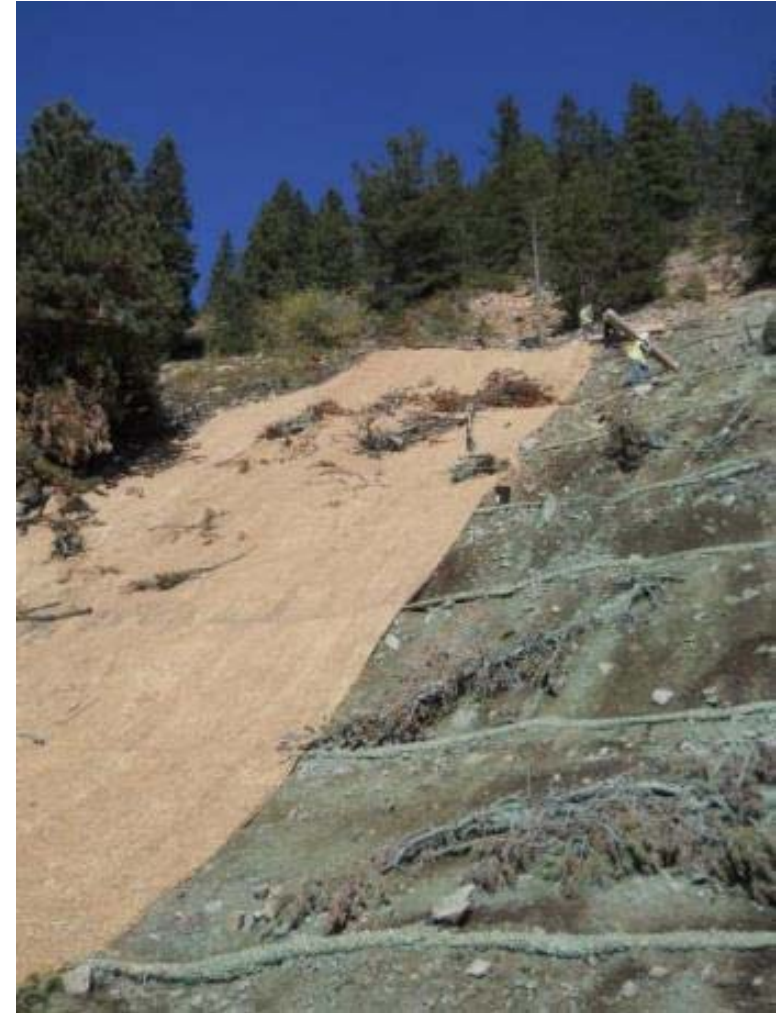
Remedial Action –Philadelphia Mine Dump

- Erosion control and seeding

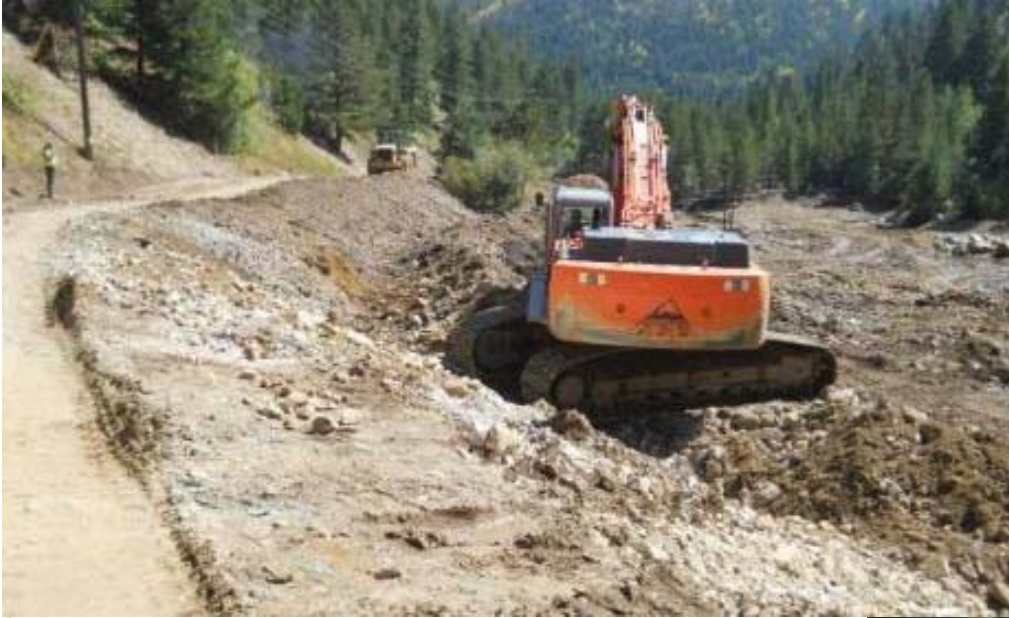
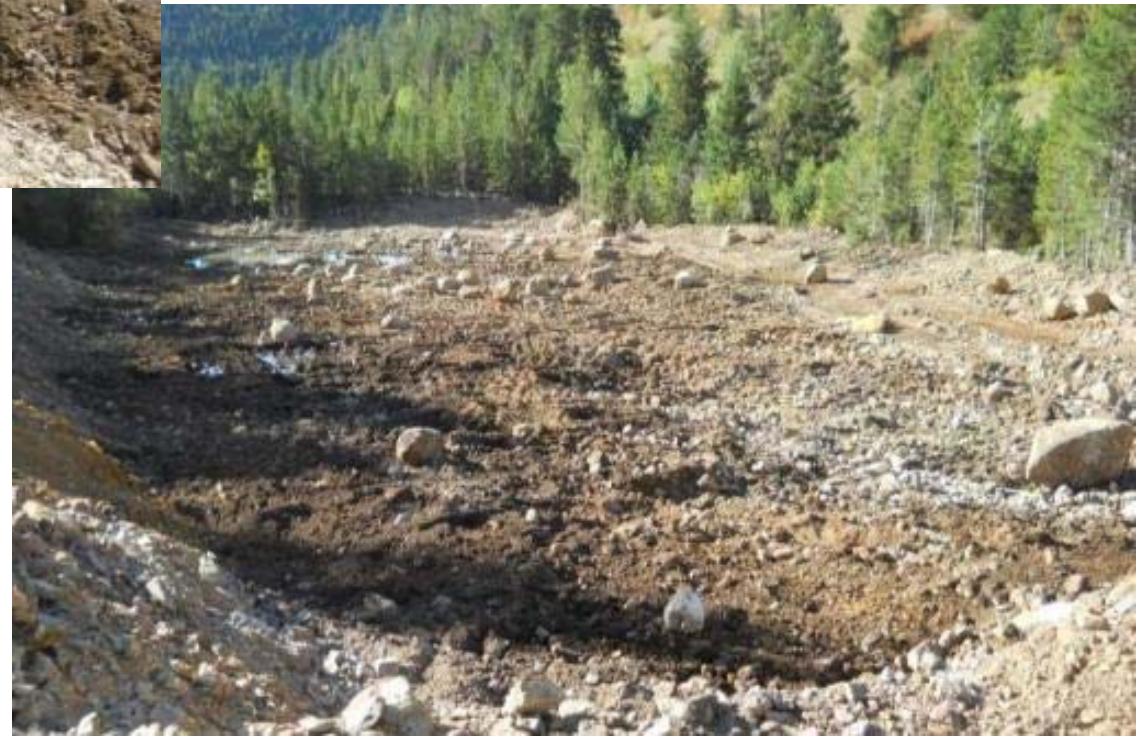
Remedial Action – White Raven Mine

- 18,300 CY excavation and consolidation at Captain Jack Repository

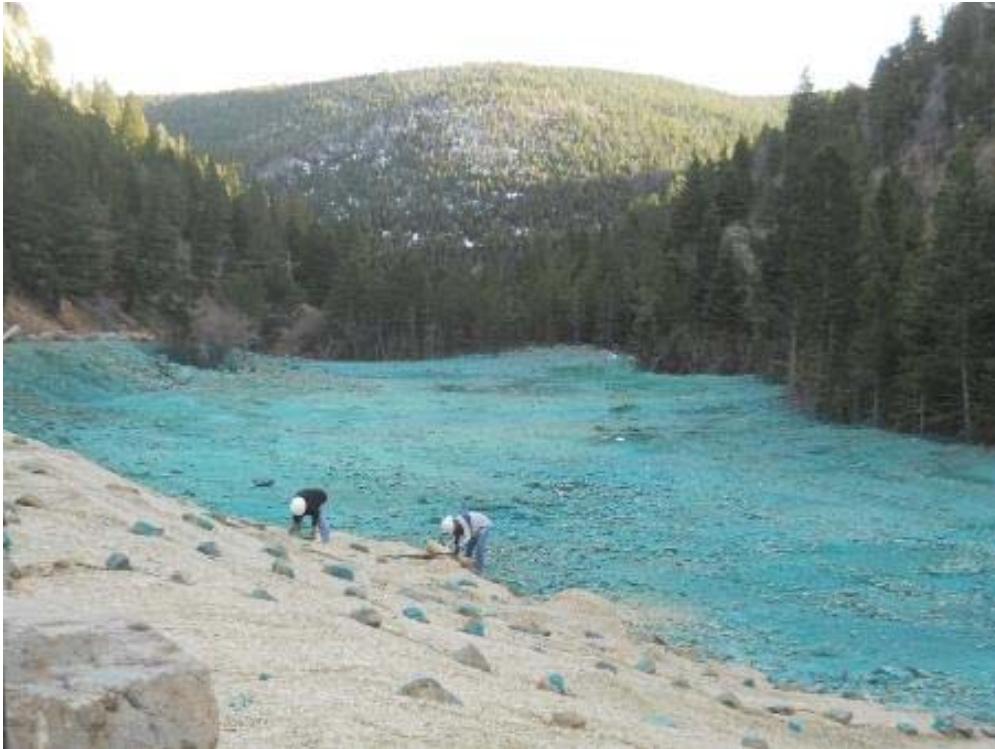
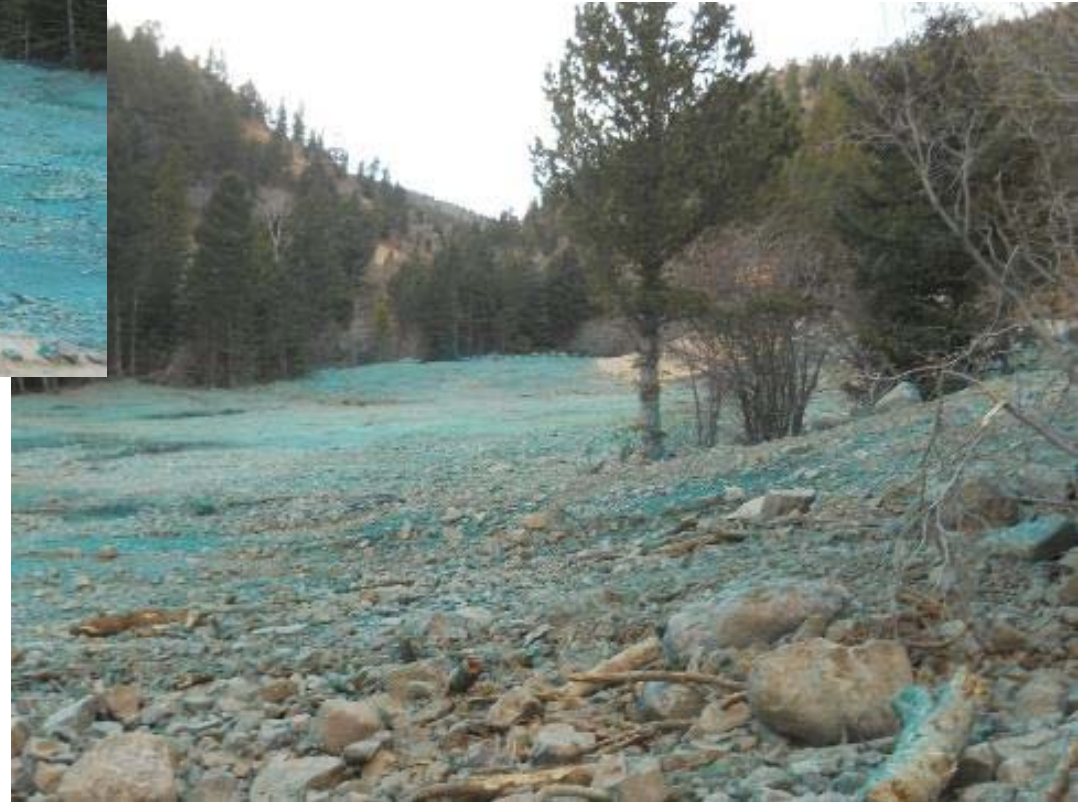
Remedial Action – White Raven Mine

- Restoration – Fill and rock placement, erosion controls, seeding

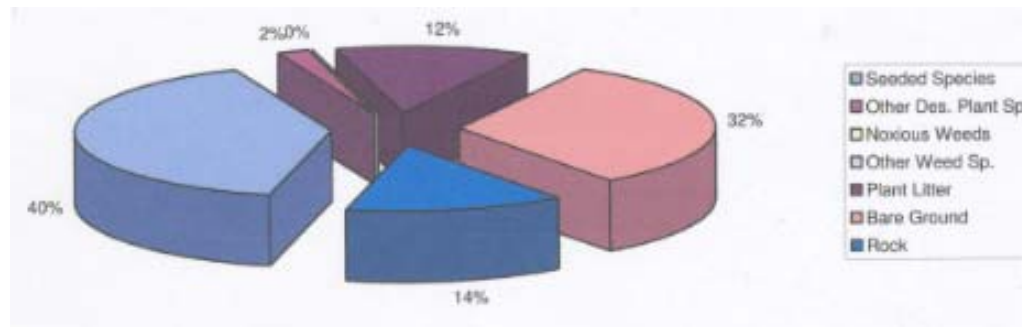
- Peak growth inspection Year 1, August 2013
 - Overall average perennial non-weedy plant canopy was 42%
 - Exceeds 30% warrantee criteria
 - Dominated by Elymus grass species
 - Many other minor species including fescues, Canada bluegrass, sage, brome, sweetvech, and yarrow
 - Average perennial non-weedy plant canopy breakdown:
 - Captain Jack Repository: 57%
 - Big Five Repository: 43%
 - Residential property: 23%

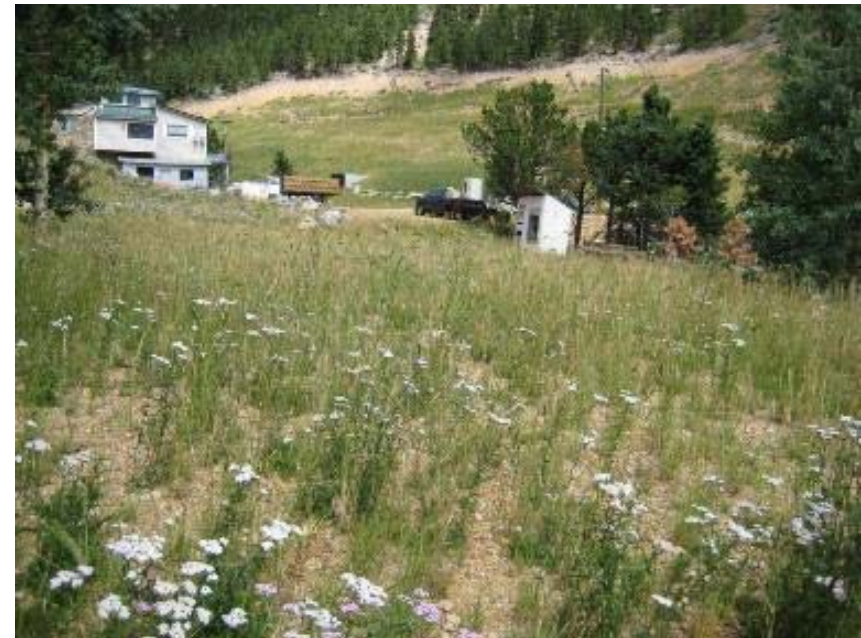
- Final 1-year warrantee inspection in October 2013
 - Further improvements to residential property seed success due to addition of topsoil, fertilizer, water, and re-seeding
- Peak growth inspection 2, August 2014
 - Used a frame and grid inspection approach only on residential property area
 - Other areas visually similar or more dense than previous year
 - Improved average perennial non-weedy plant canopy at residential property to 38%
- 2015 season - limited inspection
 - Met or exceeded previous years
