Blue Ledge Mine Superfund Site Presentation Overview

US Forest Service
Non-Time-Critical
Removal Action

Emphasis on AMD Source Control by Removing Waste Rock Piles

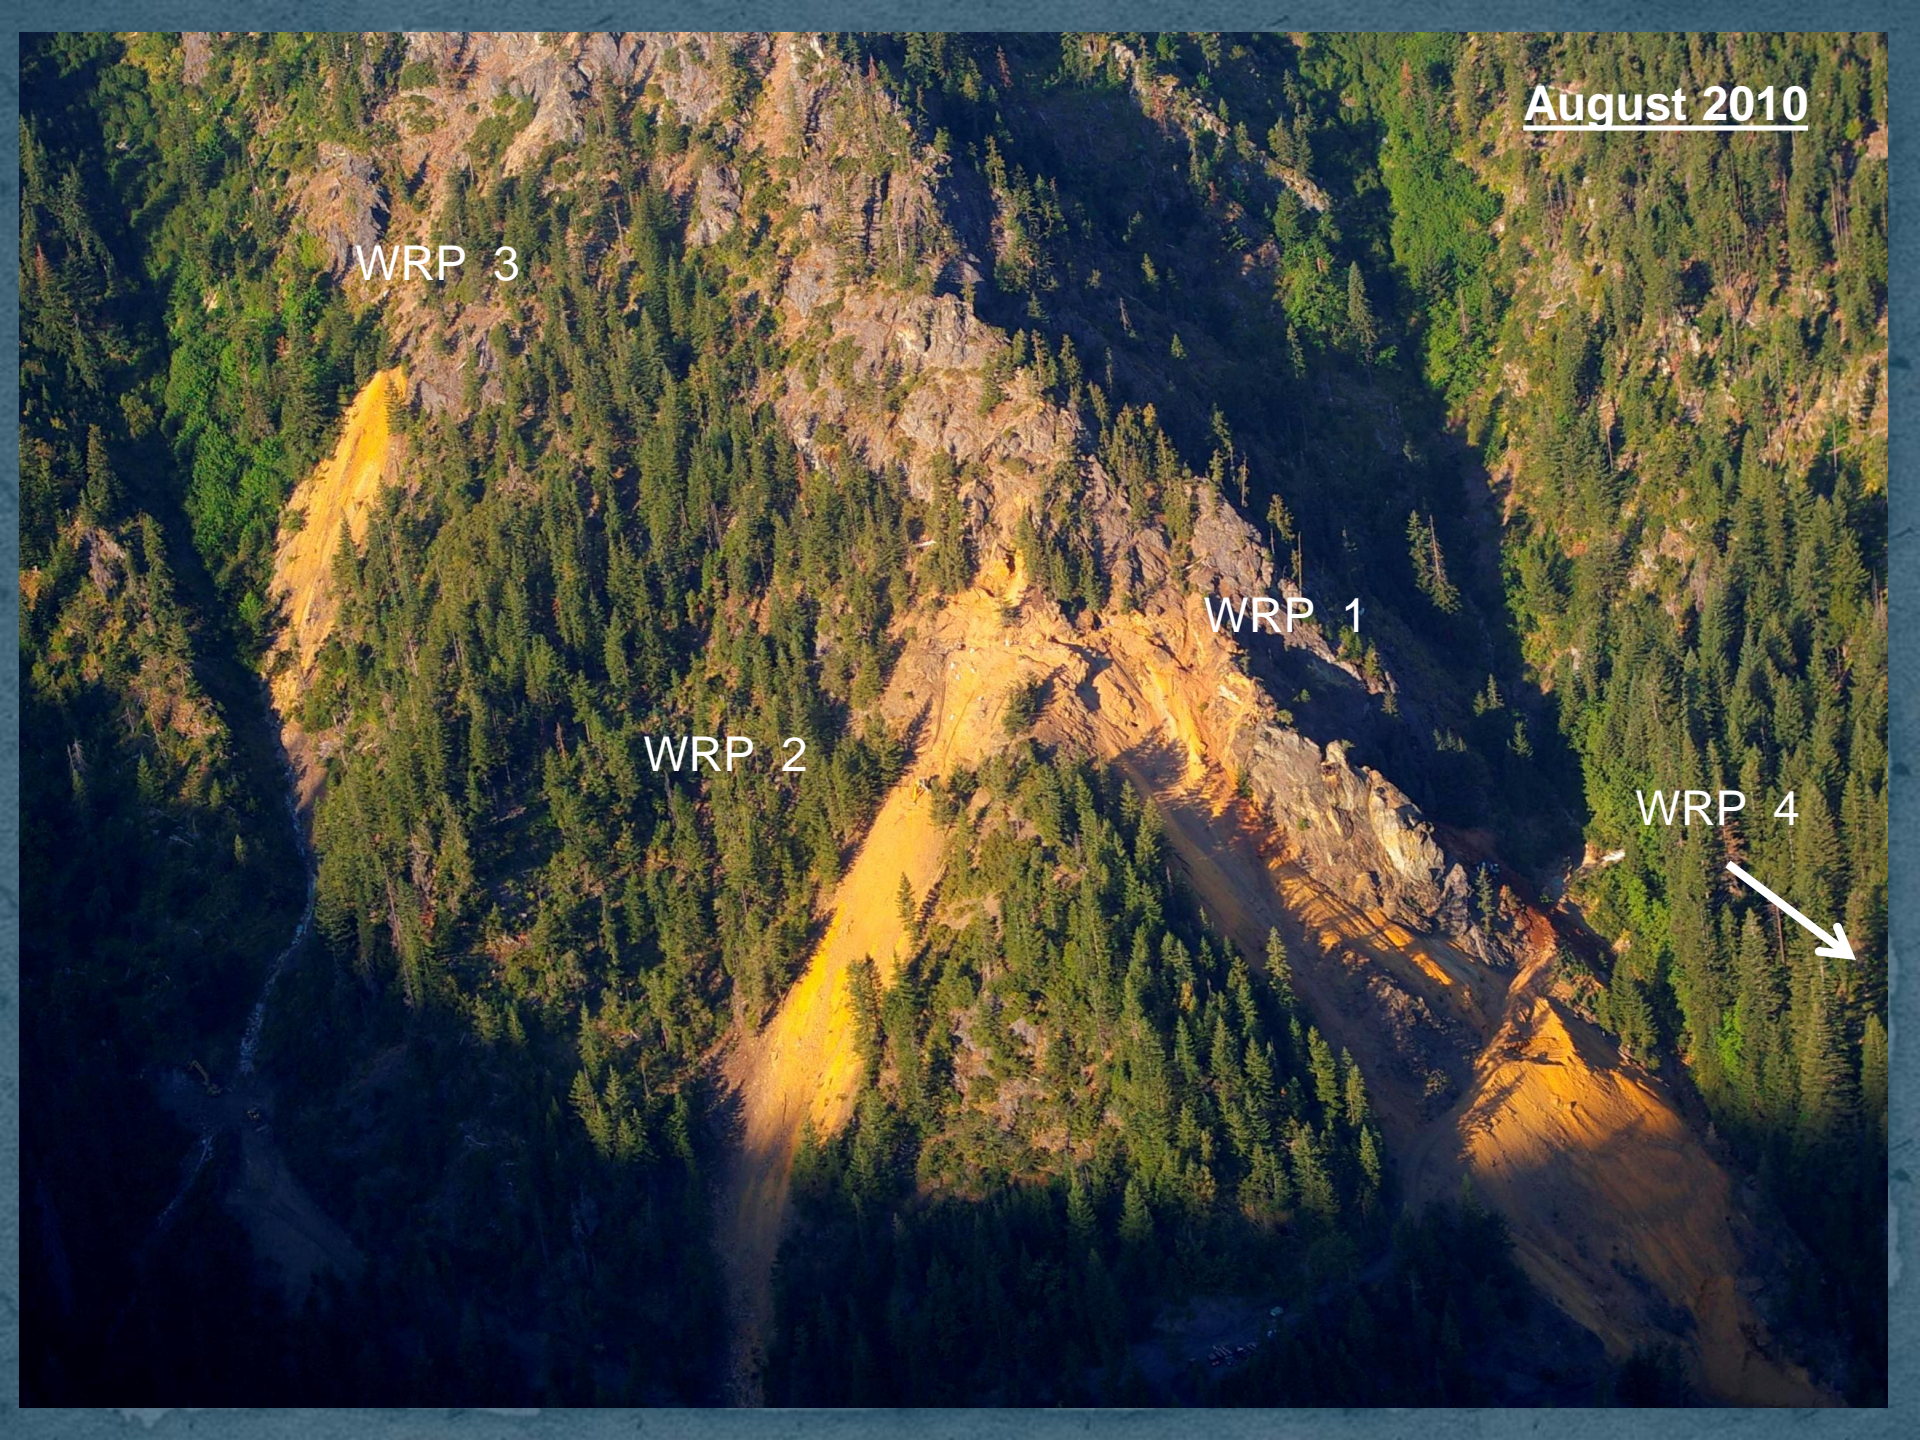
Waste Rock Areas
US Forest Service
Blue Ledge Mine
Rogue/Siskiyou National Forest

WRP 3

WRP 1

WRP 2

WRP 4

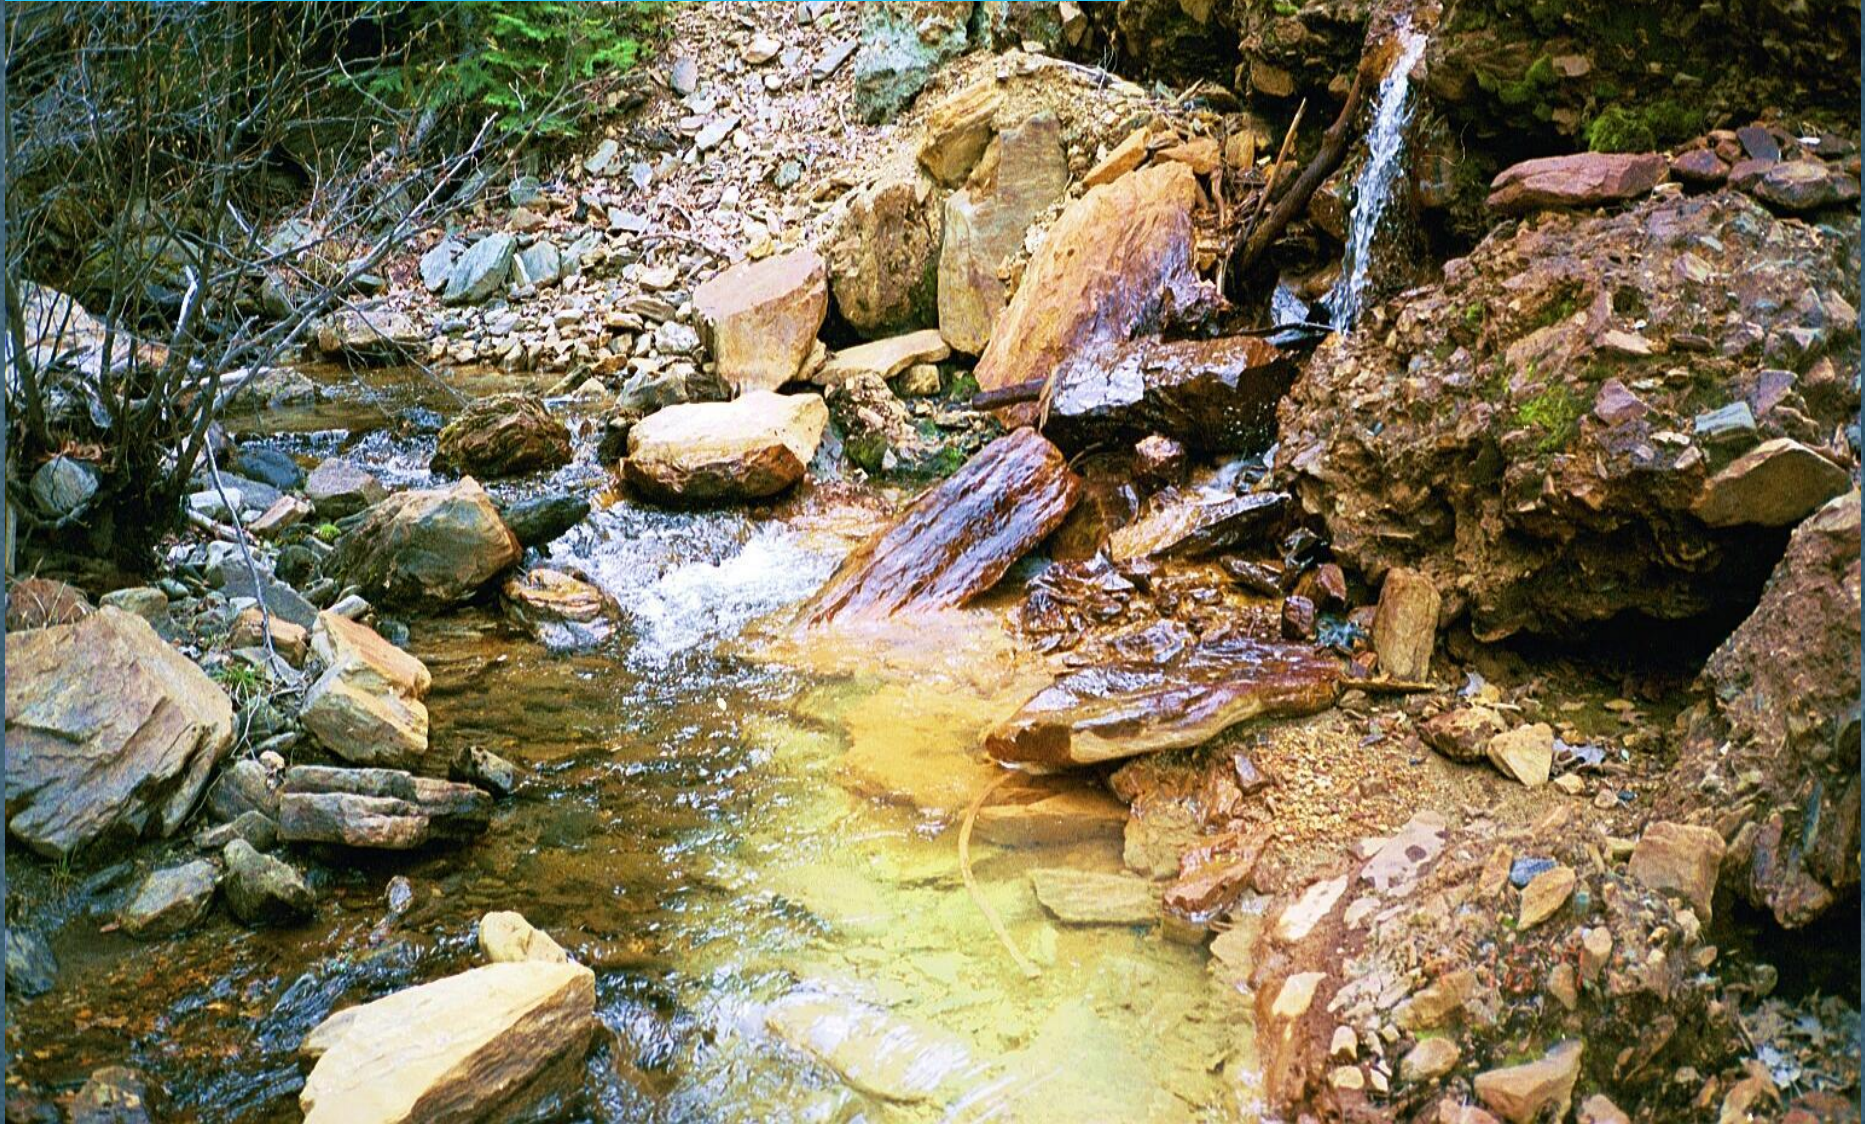
Blue Ledge Mine
Acid Mine Drainage
Discharged to the Environment

500k g/p/d AMD Entered Joe Creek in Spring

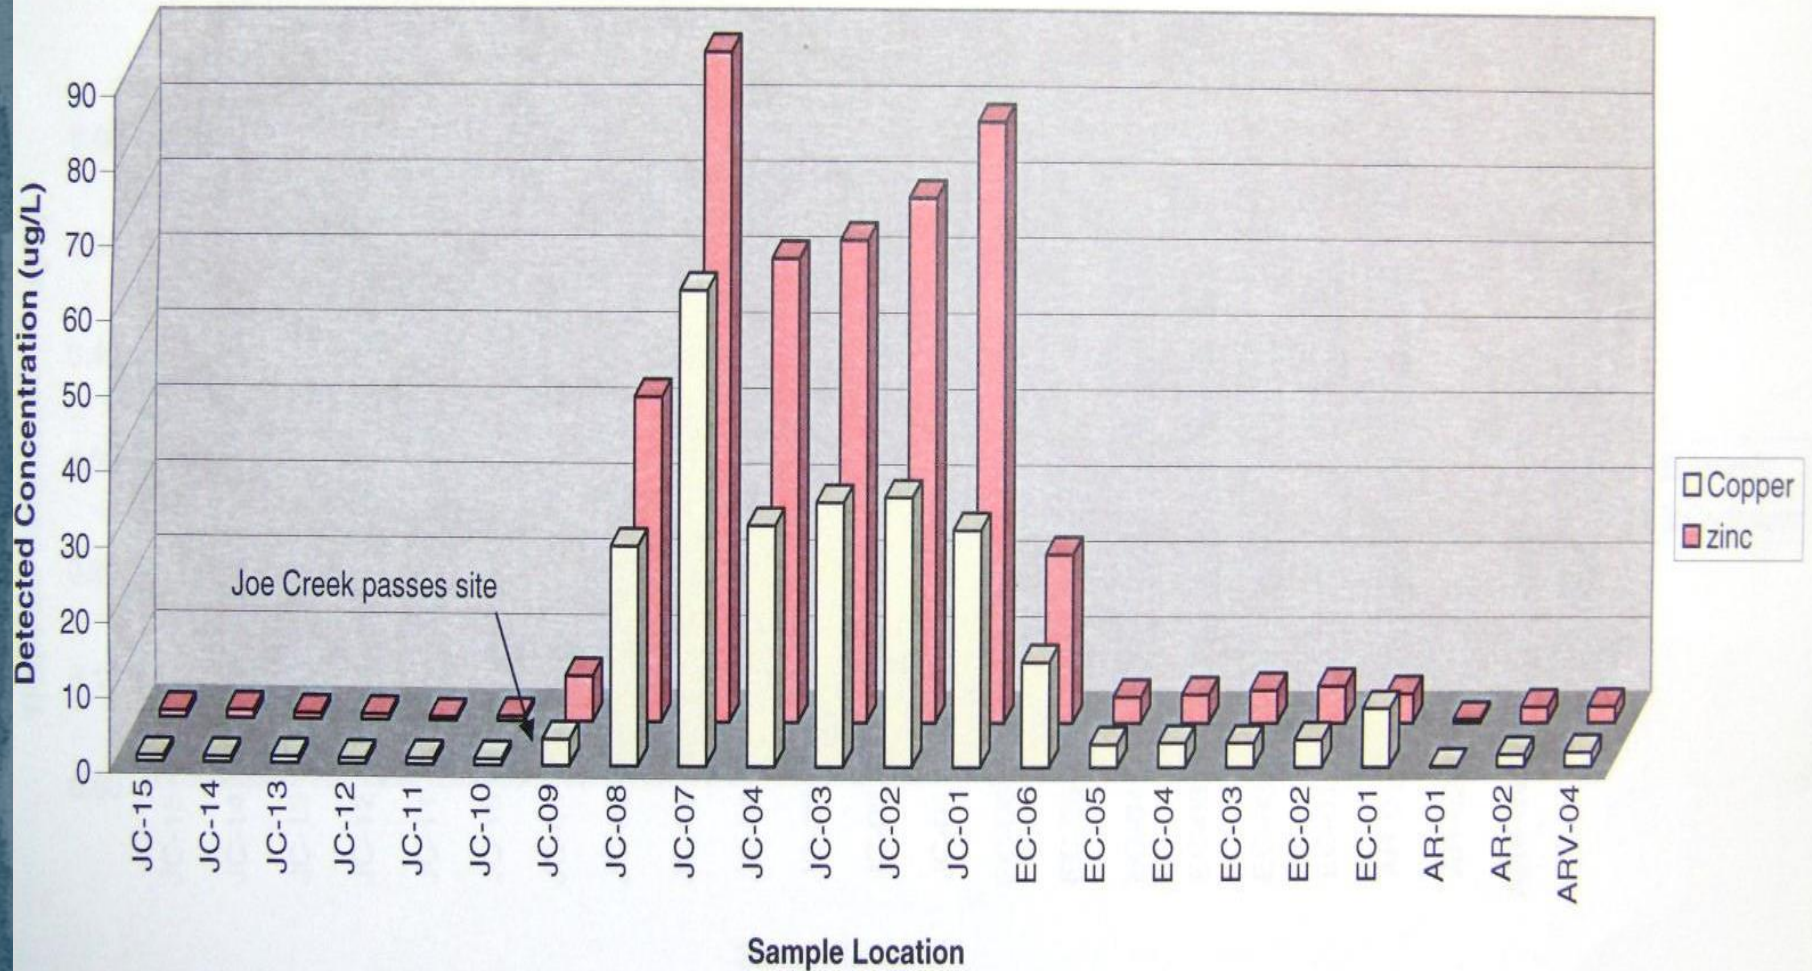
Dissolved Copper & Zinc in Surface Water

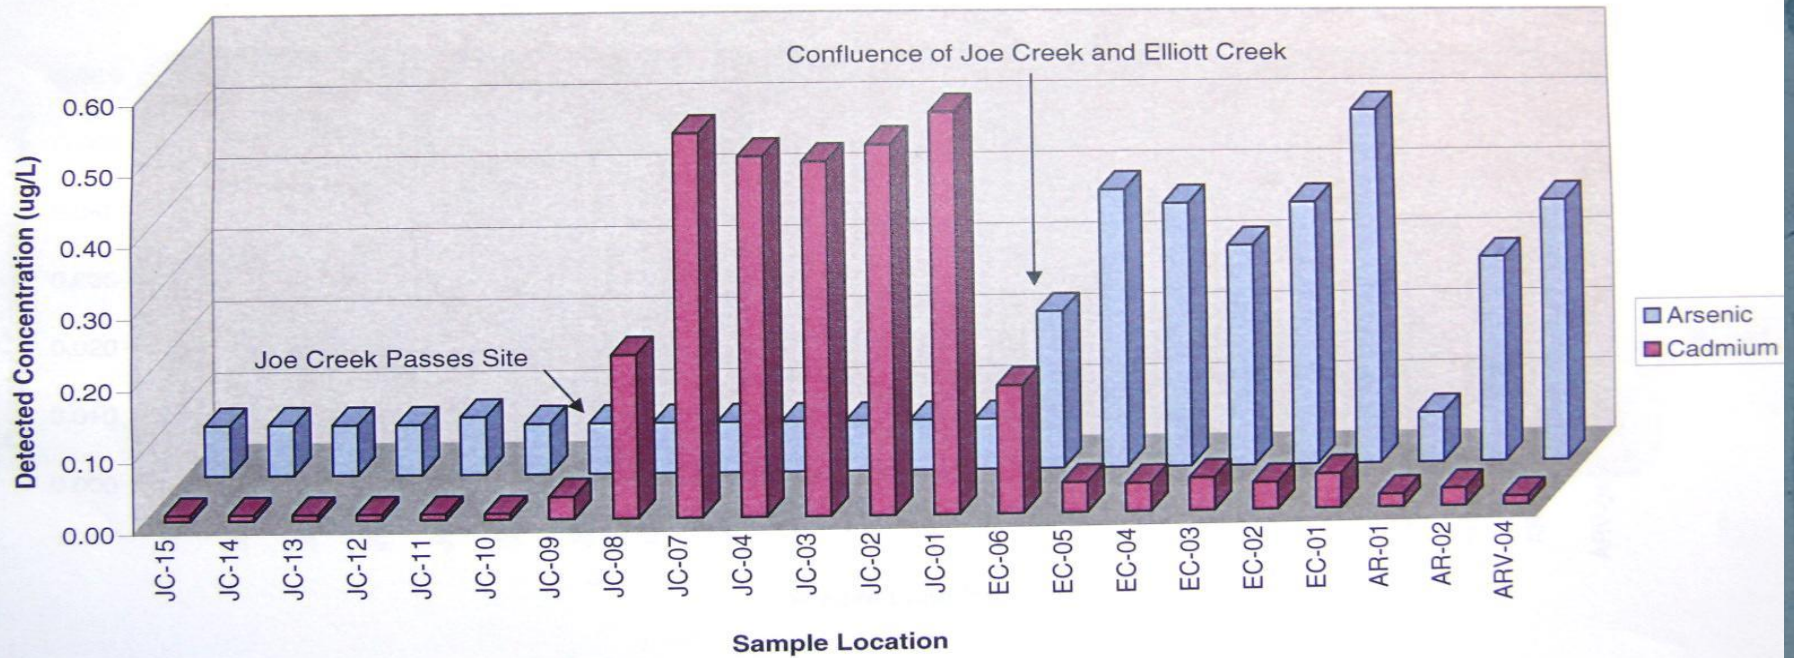
Chart 2
Dissolved Arsenic and Cadmium in Surface Water

Arsenic & Cadmium in Water

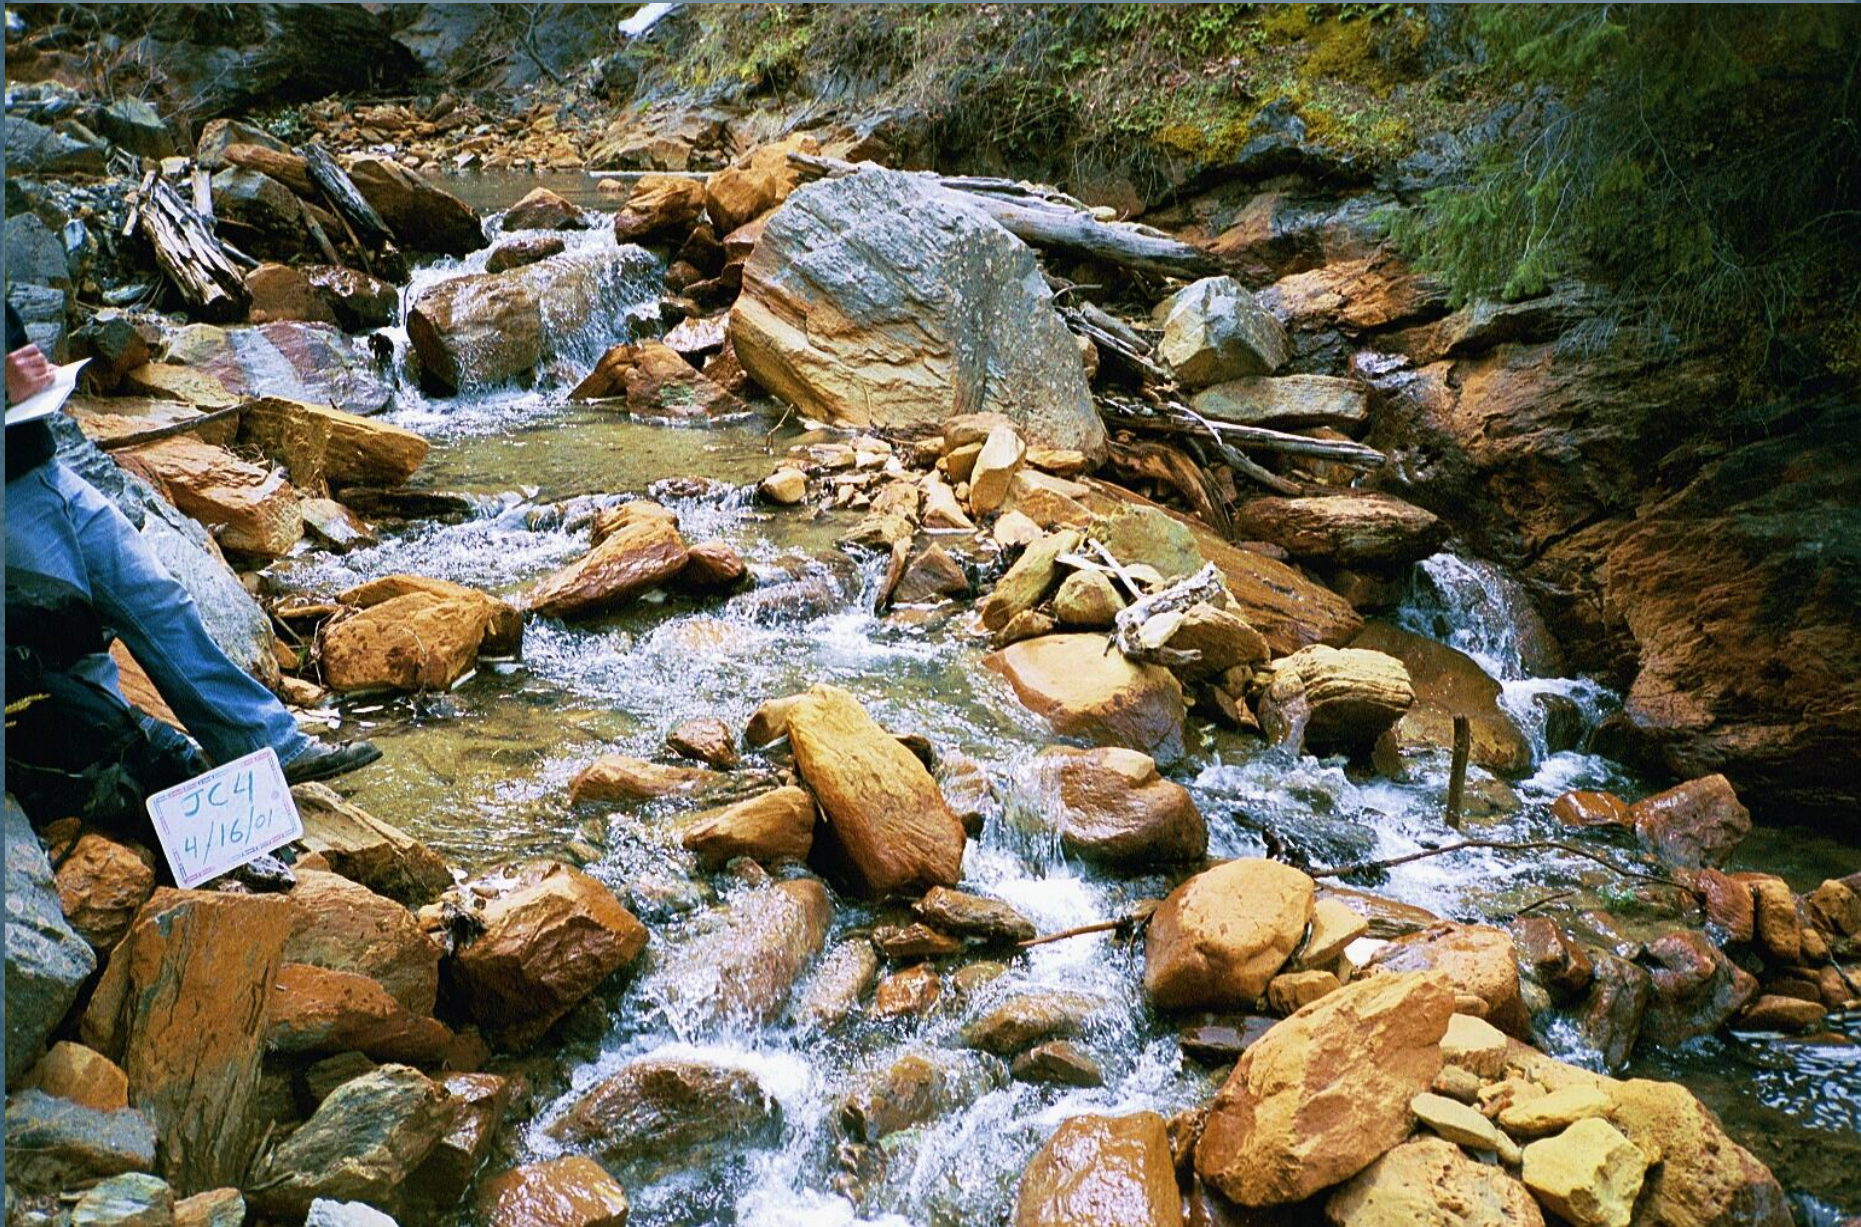
4 Miles of Sterile Stream Below Waste Rock Piles

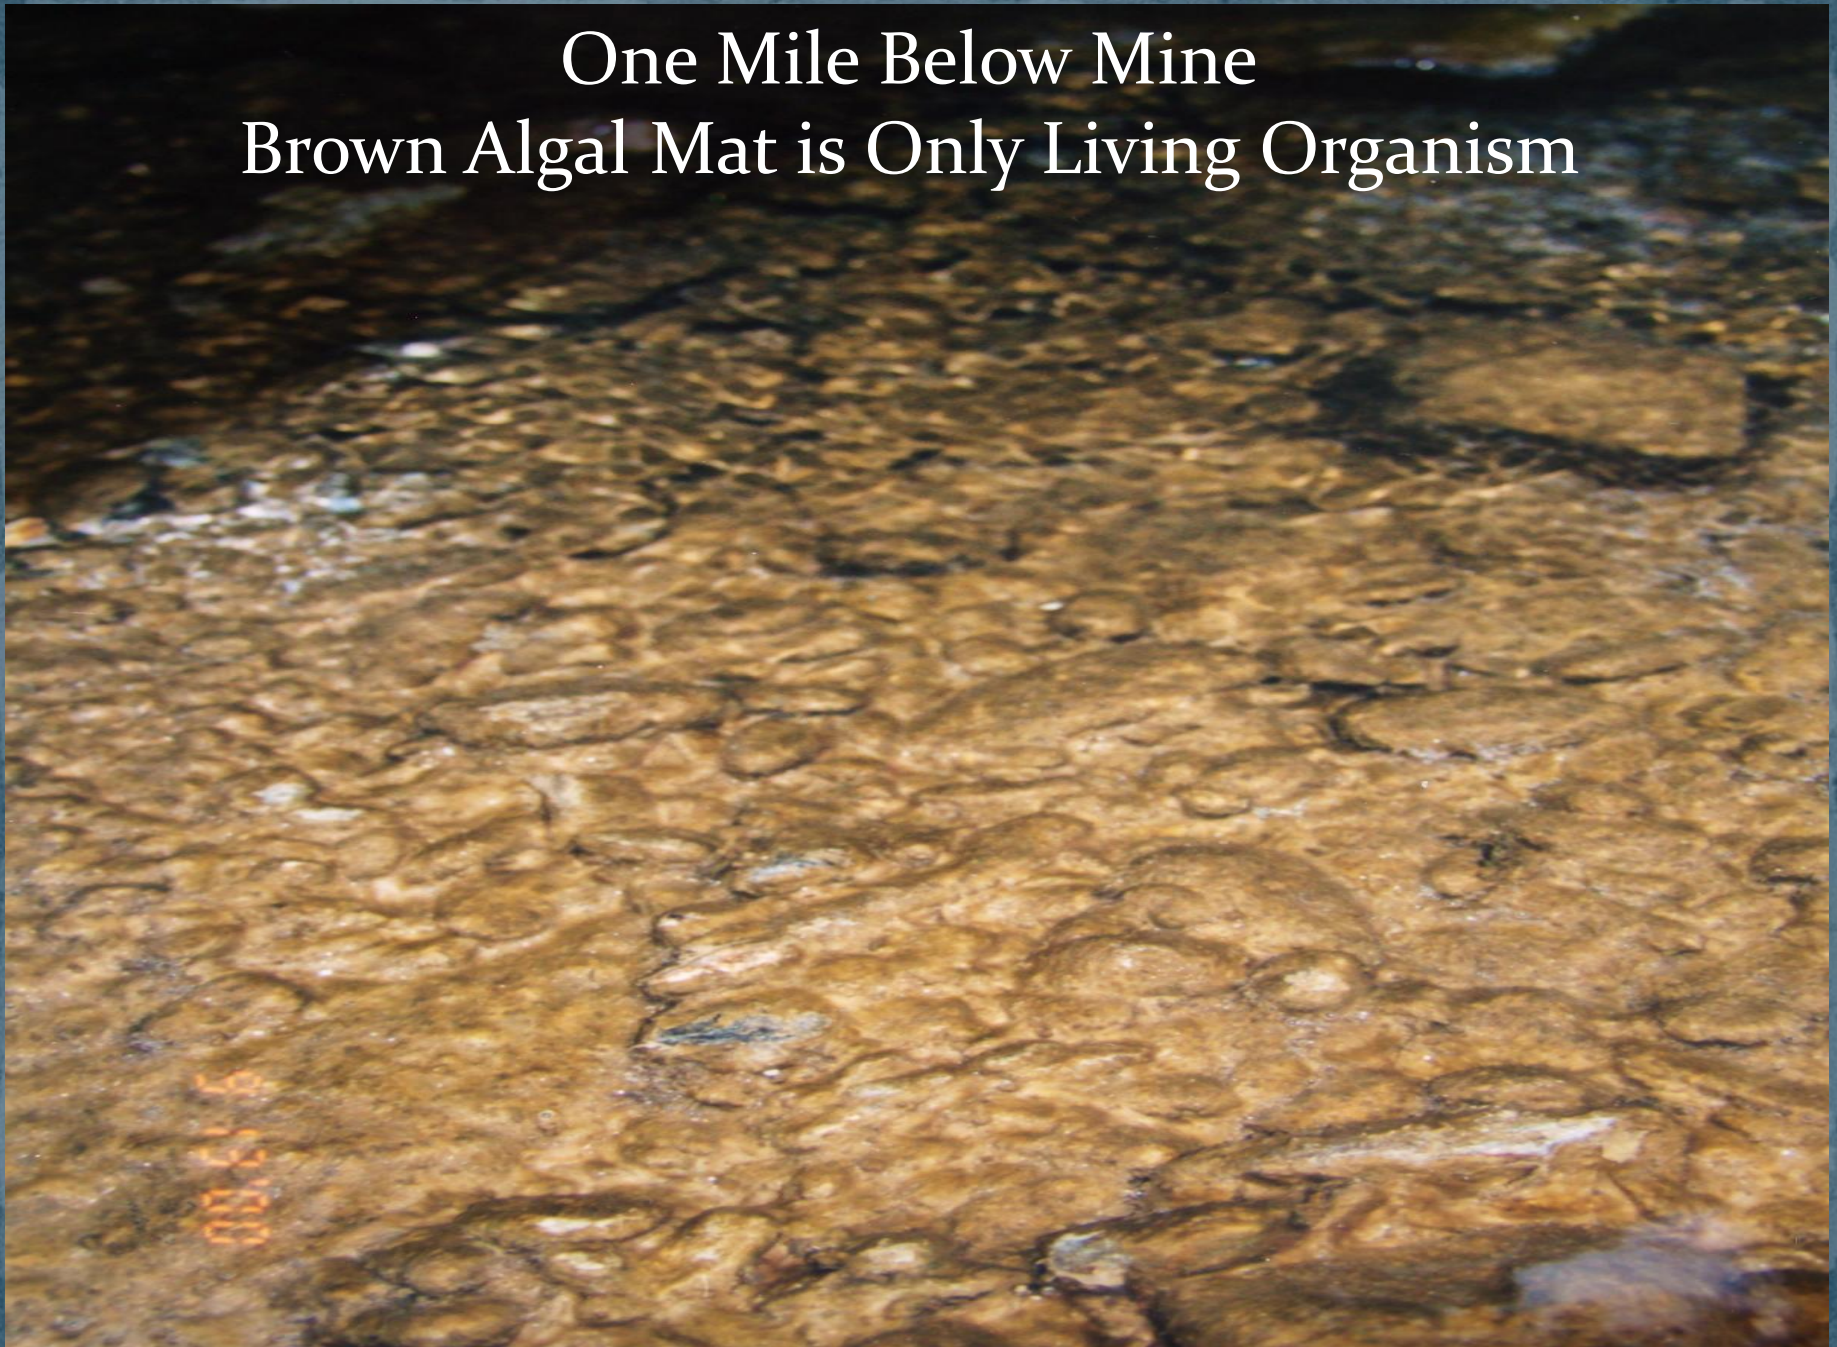
One Mile Below Mine
Brown Algal Mat is Only Living Organism

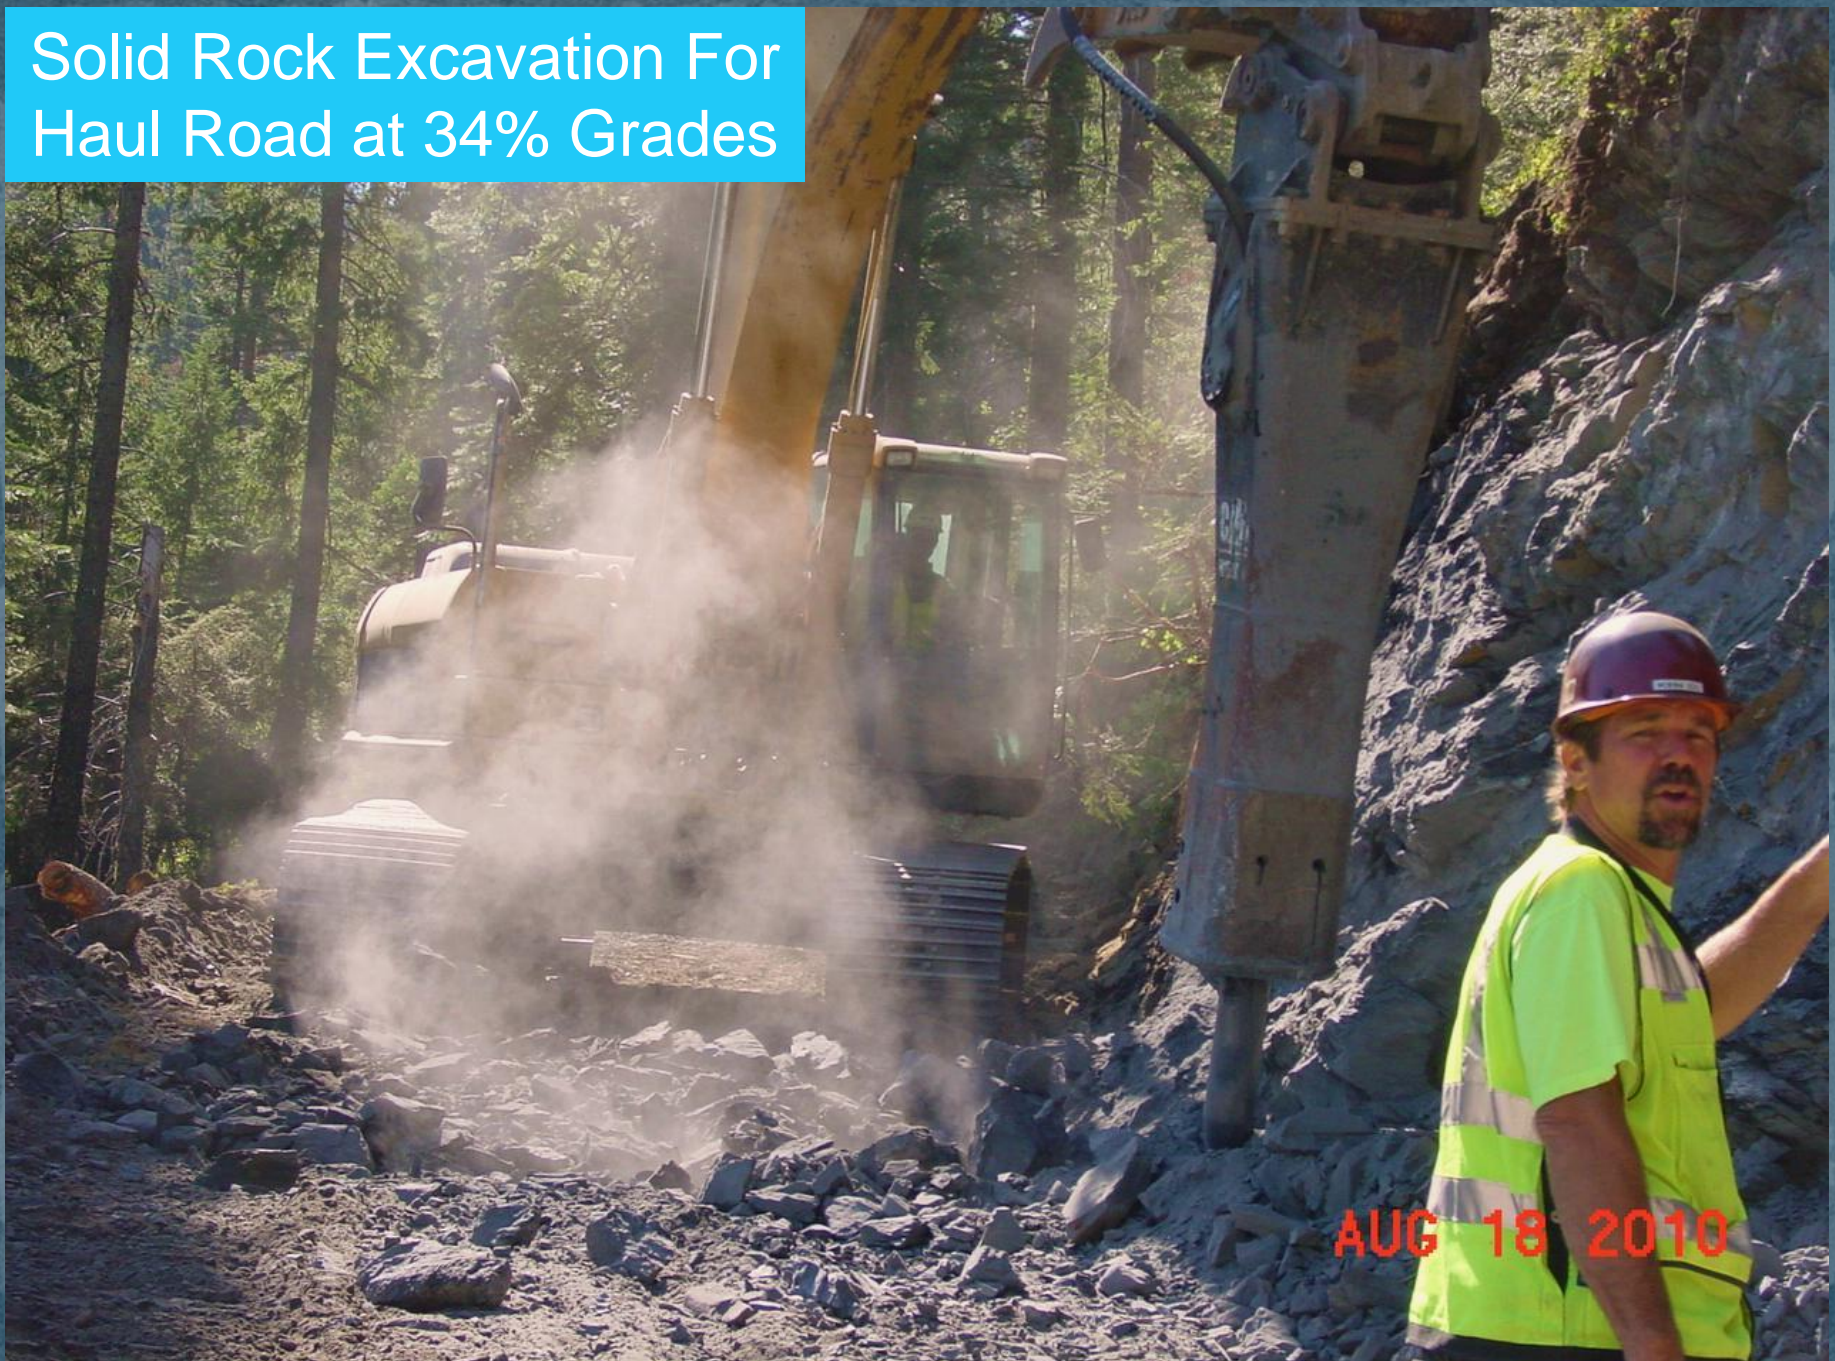
Solid Rock Excavation For Haul Road at 34% Grades

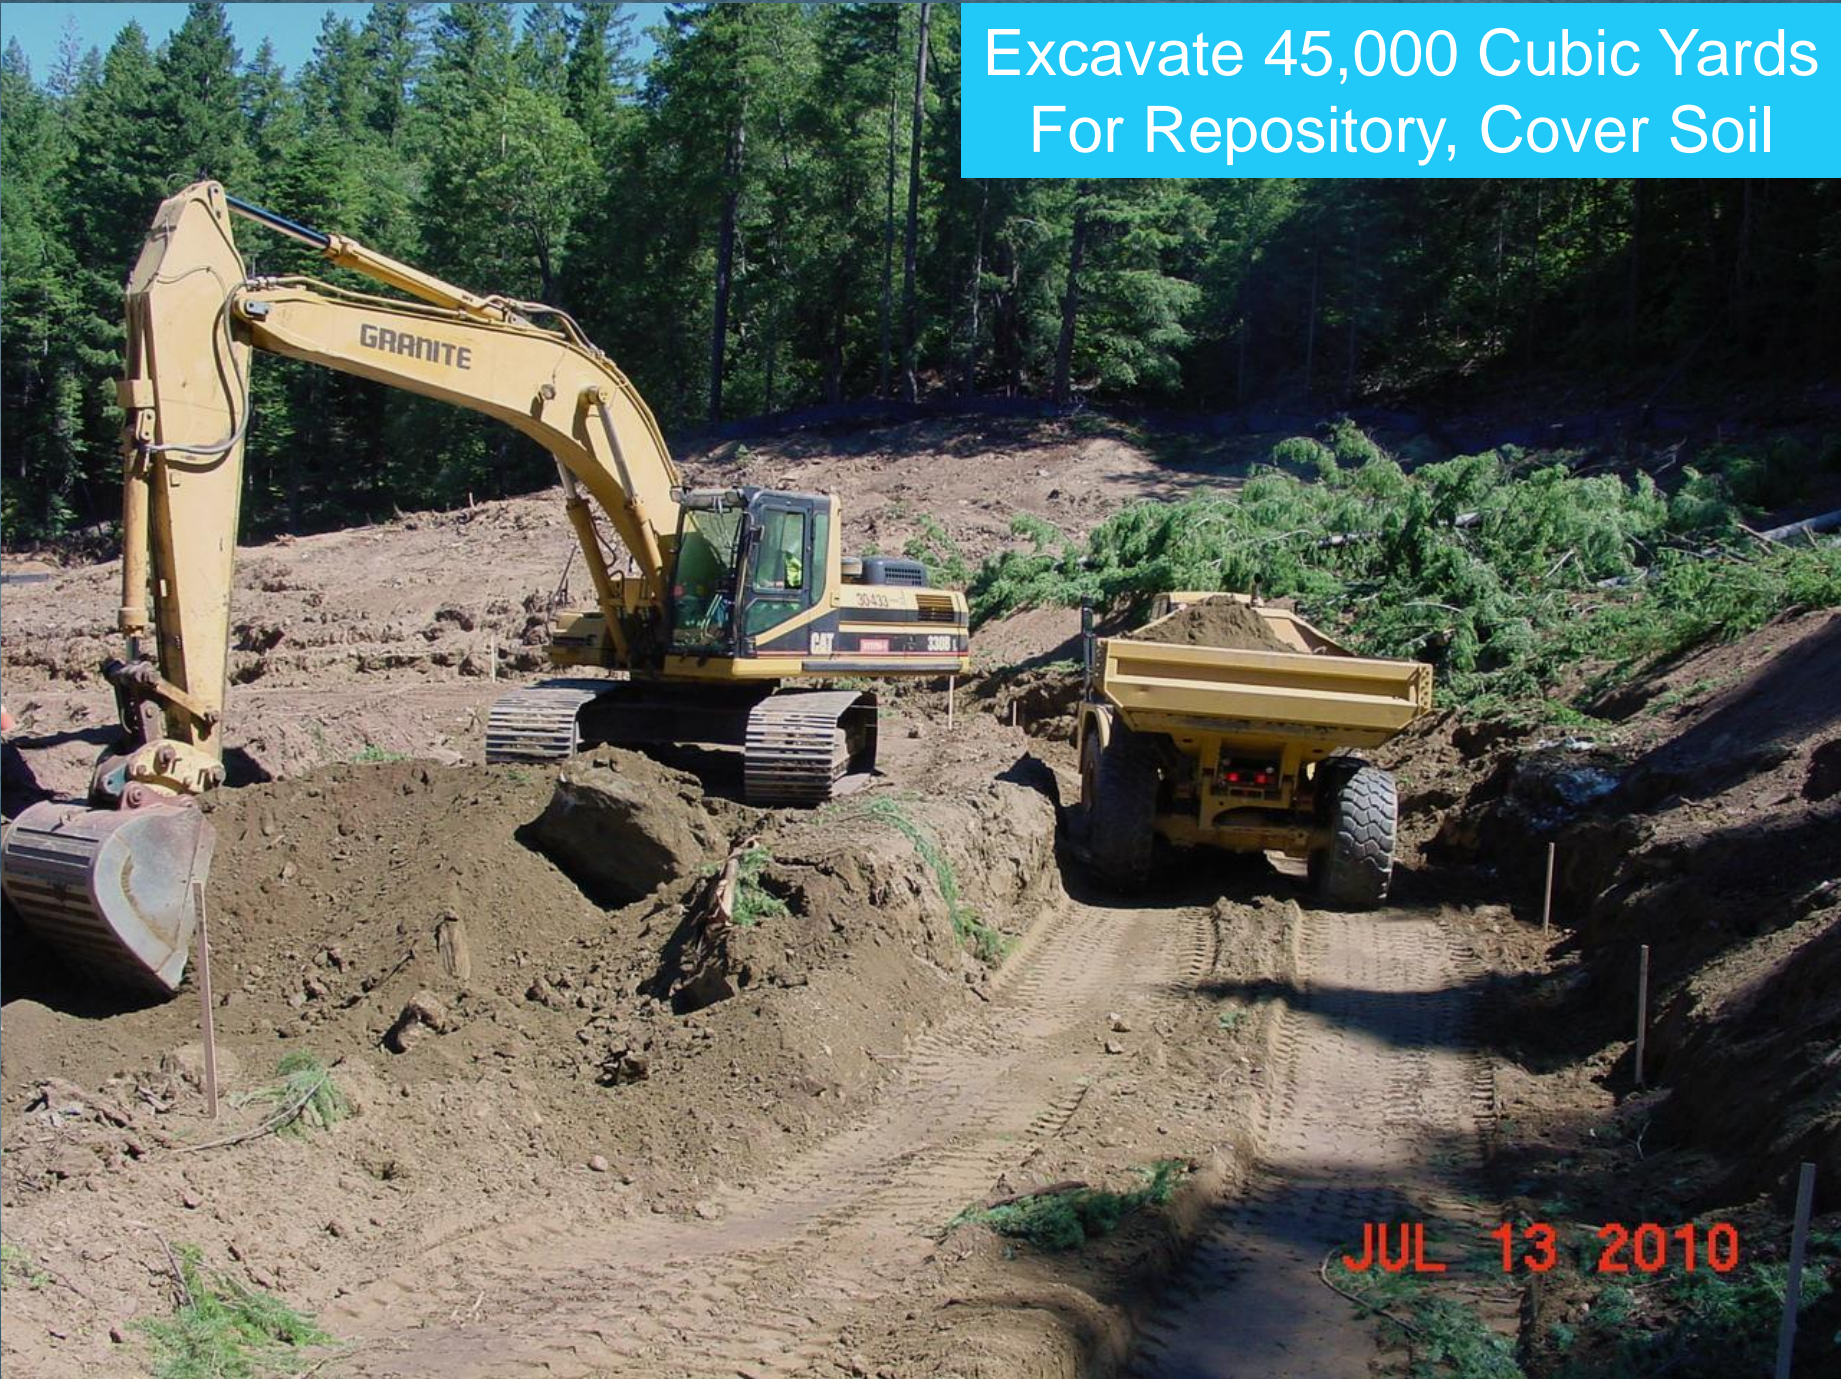
Excavate 45,000 Cubic Yards
For Repository, Cover Soil

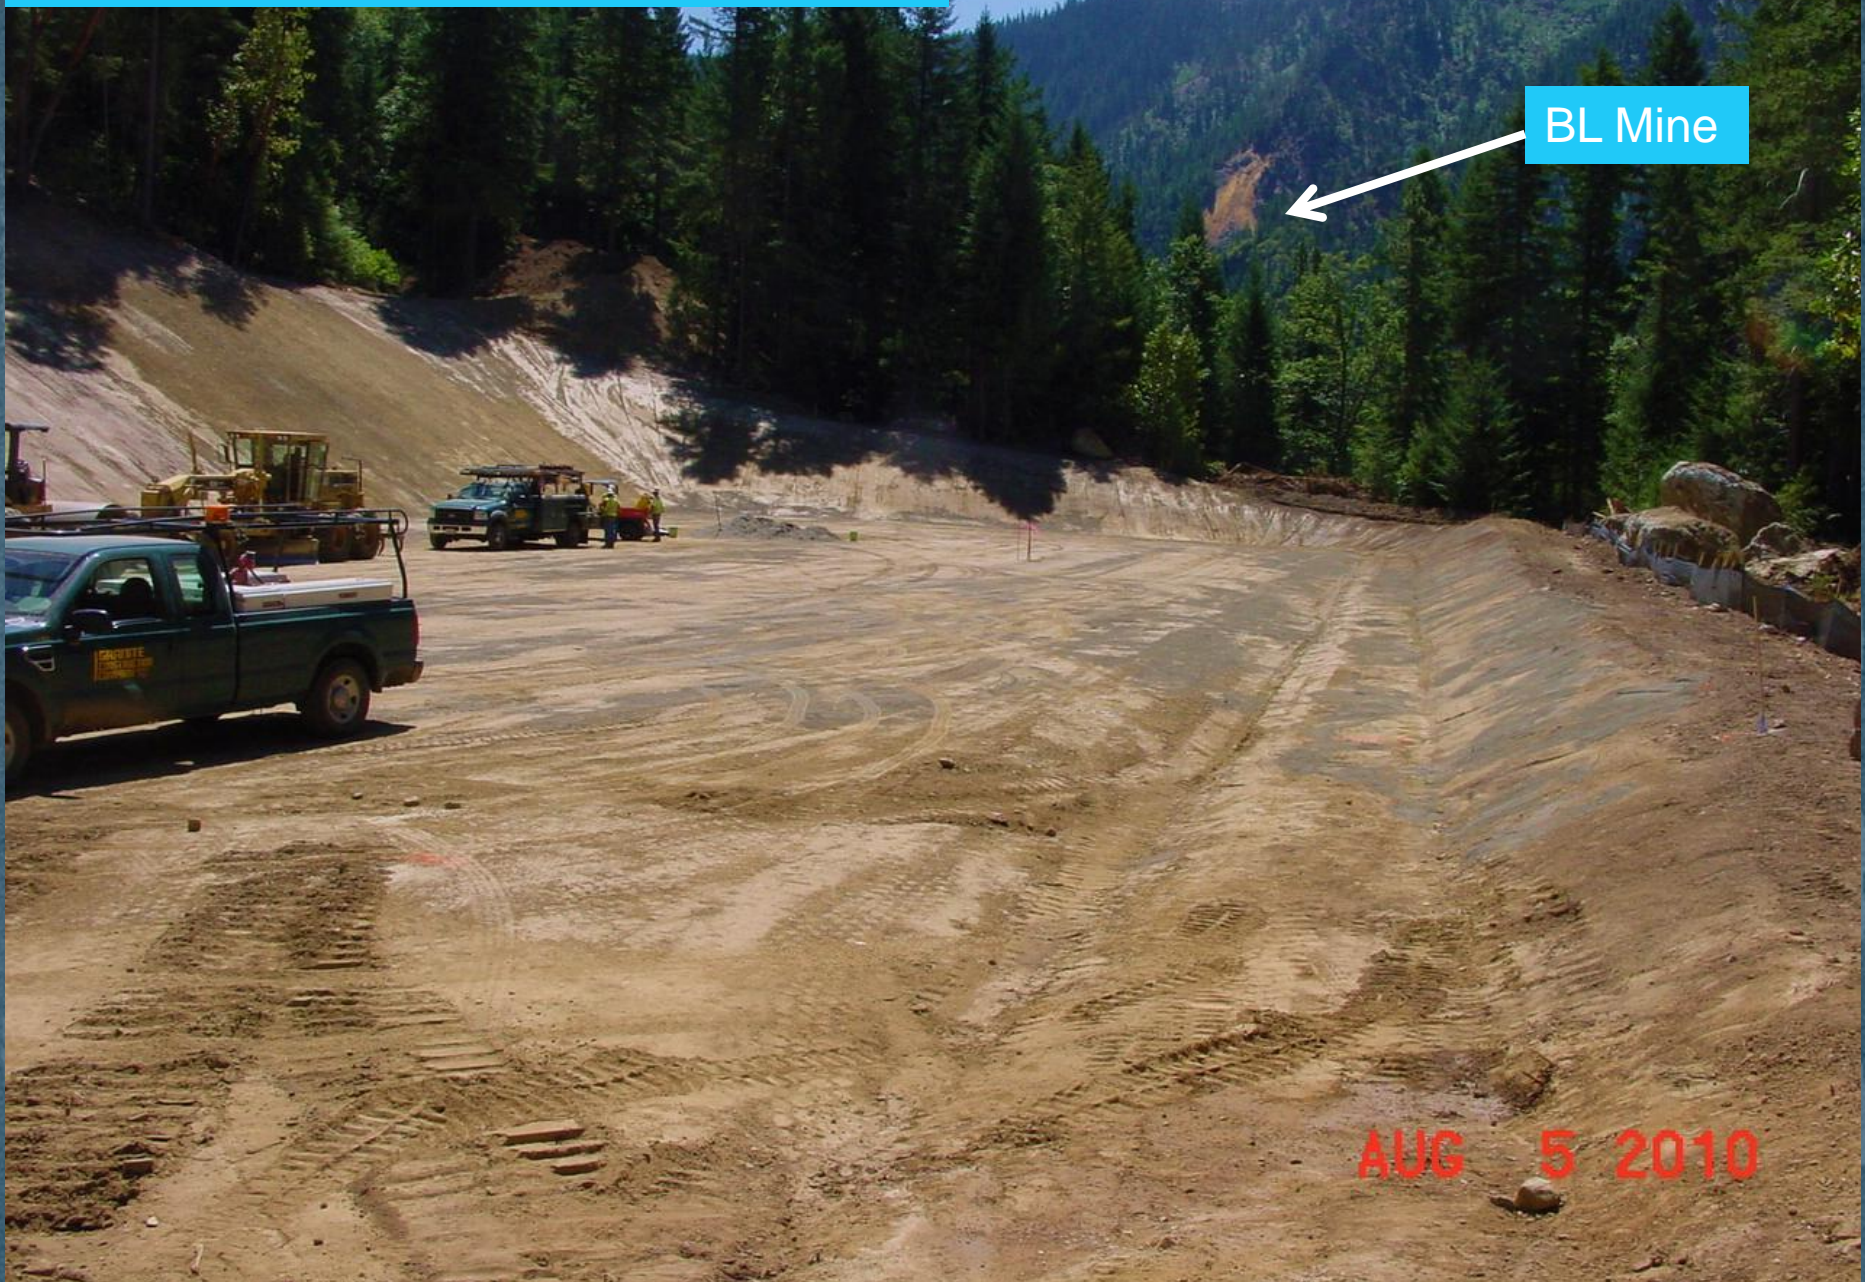
Prepared Repository Subgrade

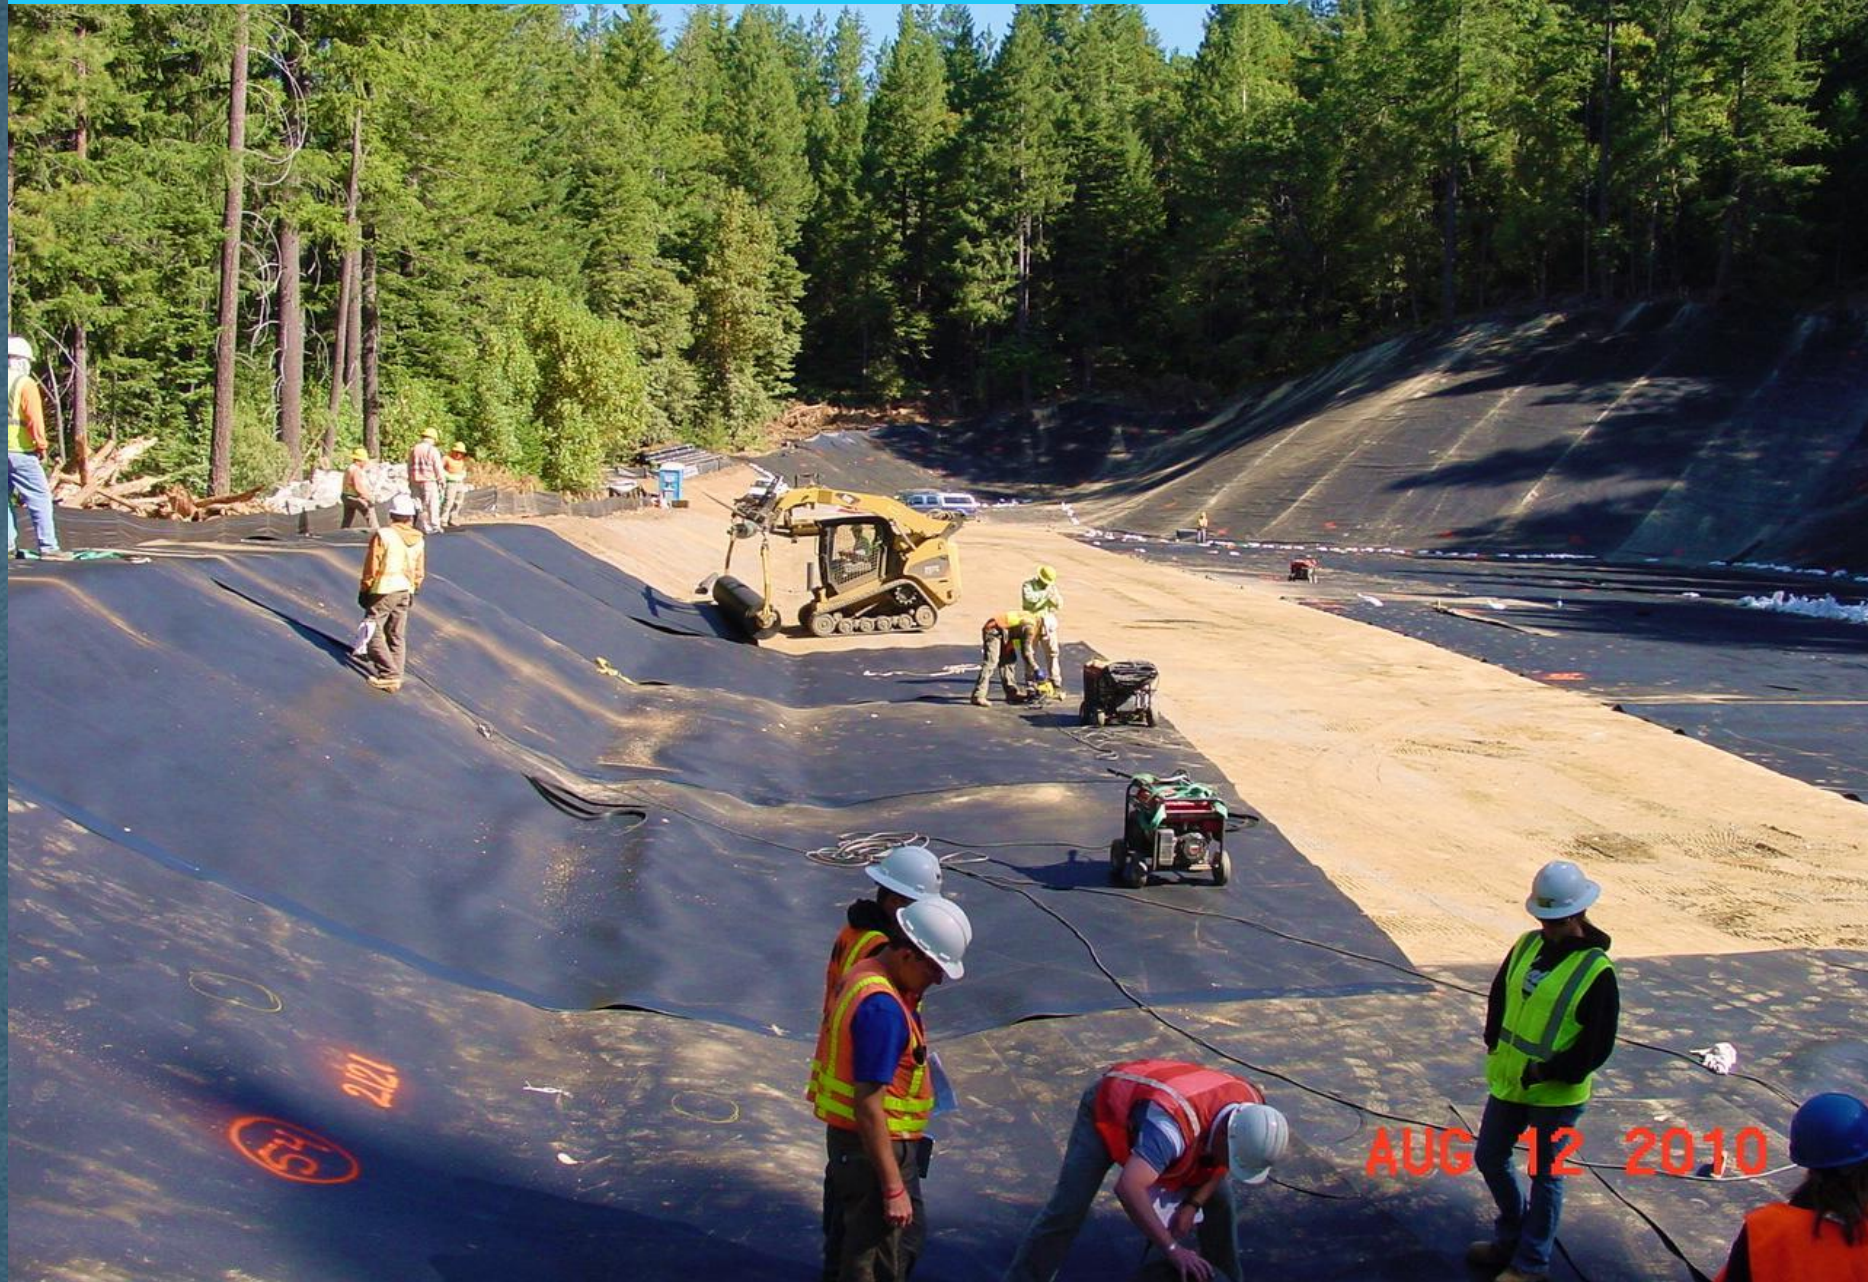
Install 60 mil Double-Textured HDPE Liner
