Blue Ledge Mine Superfund Site Presentation Overview

US Forest Service
Non-Time-Critical
Removal Action

Emphasis on AMD Source Control by Removing Waste Rock Piles

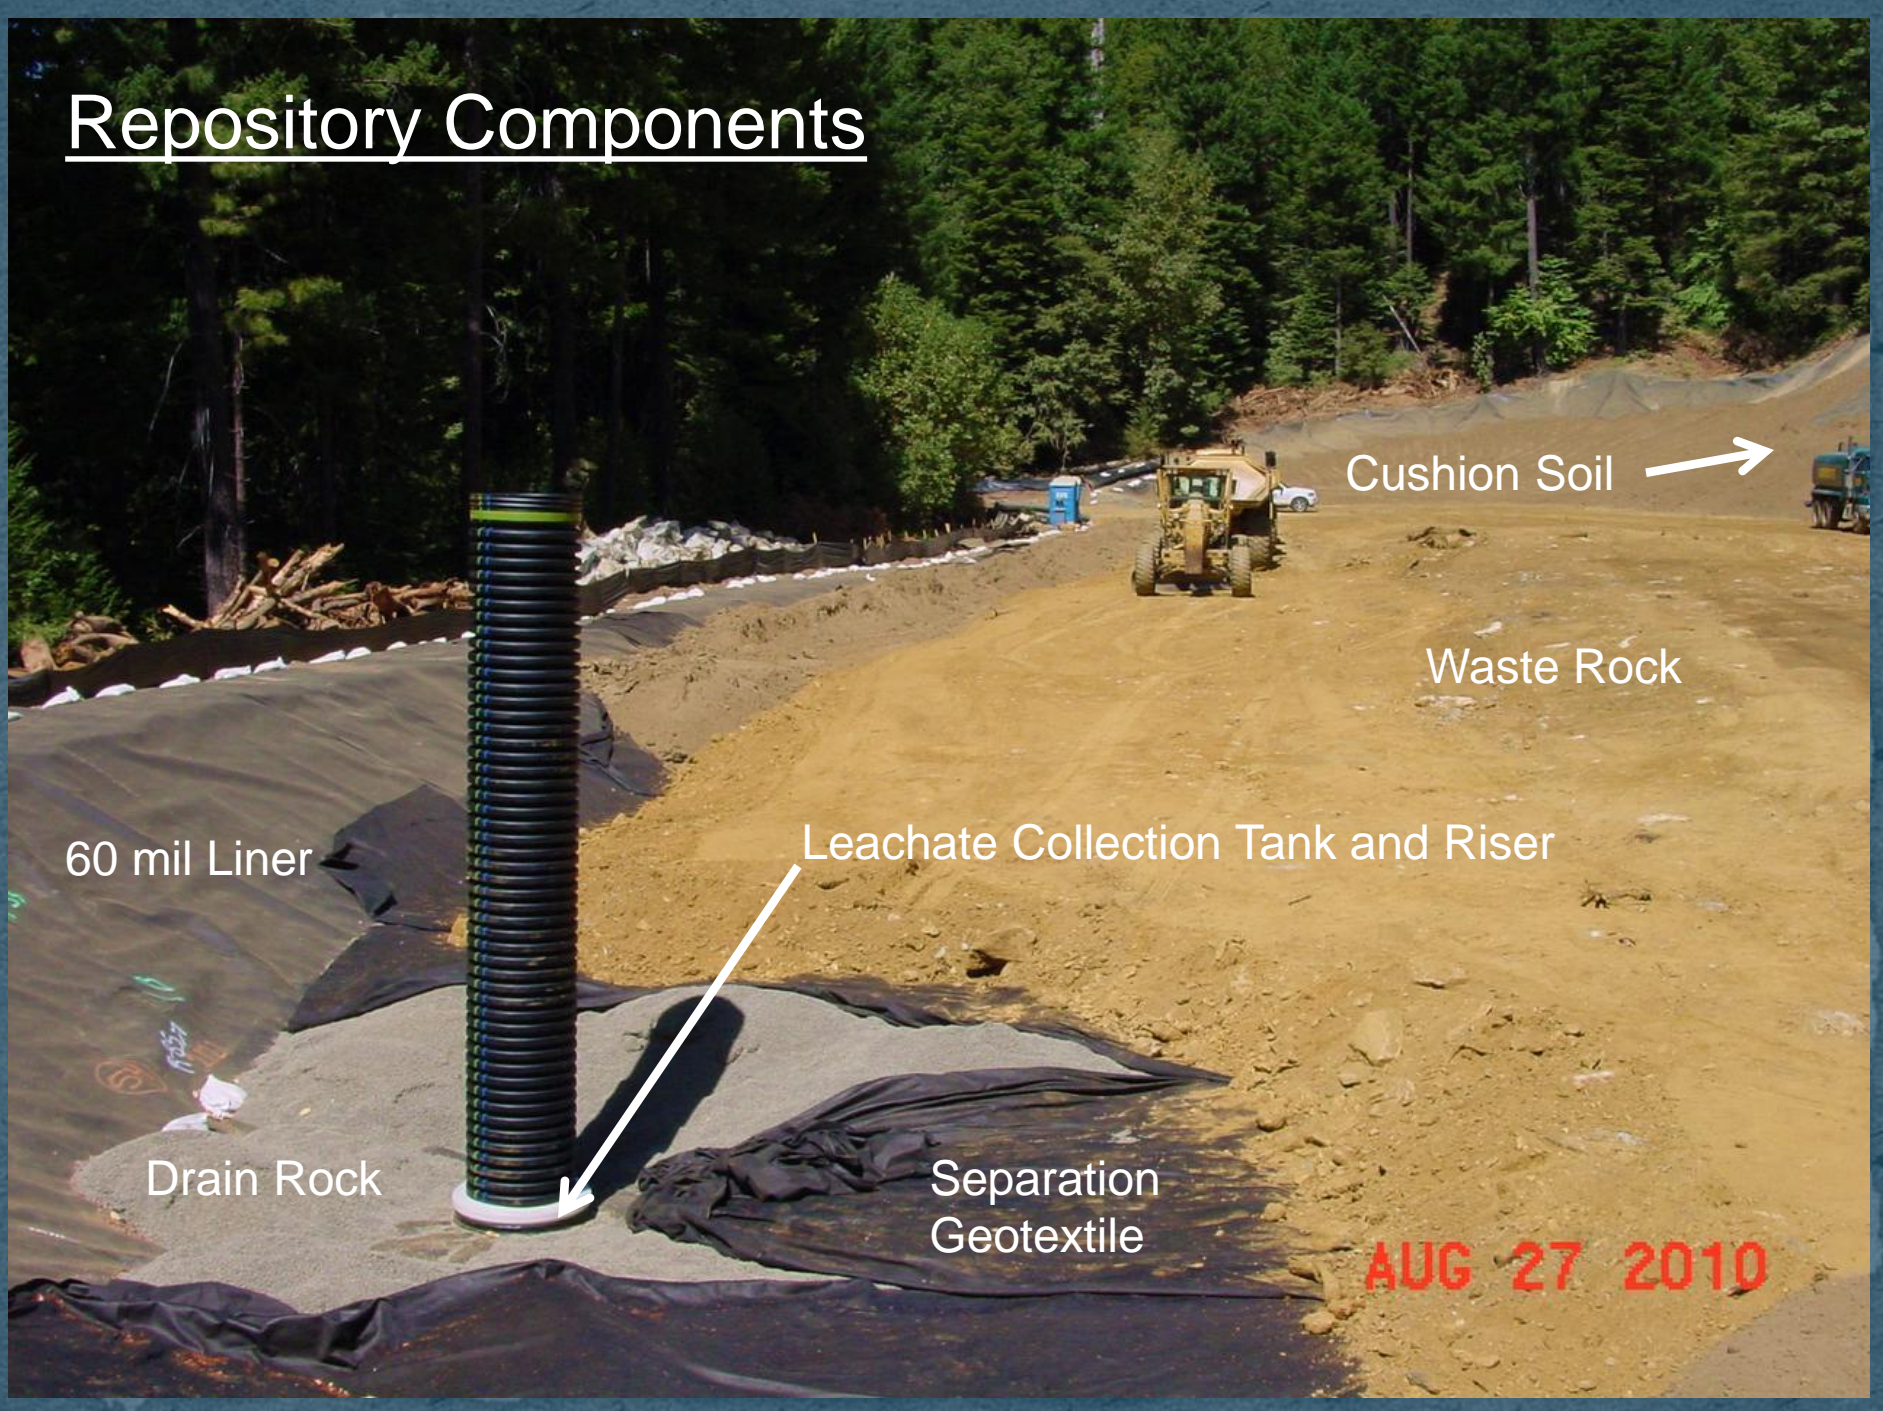
Repository Components

60 mil Liner

Drain Rock

Leachate Collection Tank and Riser

Separation Geotextile

Cushion Soil

Waste Rock

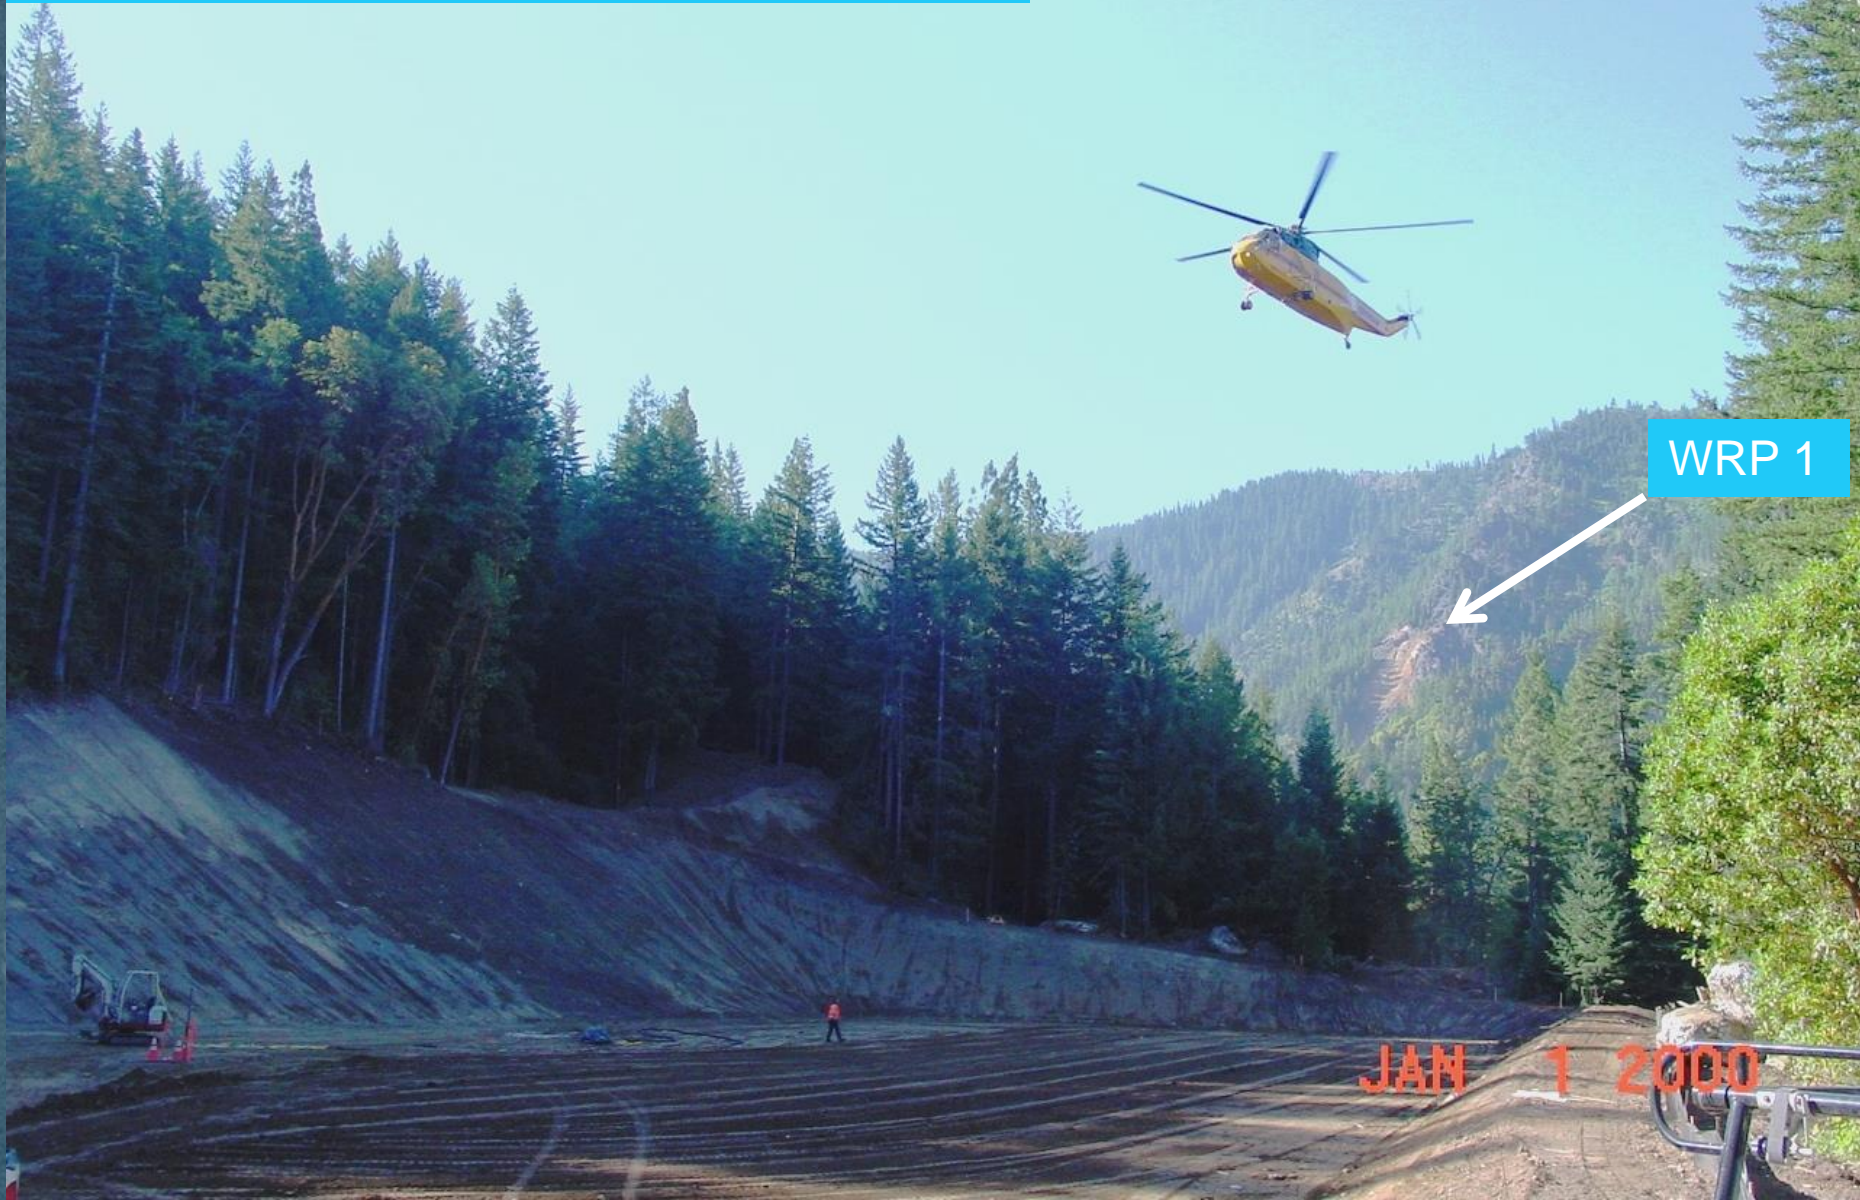
Helicopter Lifting Mini-Excavator From Repository to Top of WRP 1

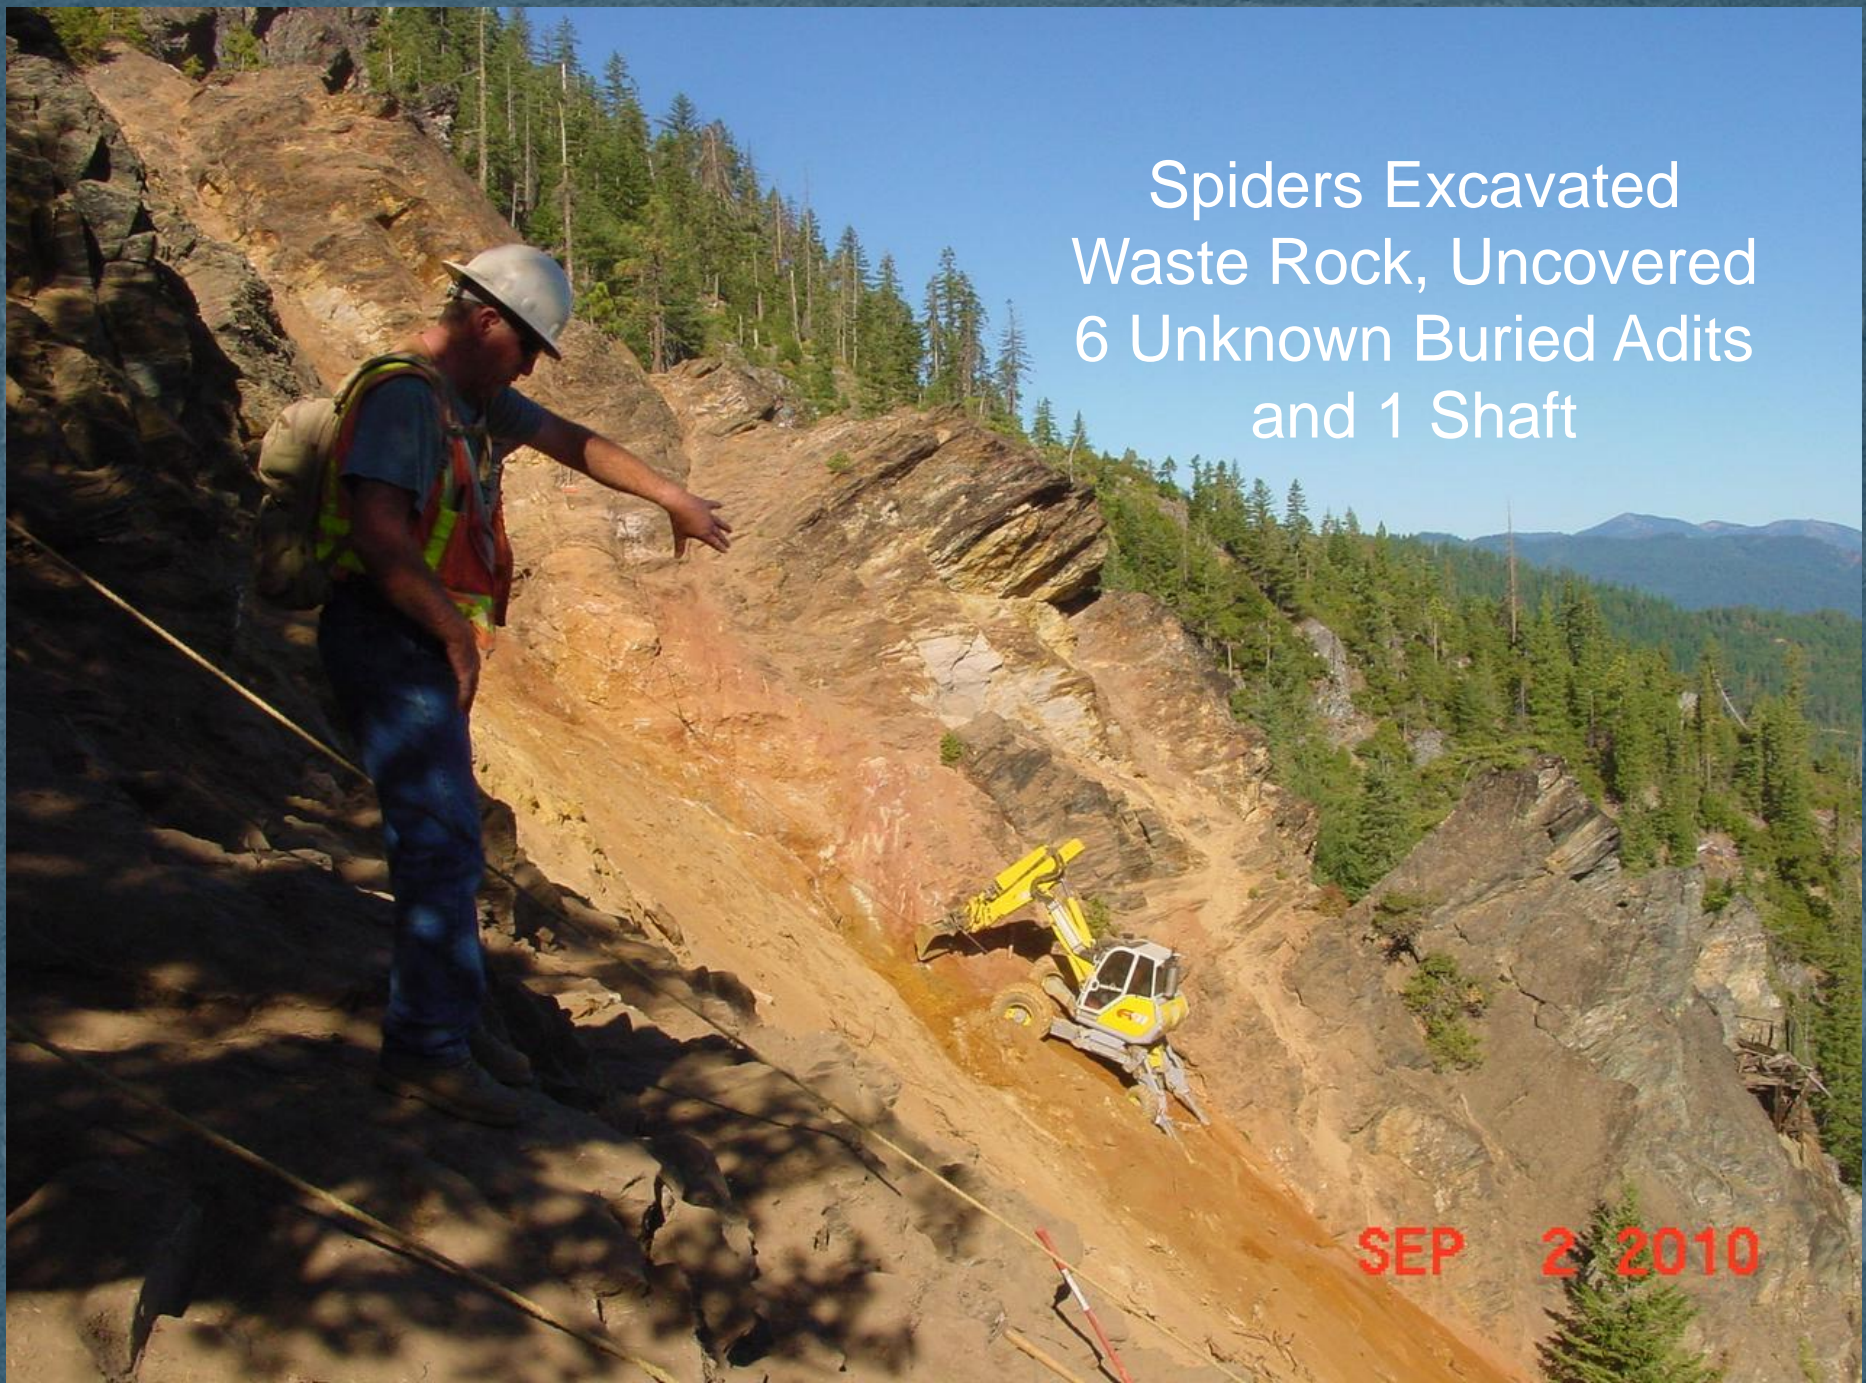
Spiders Excavated
Waste Rock, Uncovered
6 Unknown Buried Adits
and 1 Shaft

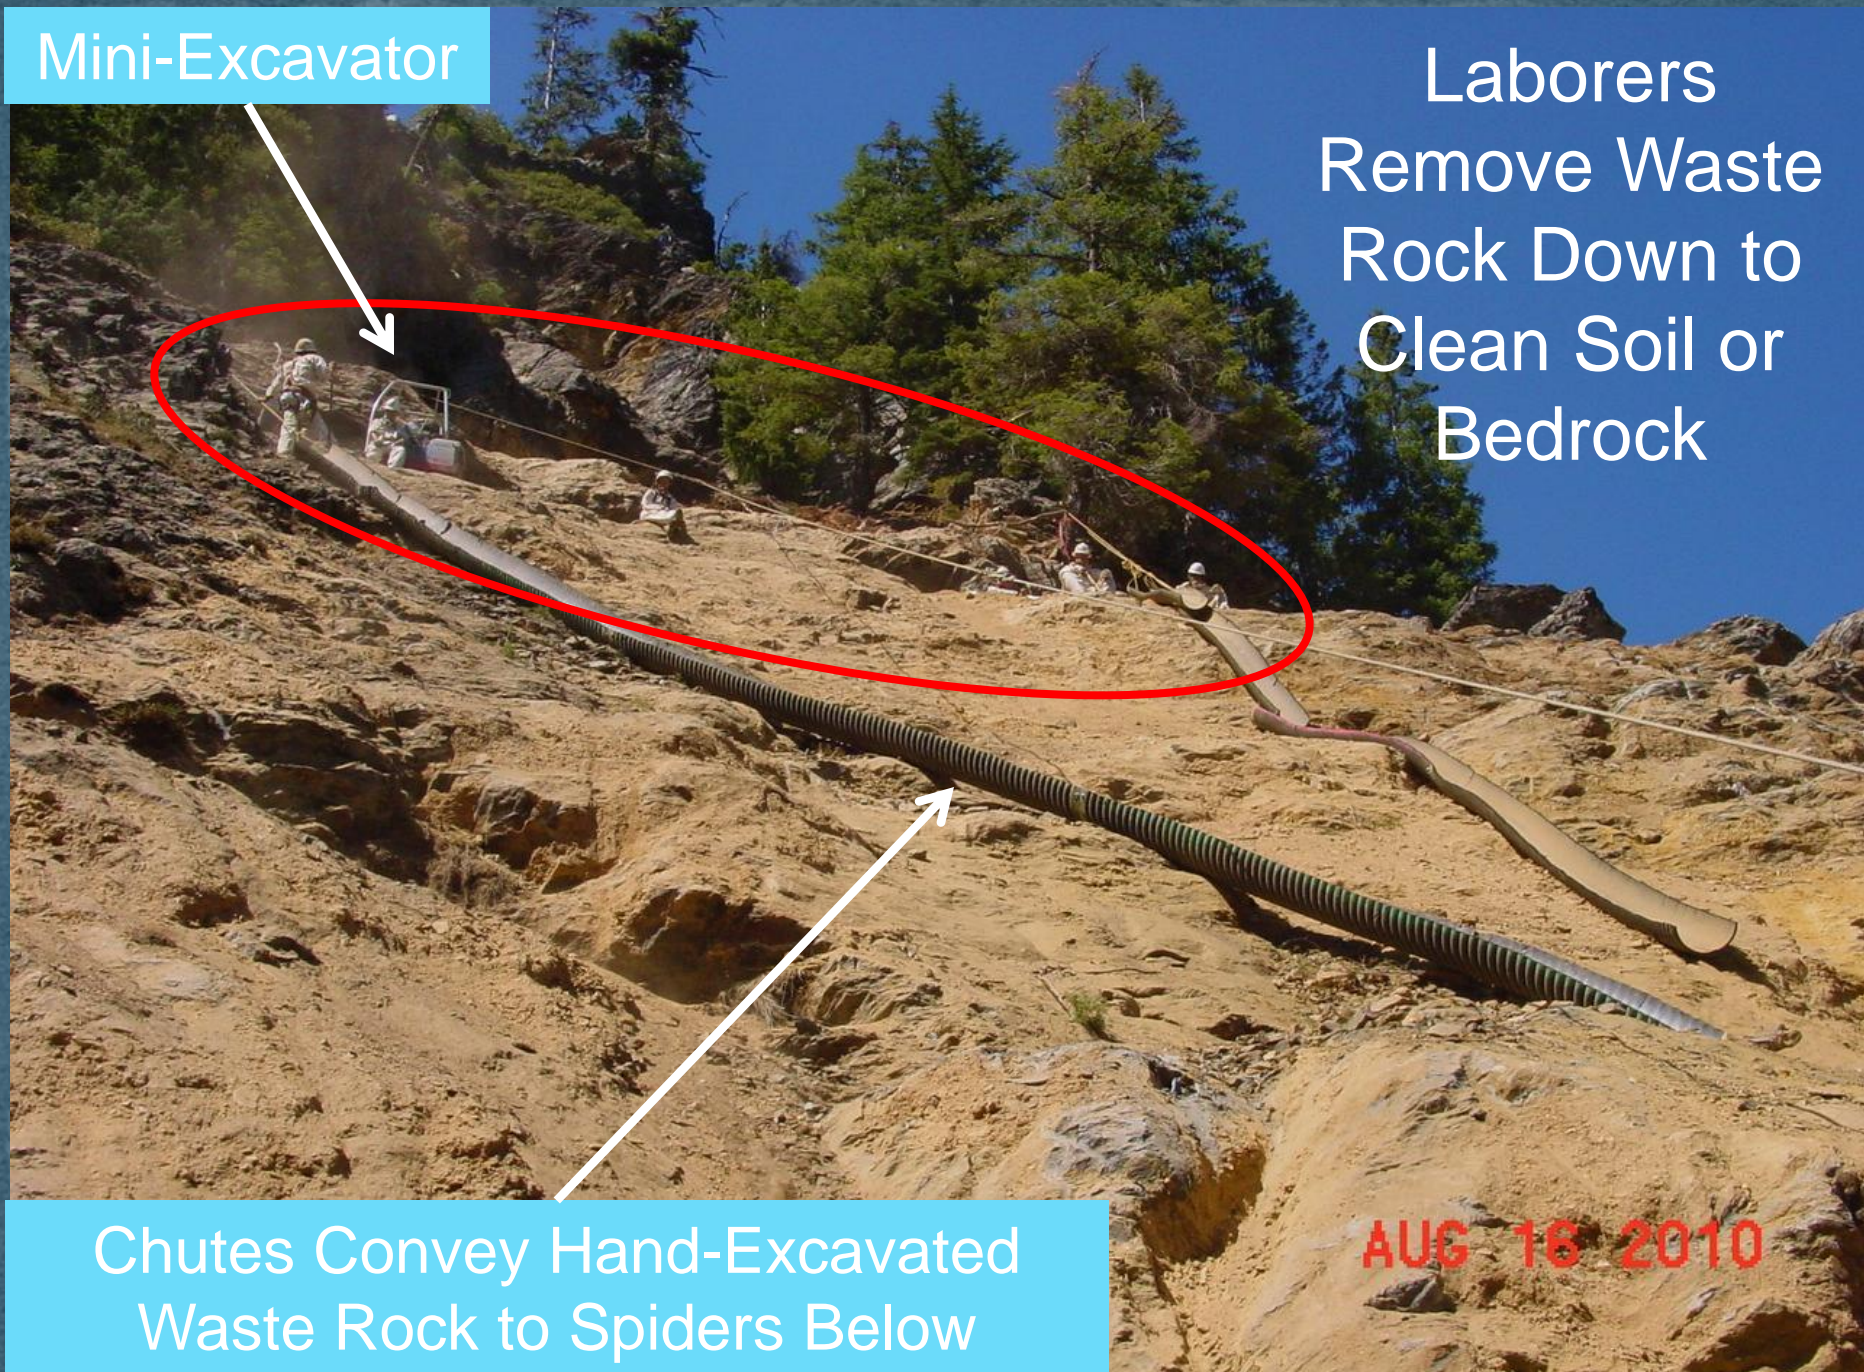
Mini-Excavator

Laborers
Remove Waste
Rock Down to
Clean Soil or
Bedrock

Chutes Convey Hand-Excavated
Waste Rock to Spiders Below

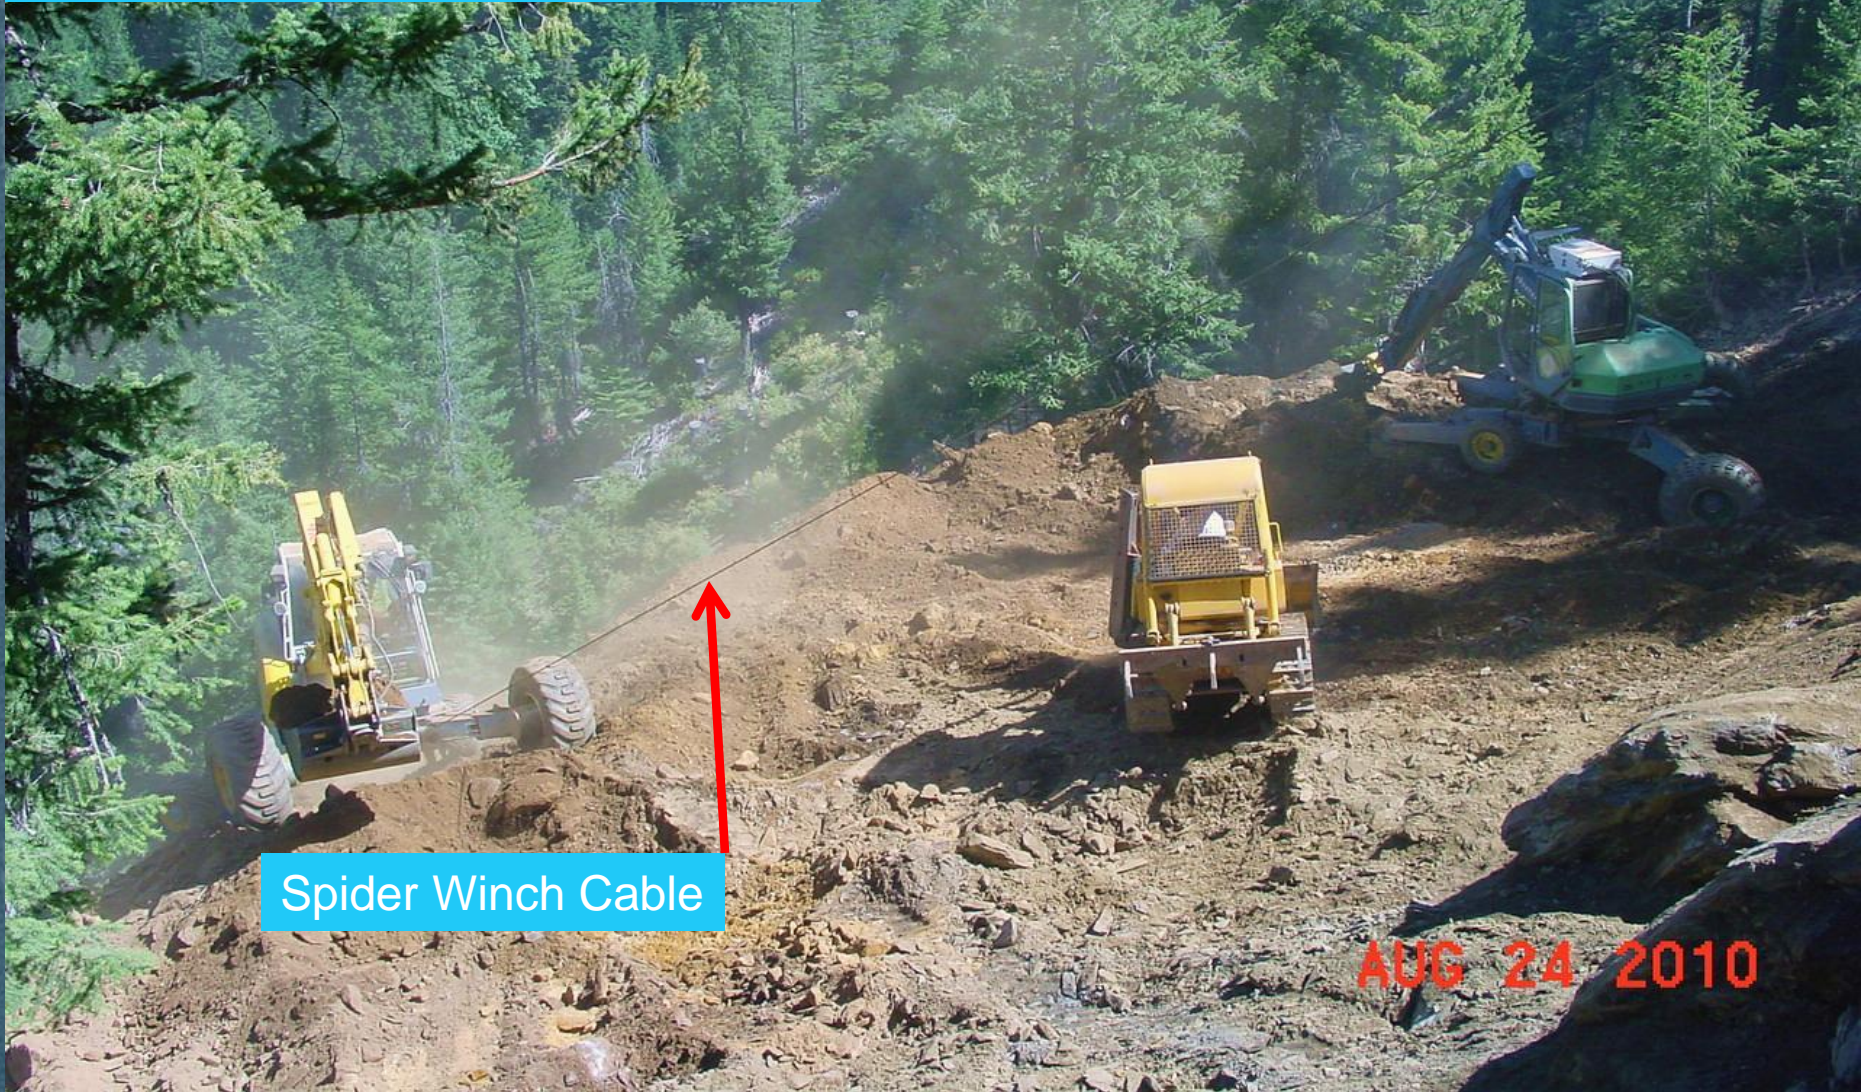
D4 Joins Spiders to Push Surge Pile to Excavator & Haul Trucks Below

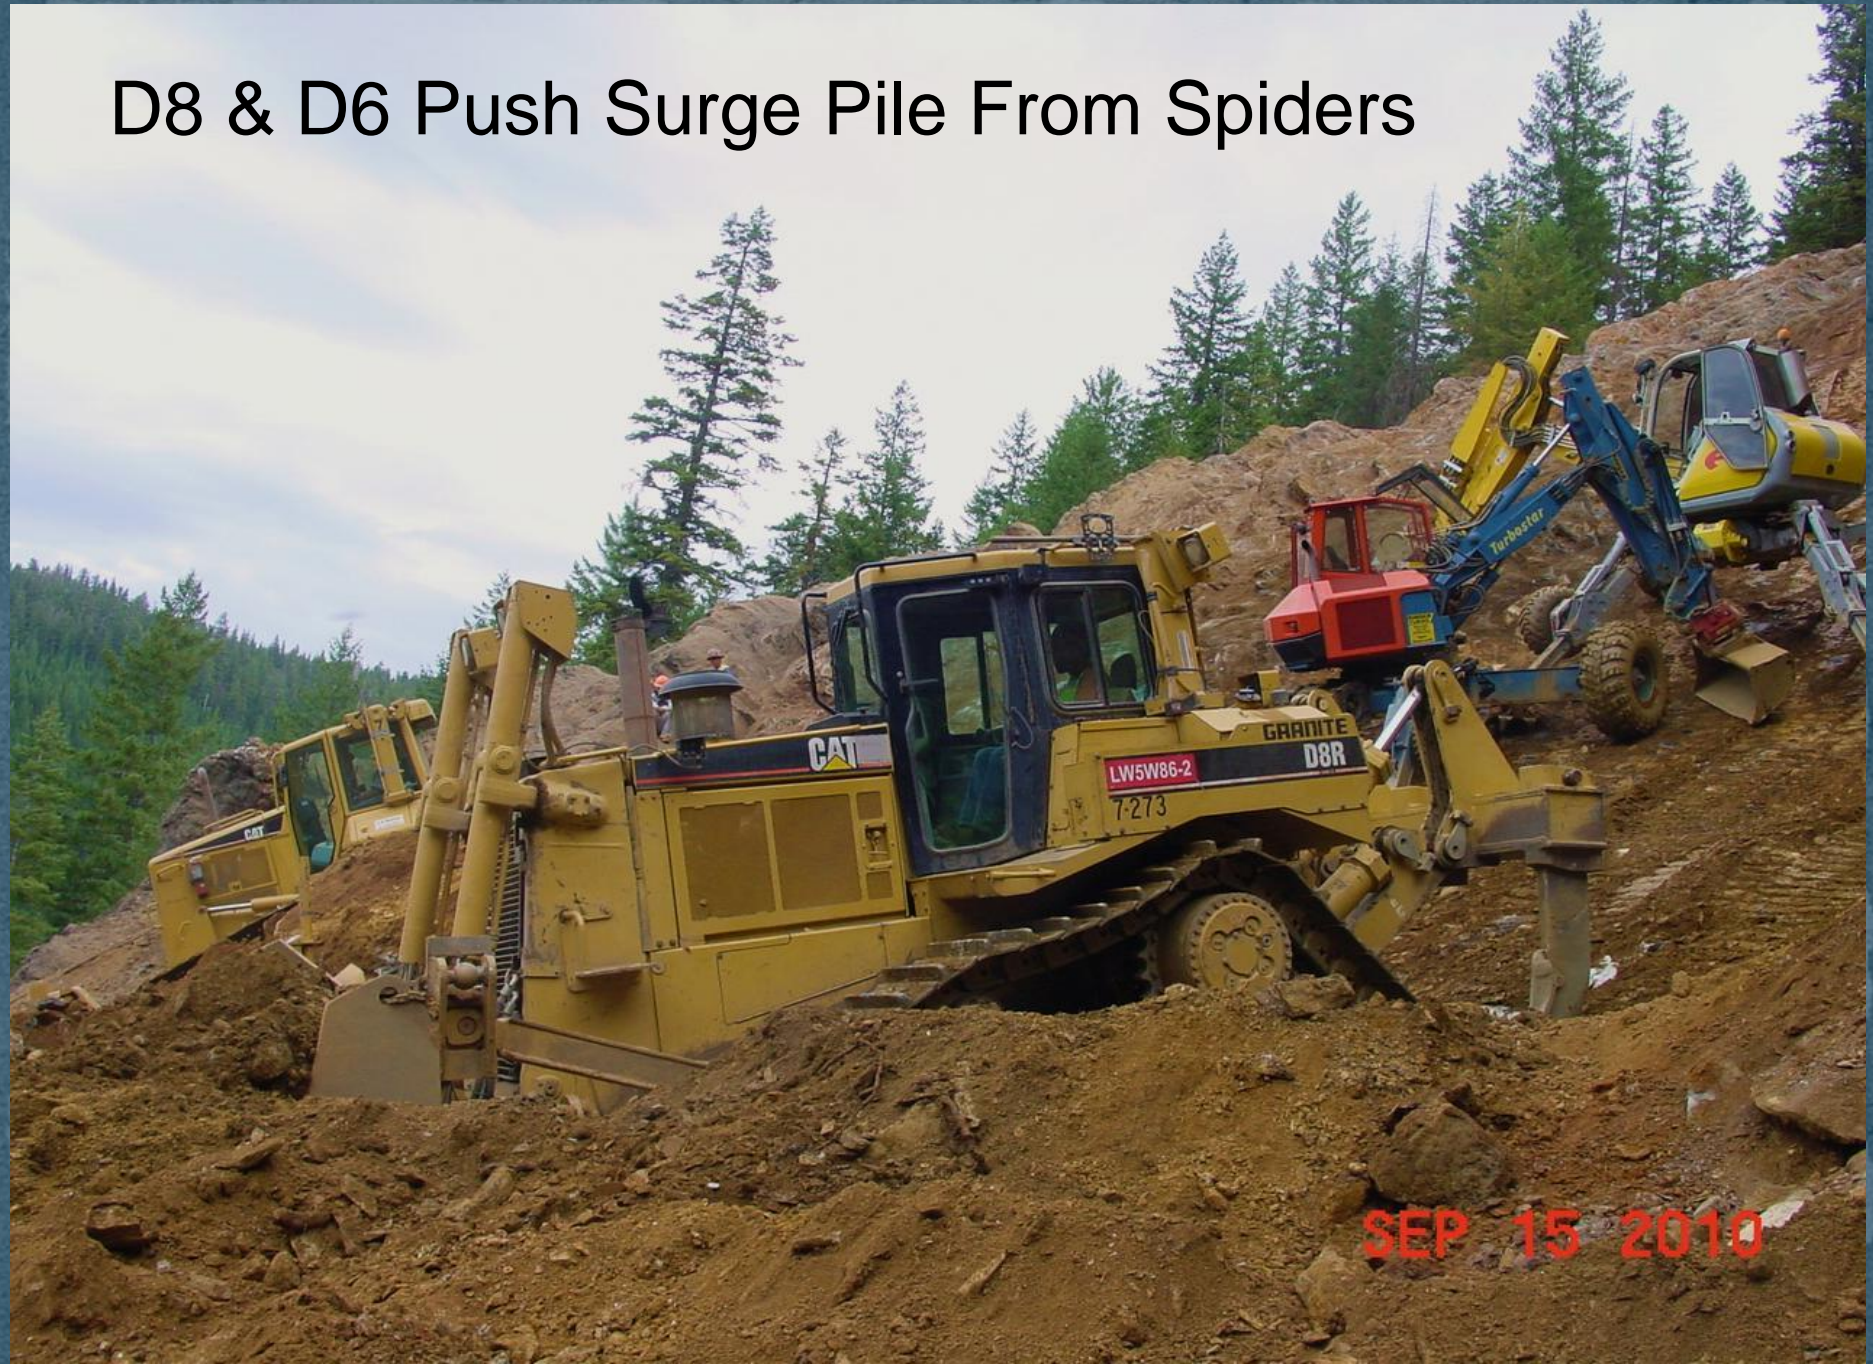
D8 & D6 Push Surge Pile From Spiders

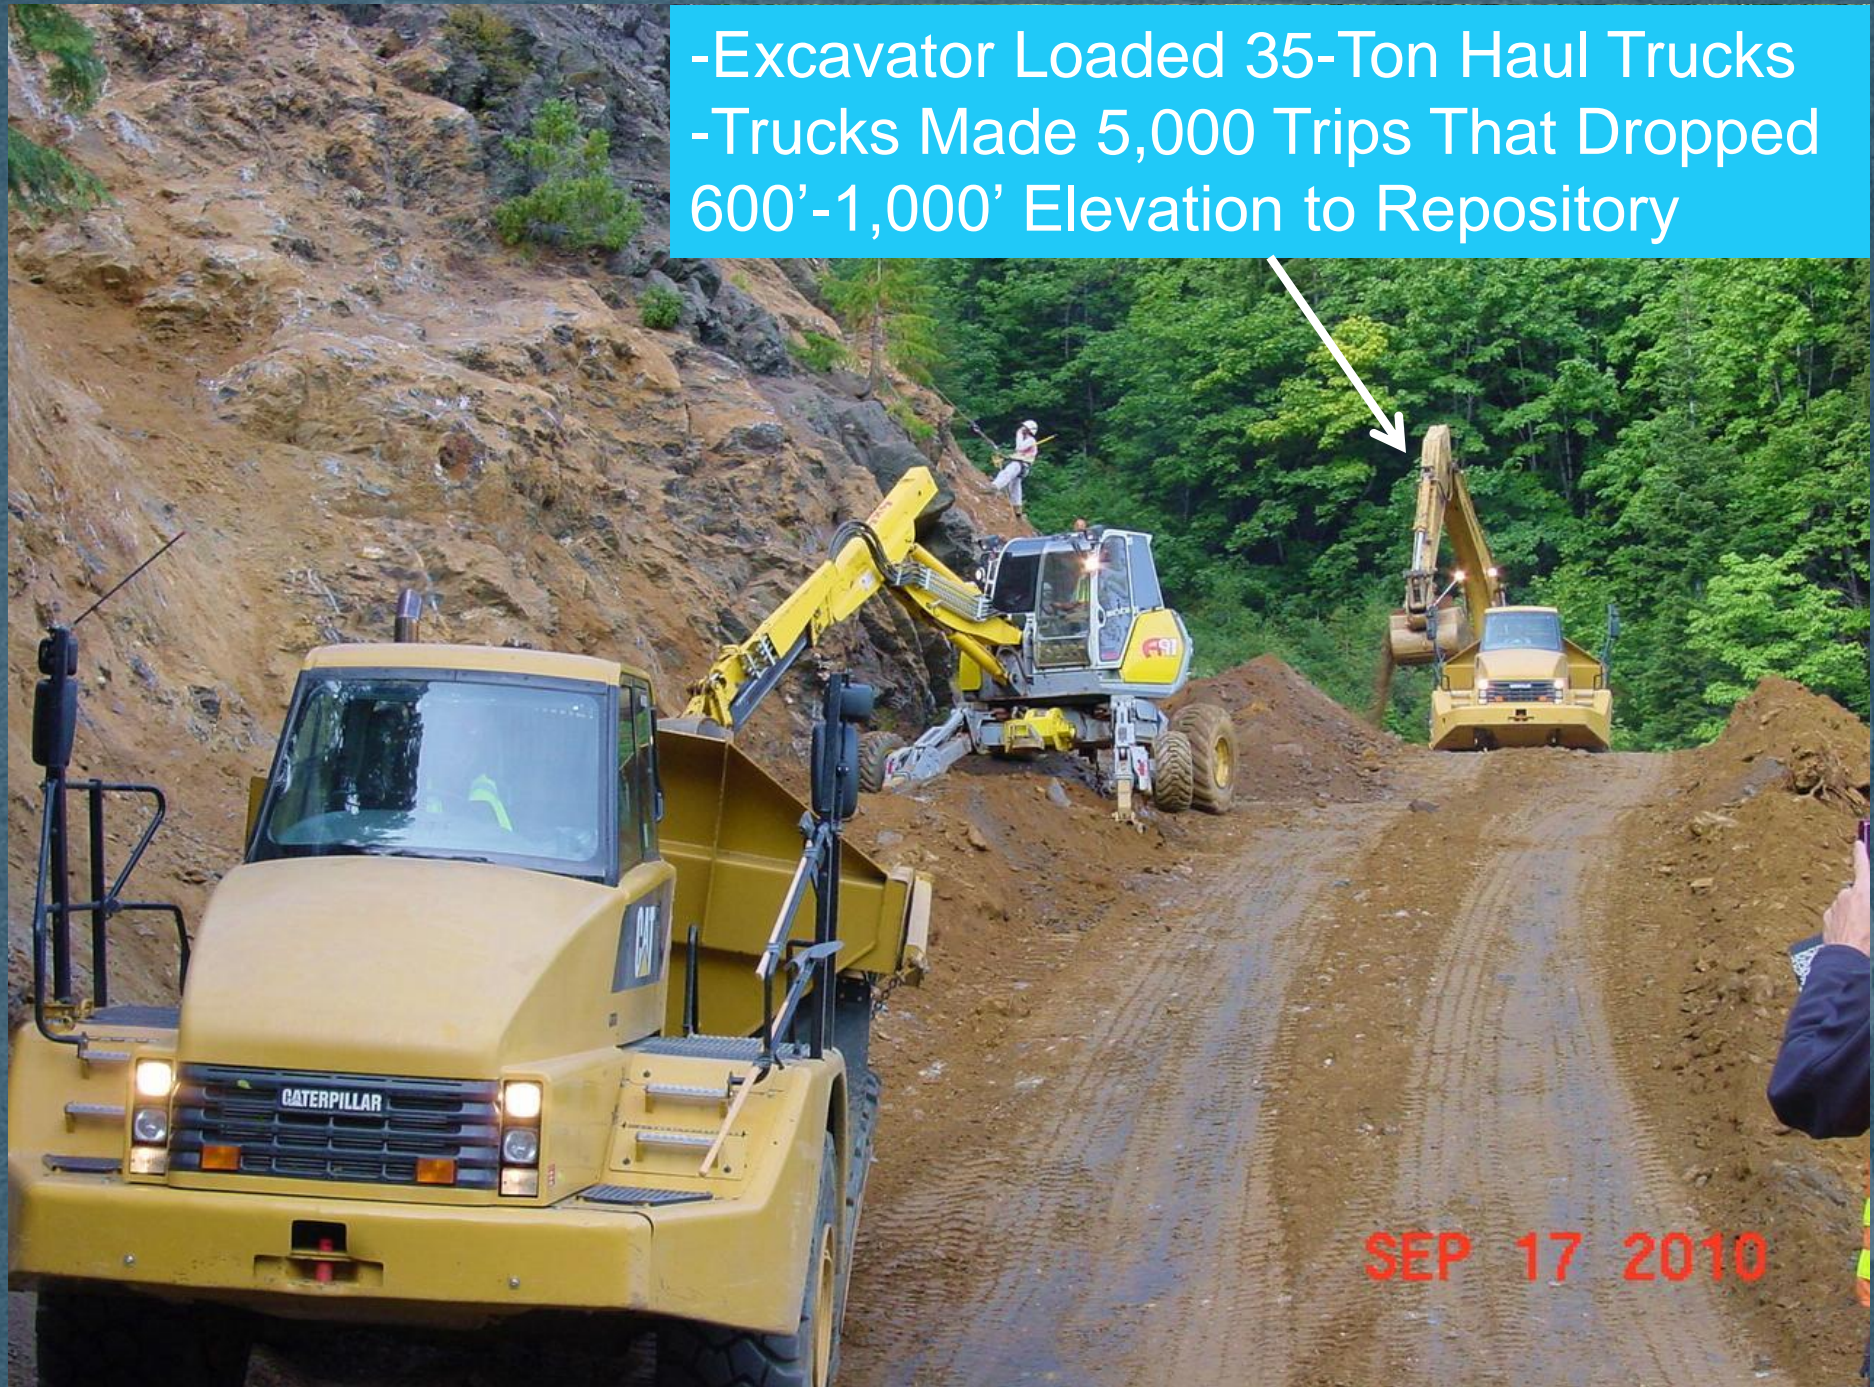
-Excavator Loaded 35-Ton Haul Trucks
-Trucks Made 5,000 Trips That Dropped
600'-1,000' Elevation to Repository

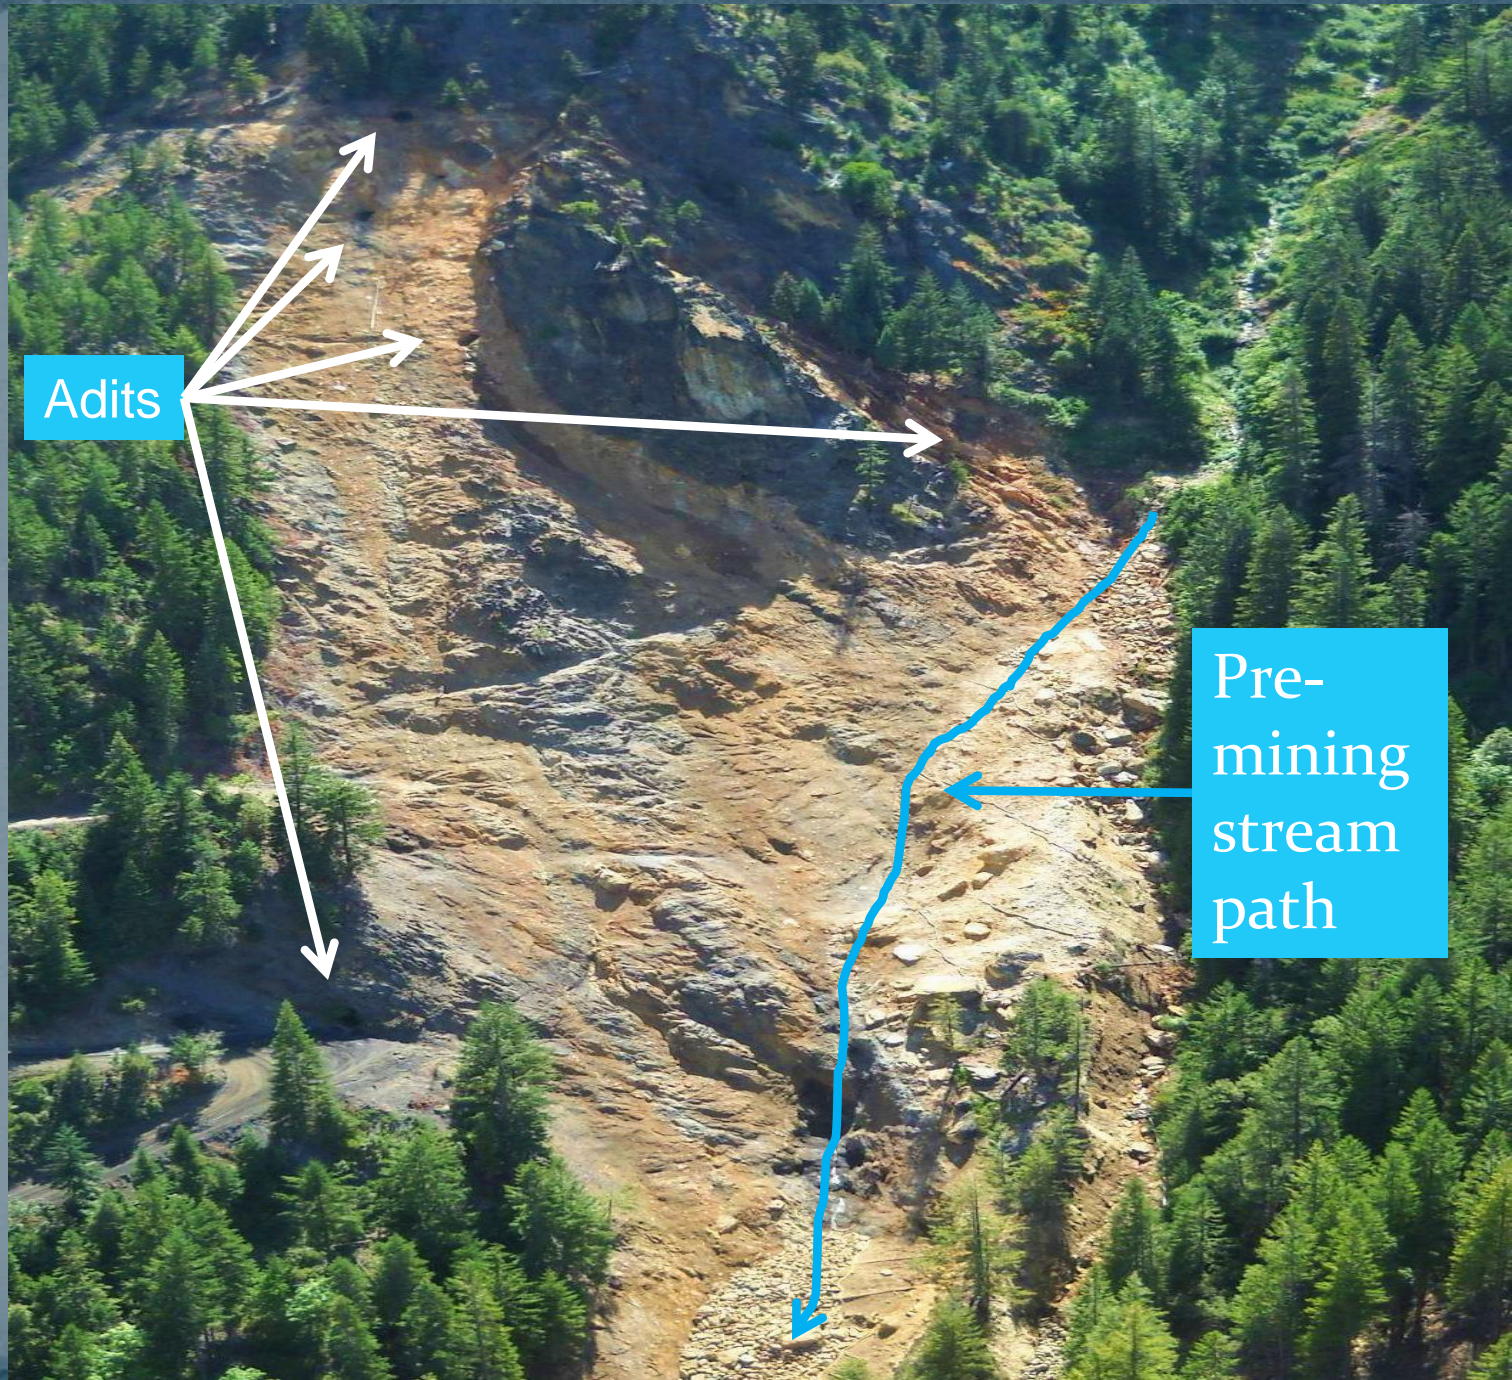
Aerial
View
After
Removal

Adits

Pre-
mining
stream
path

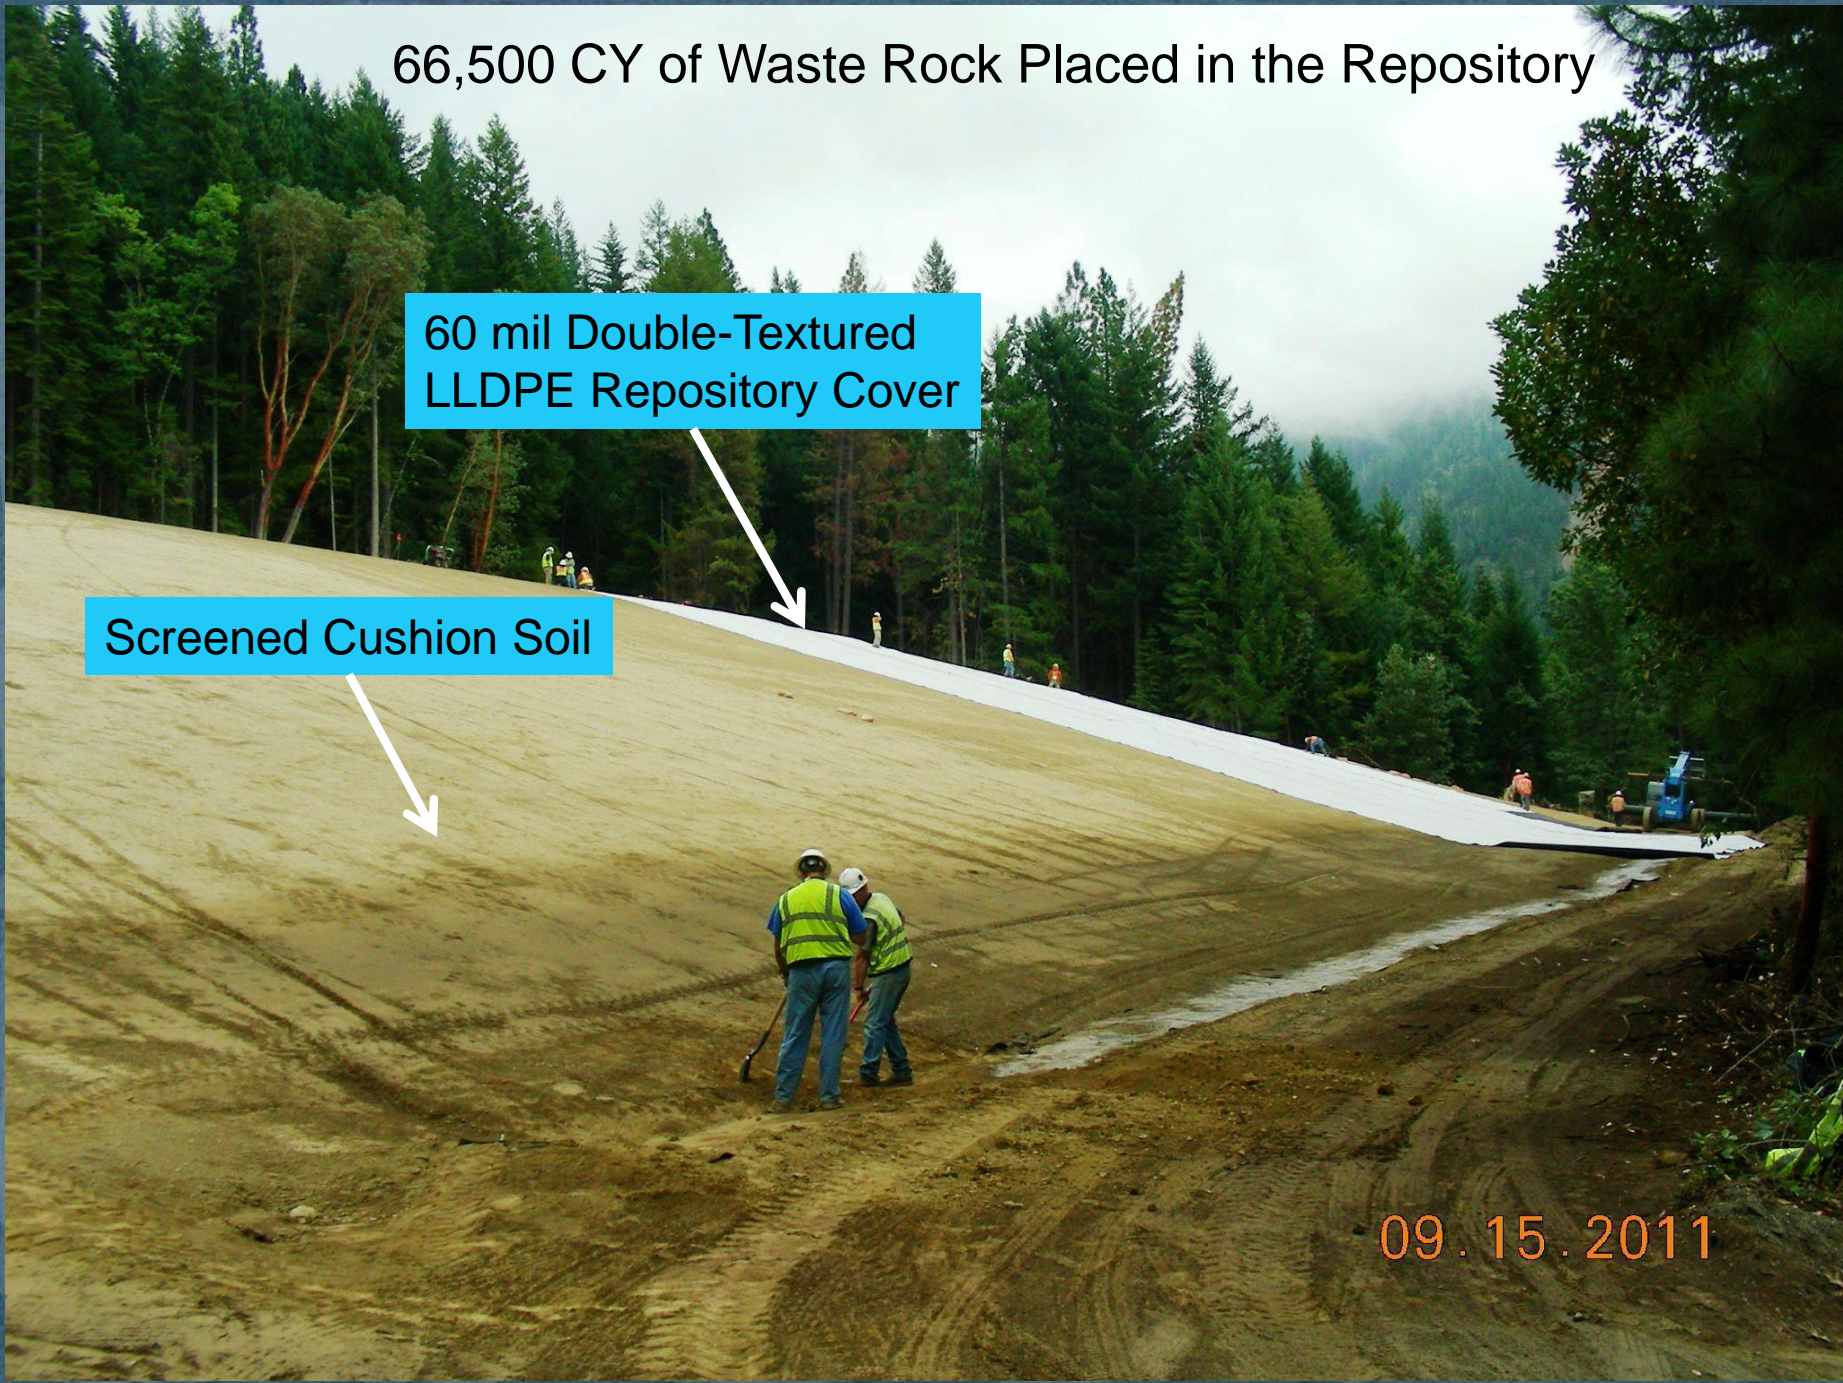
66,500 CY of Waste Rock Placed in the Repository

60 mil Double-Textured
LLDPE Repository Cover

Screened Cushion Soil
