Blue Ledge Mine Superfund Site Presentation Overview

US Forest Service
Non-Time-Critical
Removal Action

Emphasis on AMD Source Control by Removing Waste Rock Piles

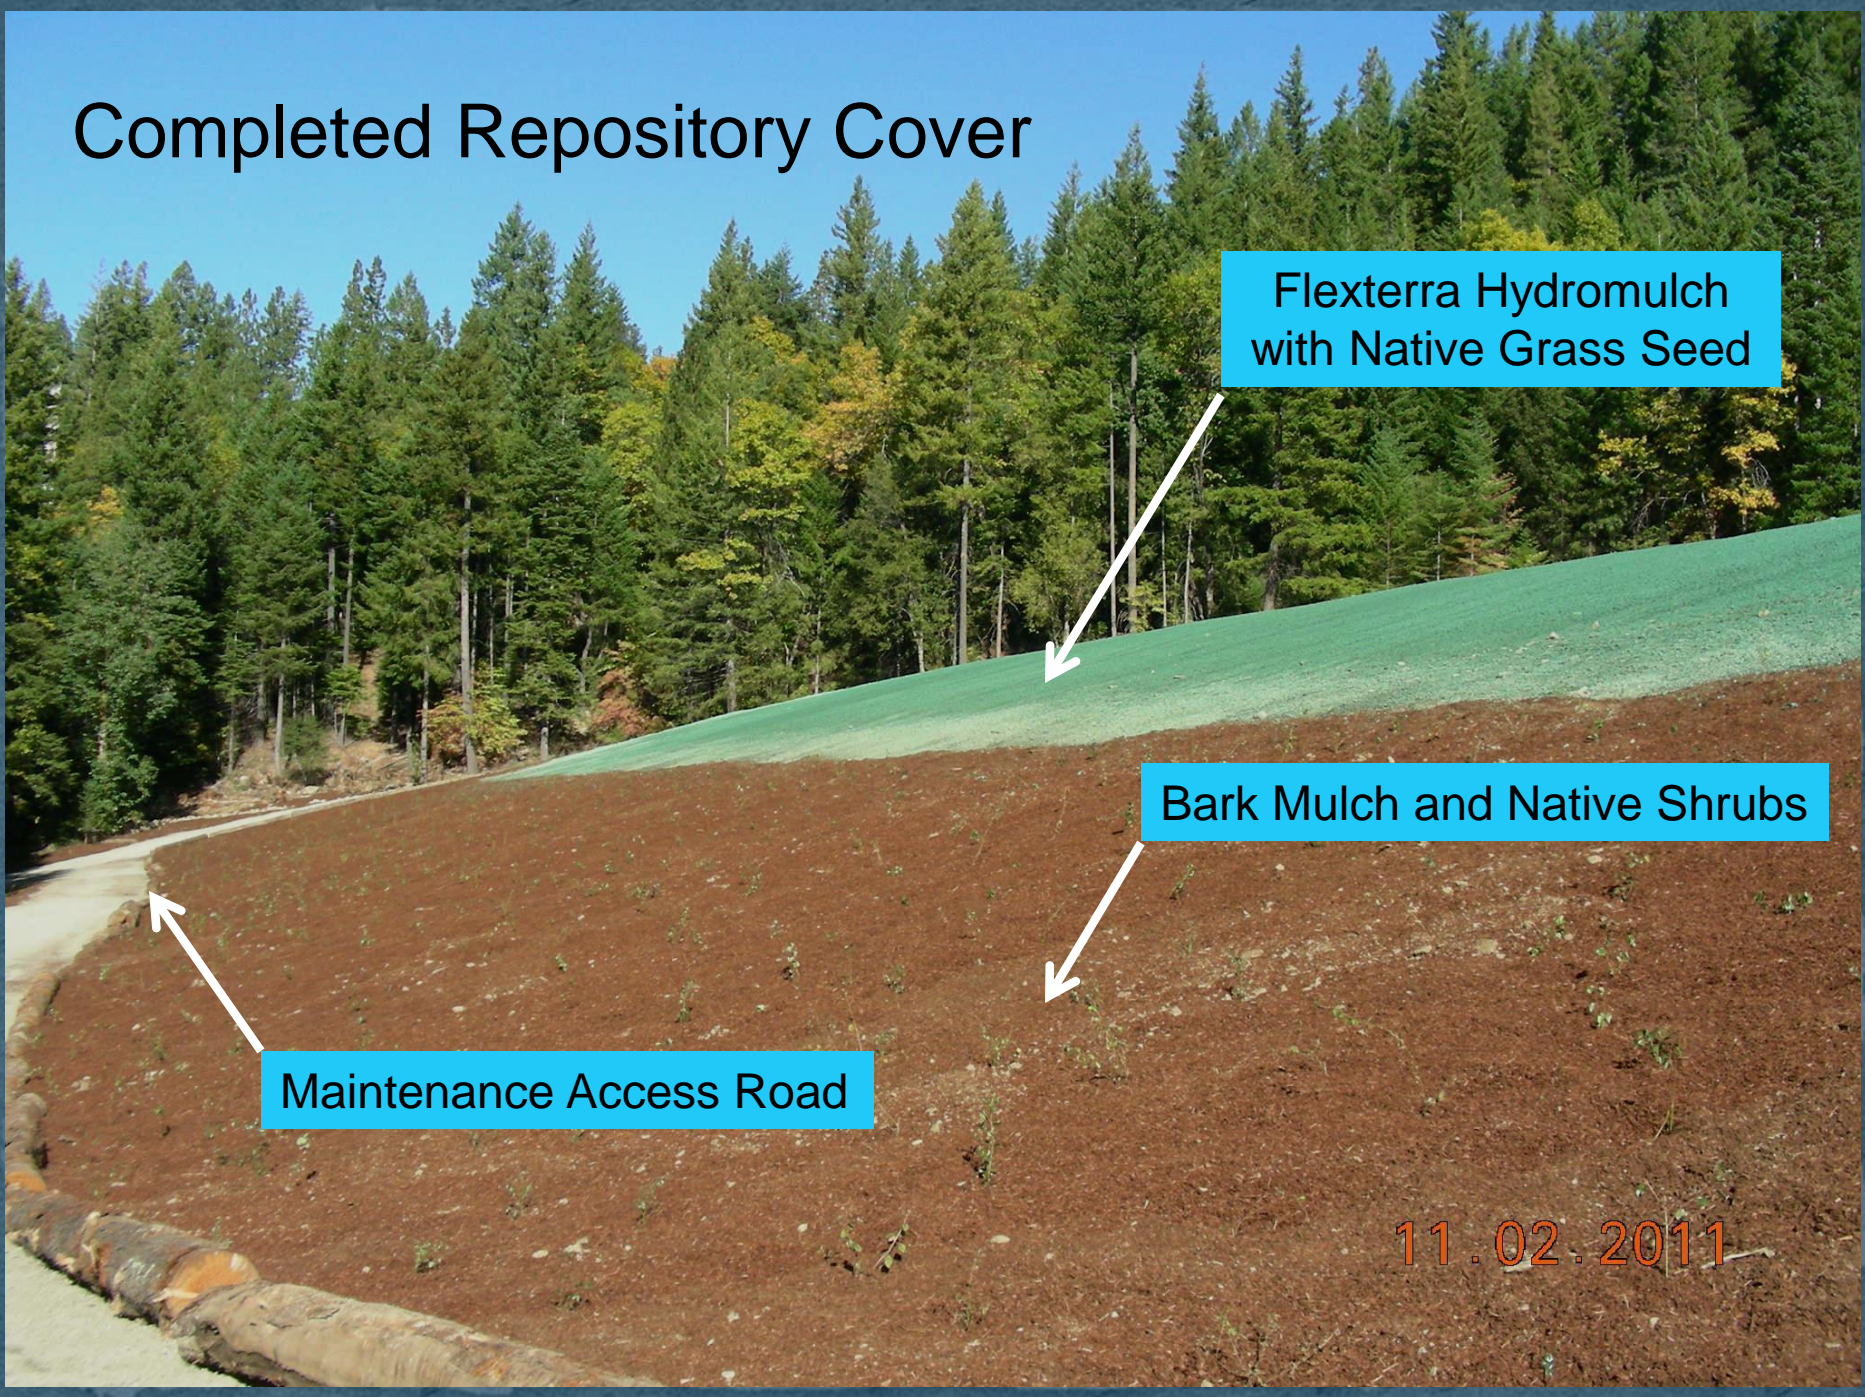
Completed Repository Cover

Flexterra Hydromulch
with Native Grass Seed

Bark Mulch and Native Shrubs

Maintenance Access Road

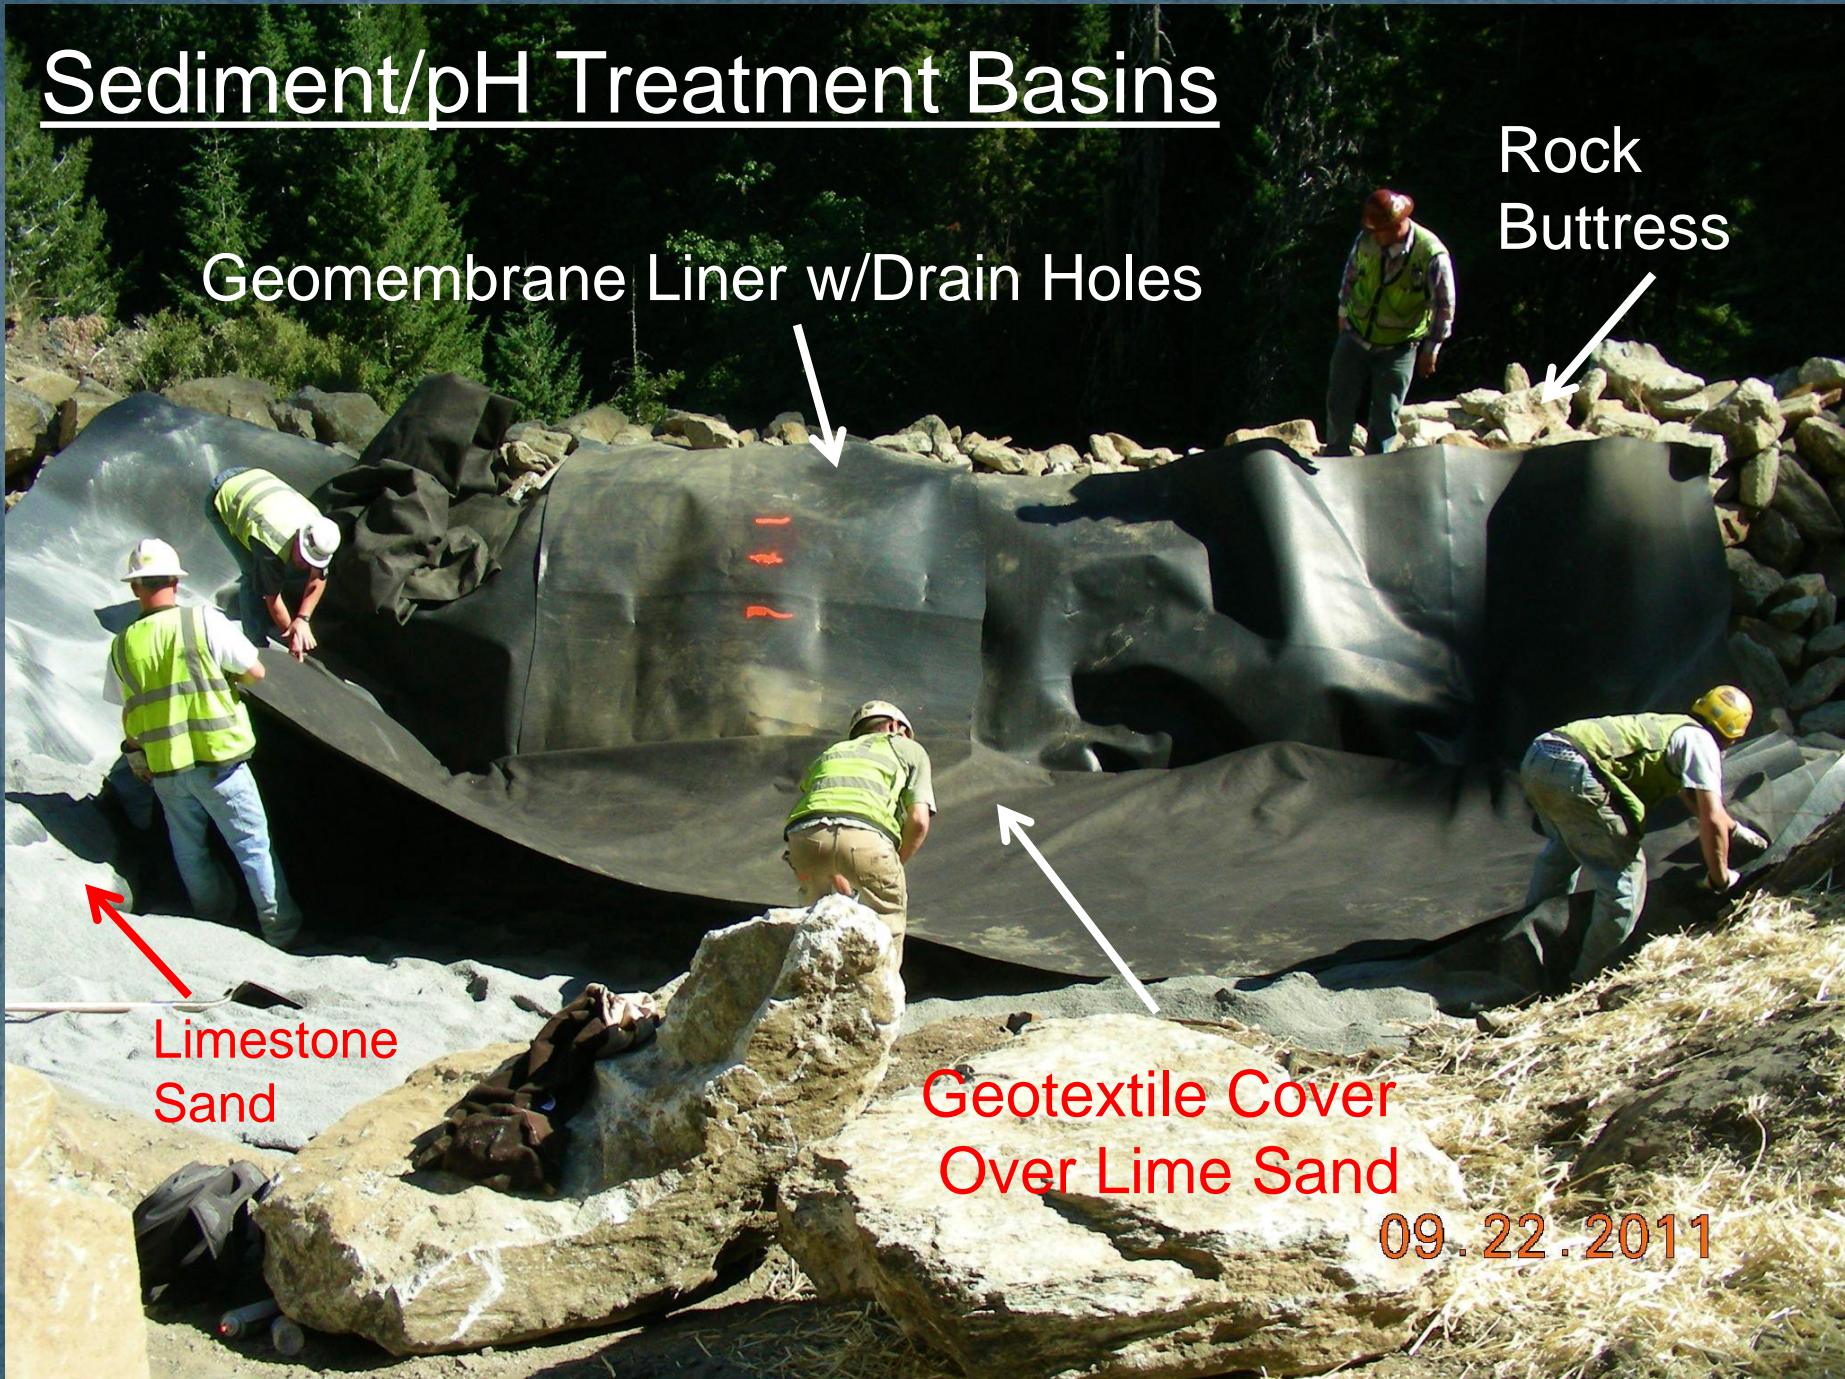
Sediment/pH Treatment Basins

Geomembrane Liner w/Drain Holes

Rock
Buttress

Limestone
Sand

Geotextile Cover
Over Lime Sand

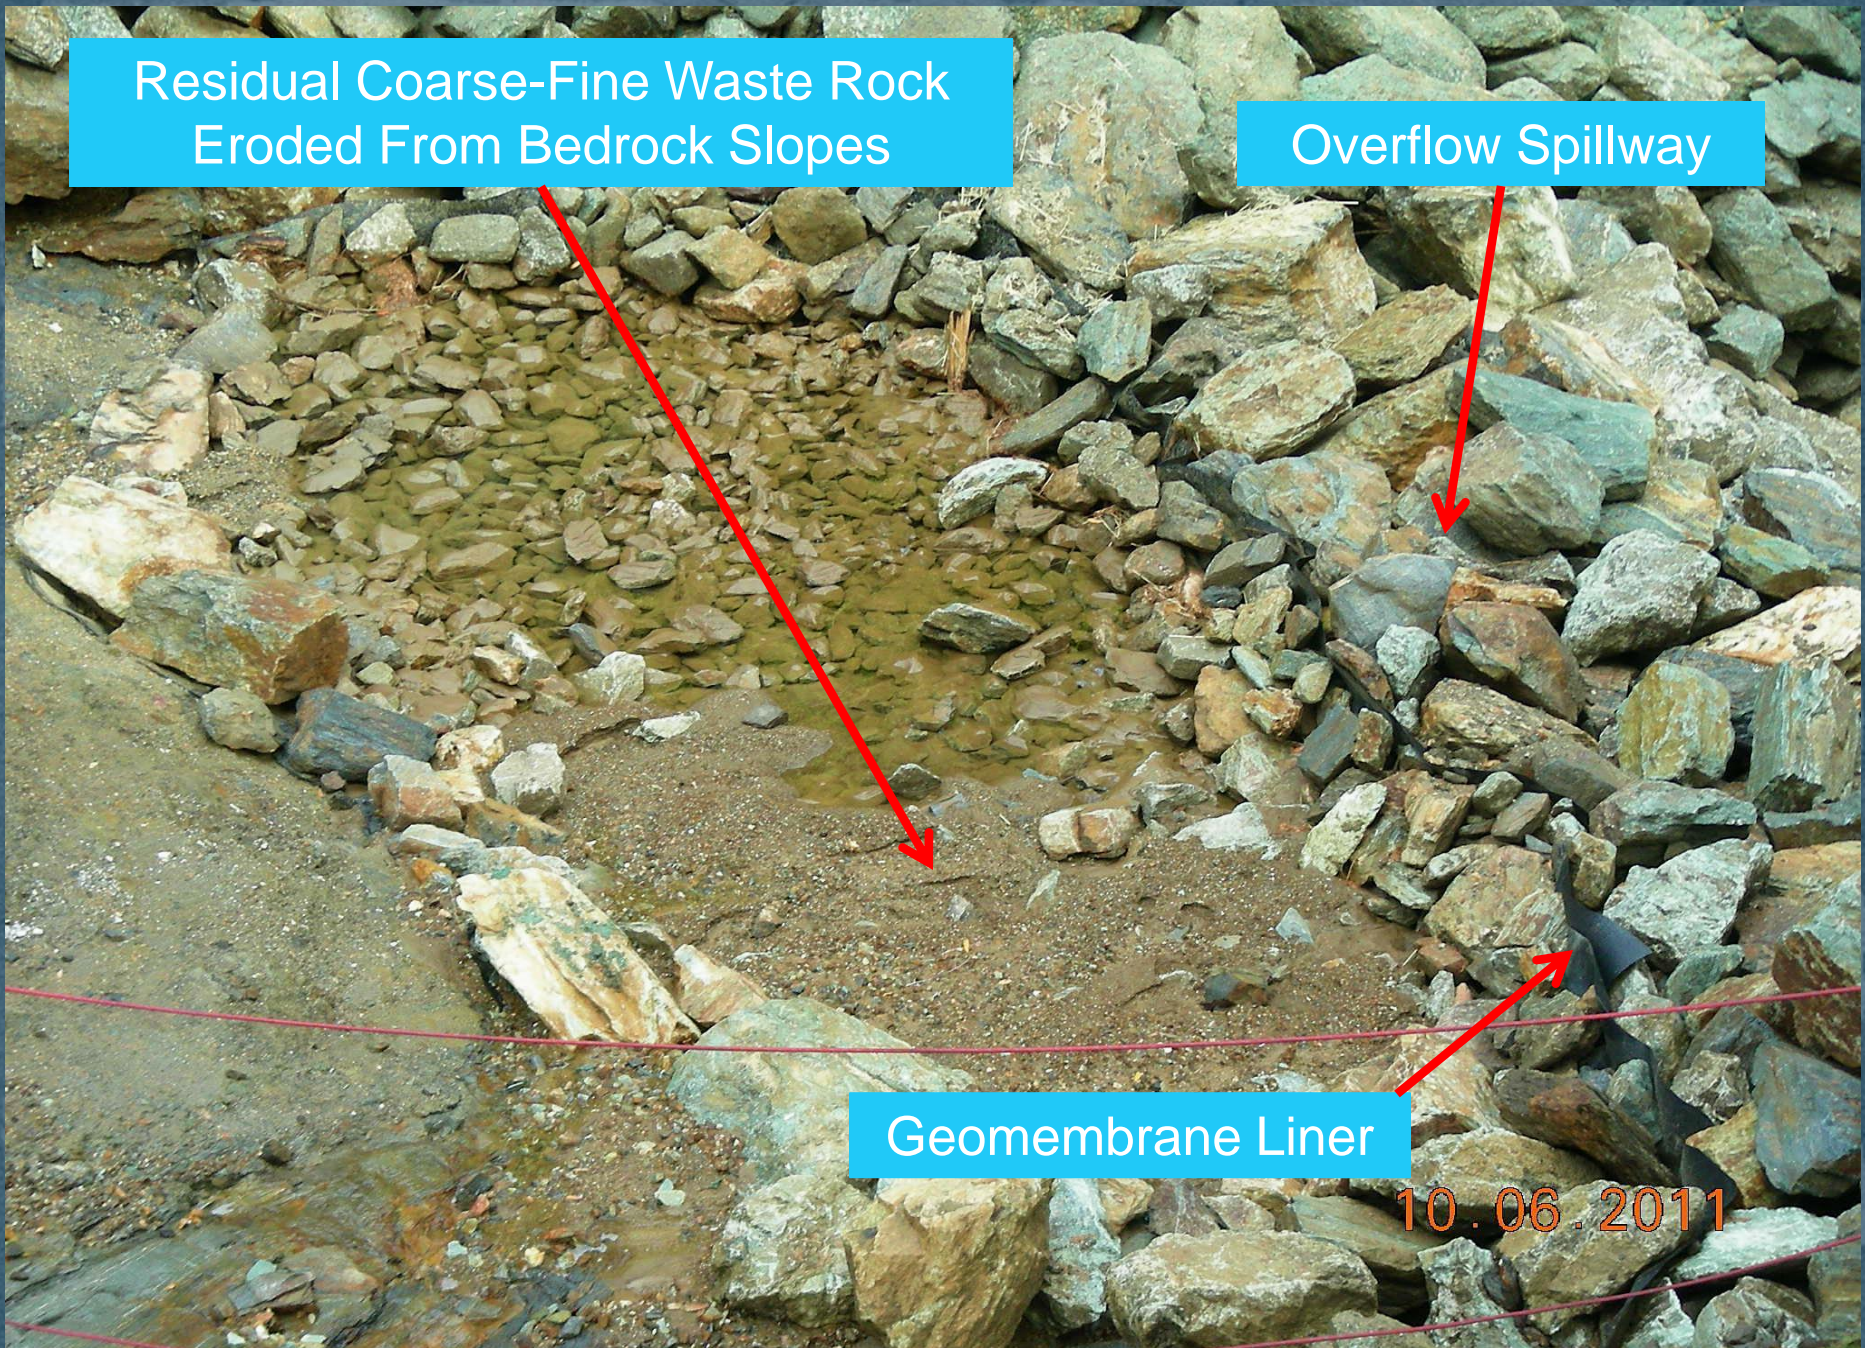
Residual Coarse-Fine Waste Rock
Eroded From Bedrock Slopes

Overflow Spillway

Geomembrane Liner

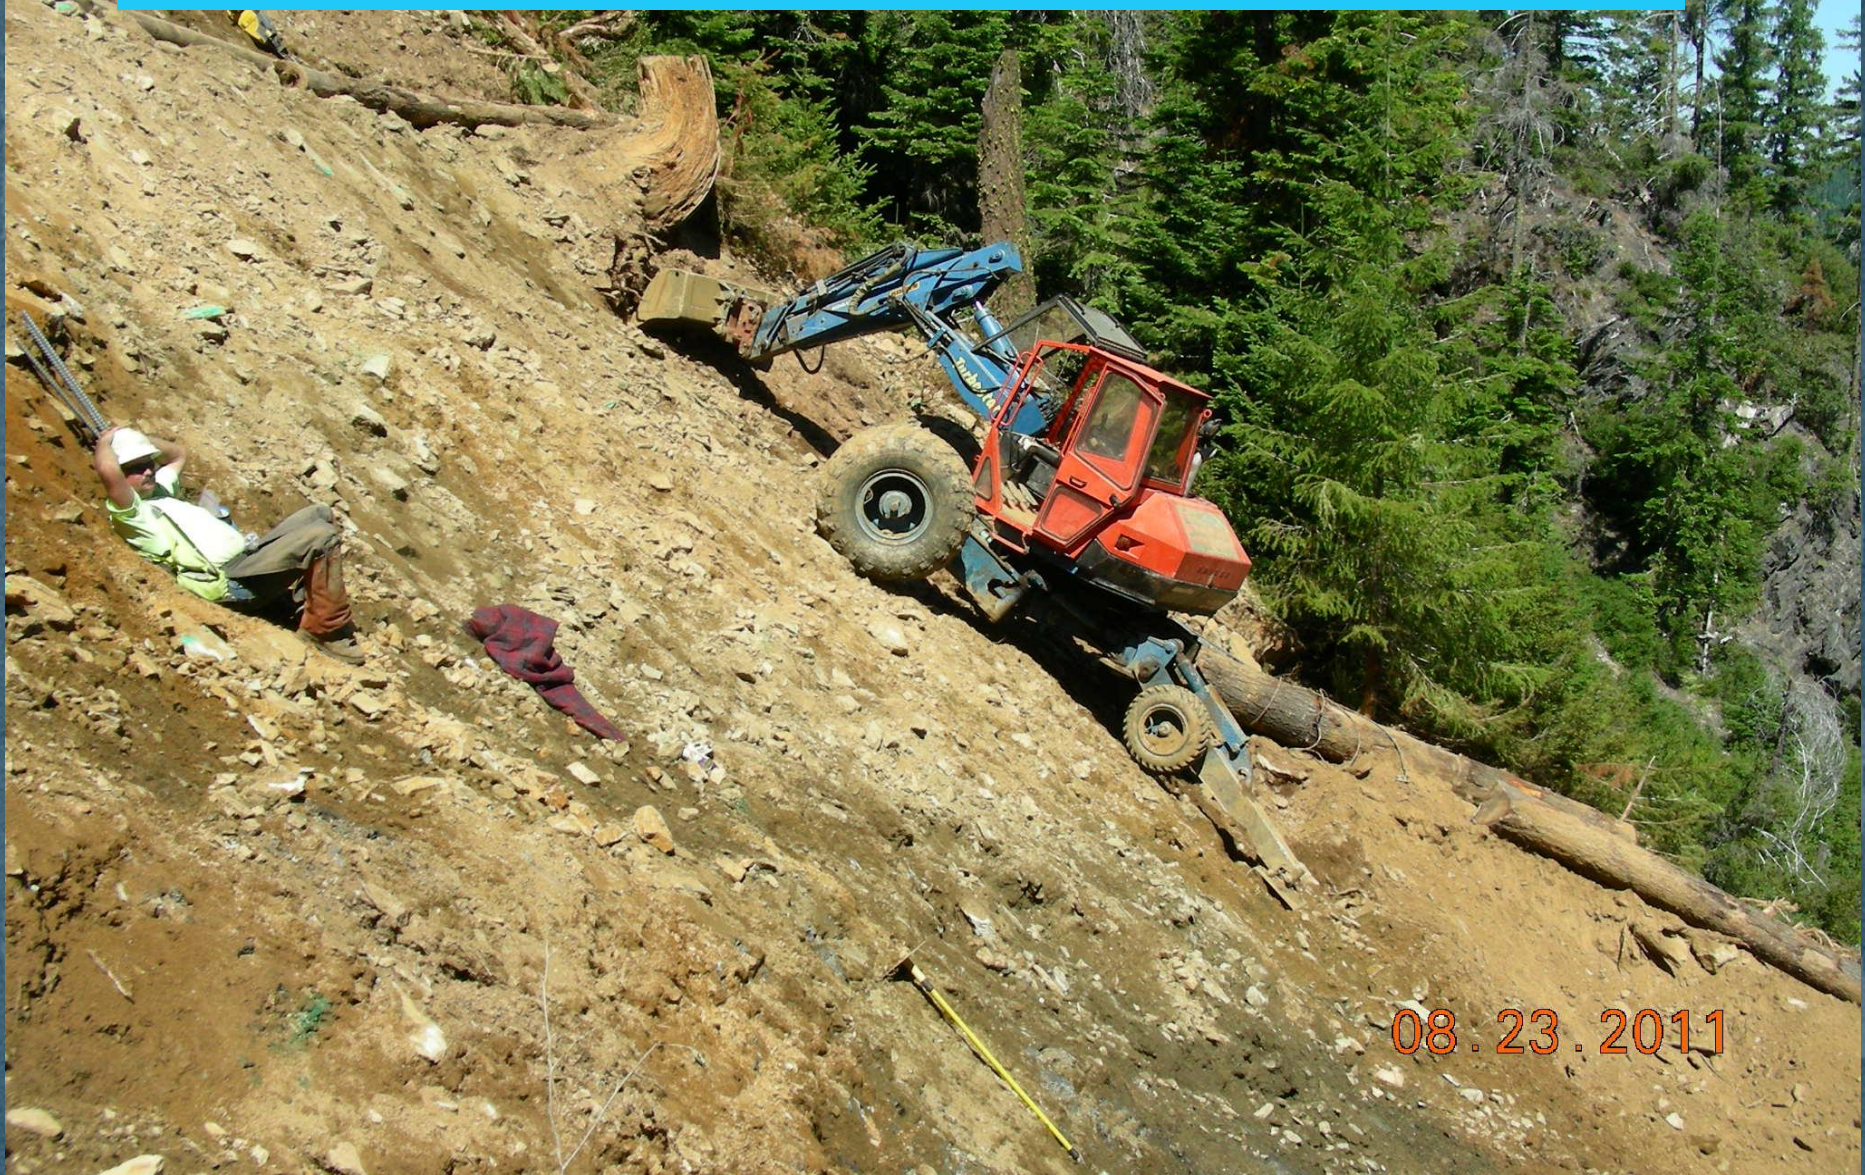
During Low
Flows

Seepage
Through
Limestone
Sand in
Basins

Raises pH
From 4 to 7

Copper and
Other Metals
Precipitate

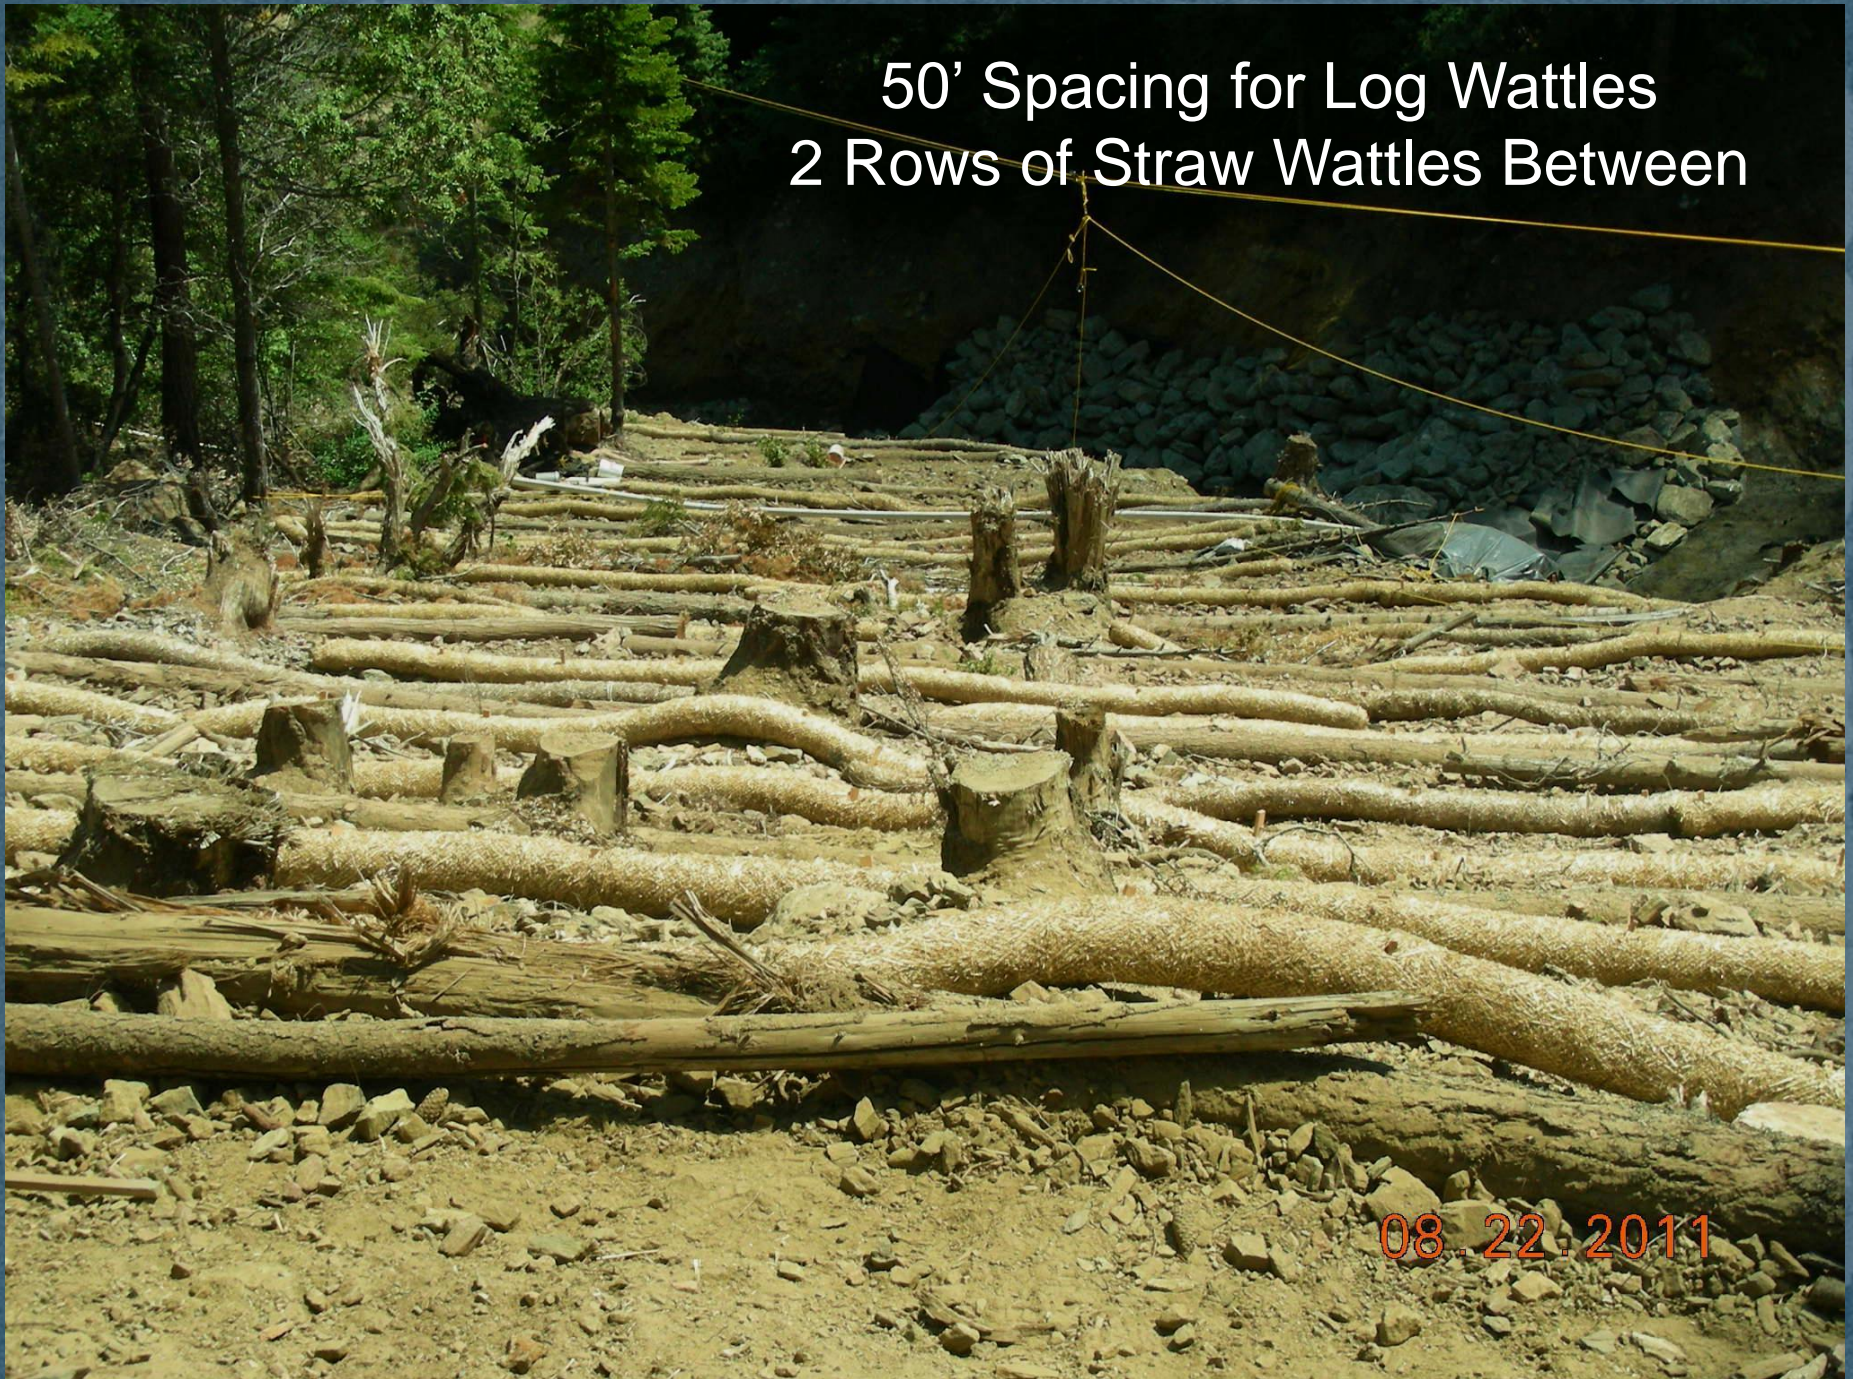
Waste Rock Pile 3
Residual Soil
Before Reclamation

50' Spacing for Log Wattles
2 Rows of Straw Wattles Between

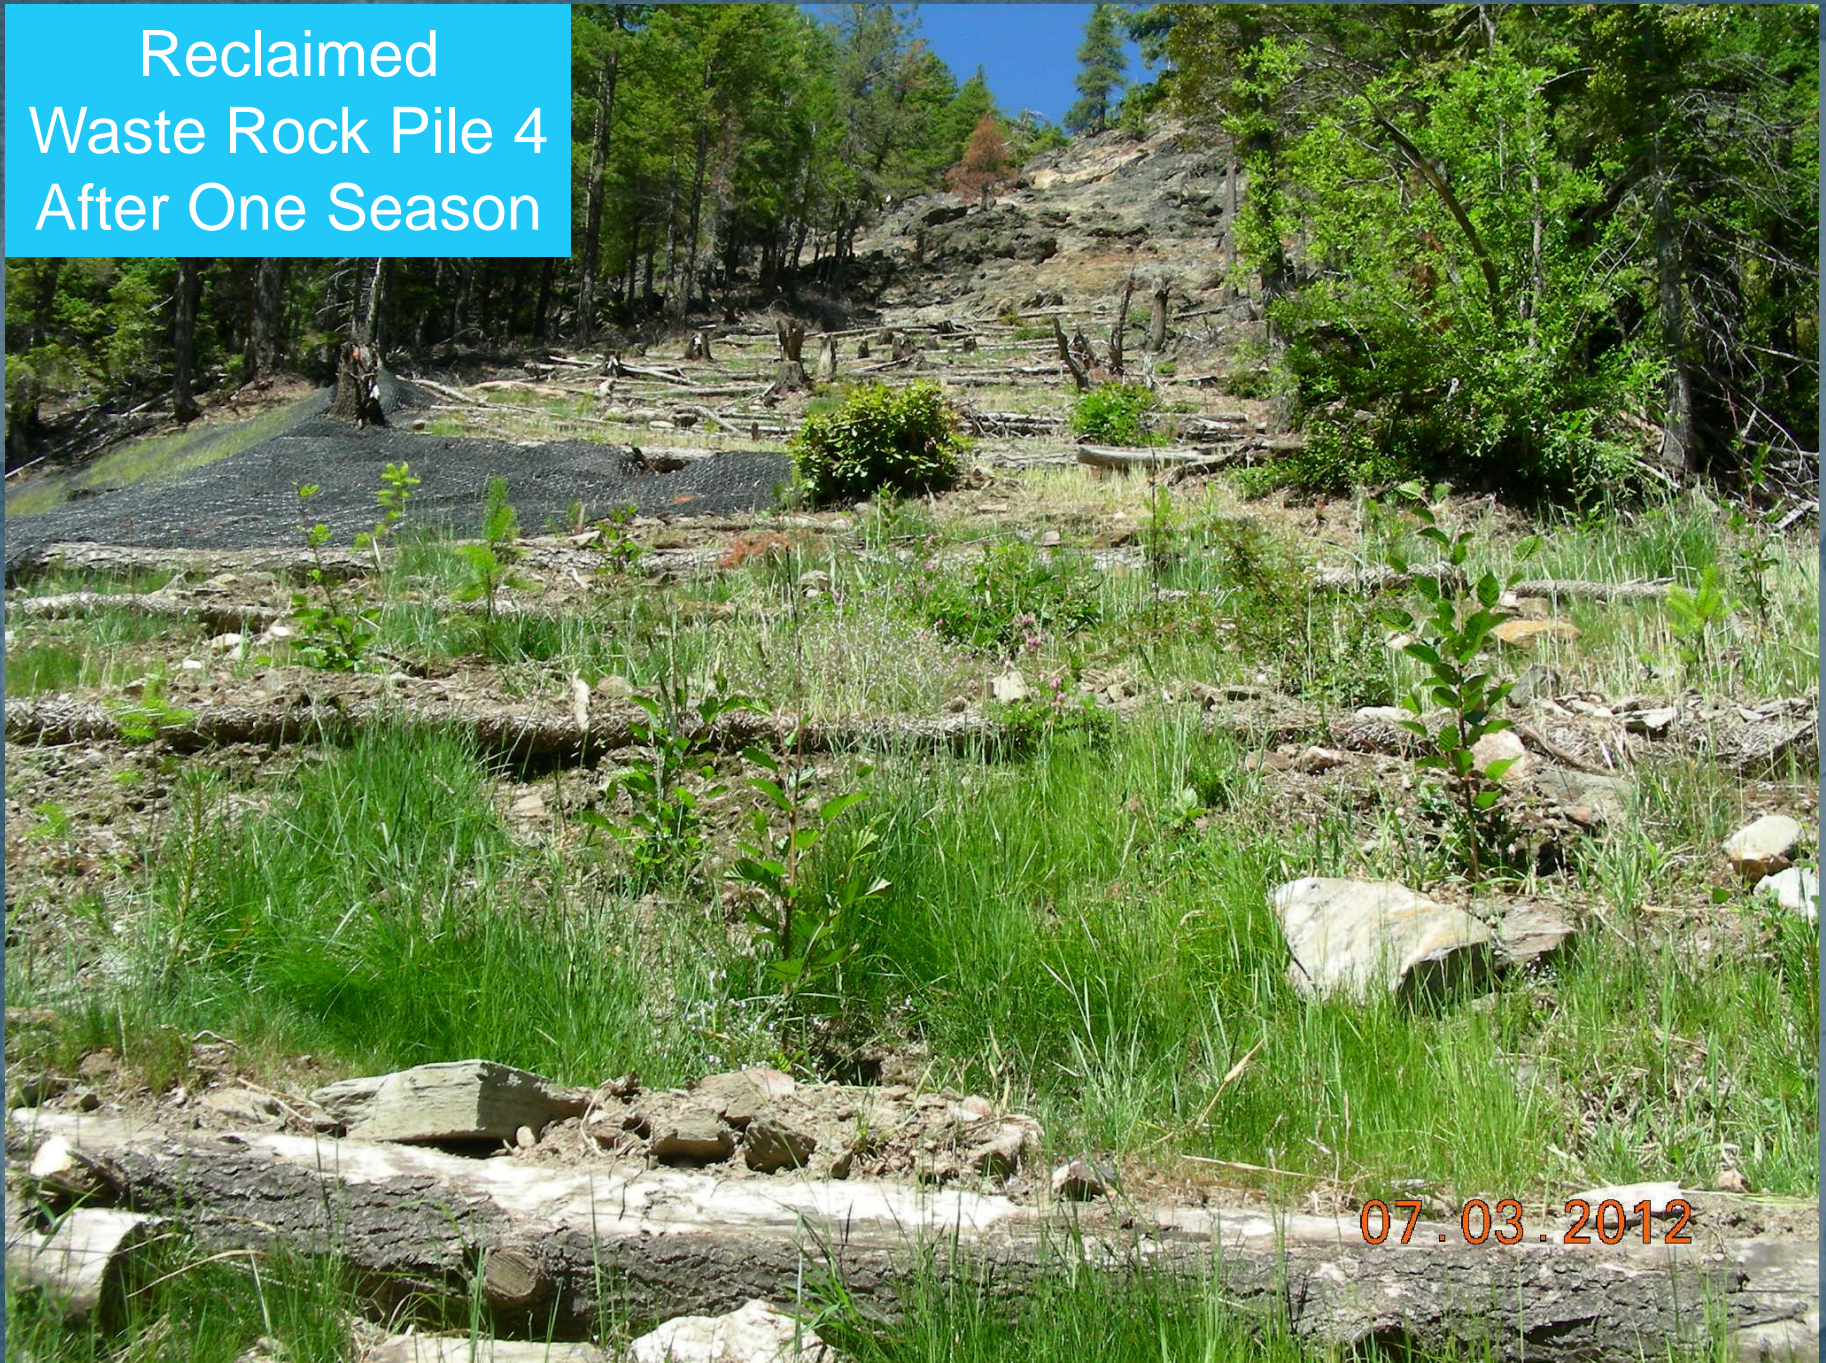
Reclaimed
Waste Rock Pile 4
After One Season

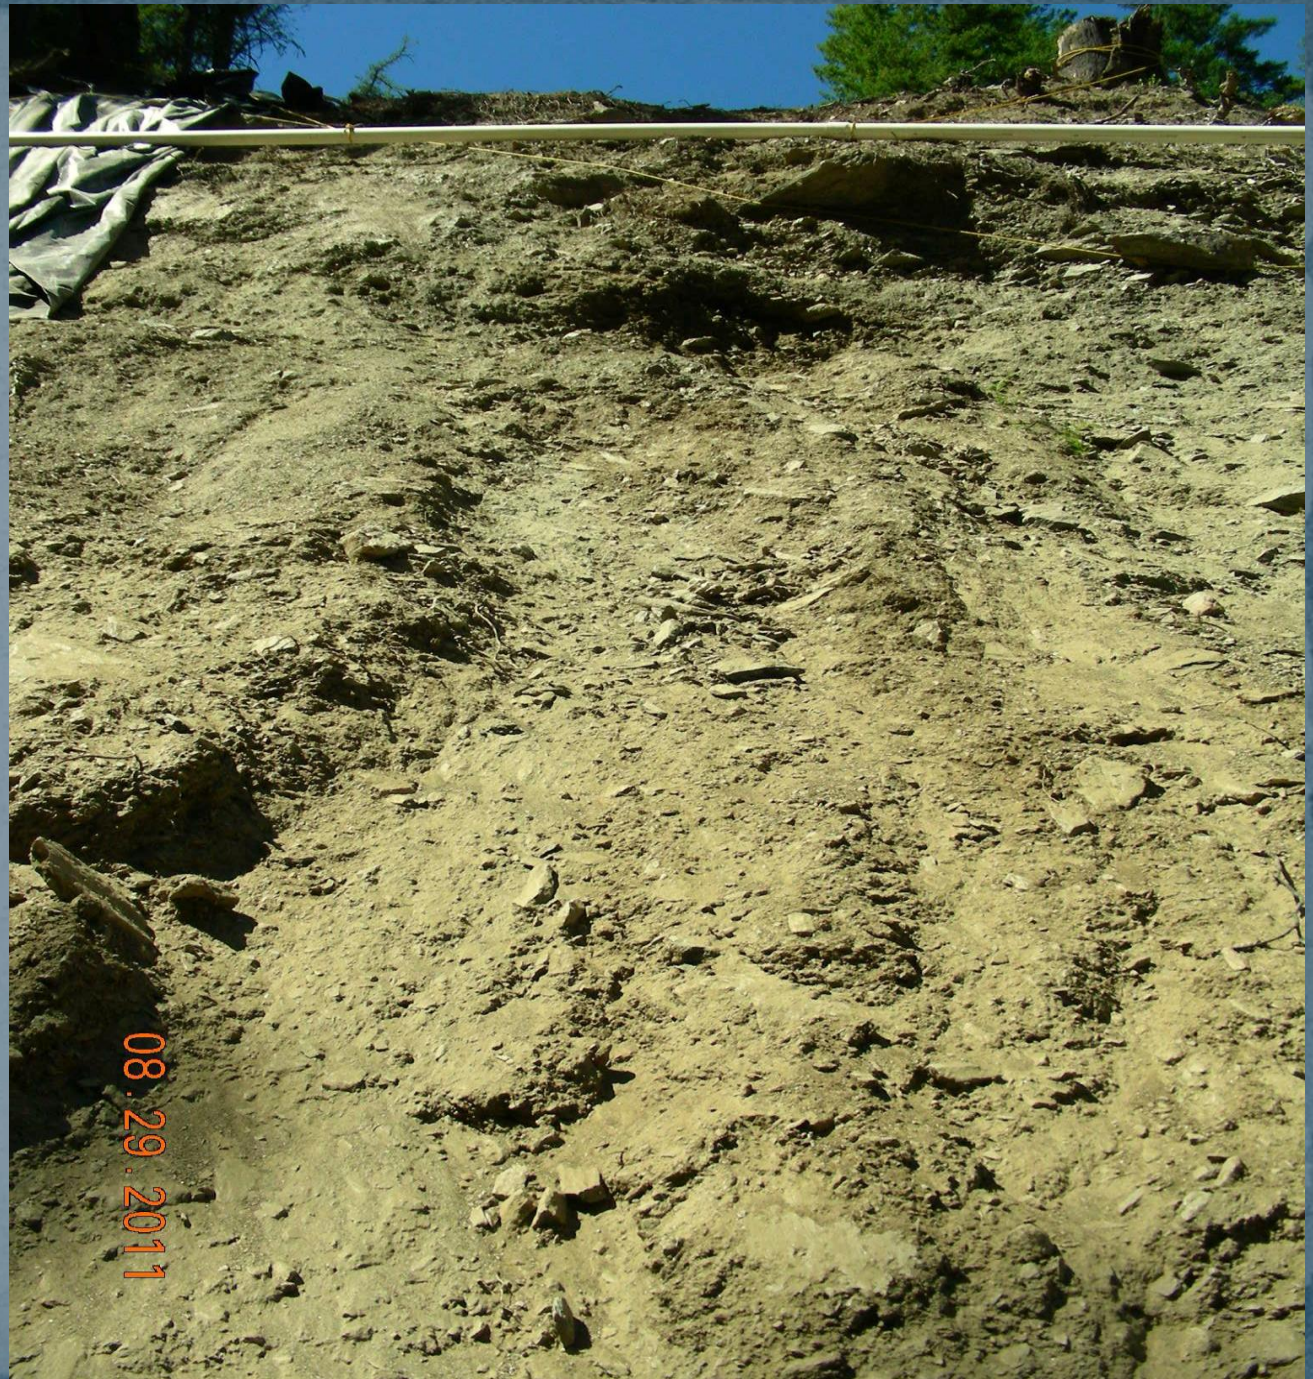
100% Slope
Raveling Above
Channel Needs
Stabilization

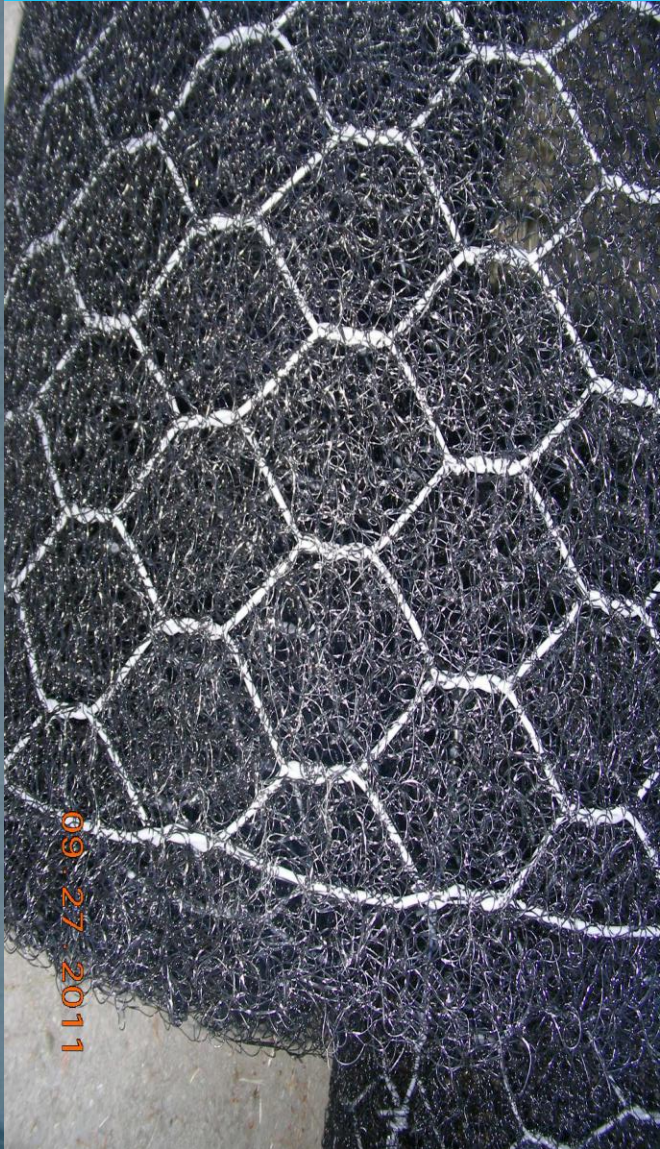
Double-Twisted PVC-Coated
Steel Mesh With Lofted
Polypropylene Netting

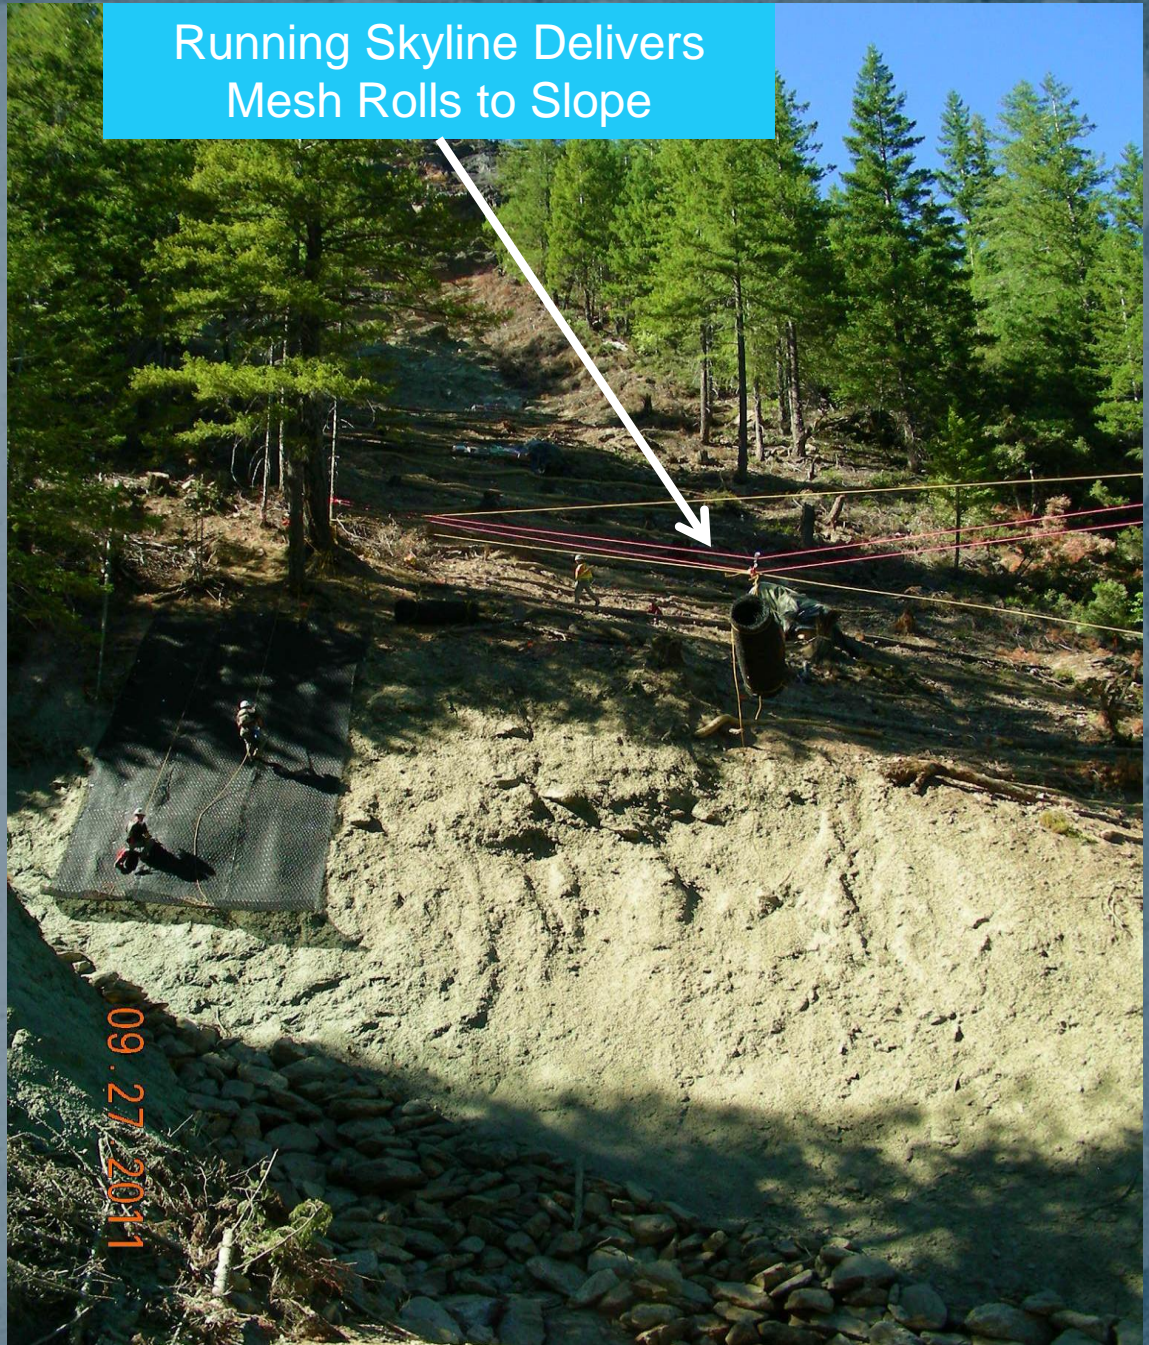
Running Skyline Delivers
Mesh Rolls to Slope

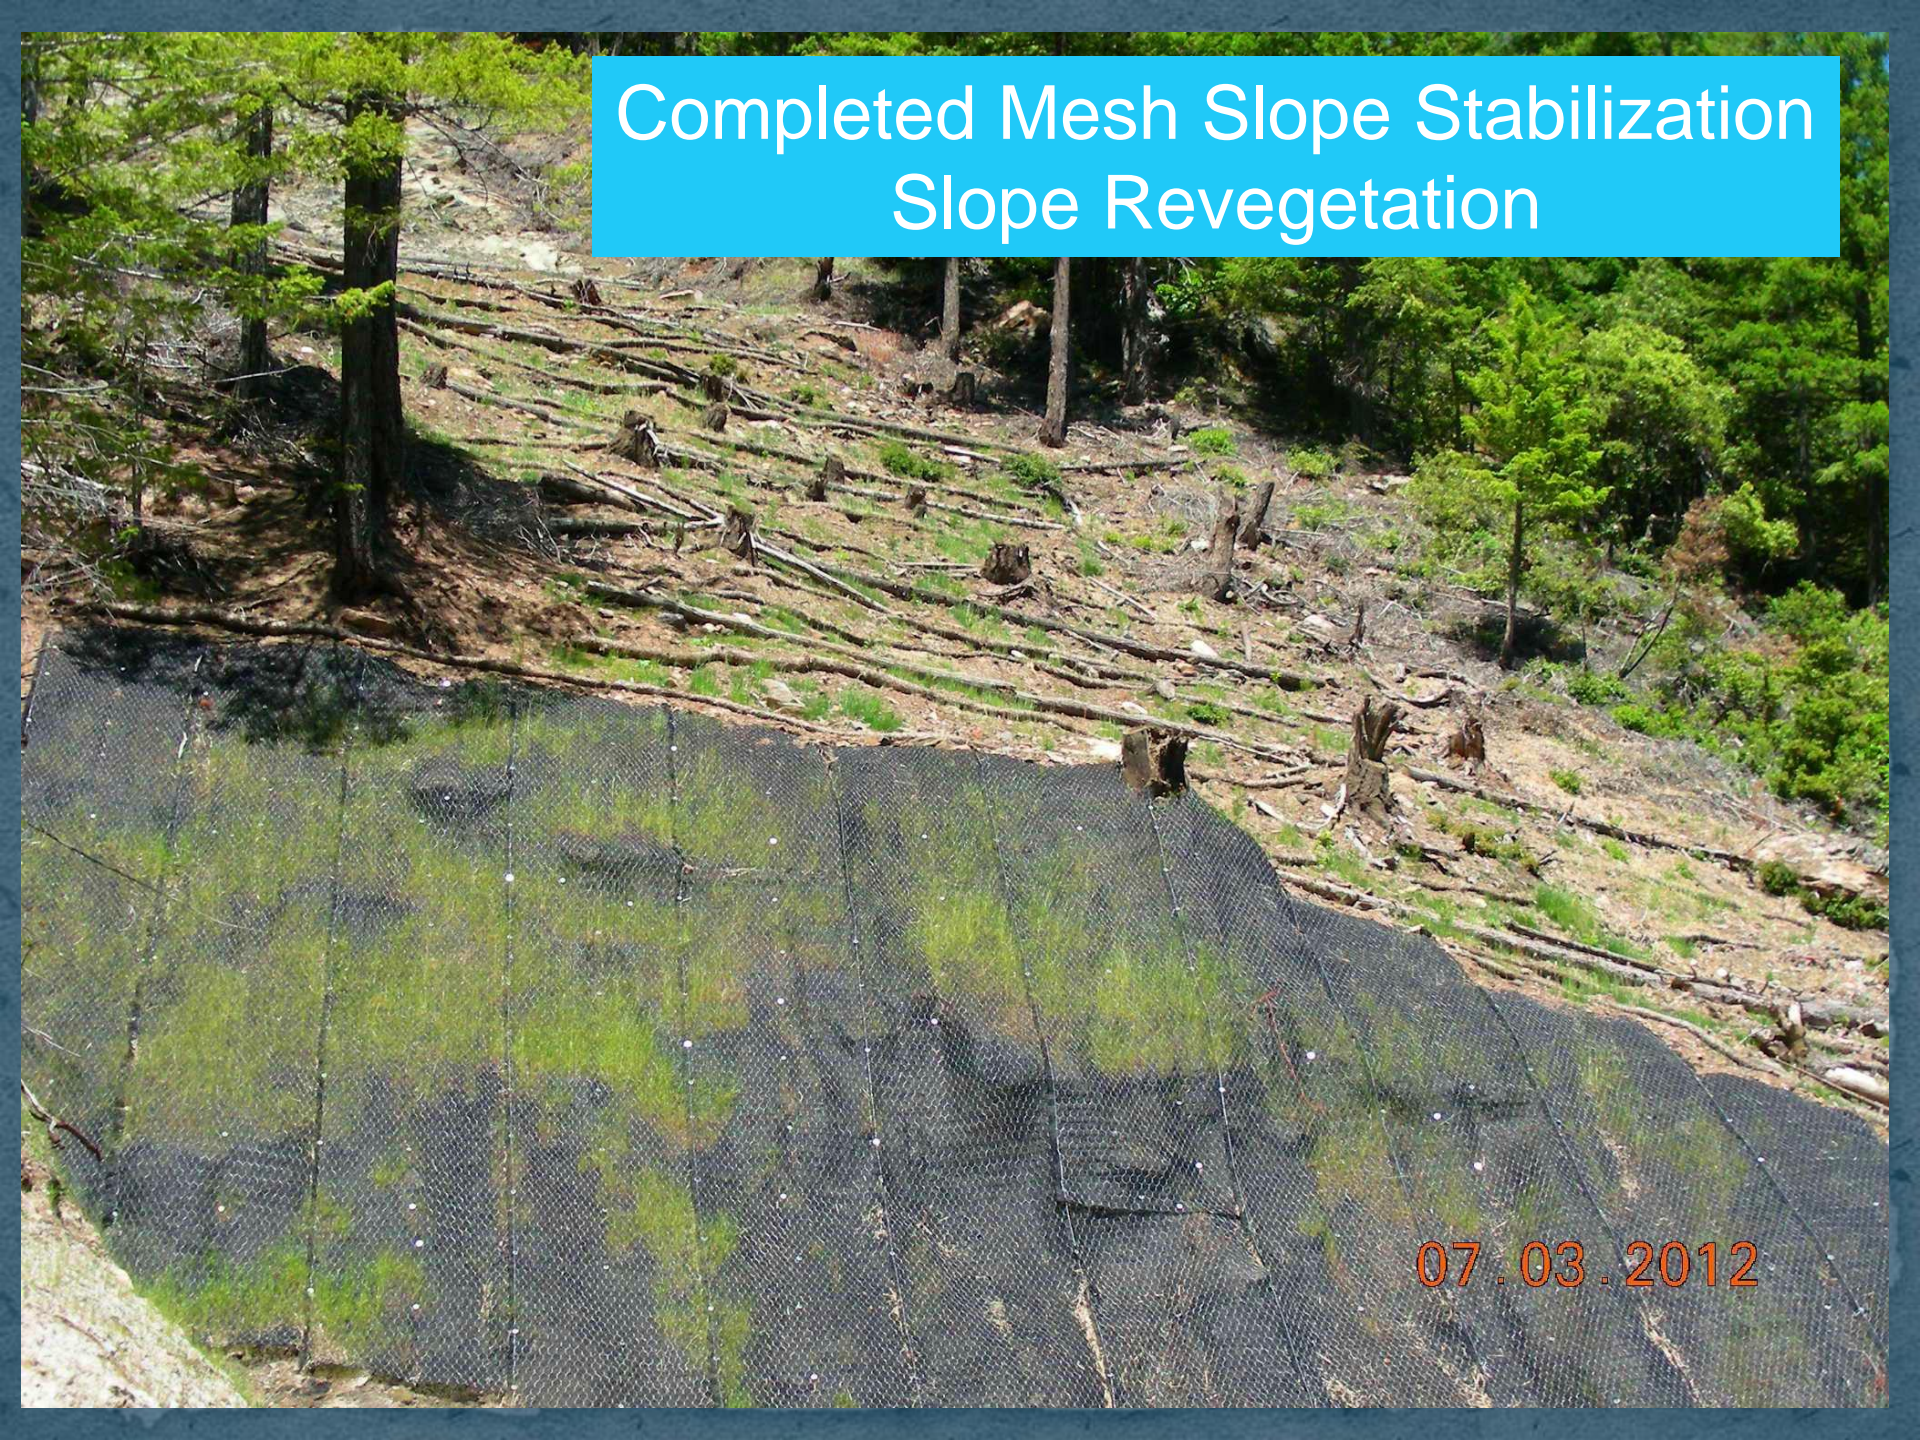
Completed Mesh Slope Stabilization Slope Revegetation
