Blue Ledge Mine Superfund Site Presentation Overview

US Forest Service
Non-Time-Critical
Removal Action

Emphasis on AMD Source Control by Removing Waste Rock Piles

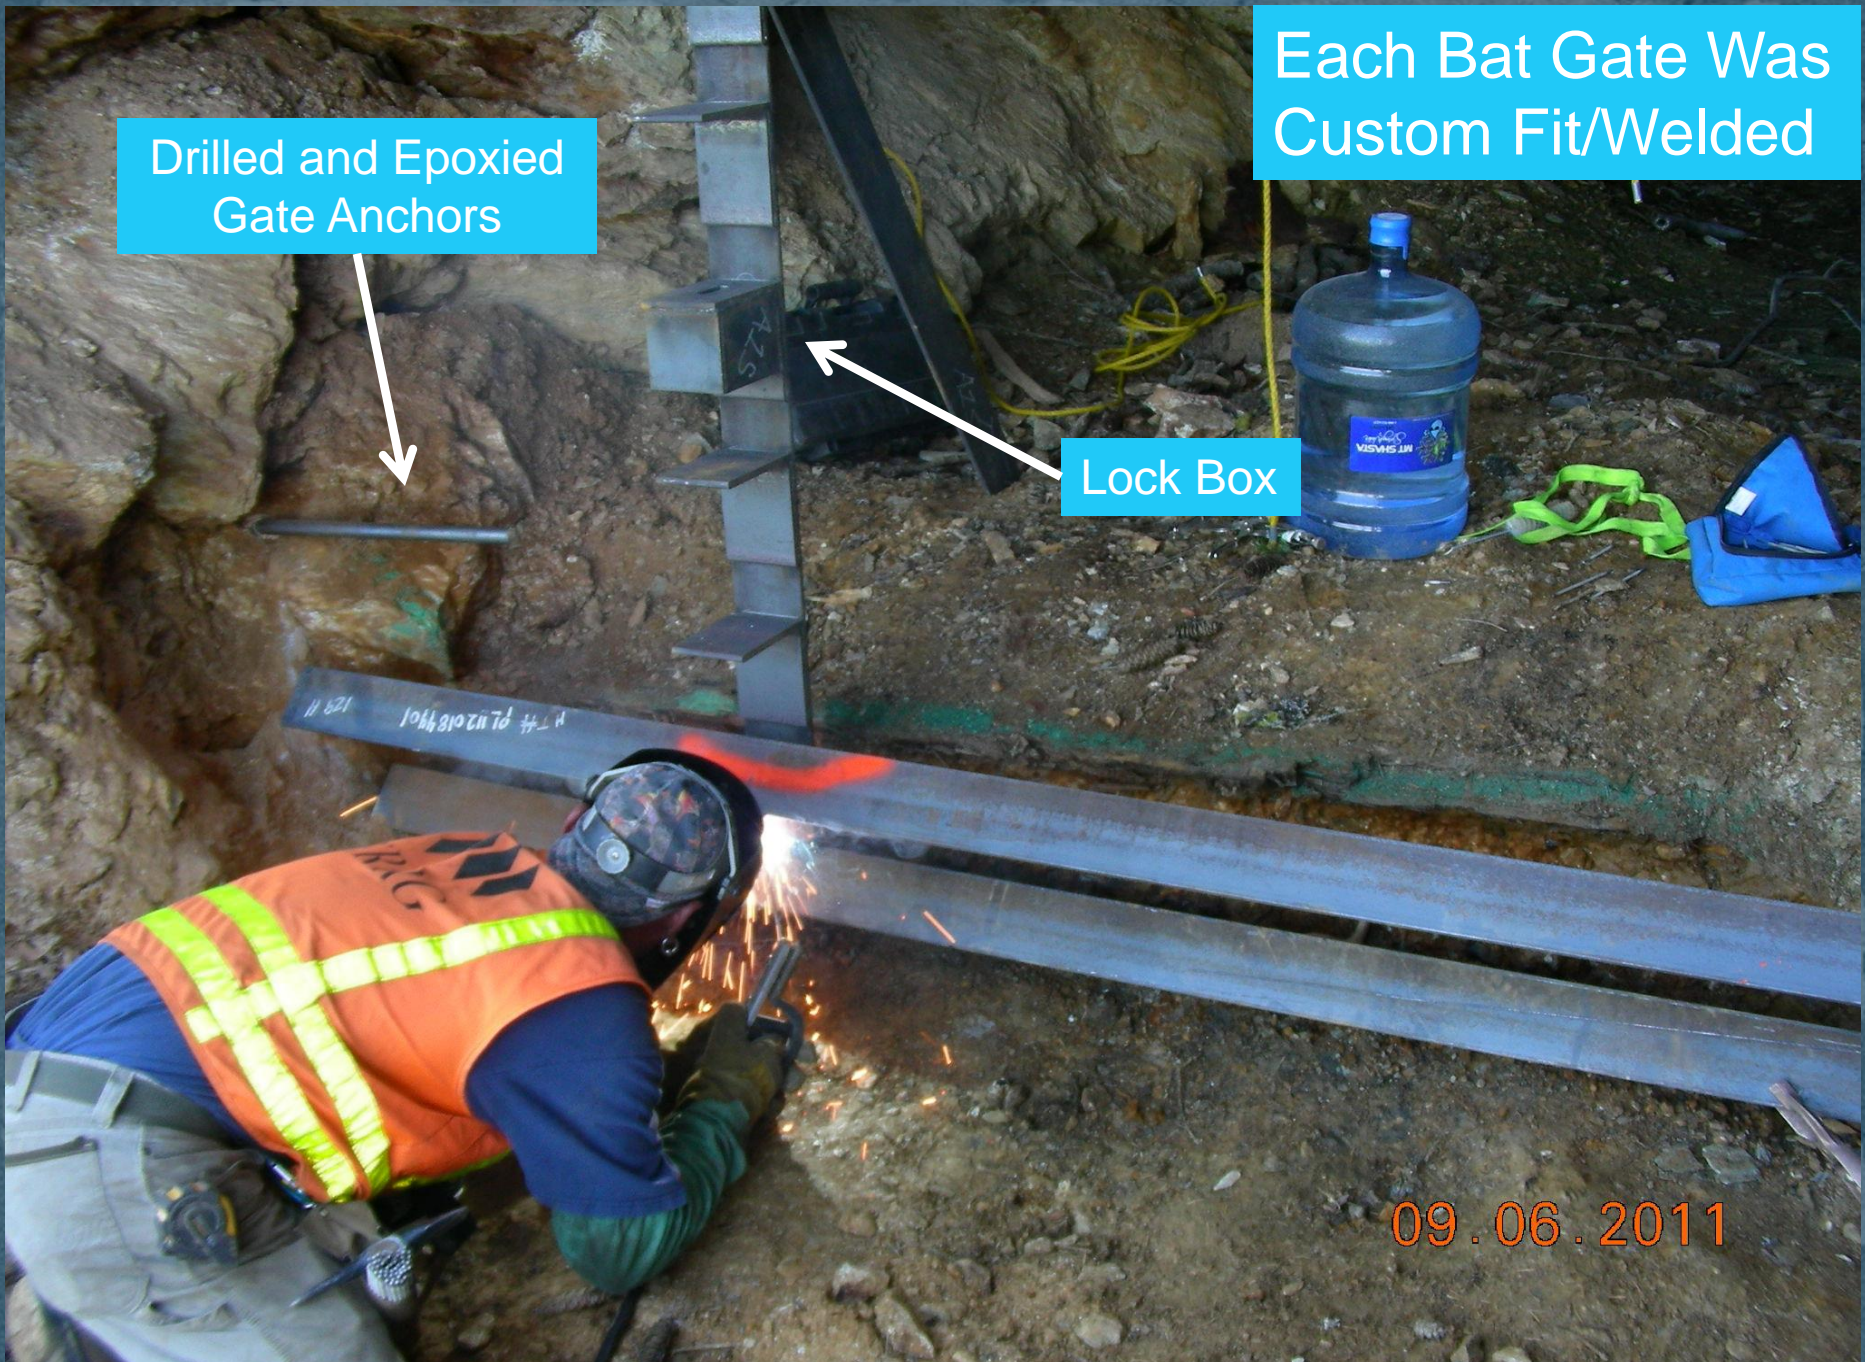
Each Bat Gate Was Custom Fit/Welded

Drilled and Epoxied Gate Anchors

Lock Box

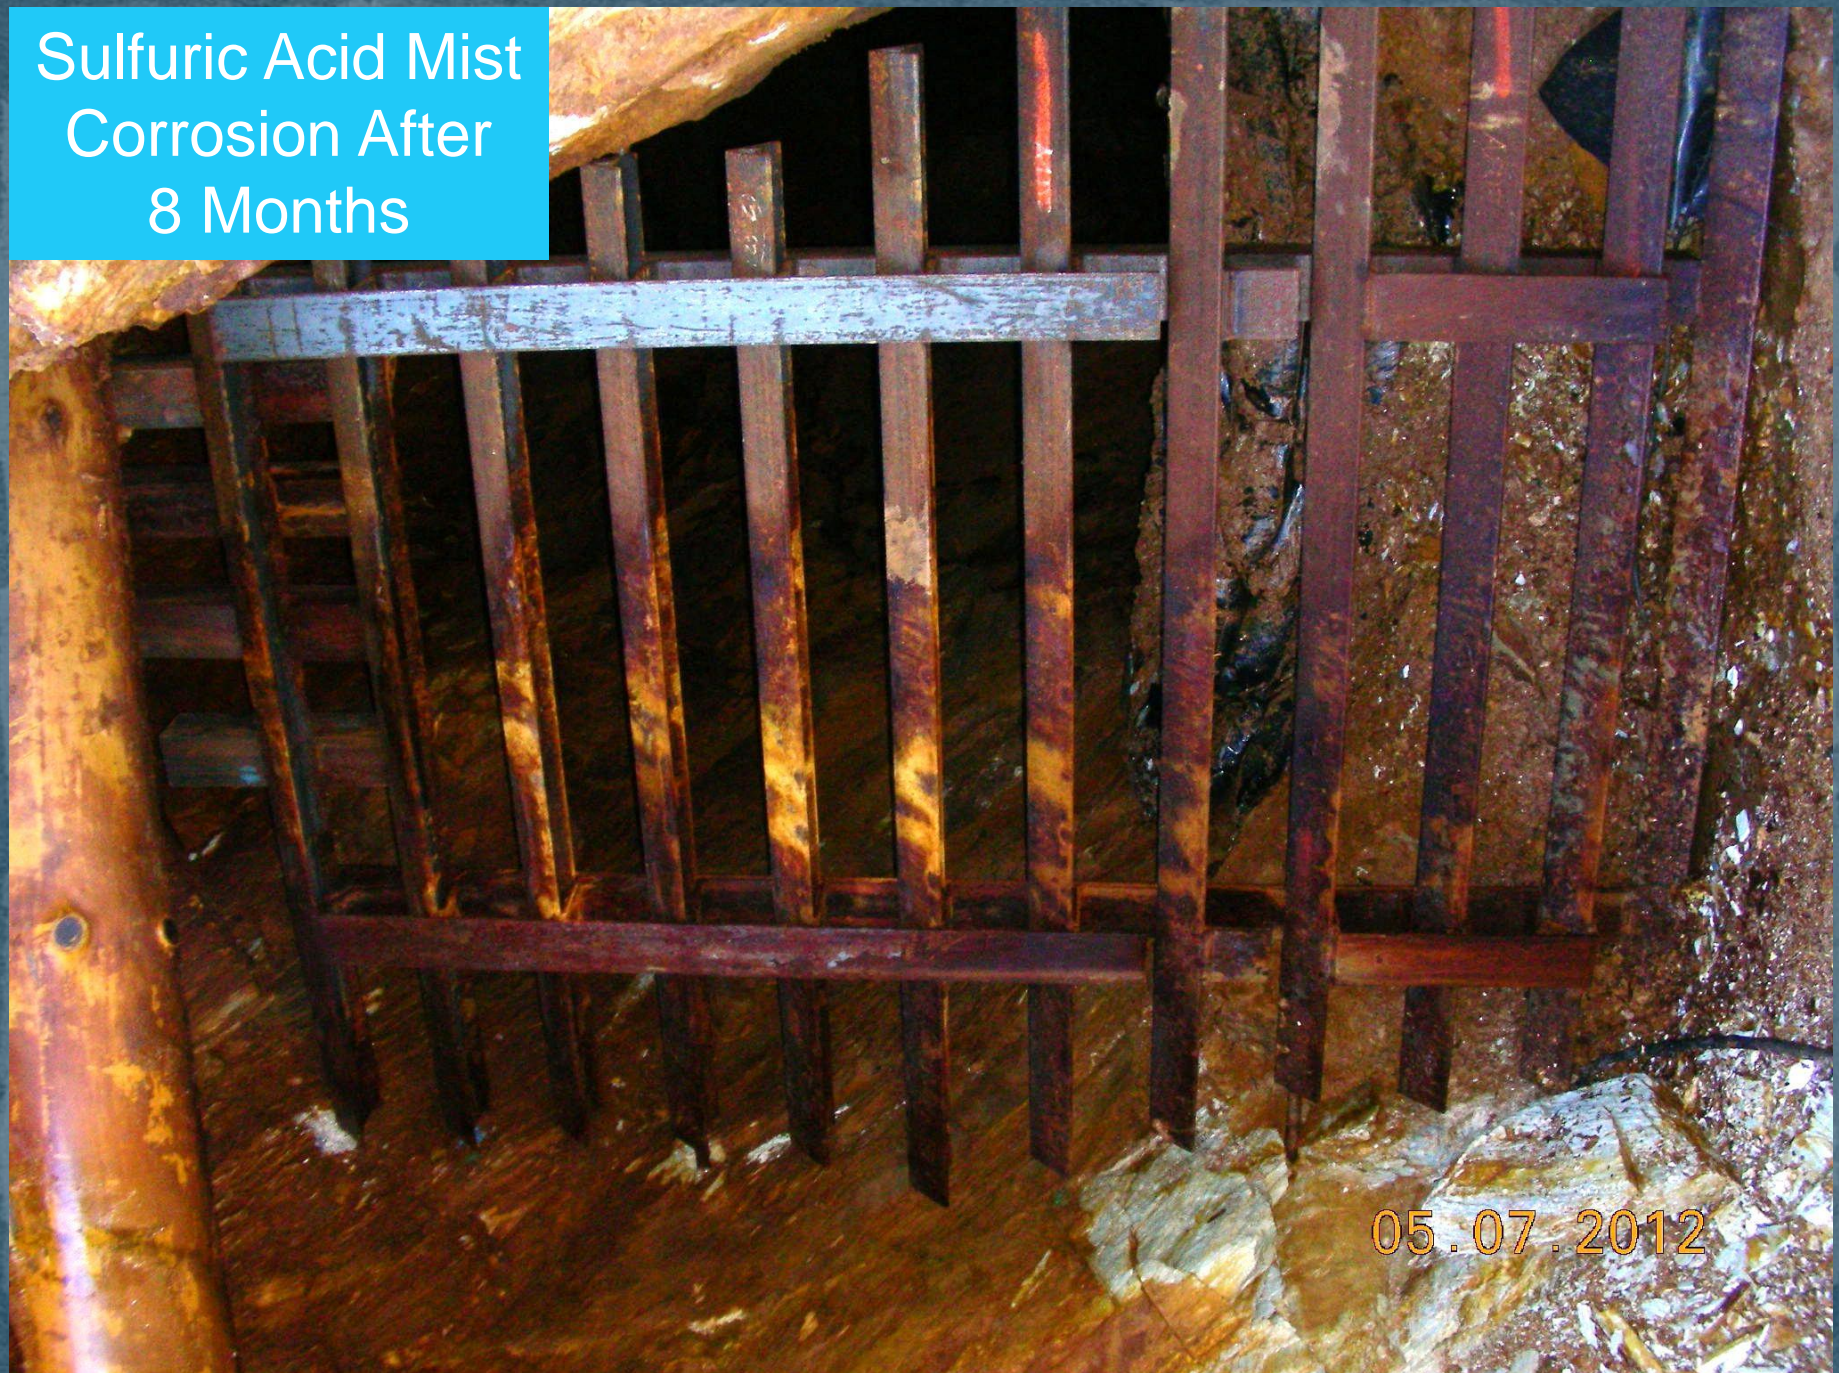
Sulfuric Acid Mist
Corrosion After
8 Months
