Emergency Response at the Ute Ulay Mine Tailings Site, Lake City Colorado

Michael J. Gobla, P.E.

U.S. Department of the Interior
Bureau of Reclamation

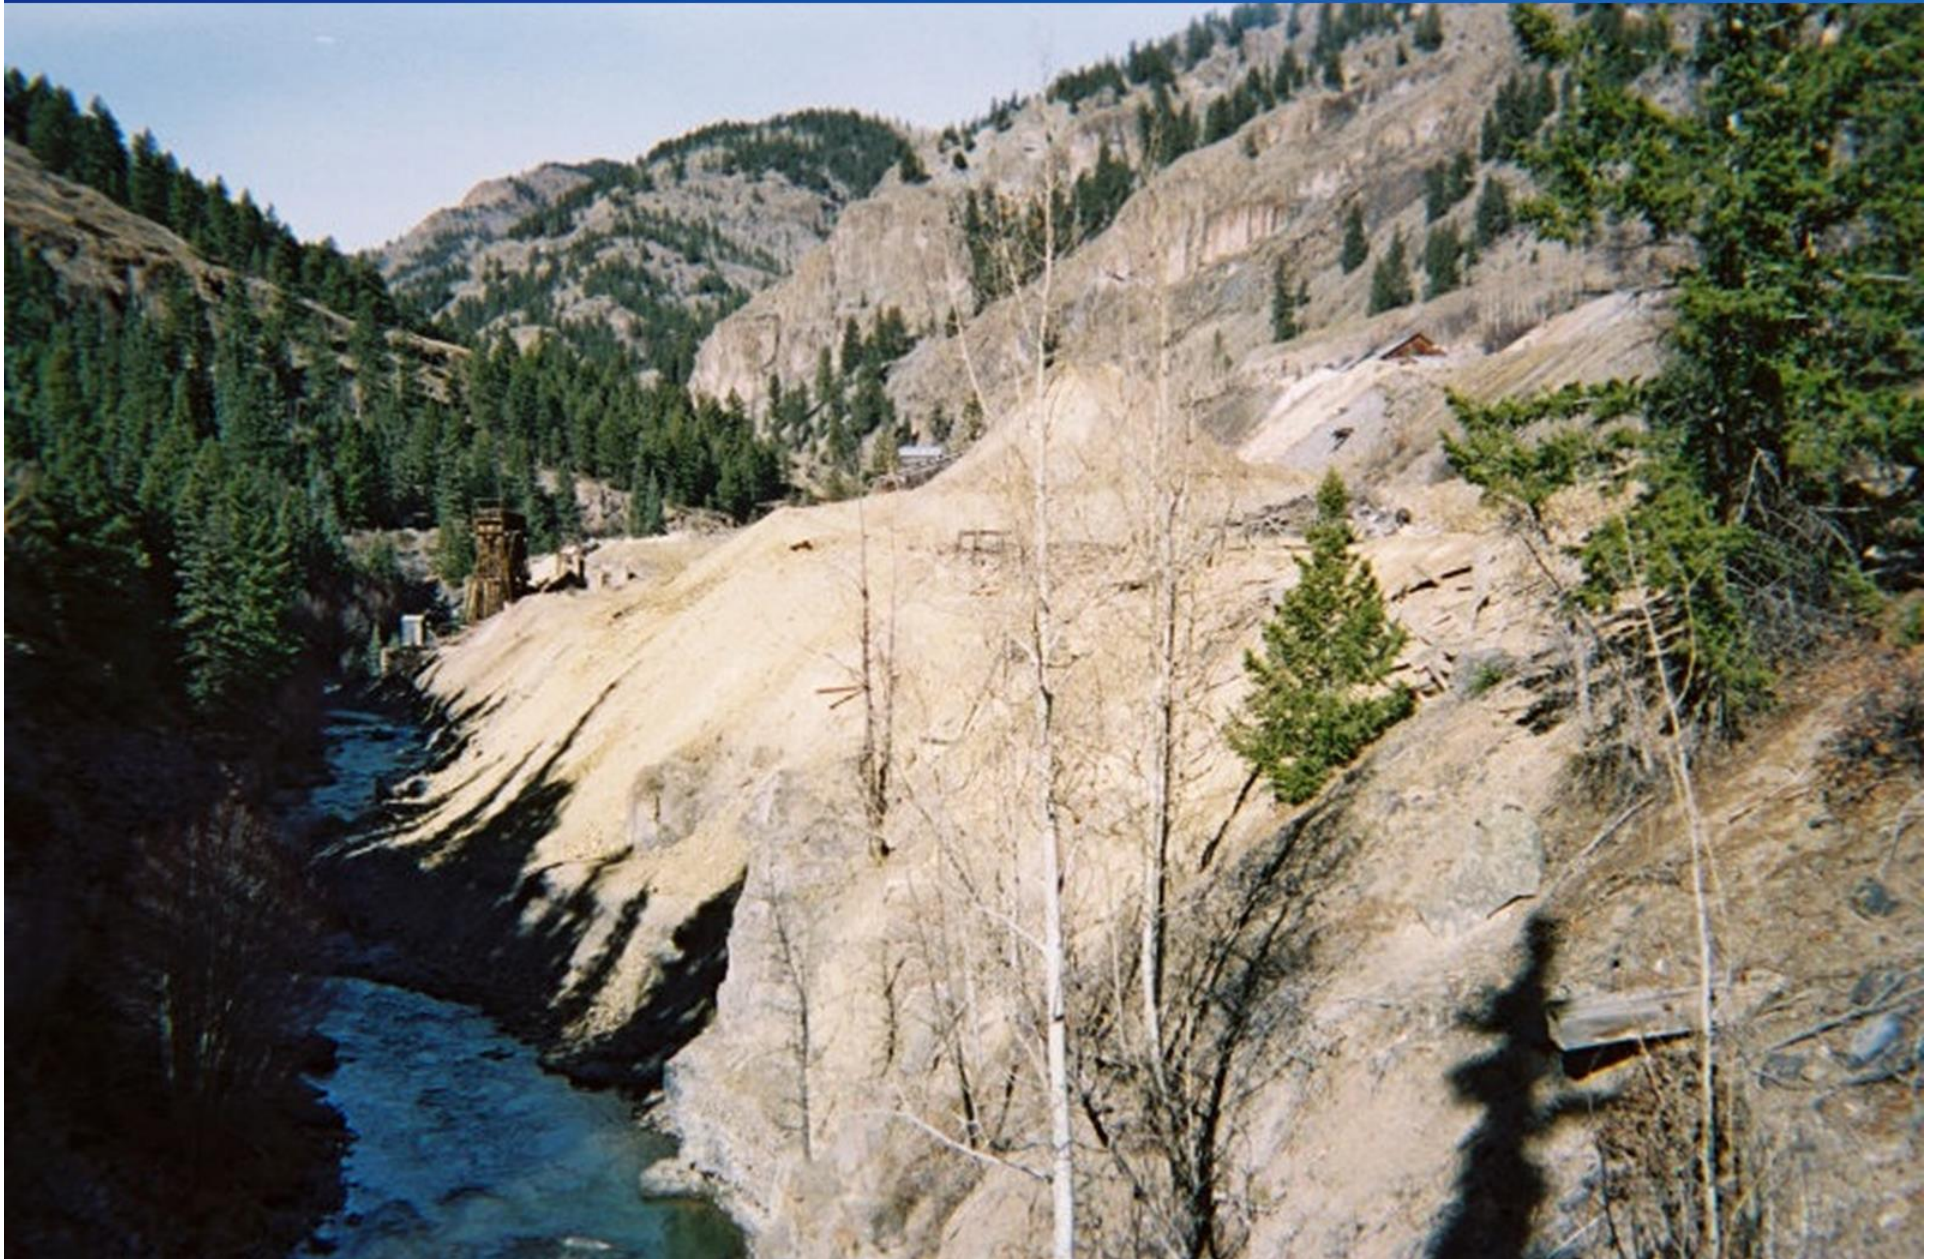
Site Overview

April 2011 - Avalanche blocks Henson Creek

A 30-ft deep pool formed against the tailings and waste rock. The snow dam failed 24 hours later.

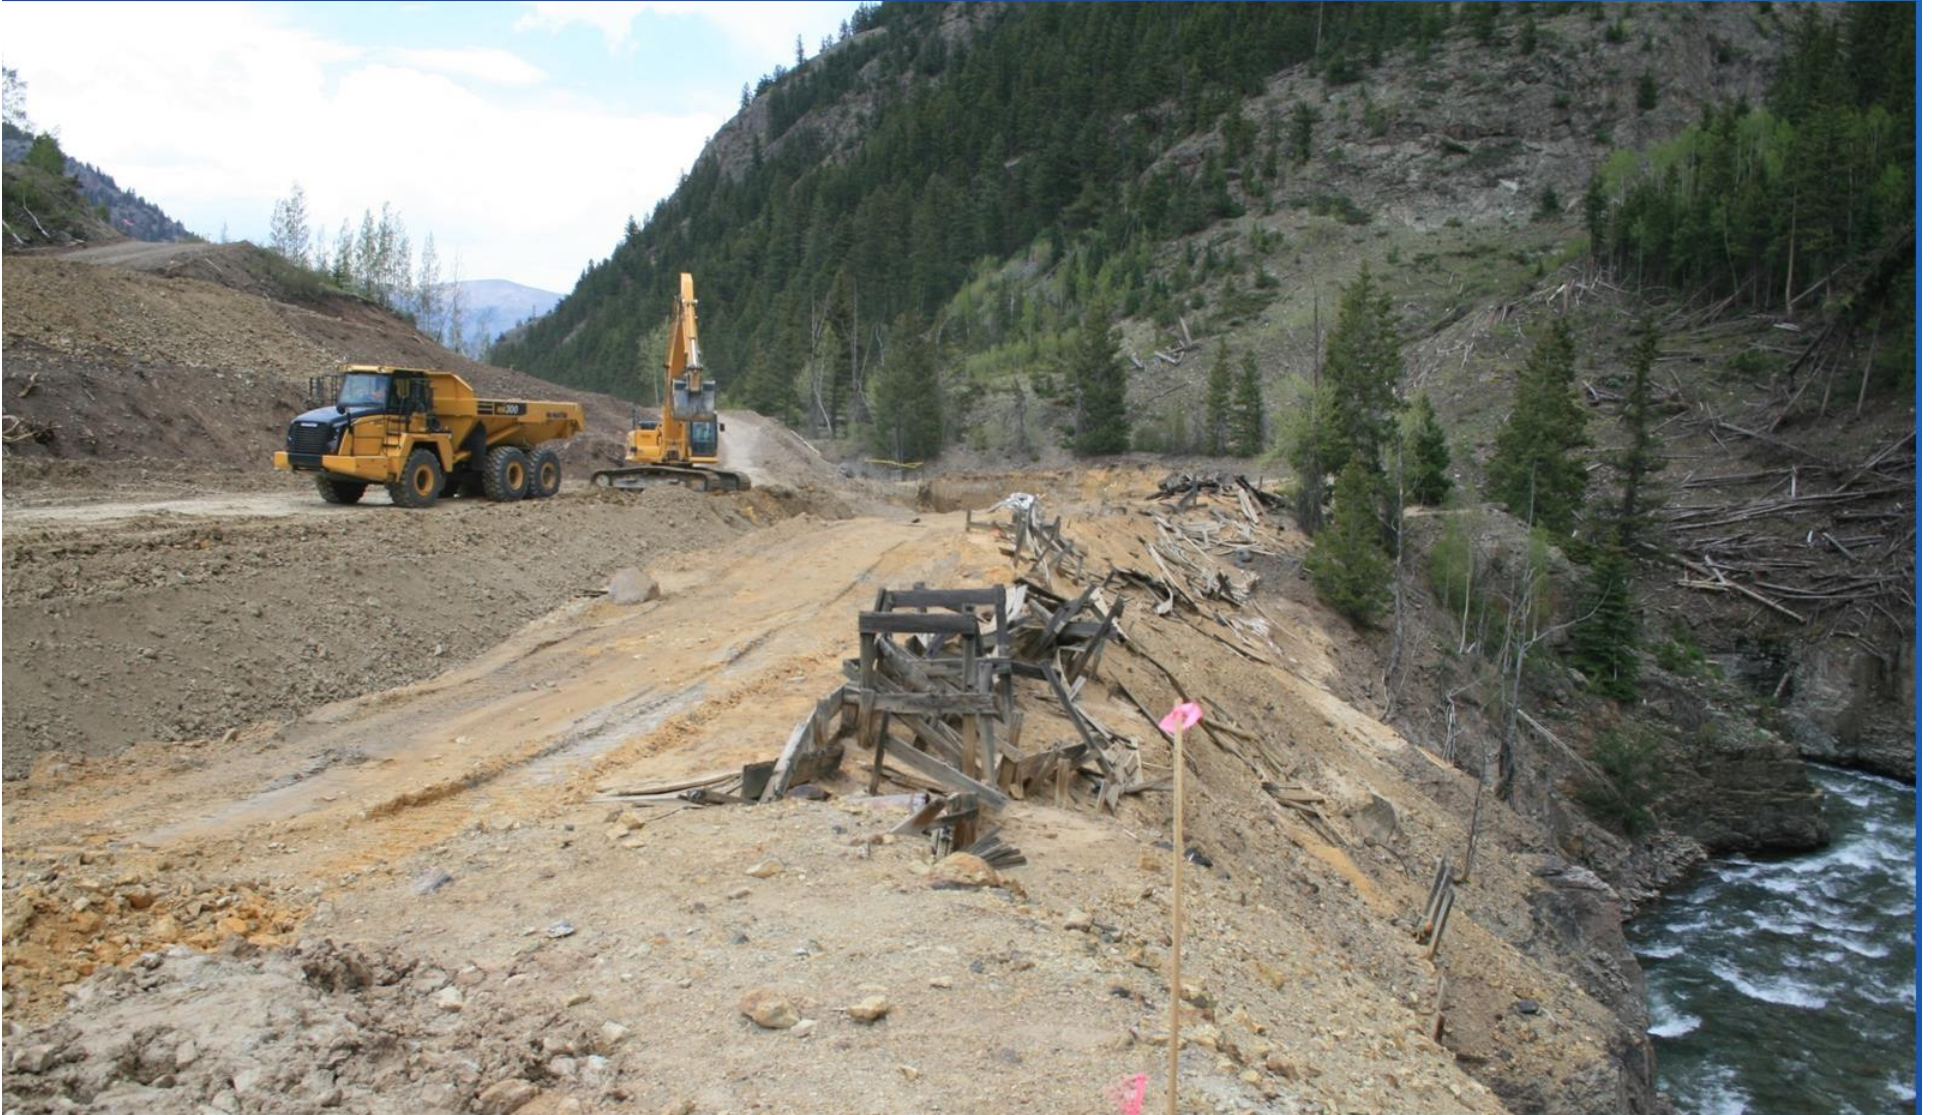
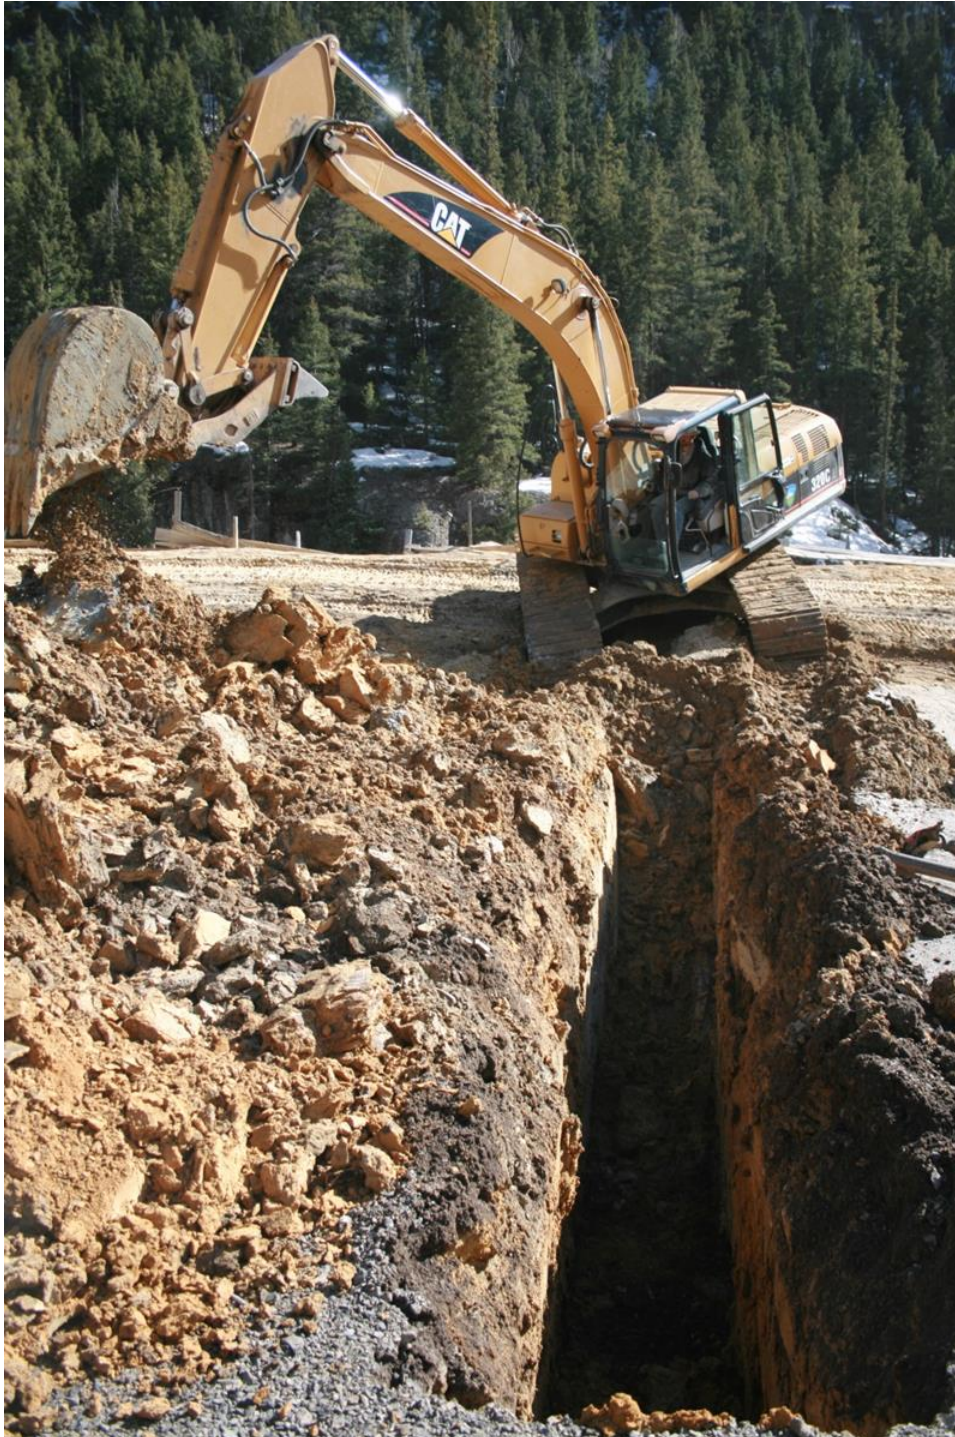
Original design would have led to a massive slope failure

Weak Tailings:

**Incomplete Site
Investigaiton**

**Improper Stability
Analysis**

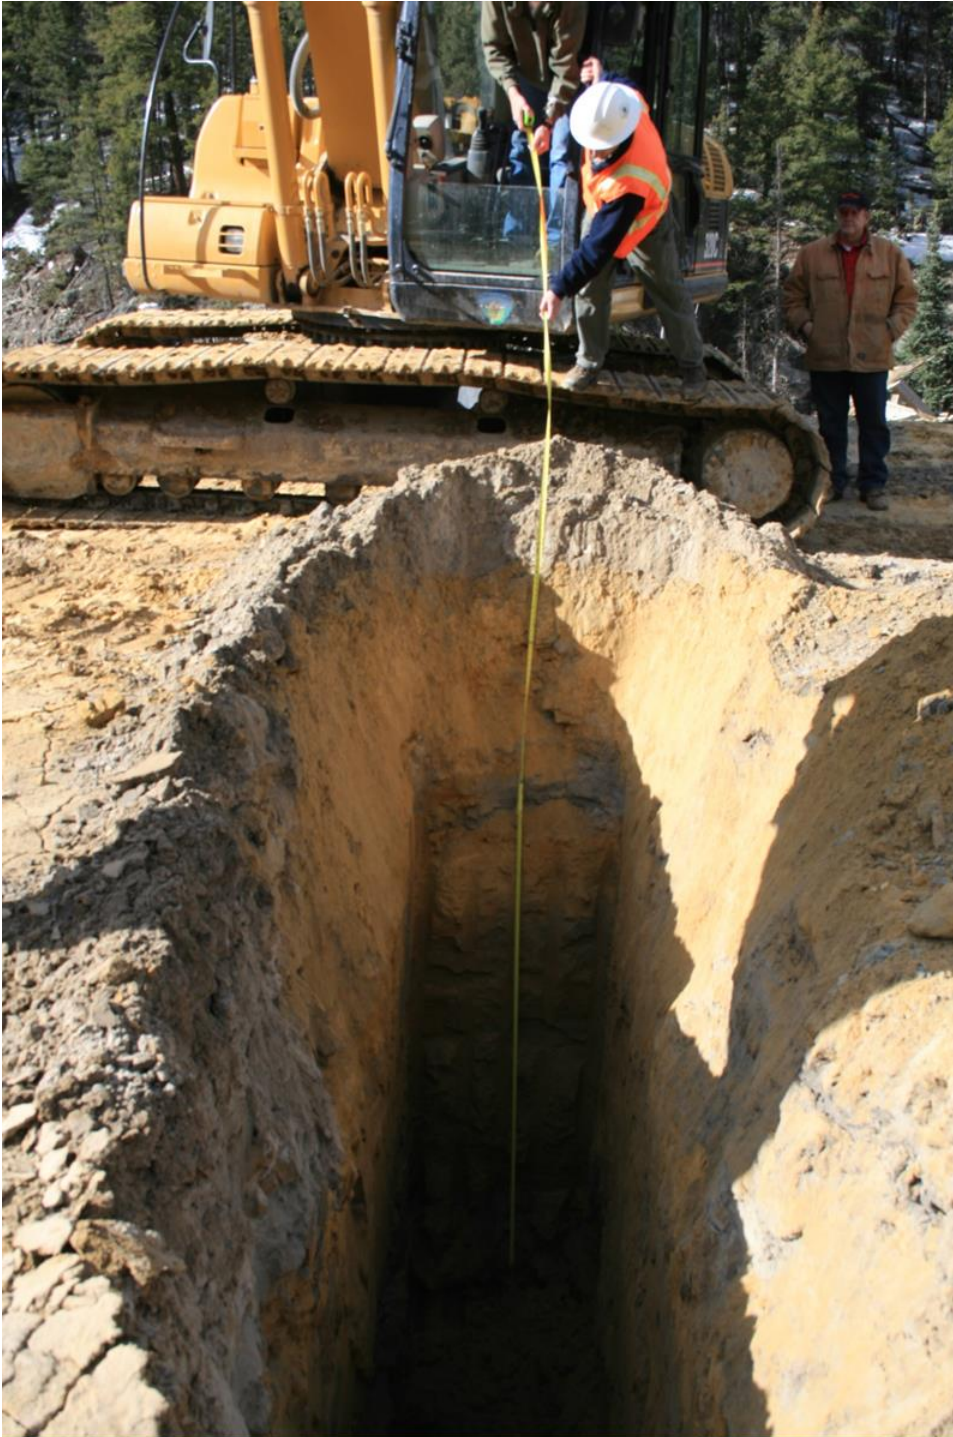
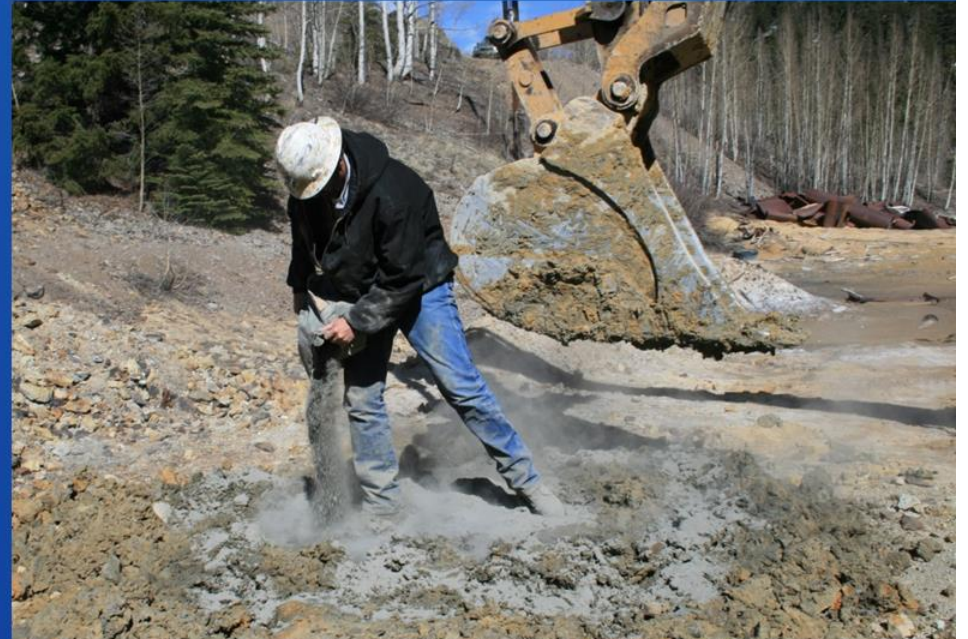
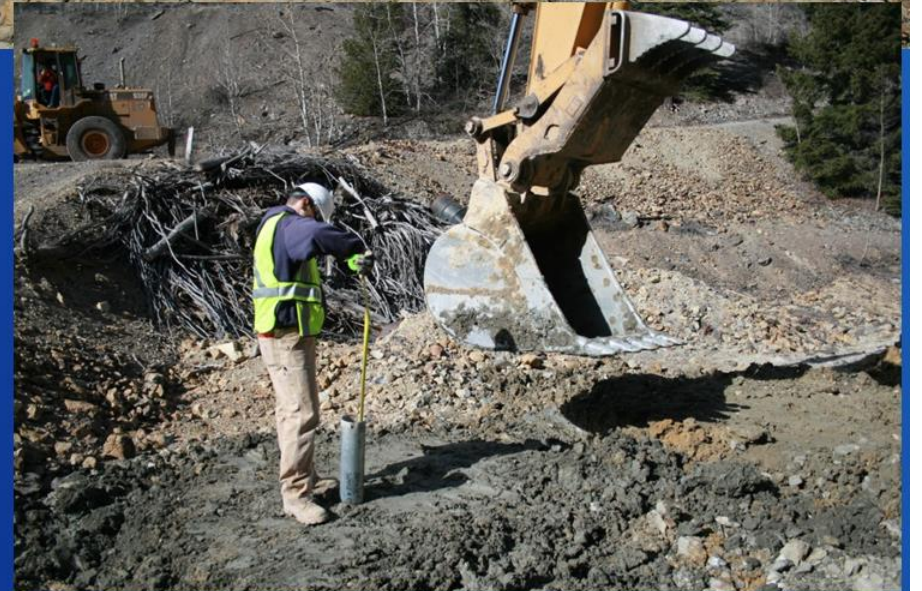
Site Investigation

Steep slopes above swift water
